National Transportation Safety Board

WPR22FA266

STRUCTURES

Location: Tryon, Nebraska
Date: July 25, 2022
Time: 0839 central daylight time
Airplane: N192MH, Experimental Homebuilt Van's RV-9A

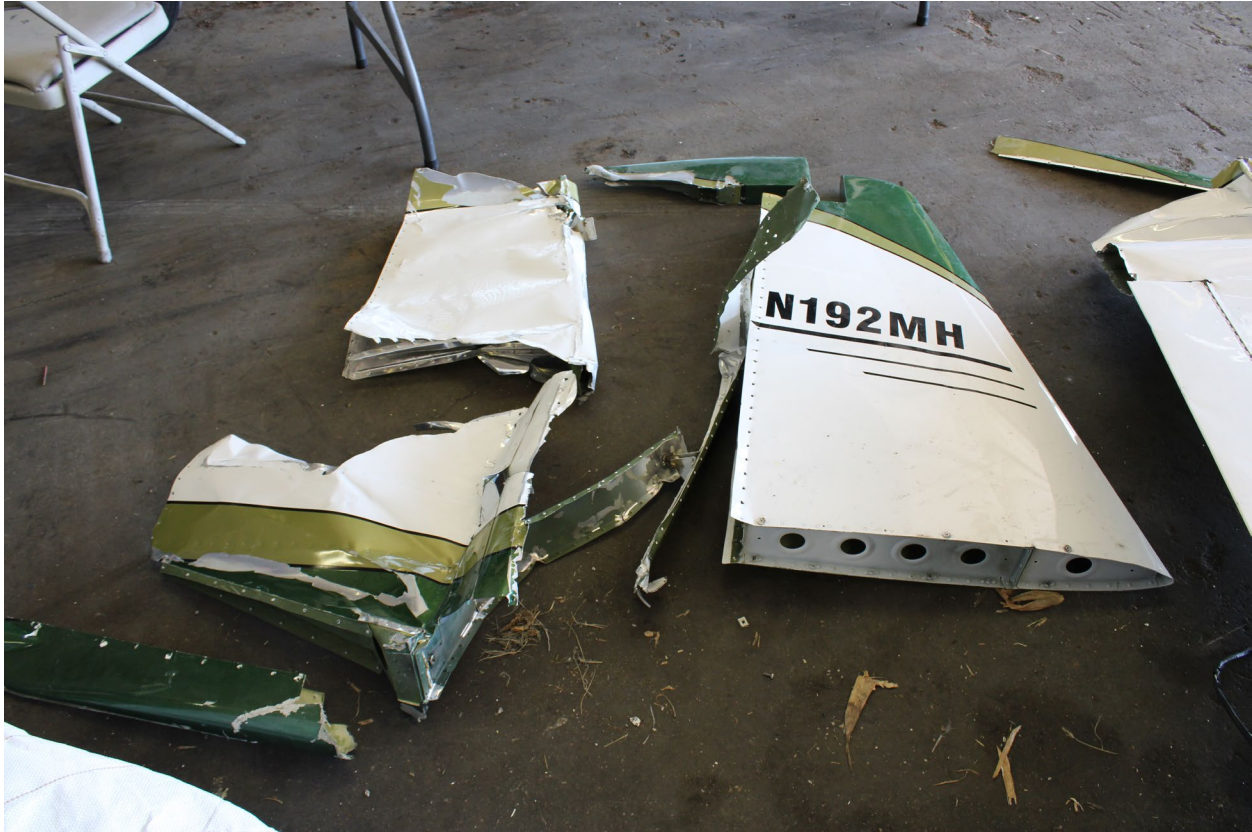
The vertical stabilizer separated mostly intact from the empennage (Figure 1). The front spar was fractured and deformed aft at the fracture location. The rear spar was pulled from the vertical stabilizer and the vertical stabilizer skins were splayed open. The vertical stabilizer spar had diagonal buckling damage along most of its length. The upper rudder hinge plates were pulled from the spar and the upper half of the spar was deformed and twisted to the right. The rudder was separated and fractured into 5 pieces. The rudder counterweight was separated from the top of the rudder. The upper half of the rudder was mostly intact, but the trailing edge was splayed open. A section of the left center rudder skin was recovered separately, and a section of the right center rudder skin was not recovered. The lower section of rudder remained attached to the vertical stabilizer spar at the center hinge and the trailing edge was splayed open. There was evidence of sealant applied on the rudder trailing edge skins and the trailing edge strip was not recovered. The lower rudder cap was separated.

Figure 1. Separated vertical stabilizer and rudder.

The observed damage was consistent with structural failure initiated by flutter of the rudder and no anomalies were found during examinations of the wreckage.
