**Component testing at Mooney International, Kerrville, Texas on behalf of the NTSB
Reference WPR18FA210
Mooney M20J N56039 SN 24-1358**

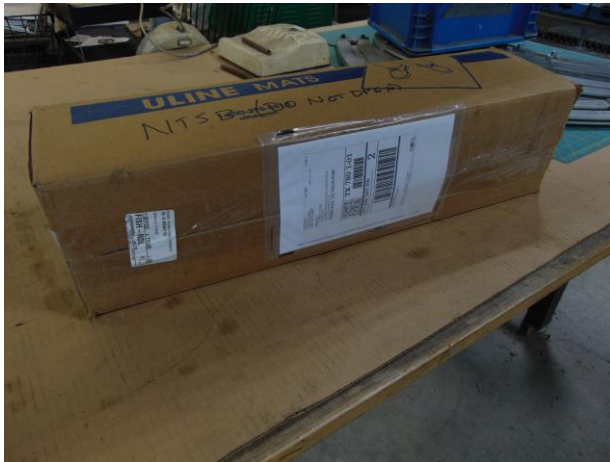
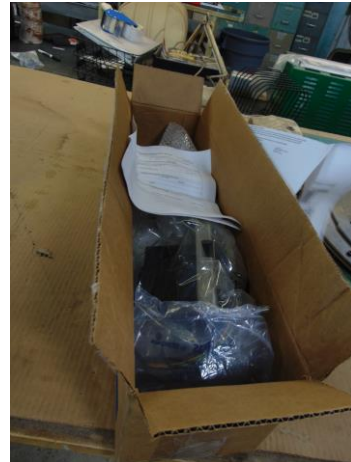
Packing as received at Mooney

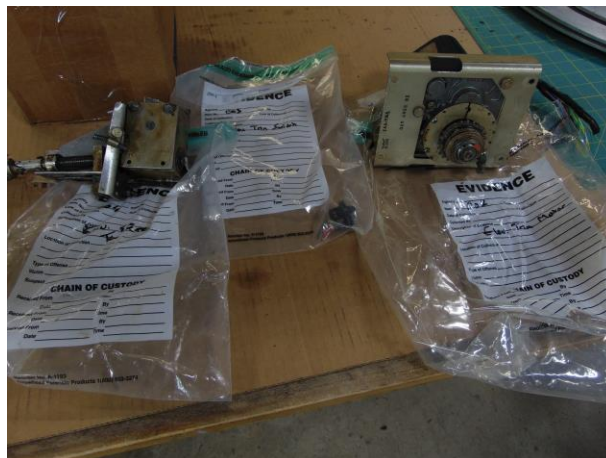
Components as received at Mooney

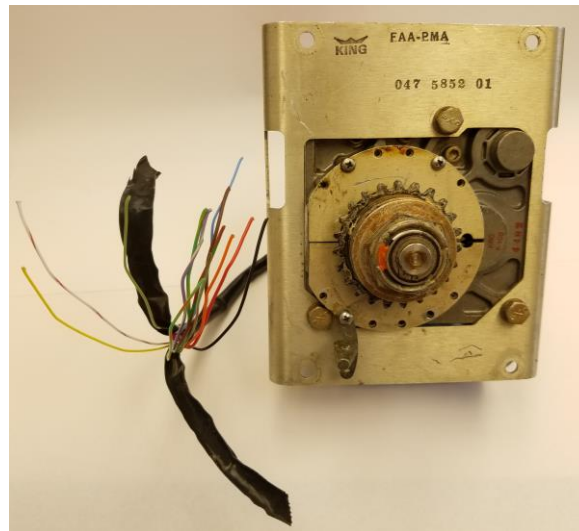
Elevator trim servo

The wiring cable to the elevator trim servo had been cut during removal of the unit from the wreckage and Mooney does not have the resources to determine which of the 13 exposed wire threads are needed to properly test the functionality of the servo. Mooney suggest that the unit be sent to the manufacturer of the unit for proper testing.

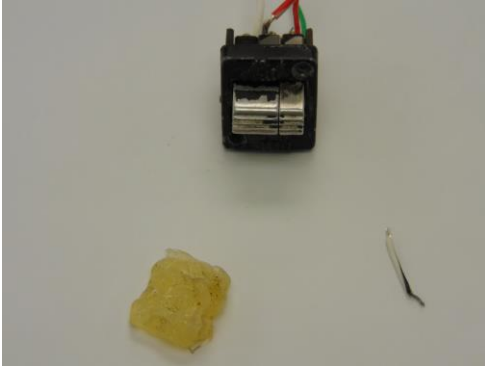
After removing the potting on the back of the elevator electric trim switch, the wiring that was attached to it was checked against Mooney drawing 810202 and found to be correct. The white wire with black stripe broke free during continuity testing. Upon close examination, the end of the wire was securely soldered to the switch post but it appeared that only a portion of the wire strands had been intact prior to breaking while being moved for testing. The red wire with white stripe also came loose at the switch post while being moved for the testing. The switch is worn from use and no longer has the same sharp detents as a newer switch but was otherwise deemed to be functional as intended.

Elevator electric trim switch (front)
with removed potting and detached wire

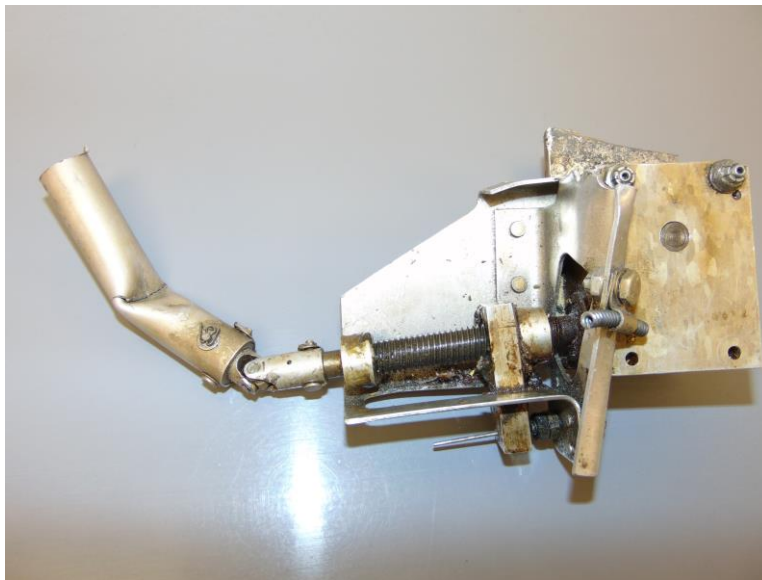
Lower portion of the stabilizer assembly, trim control

During the visual examination, it was noted that the two lower bolts on the gear box housing were missing as received. It was also noted that the rectangle traveling block was all the way up against the forward stop nut.

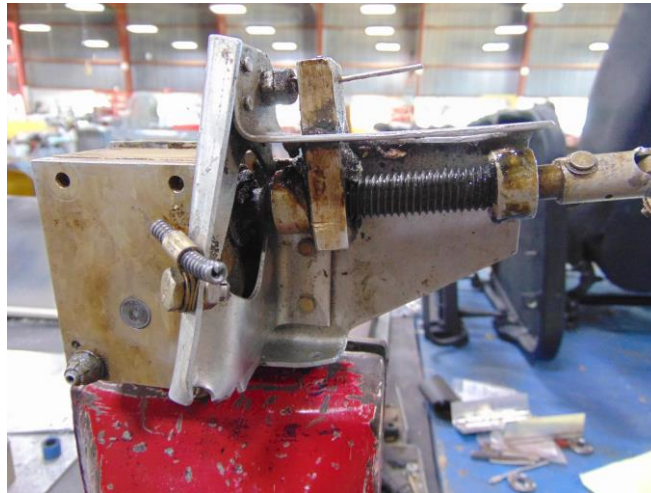
The assembly was supported in a vice in order to measure the torque required to back the traveling block away from the stop nut but as one of the connecting pins at the universal joint and torque tube was being removed to accommodate a torque wrench for the test, the jack screw rotated freely backing the traveling block away from the stop nut. Further rotation the jack screw showed that the jack screw was bent inside the gear box housing consistent with damage that would be expected during crash impact. Due to the damage and partial disassembly of the unit as received, no other testing was done.

Lower portion of the stabilizer assembly, trim control mounted for testing

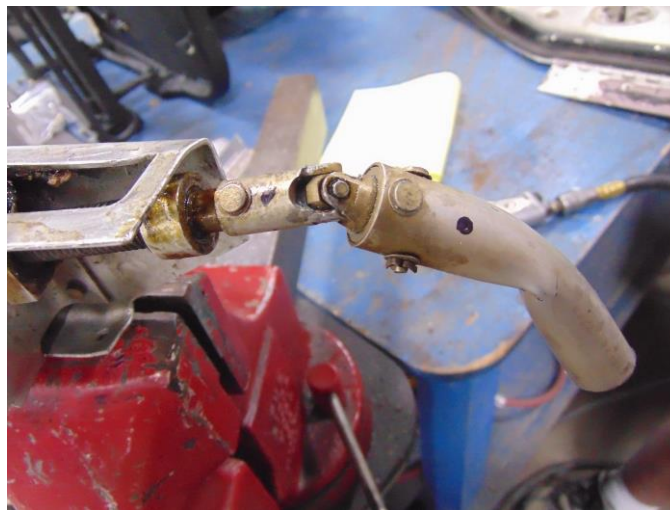
Universal joint and remaining piece of torque tube. The black dots were added as a reference of the alignment.
