## **NATIONAL TRANSPORTATION SAFETY BOARD**

### **SUMMARY OF AIRCRAFT EXAMINATION**

**(WPR19LA064)**

Location:	Port Hadlock, Washington
Date:	January 13, 2019
Aircraft:	Beech B35
NTSB Investigator-in-Charge	Thomas M. Little

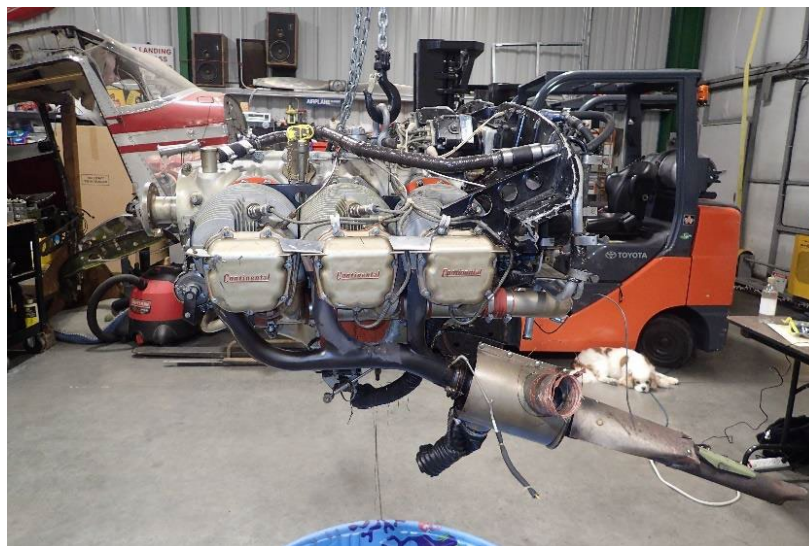
The engine had been removed from the airframe prior to the investigator's arrival. The engine displayed impact damage signatures with the majority of the damage having occurred to the front right side of the engine. The crankcase remained intact and there were no breaches that would indicate an internal engine failure. The propeller flange remained attached to the crankshaft; however, a portion of the propeller flange had broken free and remained attached to the propeller hub. All six cylinders remained attached to their cylinder bays and displayed varying amounts impact damage signatures, with the #5 cylinder displaying the most damage.

Figure 1 - view of right side of engine as received

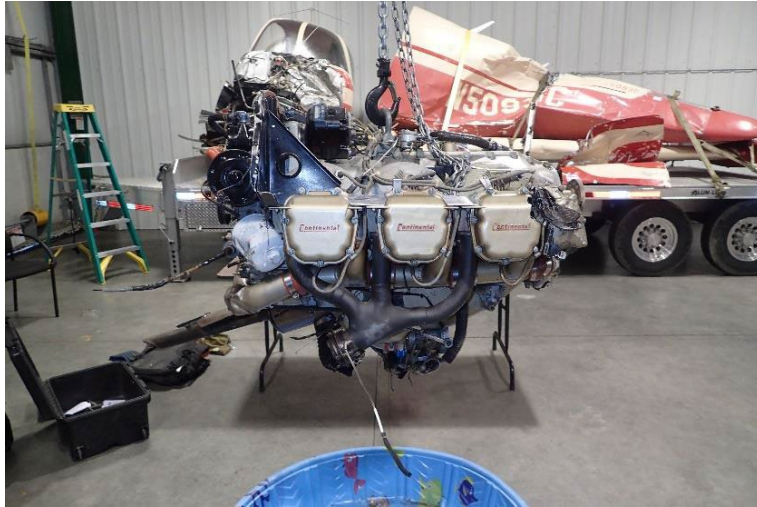
Figure 2 - view of left side of engine as received

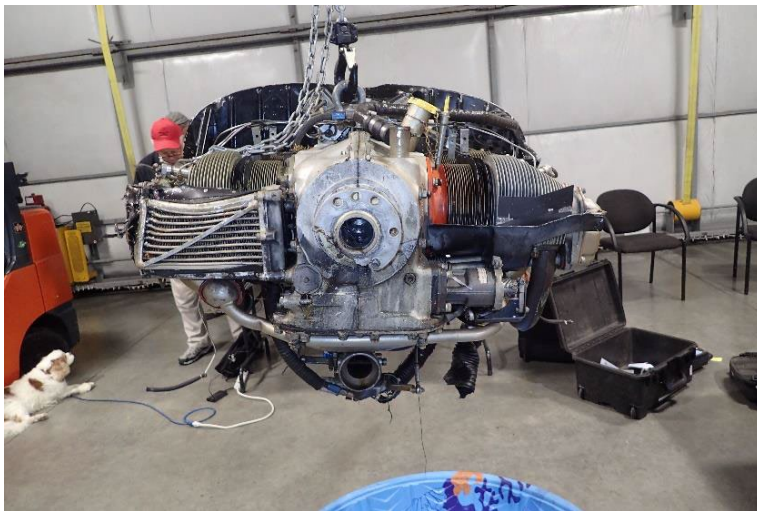
Figure 3 - view of front of engine as received

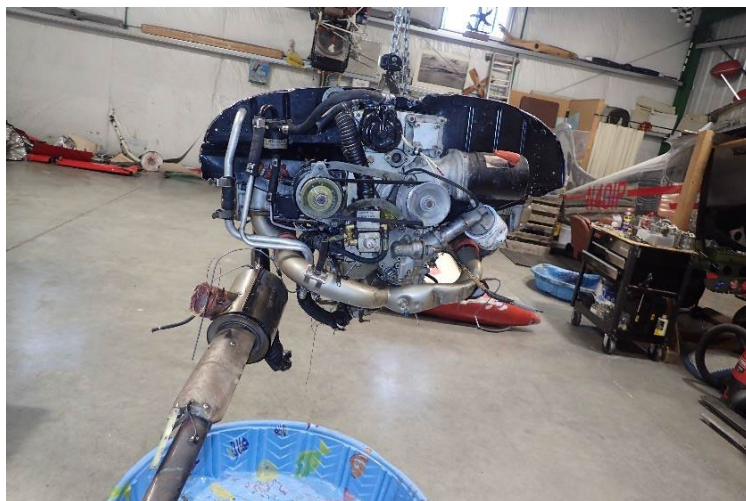
Figure 4 - view of rear of engine as received

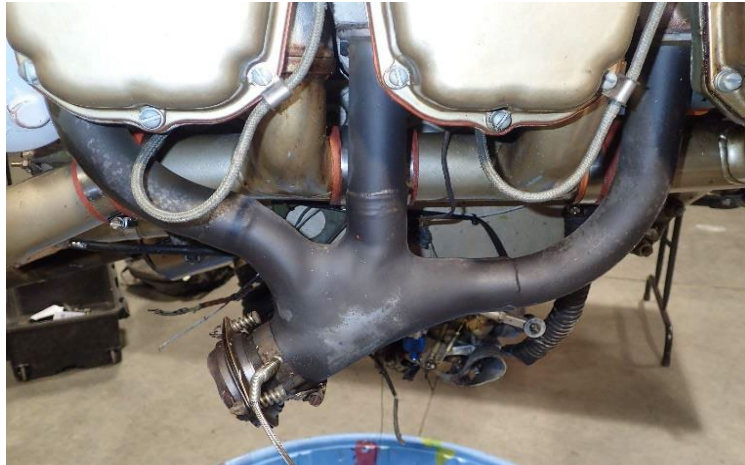
The exhaust system displayed impact damage signatures with the right-side exhaust showing the most damage. There were no signs of exhaust leaks or blockages noted.

Figure 5 - right side of exhaust system

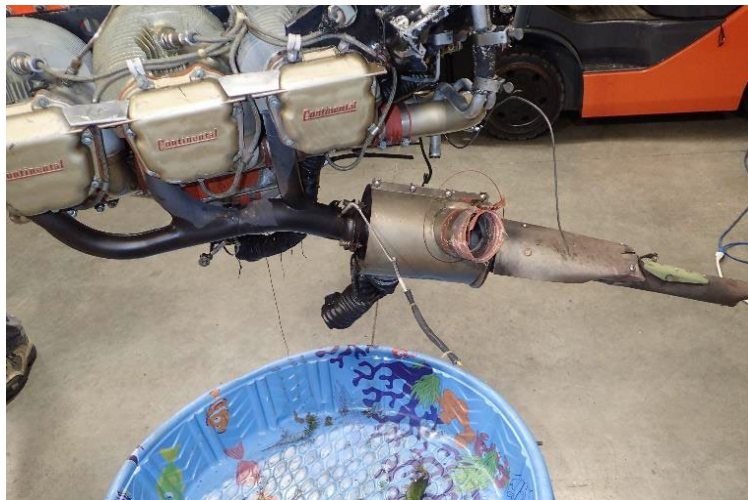
Figure 6 - left side of exhaust system

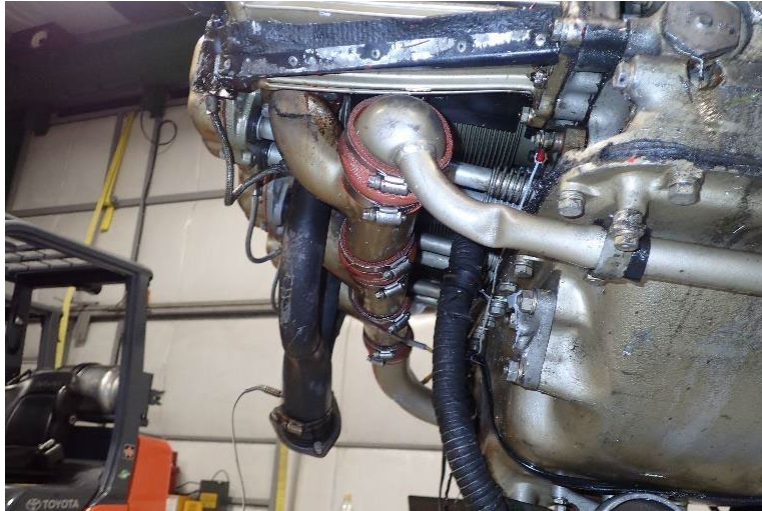
The induction system displayed impact damage signatures with the most damage occurring to the Y-pipe and the balance tube. There were no signs of induction leaks noted.

Figure 7 - view of right side of induction system

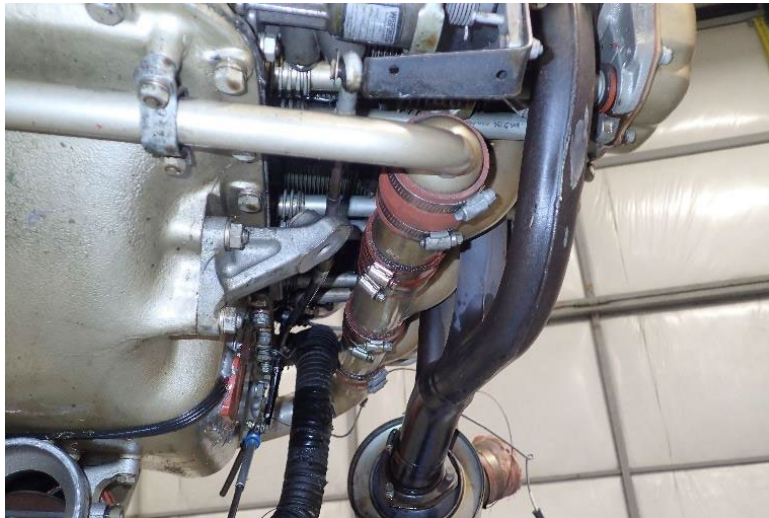
Figure 8 - view of left side of induction system

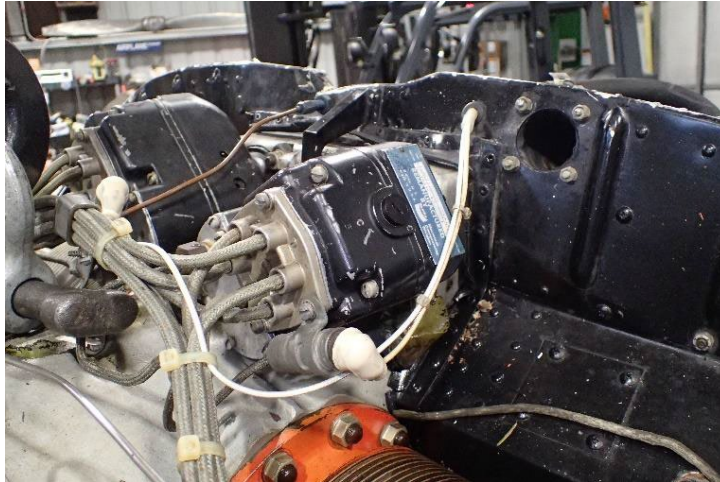
Figure 9 - left magneto

Condition: The magneto remained attached to its installation point and was undamaged. During crankshaft rotation it was noted that the impulse coupling was capable of operation. During impulse coupling operation, it was noted that the magneto could produce a spark on all six ignition leads.

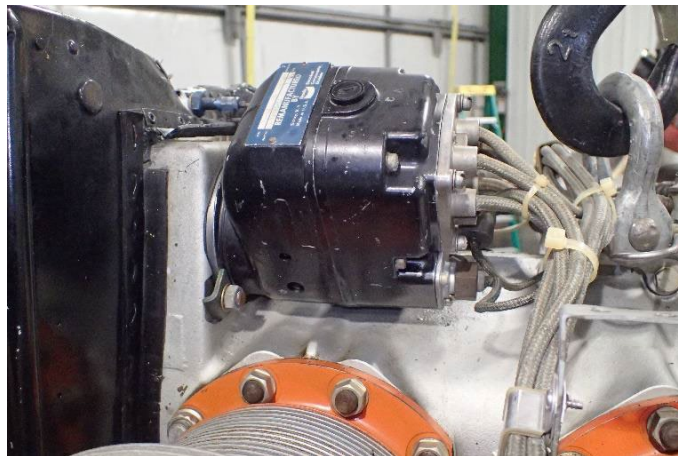
Figure 10 - right magneto

Condition: The magneto remained attached to its installation point and was undamaged. During crankshaft rotation it was noted that the impulse coupling was capable of operation. During impulse coupling operation it was noted that the magneto could produce a spark on all six ignition leads.

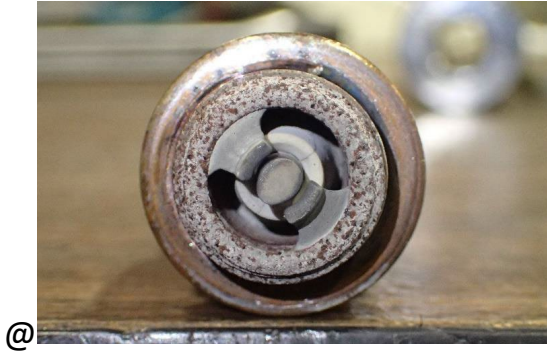
Figure 11 - #1 top spark plug

Condition: The top spark plugs were removed, and the spark plug electrodes were visually inspected. It was noted that the #1 top spark plug insulator was cracked in two places. The #1, #3, and the #5 spark plugs were grey in color with no combustion deposits noted. The #2, #4, and the #6 top spark plug electrodes were oil coated consistent with post-accident accumulation. The bottom spark plugs were inspected using a lighted borescope. The #2 bottom spark plug was submerged in oil and was unobserved; the rest of the bottom spark plugs displayed normal operating and wear signatures.

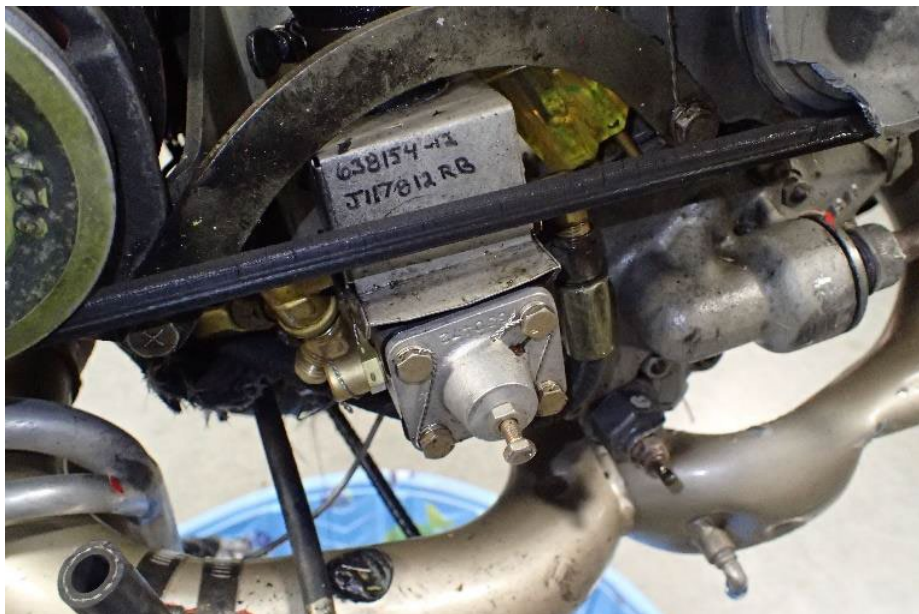
Figure 23 - fuel pump

Condition: The fuel pump remained attached to its installation point and displayed impact damage signatures; the fuel return AN fitting was broken and the adjustment bolt was bent. The fuel pump was removed, and it was noted that the drive coupling and gear remained intact and were undamaged. The fuel pump was primed with solvent and the drive shaft was rotated using a drill; the fuel pump as capable of pumping the solvent and was able to vary the rate with varying the RPM of the drill. There were not anomalies noted the fuel pump.

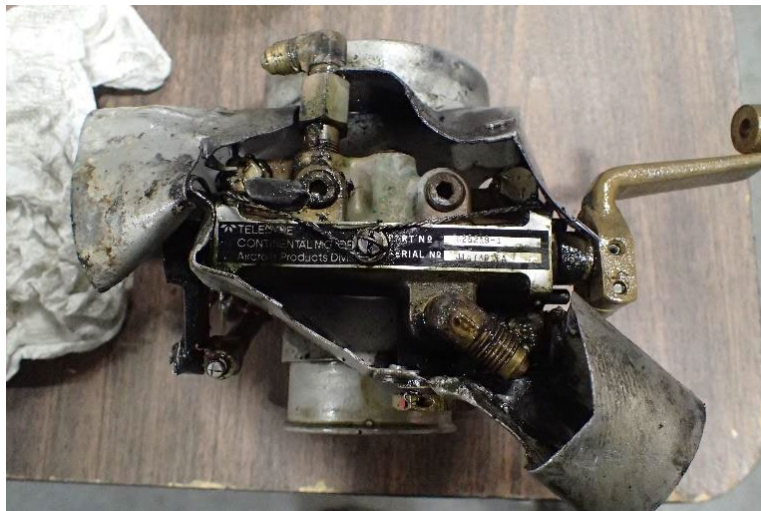
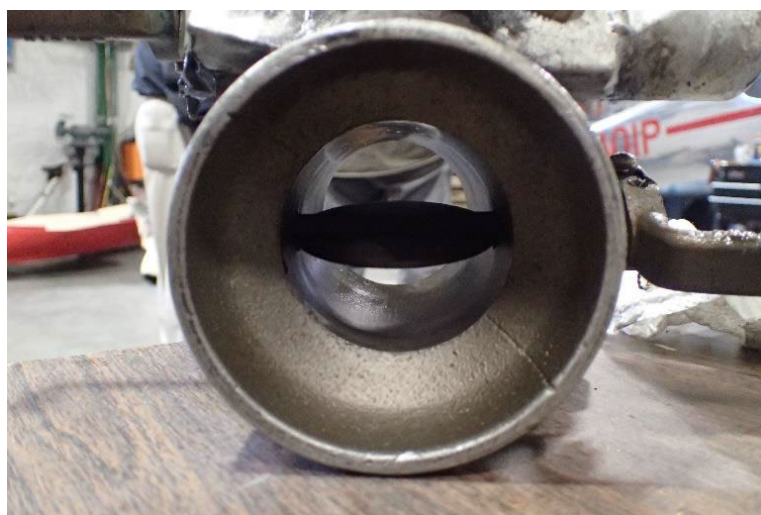
Figure 24 - throttle body metering unit

The throttle and metering assembly remained attached to its installation point and displayed impact damage signatures; one of the fuel AN fittings had broken free from the assembly. The throttle and mixture cable rod ends remained attached to the control arms and the control arms were secured to their shafts. Compressed air was blown into the assembly inlet and the assembly was able to meter the amount of air with adjusting the throttle and the mixture. The fuel inlet screen was removed, and it was noted to be clear of contaminants. There were no anomalies noted with the throttle and fuel metering assembly.

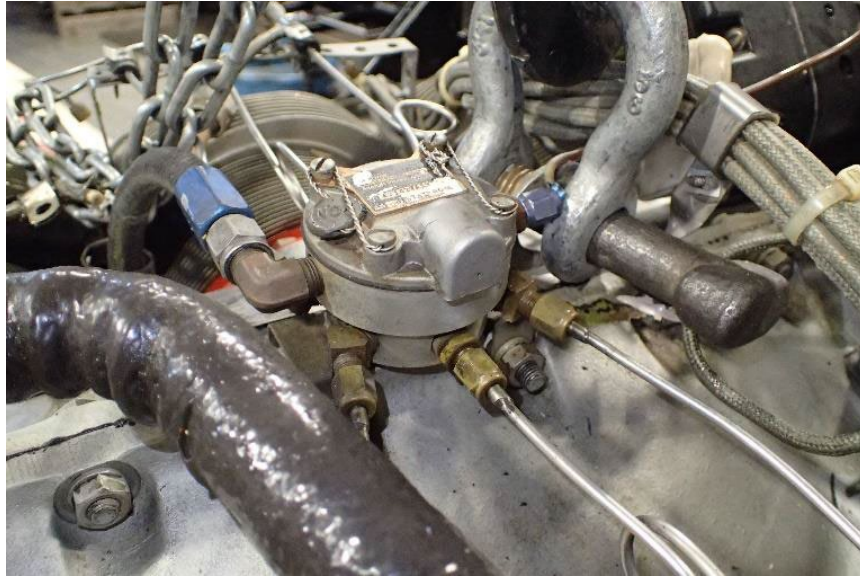
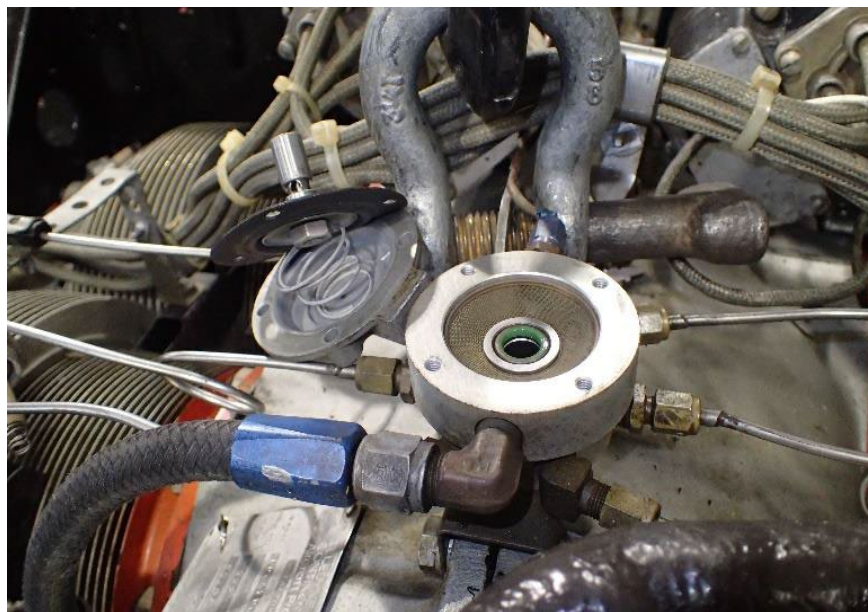
Figure 26 - fuel manifold valve

The fuel manifold valve remained attached to its installation point and was undamaged; there were no signs of fuel staining around the manifold valve. The manifold valve was disassembled, and the internal components were visually inspected. The components displayed normal operating signatures and the screen was clear of contaminants. There were no anomalies noted.

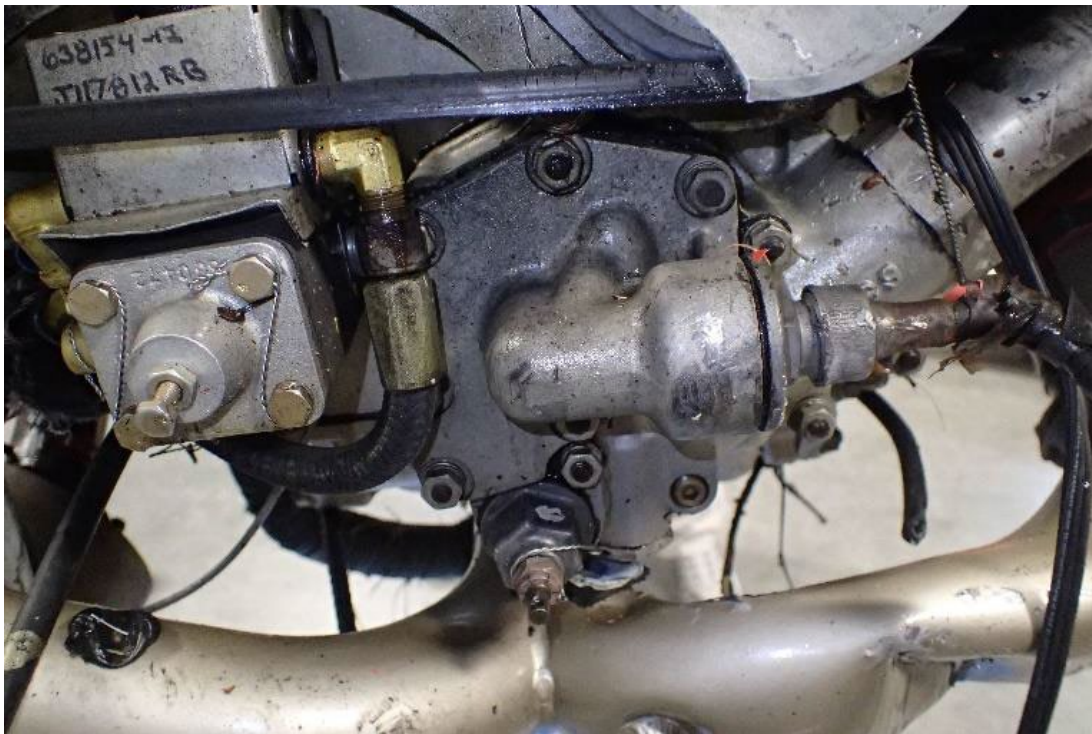
Figure 28 - Oil pump

Oil pump: The oil pump remained intact and was undamaged. During crankshaft rotation it was noted that the oil pump was capable of pumping oil out of the oil filter adapter. There were no anomalies noted.

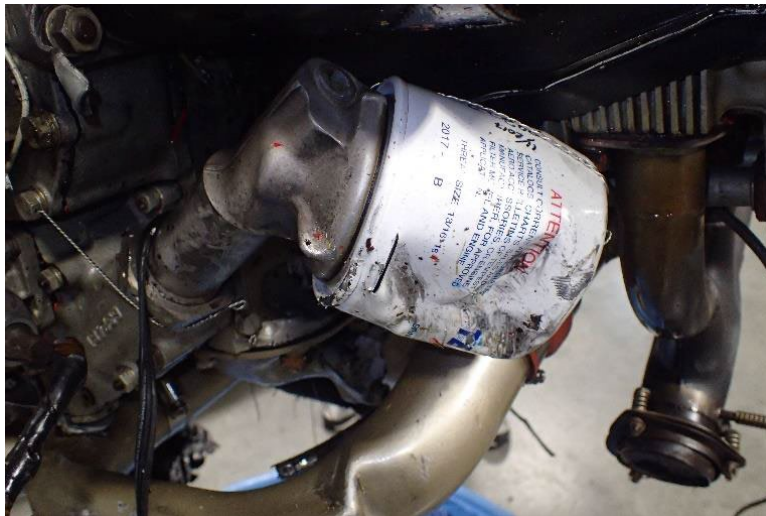
Figure 29 - oil filter

The oil filter remained attached to the oil filter adapter and displayed impact damage signatures. The oil filter was removed, and the housing was cut open. The filter pleats visually inspected; there was no metallic material noted within the filter pleats. There anomalies noted with the filter.

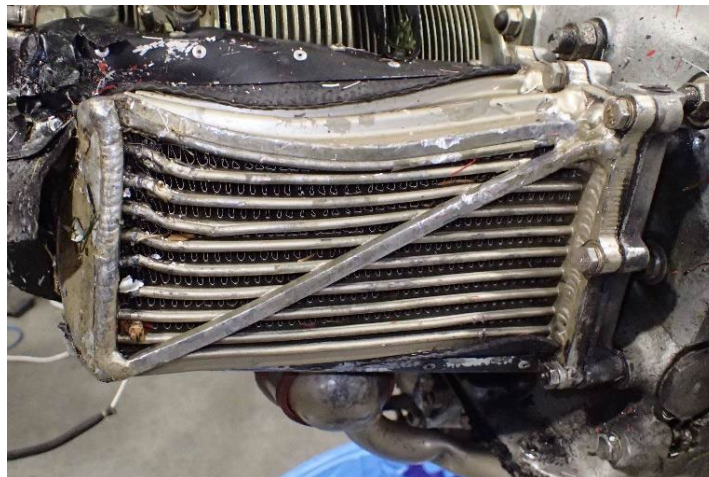
Figure 30 - Oil cooler

The oil cooler remained attached to its installation point and displayed significant impact damage. There were no anomalies noted.

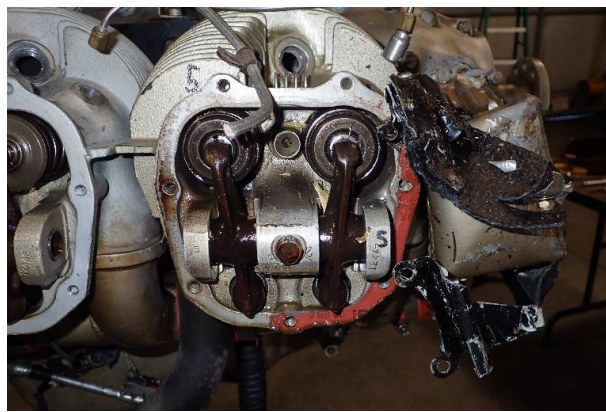
Figure 13 - cylinder #5

All of the cylinders remained attached to their cylinder bays and the #5 cylinder displayed impact damage signatures, the rest of the cylinders were undamaged. The cylinders were inspected using a lighted borescope; the piston faces, cylinder bores, and valve heads displayed normal operating and combustion signatures. During crankshaft rotation all of the cylinders displayed good thumb compression and suction. All of the overhead components (valves, springs, and rocker arms) displayed normal operating and lubrication signatures. There were no anomalies noted.

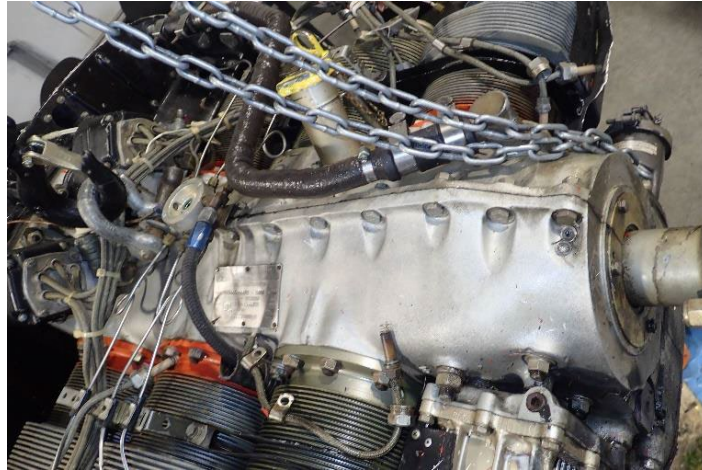
Figure 57 – Crankcase

The crankcase remained intact and was undamaged. There were no breaches in the crankcase that would indicate an internal engine failure. There were no anomalies noted.

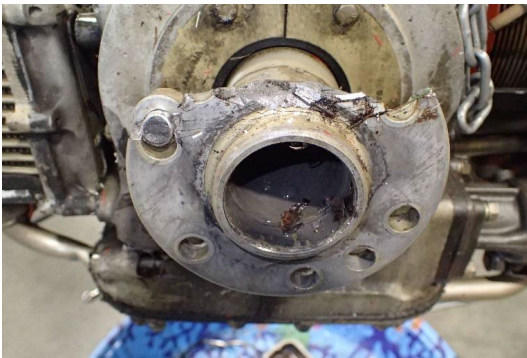
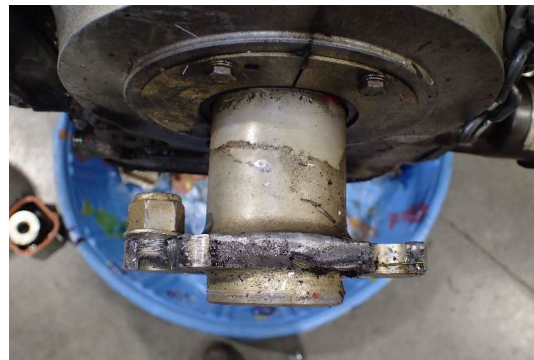
The crankshaft displayed impact damage signatures; a portion of the propeller flange had broken free and there were several cracks just aft of the propeller flange. The crankshaft was rotated using a hand tool and continuity was established between the crankshaft, camshaft, connecting rods and associated components. There were no anomalies noted with the crankshaft.

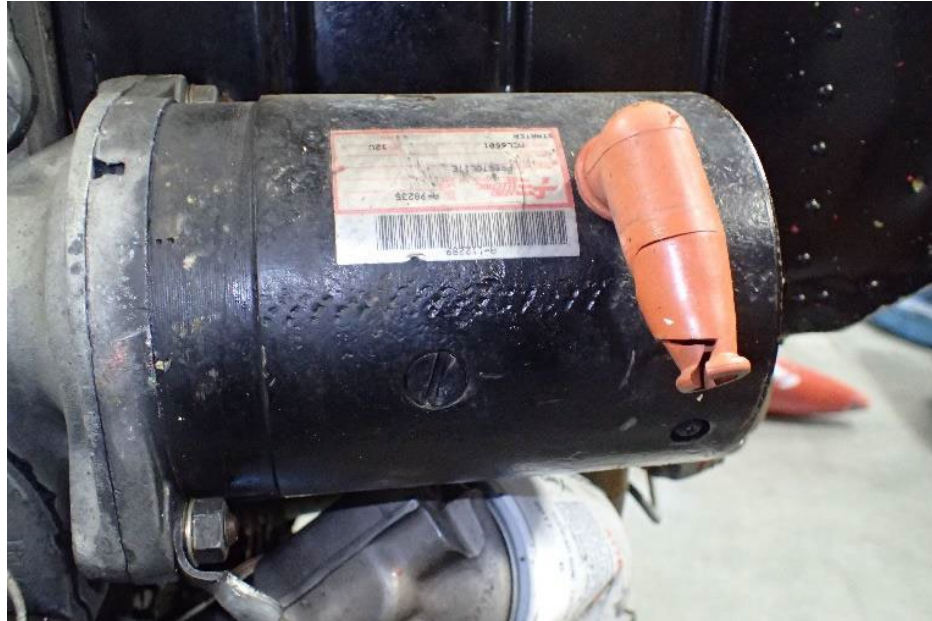
Figure 16 – Starter

The starter remained attached to the starter adapter and displayed minor impact damage signatures.

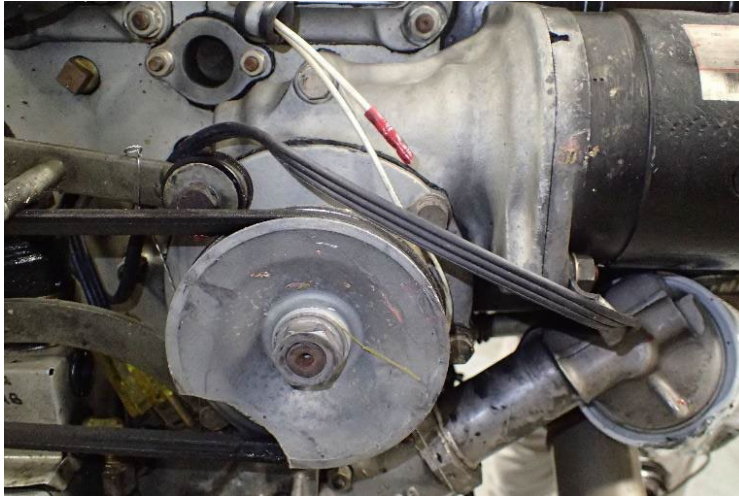
**Figure 61 - Starter Adapter**

The starter adapter remained attached to the engine and displayed impact damage signatures to the pulley. During crankshaft rotation it was noted that the pulley rotated normally.

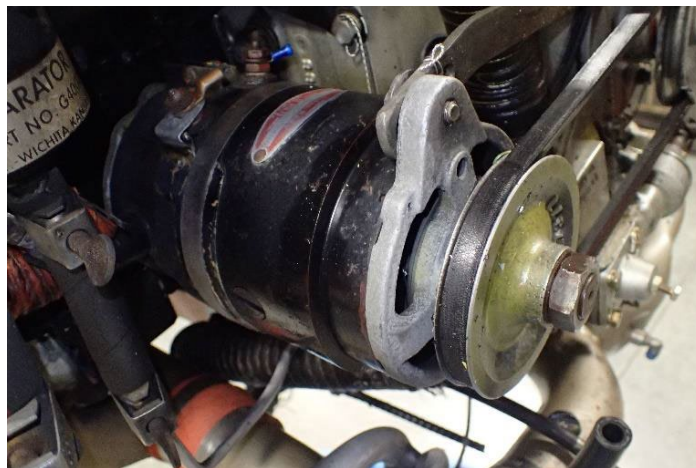
**Figure 62 - Alternator/Generator #1**

The alternator remained attached to its installation point and the alternator belt remained attached to the drive pulley; it was noted that the drive belt displayed dry rot. The alternator drive was capable of normal rotation.

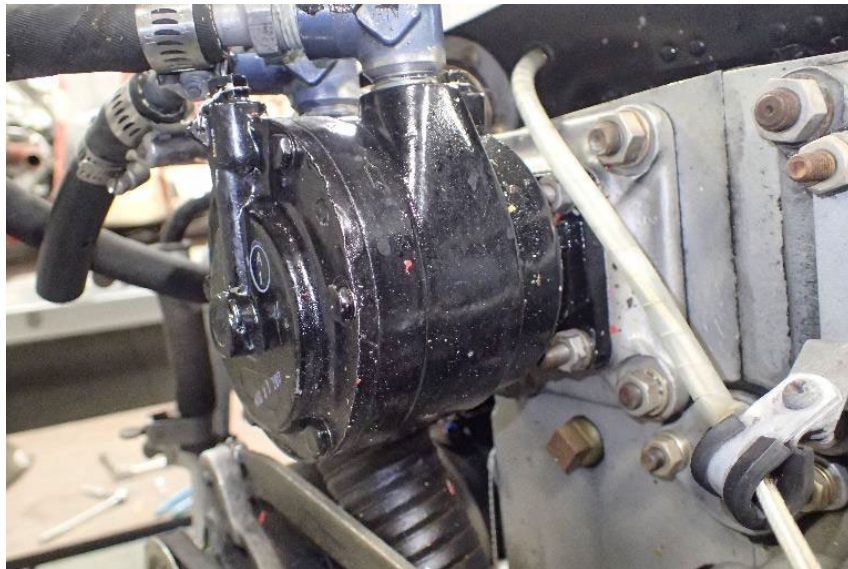
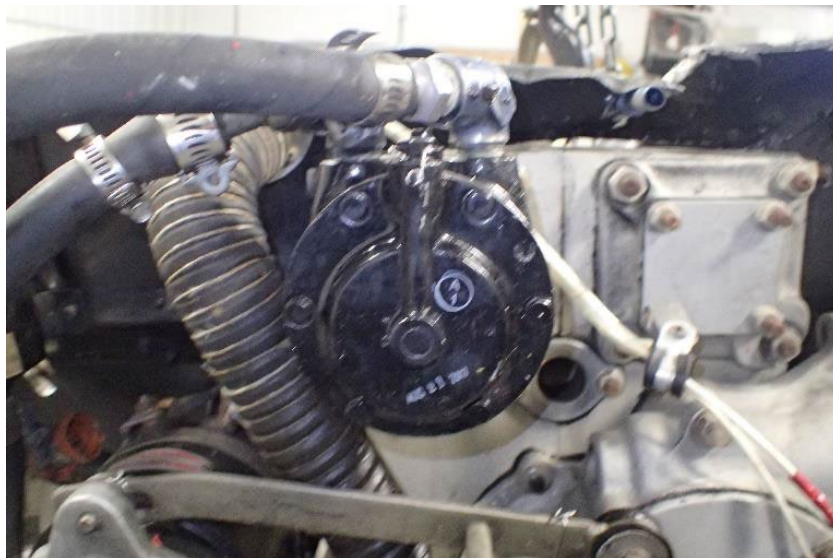
The vacuum pump remained attached to its installation point and displayed impact Damage signature.

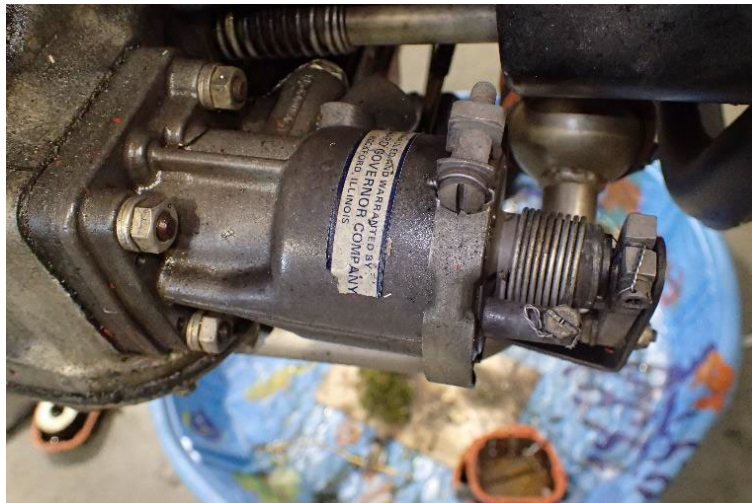
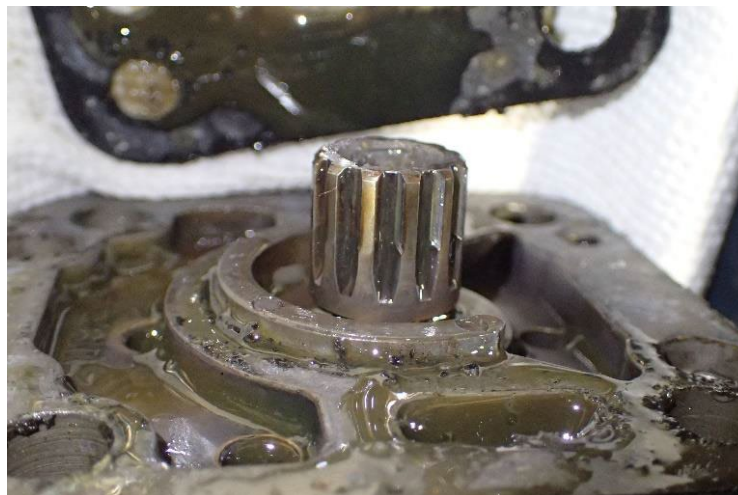
Figure 18 - Propeller Governor

The governor remained attached to its installation point and was undamaged. It was noted that the propeller governor control arm spring was disconnected; however, the control arm was capable of normal movement. After the governor was removed, it was noted that the drive shaft was capable of normal movement.

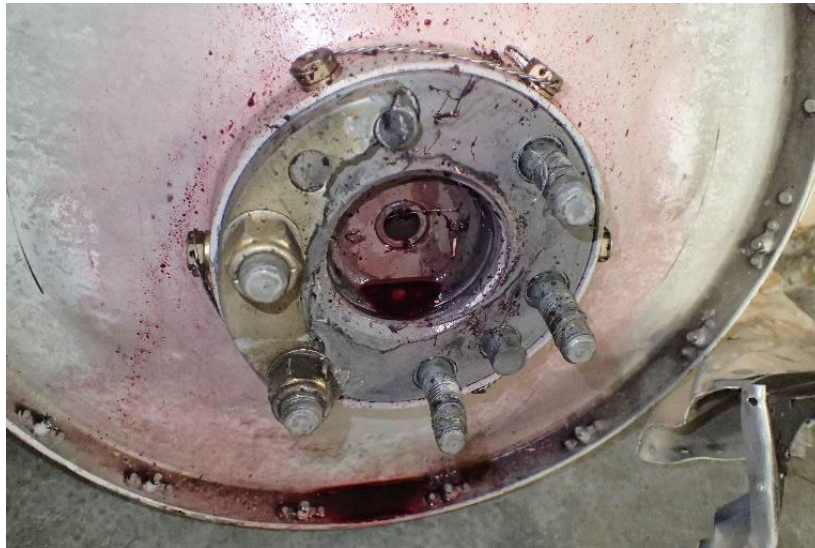
The two blade, constant speed propeller had broken free from the crankshaft; a small portion of the propeller flange remained attached to the propeller hub. Both propeller blades remained within the hub; one blade was loose in the hub. Propeller blade "A" displayed minor twisting deformation. Propeller blade "B" displayed aft bending deformation. Blade signature revealed that the propeller was rotating at the time of impact. There were no anomalies noted with the propeller.

Figure 20 - Propeller hub with a portion of the propeller flange
