### SureFly Ignition Module examination report

Ignition module model	SIM4N
Ignition module serial number	4N-0124015
Position on engine	Right
Total Time	Unknown
Time since rebuild	Unknown
Build Date	01/04/2024
In service date	Unknown
Aircraft Make Model	PA-28-161
Aircraft Serial number	28-8016147
Aircraft registration	N81250
File number	24-002

SureFly Ignition Module examination report			
File Number	24-002	Ignition Module S/N	4N-0124015

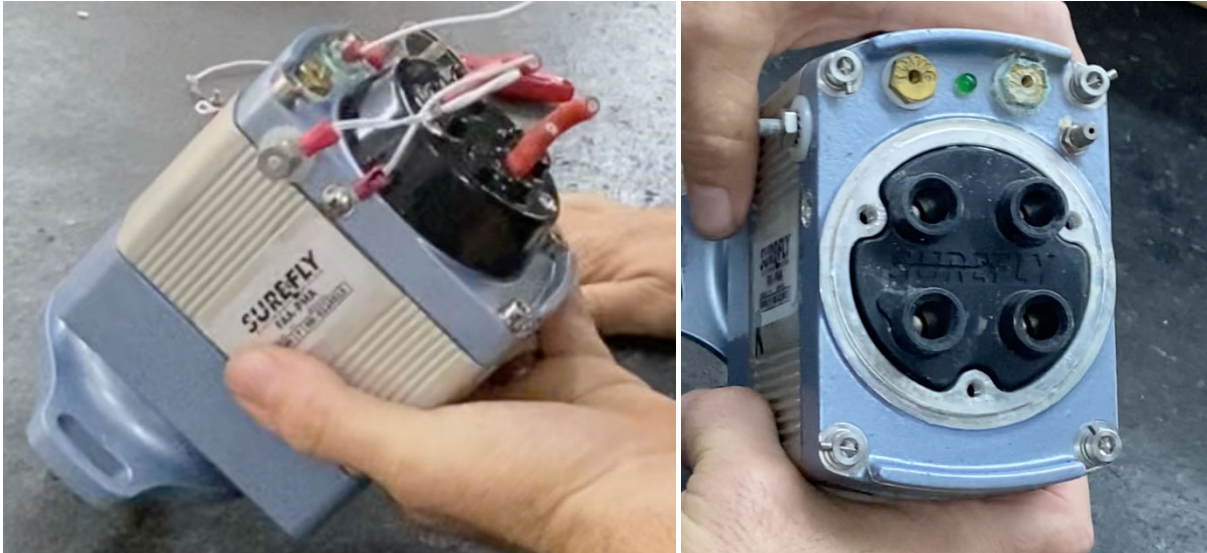
The SIM was received with the ignition harness cap, power lead, p-lead wire, and drive gear installed. All fasteners were secure. The power terminal exhibited corrosion consistent with being submerged in water. The external body did not exhibit any impact damage. The input shaft required light hand pressure to initially rotate. Once freed the shaft turned freely. This is expected ball bearing corrosion from being submerged in water.

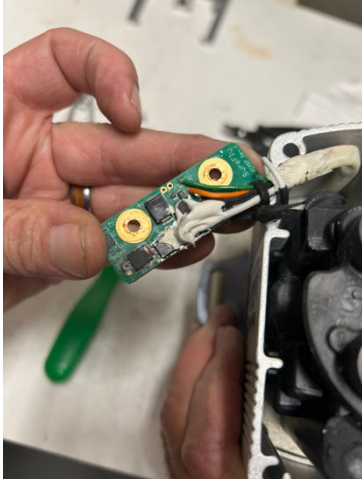
The top control circuit board exhibited damage/corrosion consistent with being underwater. No pre-accident damage was noted.

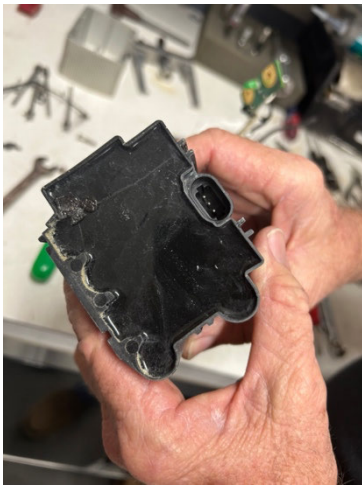
The ignition harness and power connection contacts were clean. The exterior of the coil pack had scale and debris consistent with being under water. The coil pack had a fracture in the potting compound consistent with thermal stress due to high current draw.

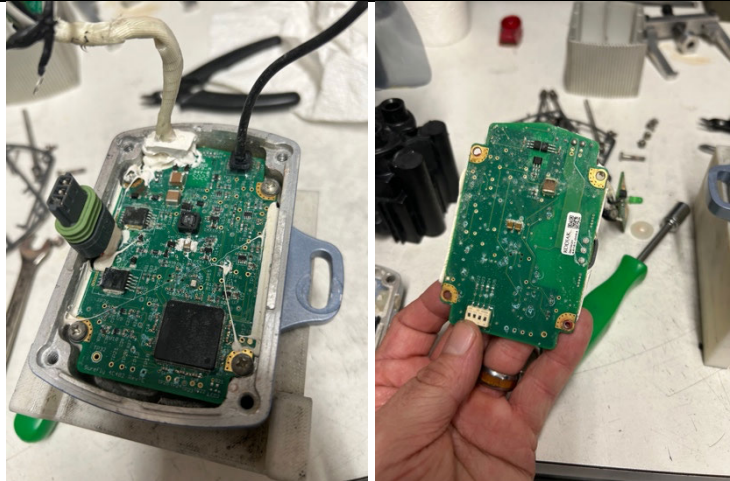
Main board also had damage/corrosion consistent with being under water. No pre-accident damage was noted.

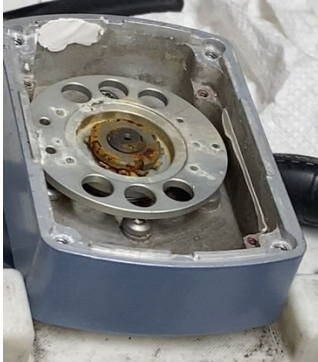
Timing wheel had damage/corrosion consistent with being under water. No pre-accident damage was noted.

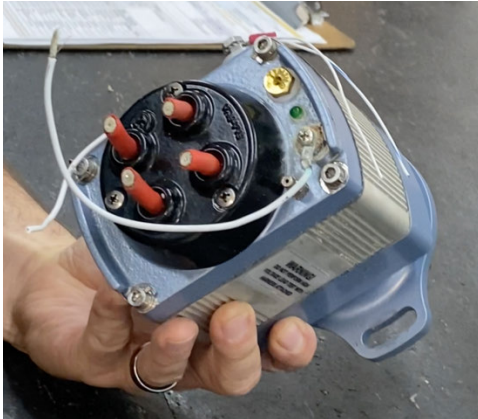
The SIM was received with the ignition harness cap, power lead, p-lead wire, and drive gear installed. All fasteners were secure. The power terminal exhibited corrosion consistent with being submerged in water. The external body did not exhibit any impact damage. The input shaft required light hand pressure to initially rotate. Once freed the shaft turned freely. This is expected ball bearing corrosion from being submerged in water.

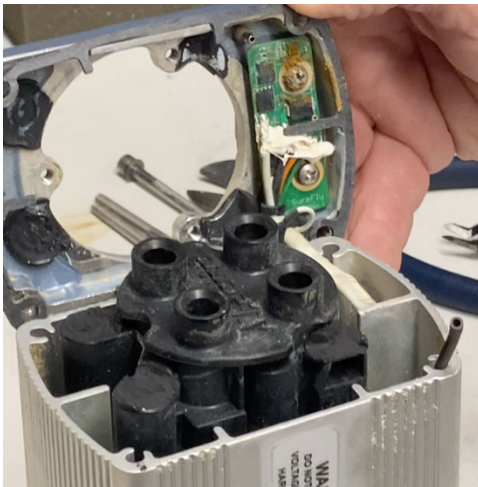
The top control circuit board exhibited damage/corrosion consistent with being underwater. No pre-accident damage was noted.

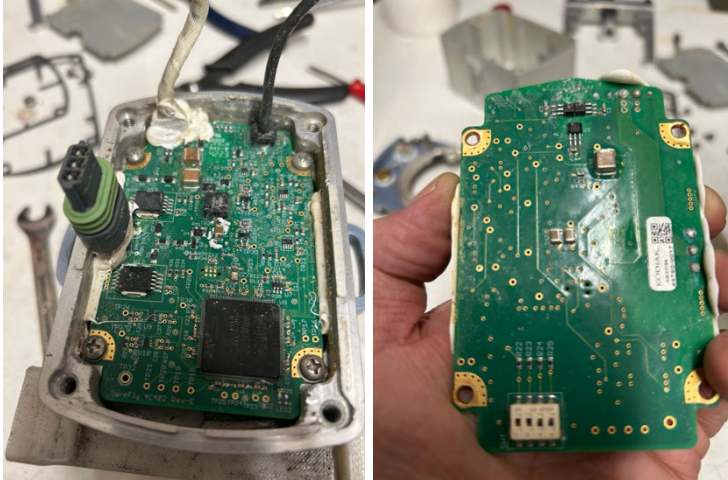
Main board also had damage/corrosion consistent with being under water. No pre-accident damage was noted.

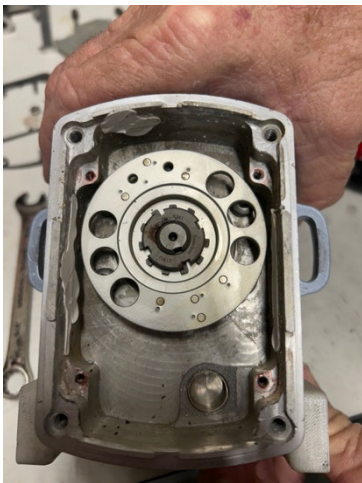
Timing wheel had damage/corrosion consistent with being under water. No pre-accident damage was noted.
