# NATIONAL TRANSPORTATION SAFETY BOARD

## SURVIVAL FACTORS

### Survival Factors Group Chairman's Factual Report

DCA19MA143

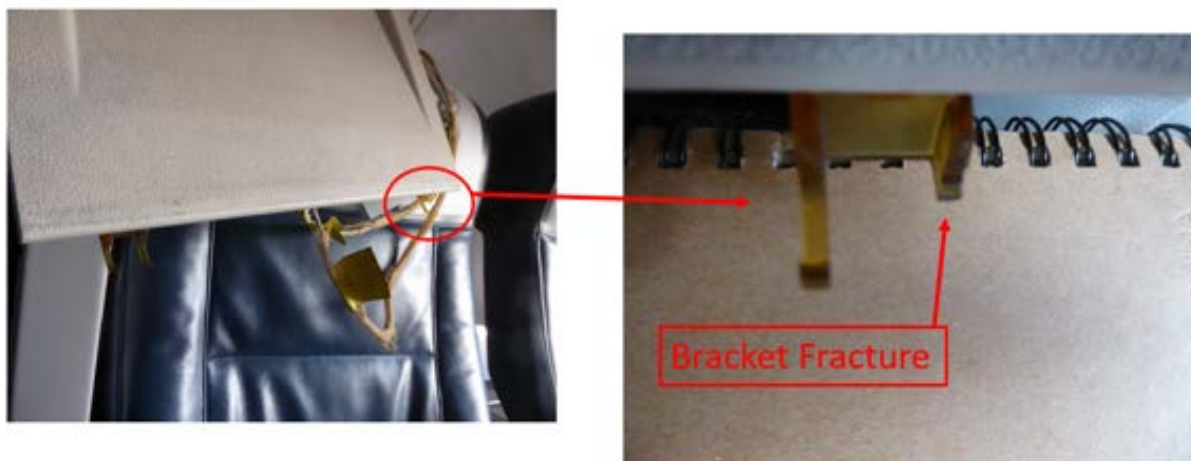
A Passenger Service Unit (PSU) video panel was down and hanging by a lanyard at row 9. The inboard latch assembly appeared to be intact however the outboard latch assembly was broken. The PSU video panel was in the area of fuselage crunch damage on the left side of the airplane, about 14 windows back from the front.

***Photograph 1- PSU video panel and fracture of the inboard latch assembly over row 9 ABC.***

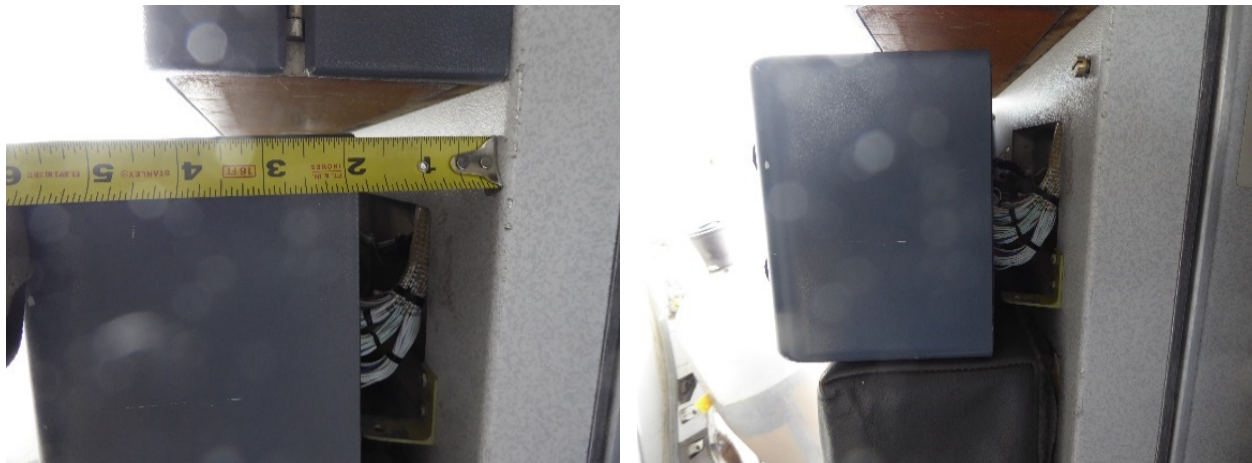
The forward flight attendant panel (FAP) entry lighting was turned to the off position. The ceiling light was turned to bright. The top end section of the panel was pulled away from the bulkhead about 1 ¾ inch. The panel had released from the top key slot attachment. Two screws that fasten the panel to the lower brackets under the panel were missing. The interphone was present. The emergency equipment cabinet above the FAP held a fire extinguisher. It was labeled:

*Photograph 2- FAP pulled away from the bulkhead.*

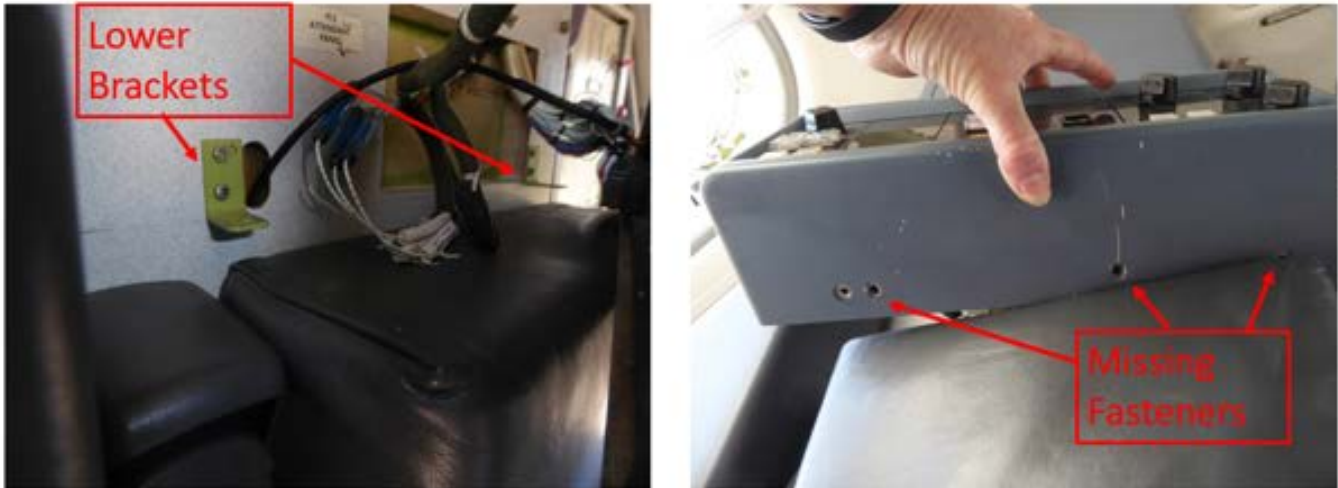
*Photograph 3- FAP removed from the bulkhead*

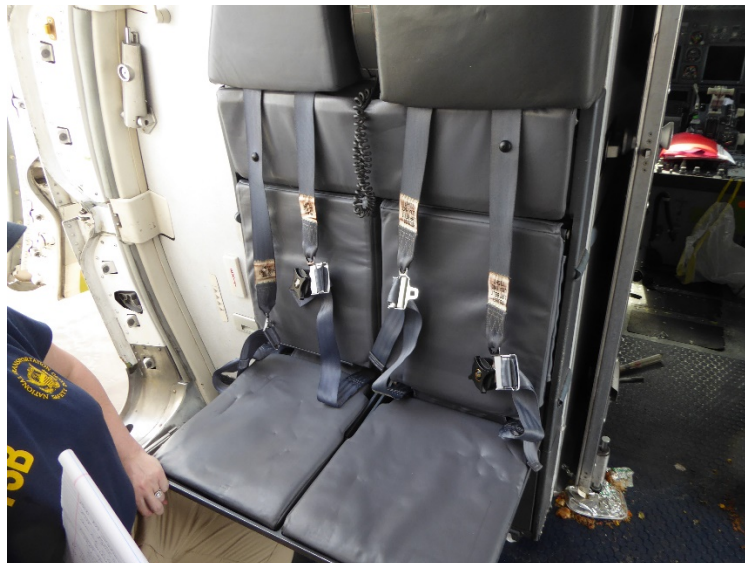
The 1L jumpseat was the outboard seat of a dual position jumpseat that held the 1L and 1R seat positions. The seat bottom of the 1L jumpseat retracted without resistance. There was no deformation in the frame, however there was some indentation in the cushions. The restraints retracted without resistance. The crew life vest and flashlight were not present under the 1L seating position.

*Photograph 4- 1L and 1R jumpseat.*

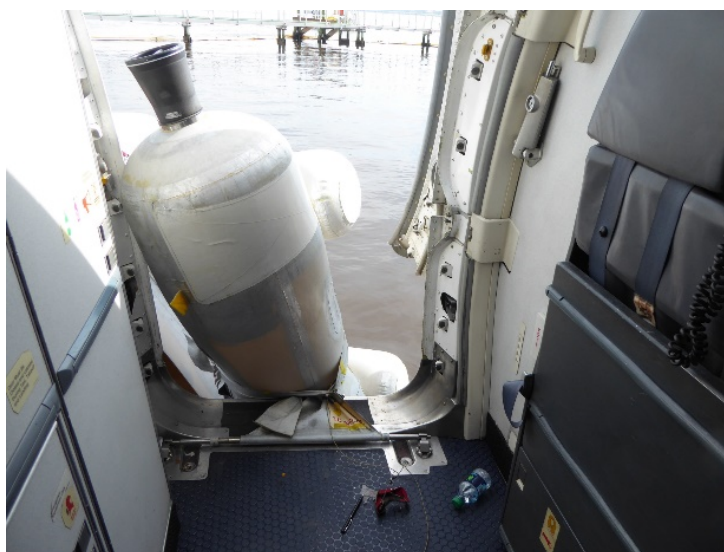
The 1L door was in the fully open position and the door and door frame had no structural damage. The slide was found fully inflated and attached to the airplane. The slide was twisted at the girt shown in photograph 5 and 6. The head end of the slide was partially blocking the exit. The slide was removed by the Survival Factors group and sent to the manufacturer for examination<sup>1</sup>. The red manual inflation handle had been pulled and the girt bar was still intact in floor fittings. The 1L evacuation slide was manufactured by Collins Aerospace and the following was information obtained from the slide's data tag:

*Photograph 5- Internal view of the 1L door and slide.*

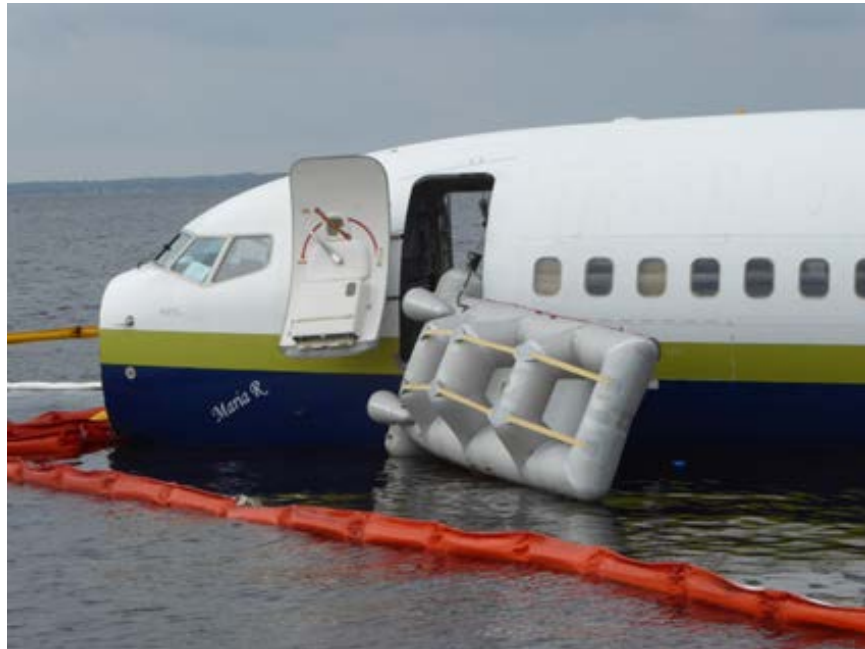
*Photograph 6- External views of the 1L door and slide.*

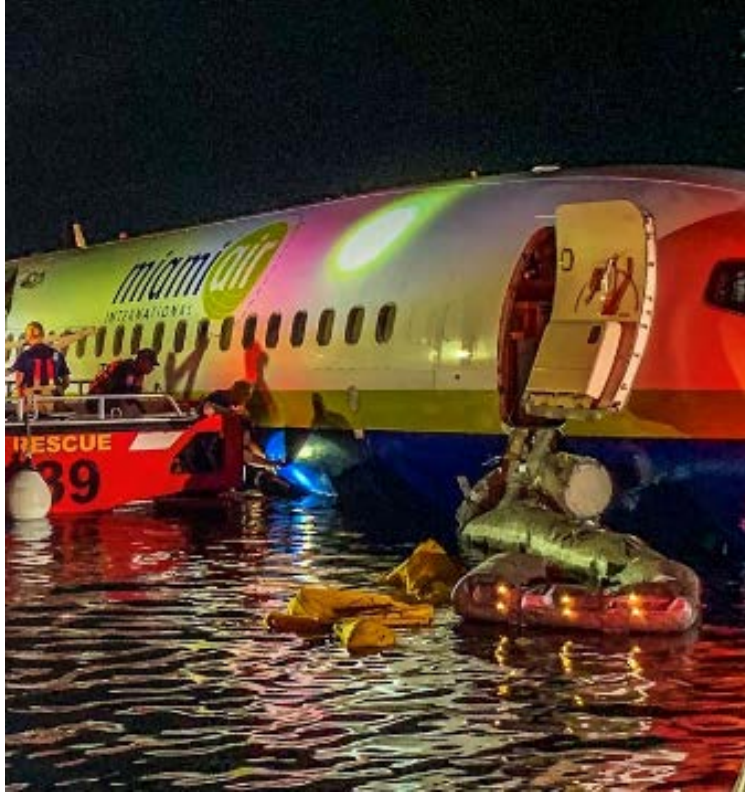
The 1R door was in the fully open position and the door and door frame had no structural damage. Upon arrival, the slide was deflated and under water. Photograph 7 taken in the evening of the evacuation by firefighting personnel showed the slide partially inflated and the slide toe end lighting was illuminated. The slide was removed by the Survival Factors group and sent to the manufacturer for examination. The red manual inflation handle was released from the Velcro patch and the girt bar was still in the floor fittings. The 1R evacuation slide was labeled:

*Photograph 7- 1R slide partially inflated and the toe end lighting illuminated.*

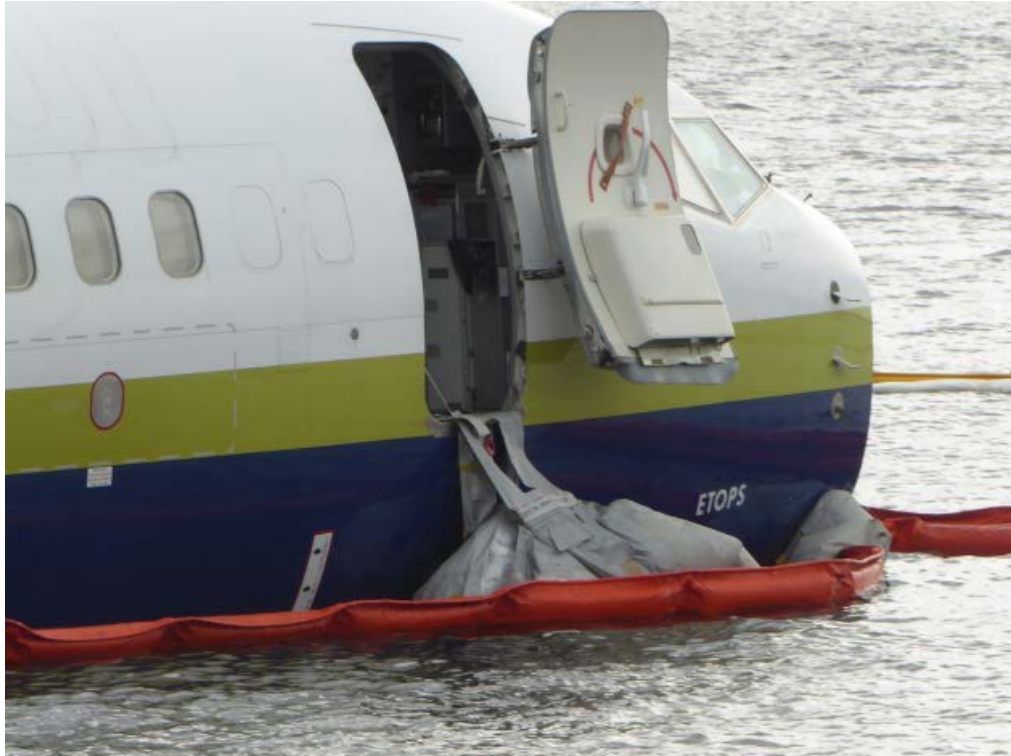
*Photograph 8- External views of the 1R door and slide.*

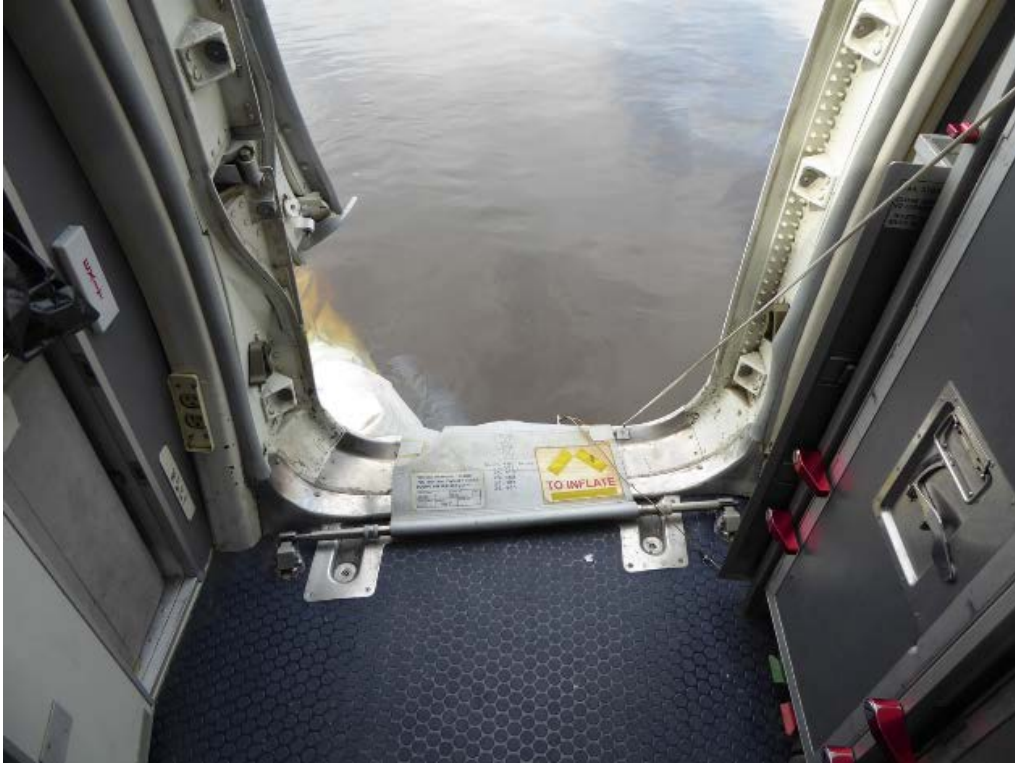
*Photograph 9- Internal views of the 1R door and slide.*

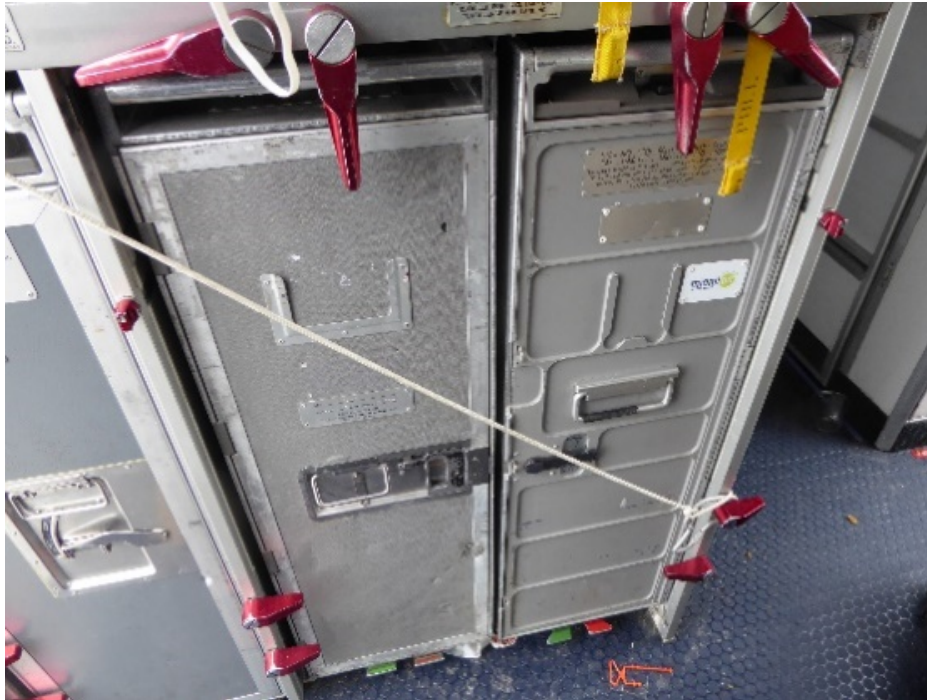
**Photograph 16-** Raft lanyard connected to the galley cart latch in the G1 galley.

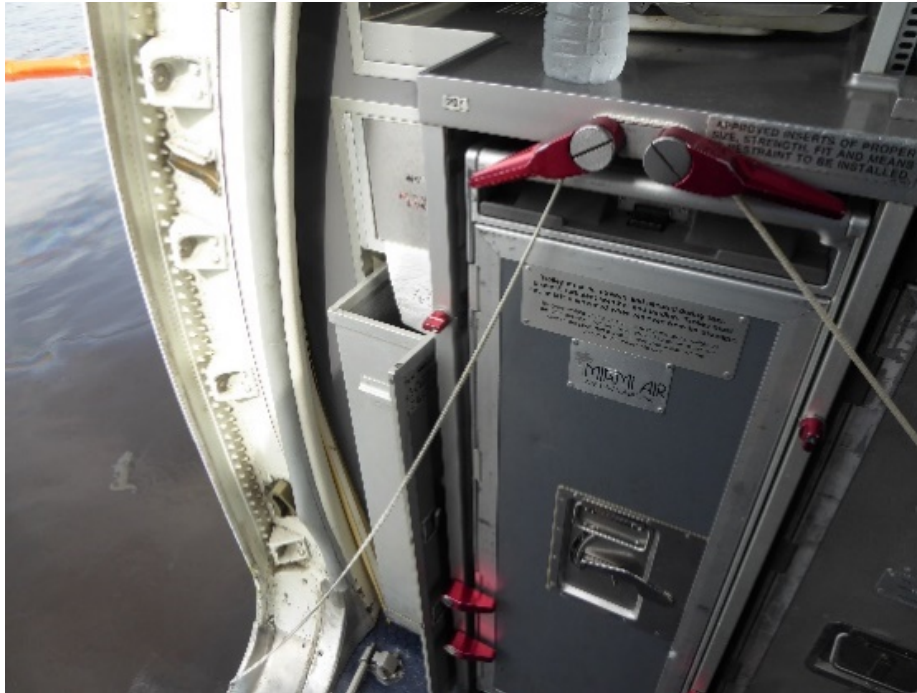
**Photograph 17-** Raft lanyard that was connected to a galley storage/servicing cart latch in the G1 galley and to one of the rafts.

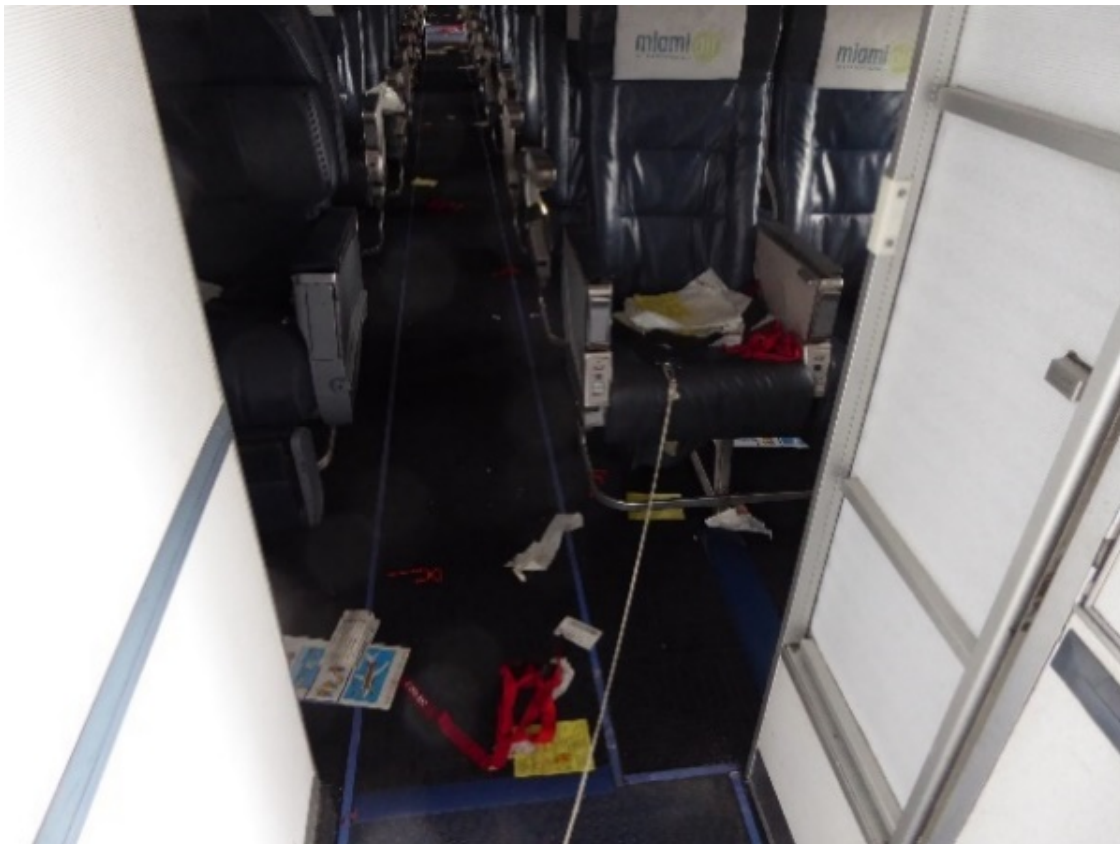
**Photograph 18-** Raft lanyard that was connected to connected to a seatbelt fitting at seat 1C.

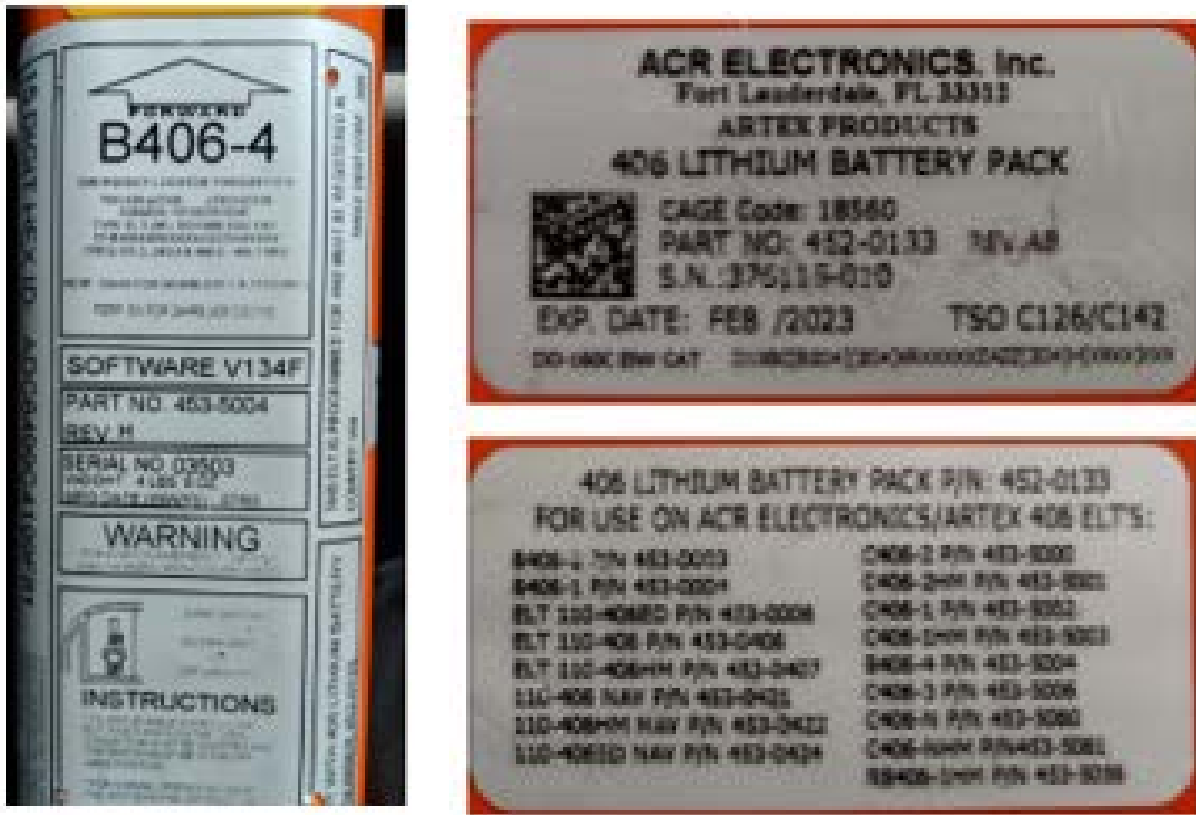
The cover to the ELT was present, however the ELT was missing from the overhead compartment as it had activated and had been removed by first responders to deactivate it. Photograph 20 shows the placards on the device:

*Photograph 20- Labels obtained from the Fixed ELT.*

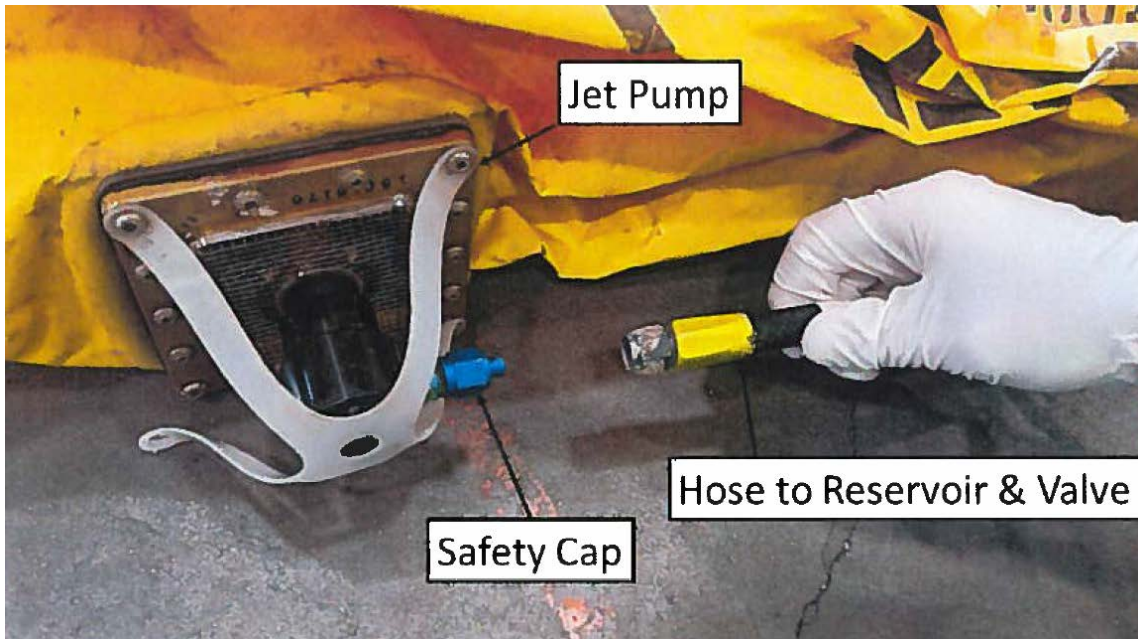
Survival Factor group members met on July 9, 2019 in Wall Township, New Jersey at the Safran AeroSystems facility for a raft examination from airplane N732MA. See Attachment 7 for the full investigative report. The raft was pulled from the box, rolled up, and inside a plastic bag. The raft was a reversible design. Both bottles were at 0 psi. Both inflation hoses were connected to the bottle and routed properly. The tubes were not connected to the jet pump. The jet pump connectors for the inflation hoses were safety capped.

**Photograph 25-** The jet pump connectors for the inflation hoses that were safety capped.

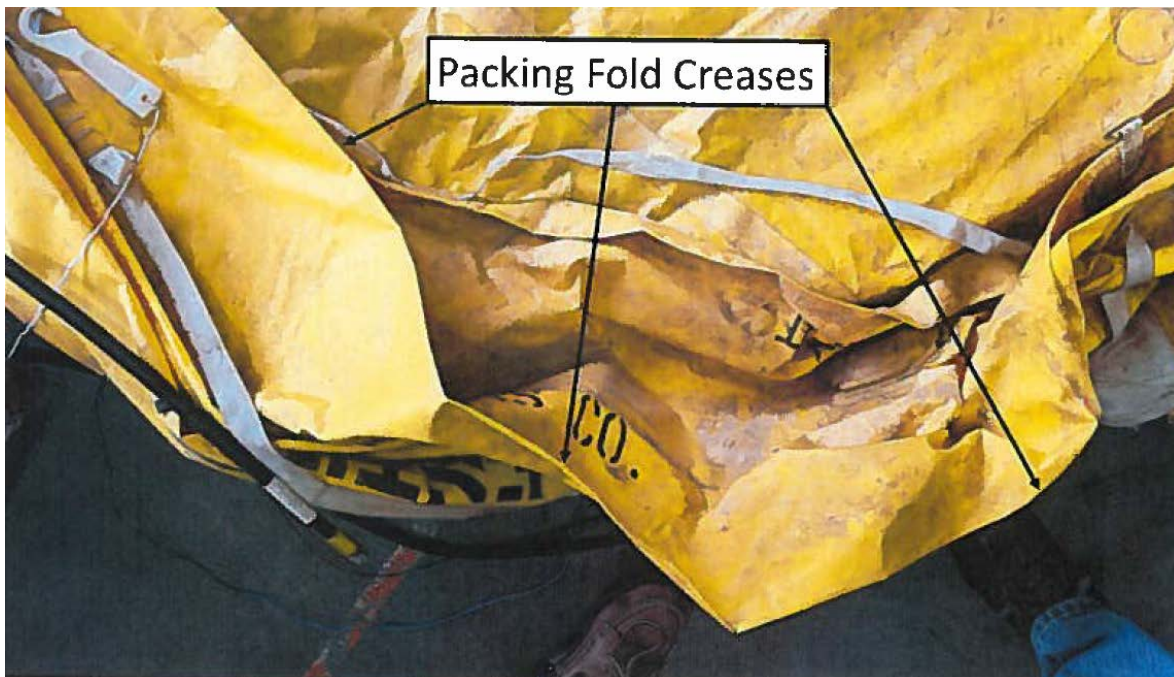
**Photograph 26-** The fold creases in the raft.

The mooring line was frayed and one of the locator light wire conductors was frayed. There was a 6” tear near the locator light. Patches were present in various places but seemed to be intact and secured to the life raft.
