## **NATIONAL TRANSPORTATION SAFETY BOARD**

### **Group Chairman's Factual Report**

# **SURVIVAL FACTORS**

DCA22FA132

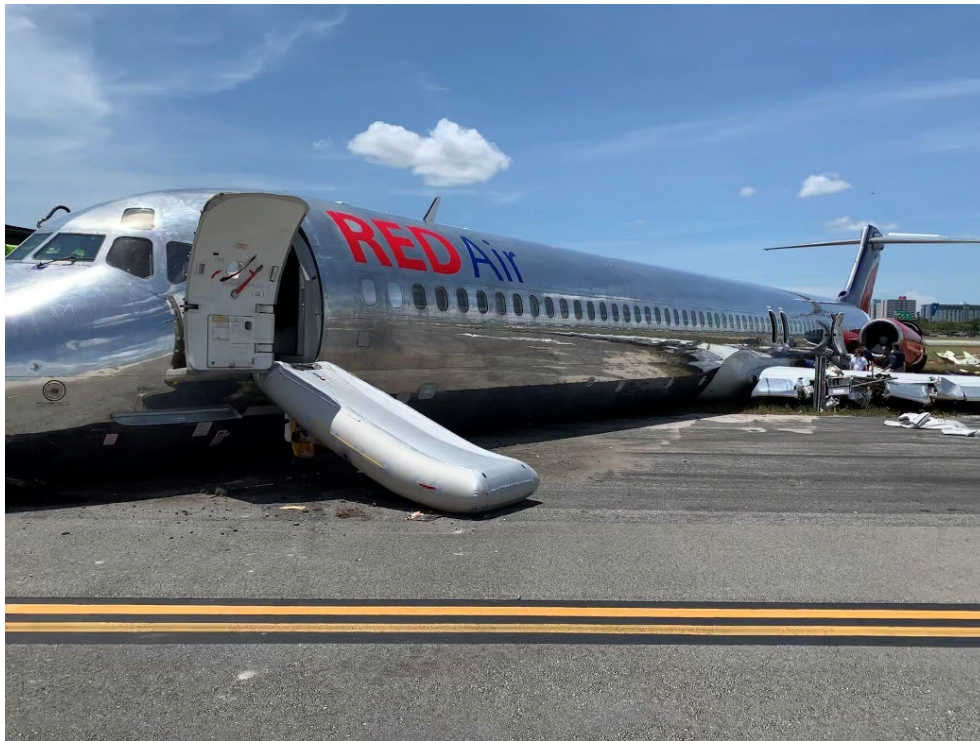
The airplane was found resting on the fuselage with all landing gear collapsed. L1 and L2 were found opened with evacuation slides fully inflated and usable. The forward right OWWE was opened, and both left OWWE were opened. The R1, tailcone, and aft right OWWE were not opened.

**Figure 2- Left side of the airplane.**

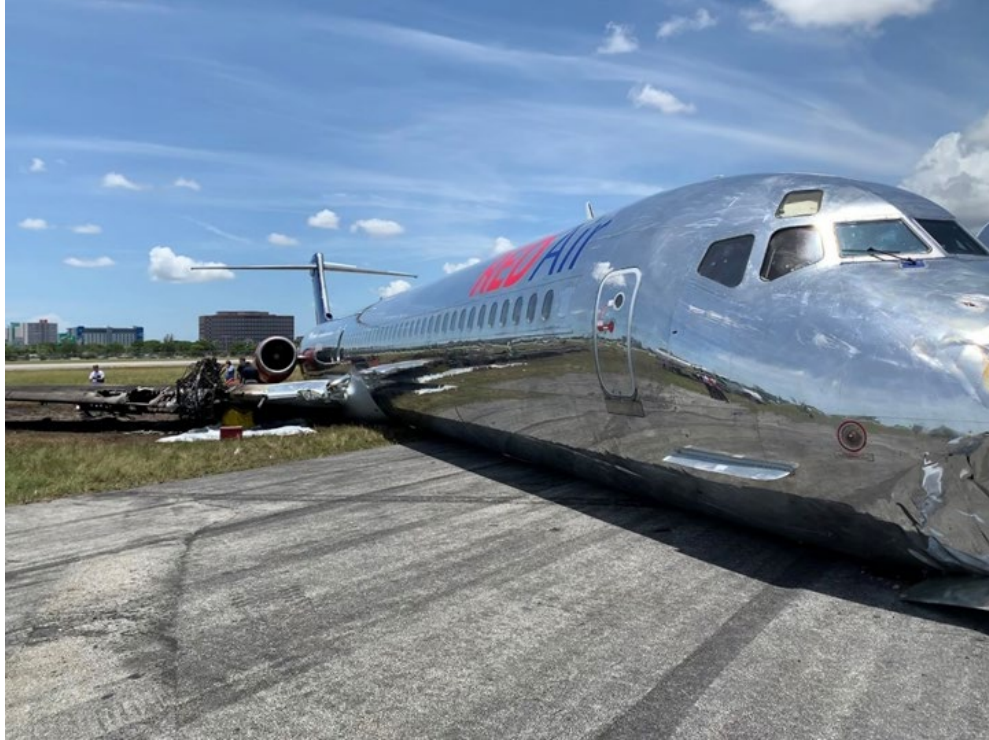
**Figure 3- Right side of the airplane.**

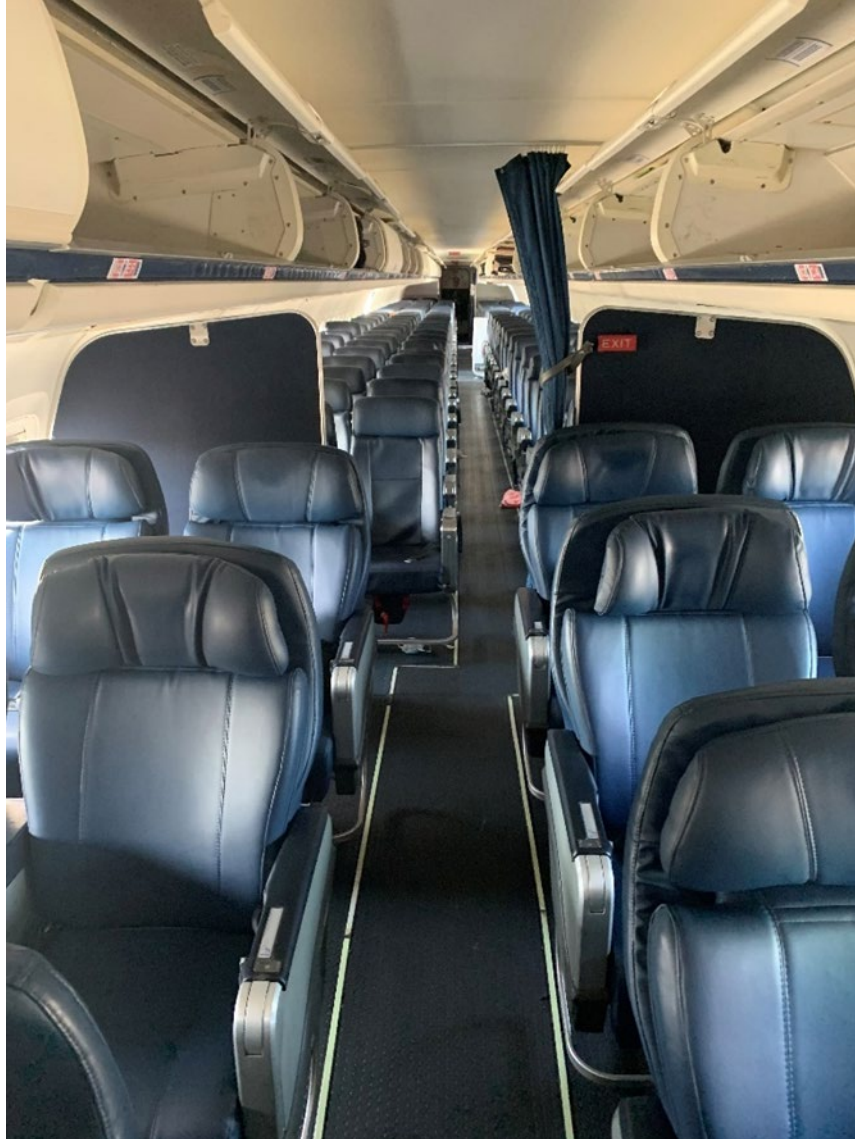
The interior of the cabin remained intact. The overhead stowage bins and the passenger service units (PSU) panels were all in place. There was no noticeable deformation of monuments. There was no visible buckling of the floor structure, however, on the right side of the cabin one bank of seats at row 29 DEF was found to be off the track and easily moved up and down and another seat bank at row 23 DEF was missing a screw that fastened the seat bank to the track and could be moved back and forth slightly. Further inspection revealed other seat banks with loose fasteners.

**Figure 4- Cabin interior, main aisle looking aft.**

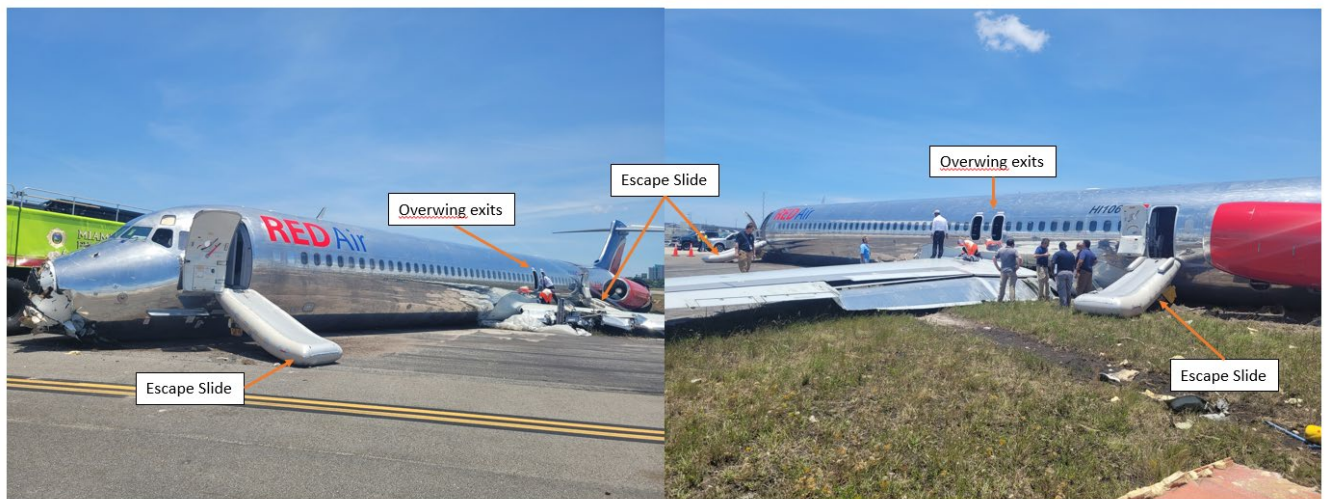
Passengers used L1, both left OWWE and L2 for egress. The forward right OWWE was used by 1-3 passengers before the fire started. The evacuation slides automatically deployed after doors L1 and L2 opened. The aft right OWWE was not used during the evacuation. Door L1 was opened by flight attendant four, the L2 door was opened by flight attendant three, and the OWWE were opened by passengers seated in the emergency exit rows.

**Figure 6- Left emergency exits and slides.**

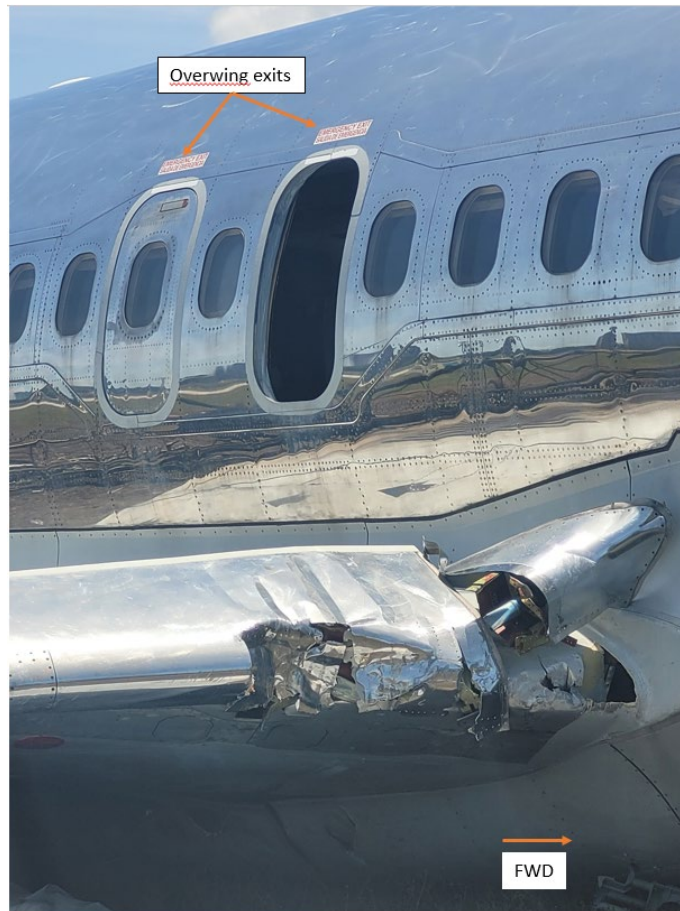
The passageways leading up to the OWWE were littered with personal effects (i.e., glasses, jackets, baggage). On the right side, the forward right OWWE hatch was resting on the cabin floor leaning against the seatbacks forward of the exit. On the left side, one OWWE hatch was found on the trailing edge of the left wing and another OWWE hatch was found on the cabin floor near the forward exit. The lifelines were not used and found stowed.

**Figure 7- Right overwing window exits.**

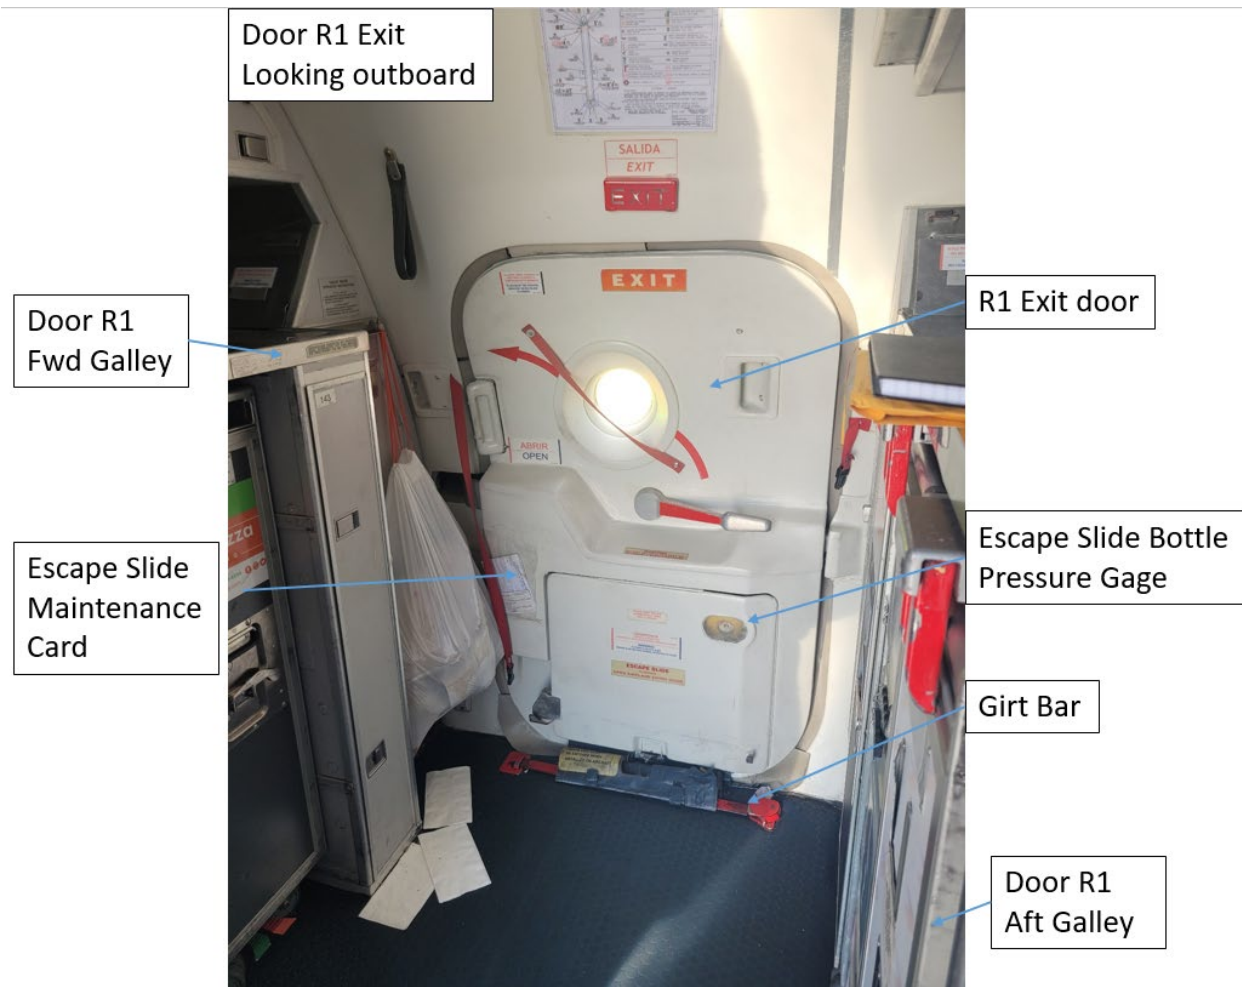
The exits that were not used for evacuation (R1 and the tailcone) were opened and slides deployed. R1 opened easily, and the slide automatically deployed once the door

was fully opened. The R1 slide deflated about 3 minutes after inflation. There was loud pop and hissing sound as the slide deflated. The slide was removed by the Survival Factors group and sent to the manufacturer for examination<sup>2</sup>. The tailcone interior exit door was opened in the disarmed mode which functioned properly. The tailcone exterior exit was released successfully using the manual release handle however, due to the tail down of the aft fuselage, the slide was not automatically deployed and the tailcone had to be rolled away to manually deploy the escape slide.

**Figure 9- R1 exit looking out.**

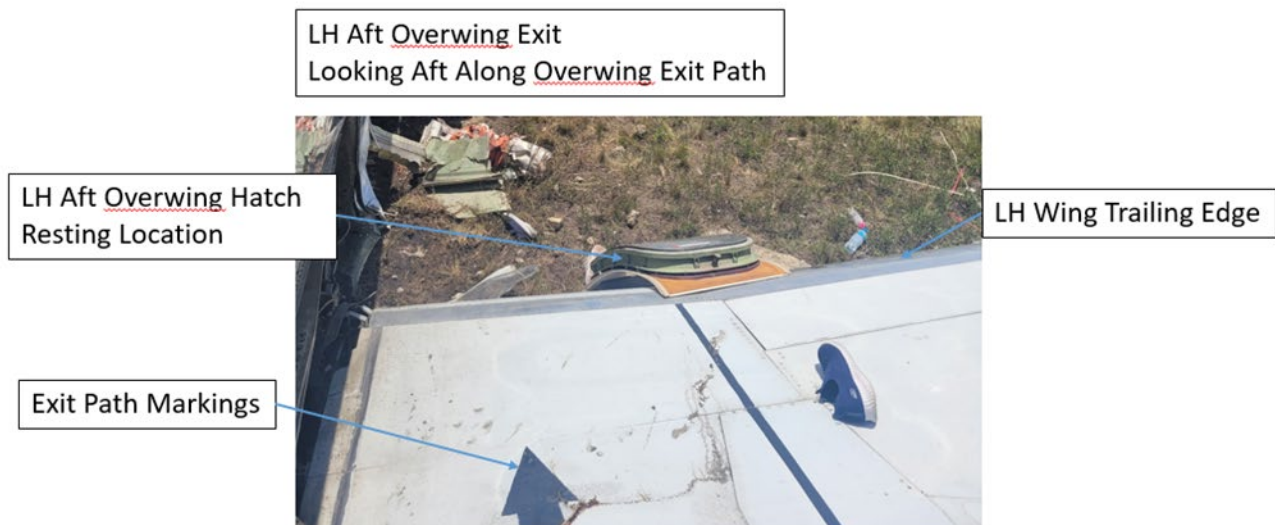
All the doors and OWWE hatches were inspected and had no visible structural damage. There was minor damage found on the aft OWWE hatch on the trailing edge of the wing. There were no matching marks on the hatch frames on the fuselage. All doors and hatches were able to be reinstalled and operable. The marked OWWE hatch was found next to the corresponding opened exit.

**Figure 12- Aft left overwing window hatch location.**

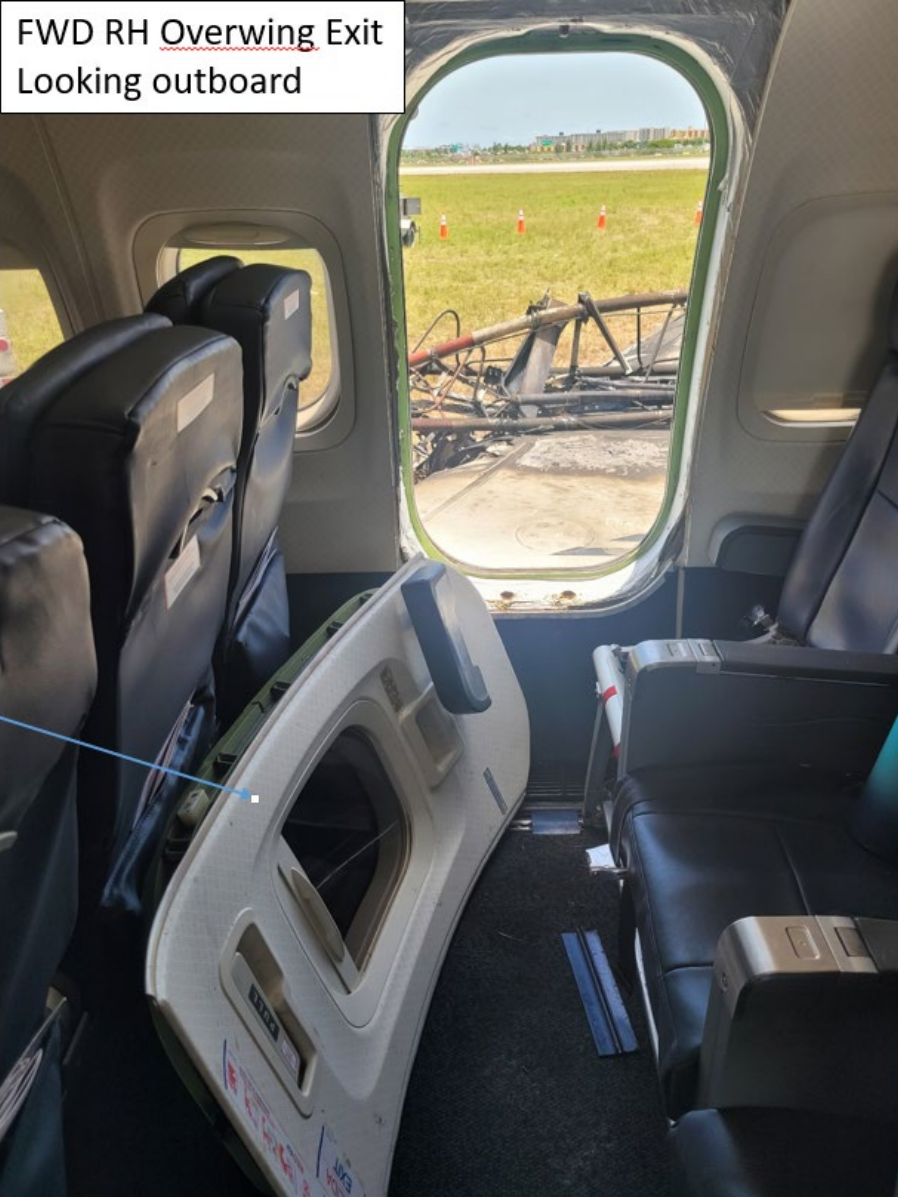
FWD RH Overwing Exit  
Looking outboard

Overwing Hatch

**Figure 13- Forward right overwing window exit looking out.**

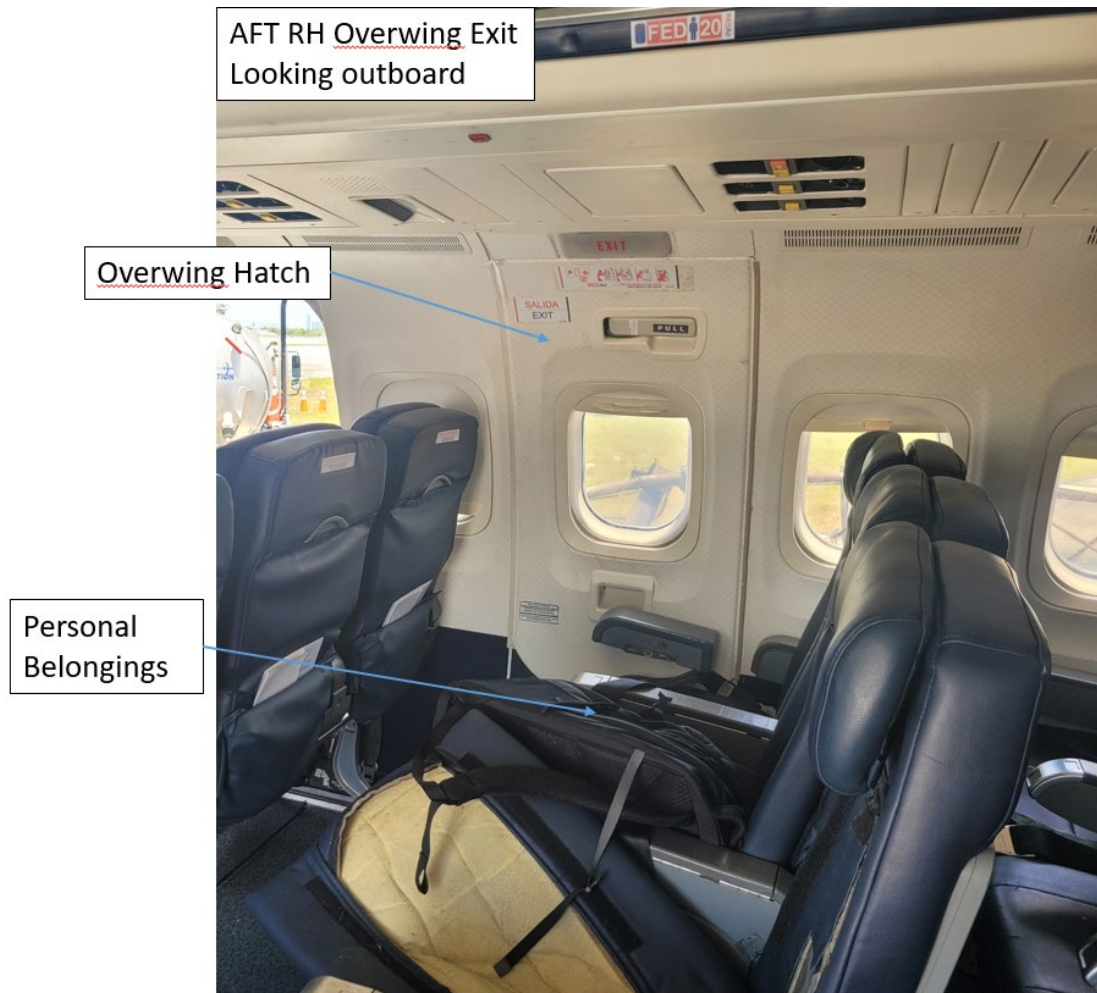
AFT RH Overwing Exit  
Looking outboard

Overwing Hatch

Personal Belongings

**Figure 14- Aft right overwing window exit.**

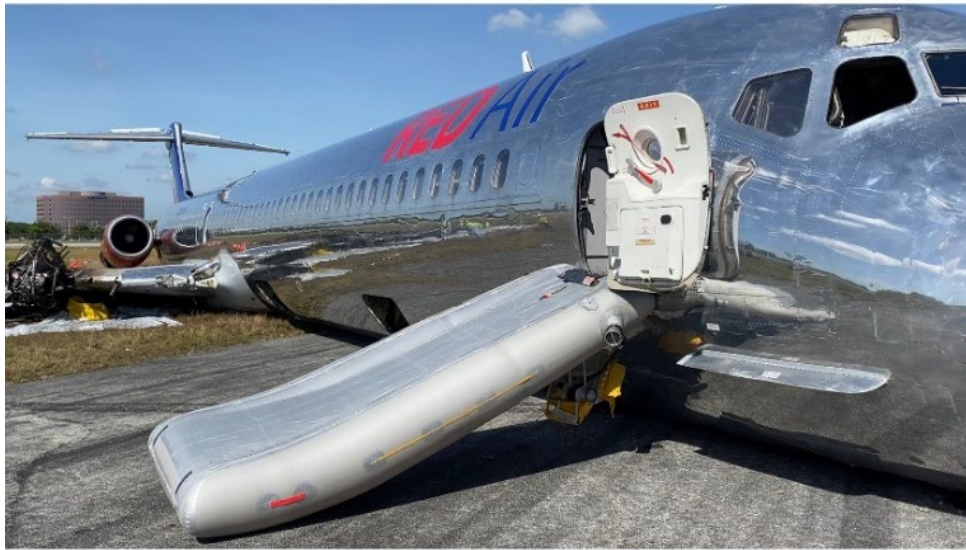
**Figure 18- R1 slide fully deployed prior to deflation.**

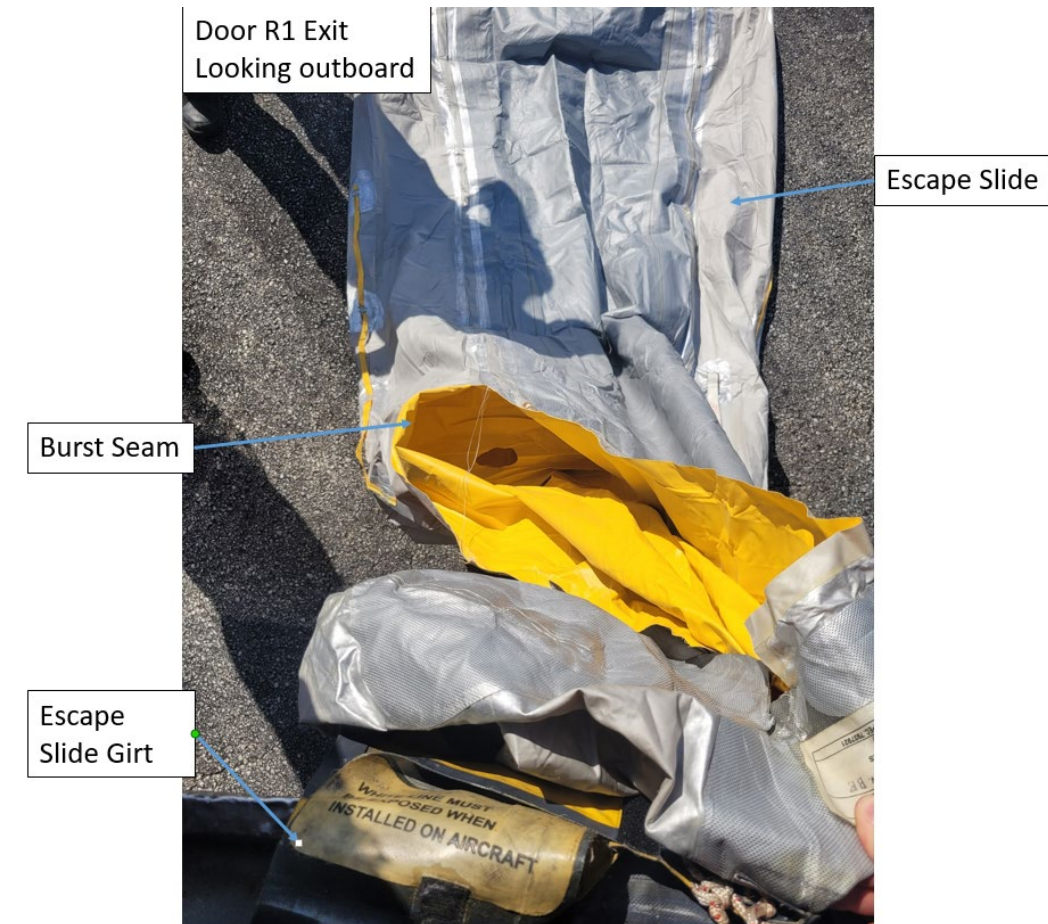
**Figure 19- R1 burst seam.**

Approximately three minutes after the deployment, a loud pop and hissing sound was heard. The slide was found to have deflated from a tear on the upper section of the side tube on the left-hand side of the slide. The failure of the seam was a result of a failure of the adhesive bond within the seam. The slide was 22.5 years old and the deterioration of the adhesive was a result of age. The weakness of the seam in the side tube may not have been apparent during the last maintenance event, the slide assembly did have several areas of questionable adhesion of cemented seams and components. Specific inspections are recommended in the Extended Maintenance protocol in the CMM for slides older than 15 years. There were visible lifts around the aspirator blister assembly and significantly weak adhesion of the cement surrounding the top off valve on the slide body.

During the examination, it was found the slide system D29982-121 was misidentified as a manual inflation configuration. The appropriate system part number was D29982-125 based on the reservoir and valve assembly and operating cable installed in this D29982 slide system. The D29982-125 configuration was an 'automatic' inflation configuration. The slide system deployed in this manner.

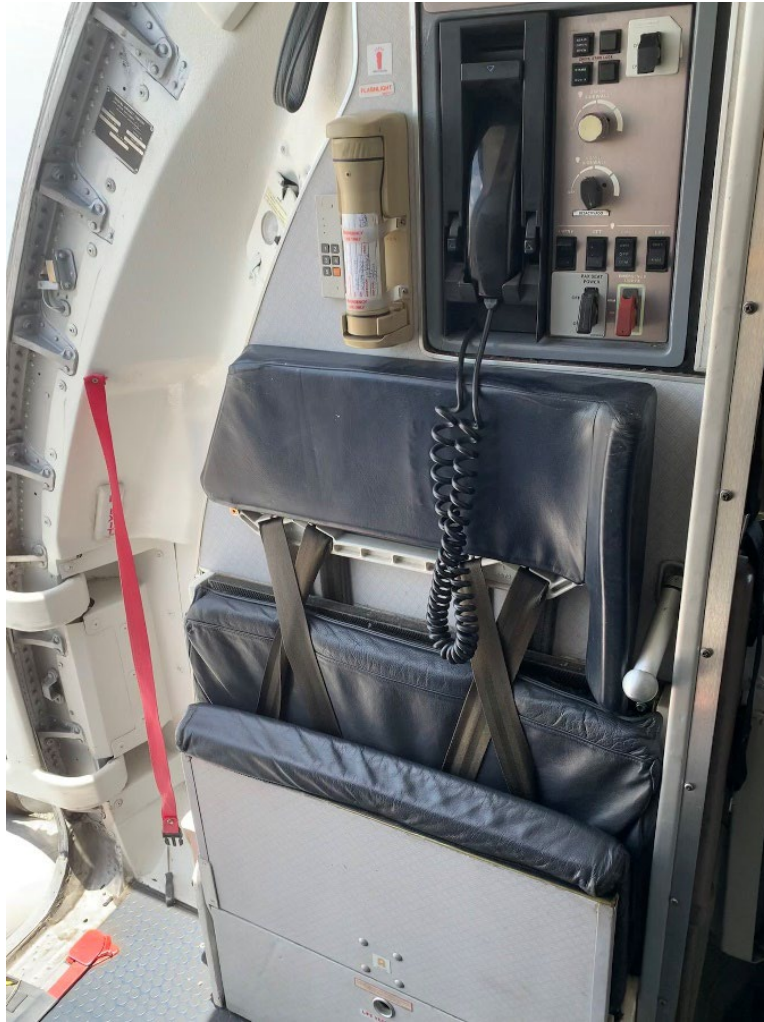
The emergency lights were not armed and in the off position on the flight attendant panel (FAP). The FAP held a flashlight and interphone. There were two lifevests and fire extinguisher under the jumpseat. Adjacent to the jumpseat a closet held first aid kit, infant lifevests, and a flight attendant manual (Spanish). The seat bottom retracted and there was no deformation. The restraints retracted. The restraint closest to the L1 door was still buckled and the restraint outboard was unbuckled.

**Figure 23 - Forward flight attendant jumpseat station.**
