Survival Factors Factual Report Attachment-
Scene Photographs

Cleveland, Ohio

RRD23LR007

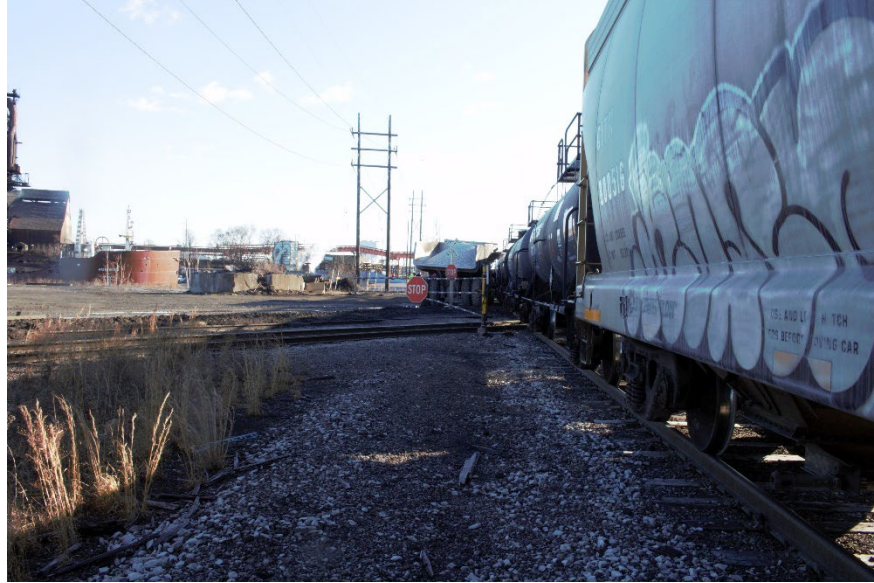
Figure 1 Photo looking westbound, in the direction of travel of the train, towards the industry crossing and showing the final rest position of the truck along side the right side of the train. (Source: NTSB)

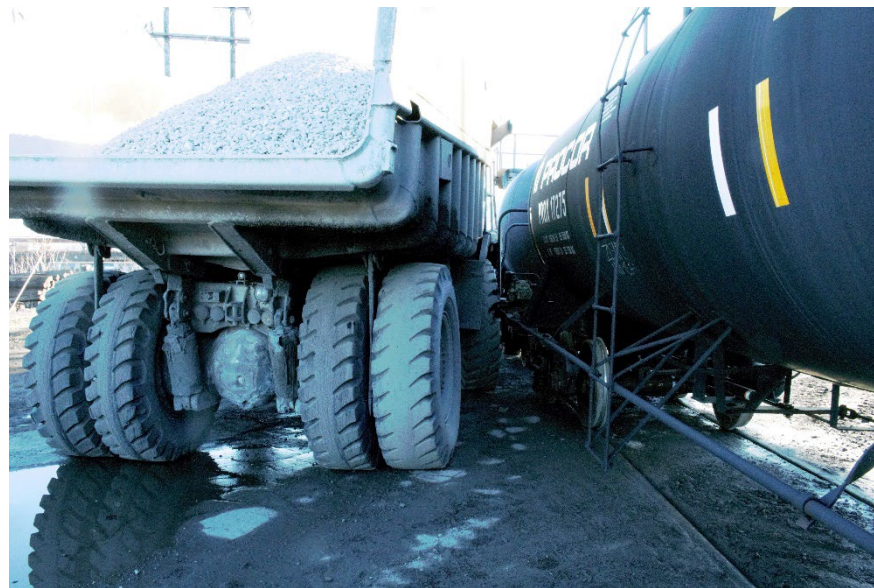
Figure 2 Photograph showing a closeup of the dump truck the final rest position adjacent to the right side of the rail car. (Source: NTSB)

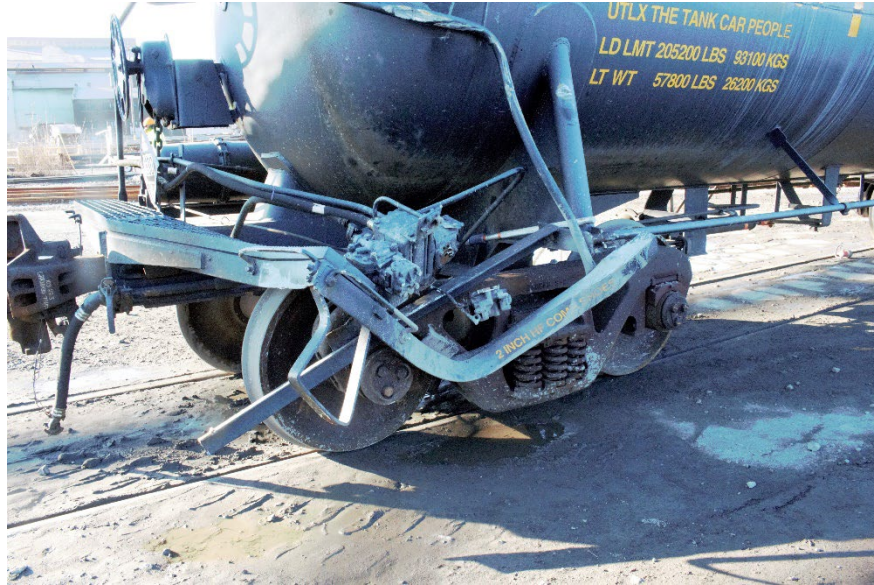
Figure 3 Photograph showing a closeup of the damage to the rear running board where the conductor was standing and the side of the rail car resulting from the impact with the dump truck (Source: NTSB)

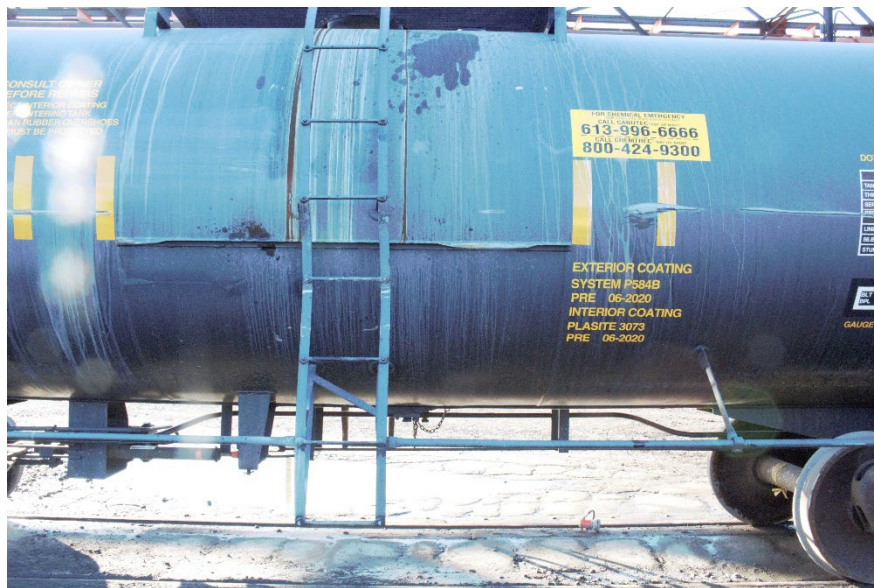
Figure 4 A closeup photograph of the side of the rail car damage by the collision with the dump truck. In the background, the conductor's lantern is seen underneath the rail car. (Source: NTSB)

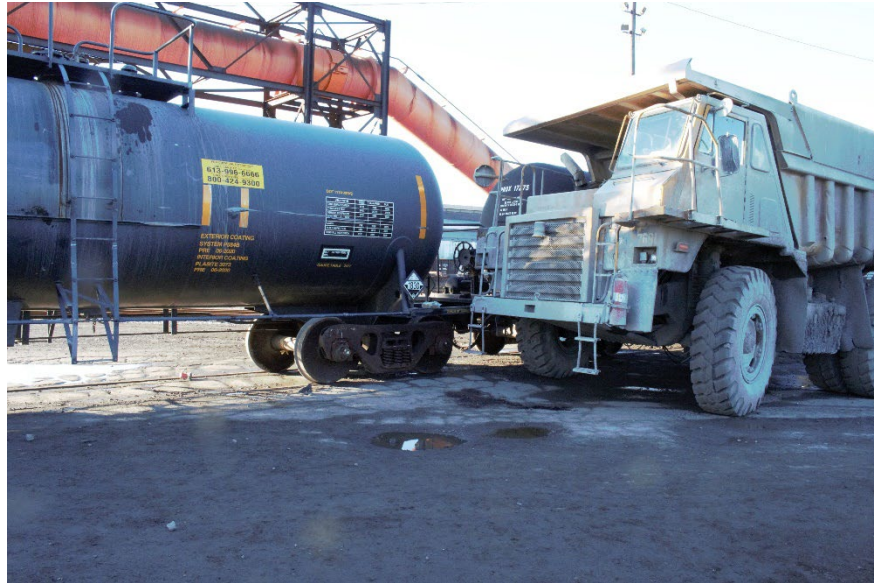
Figure 5 Photograph showing a closeup of the front of the dump truck and its proximity to the rail car at final rest. Damage seen to the side of the rail car occurred during the accident. (Source: NTSB)

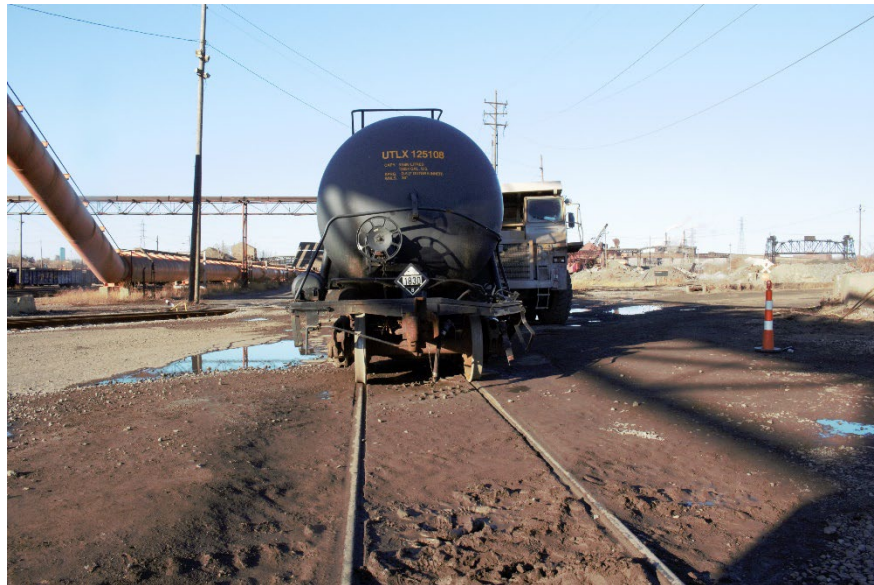
Figure 6 The photograph shows a view of the accident scene, looking eastward, the approach road to the crossing on the right and the proximity of the utility pole and the overhead lighting to the left (Source: NTSB)

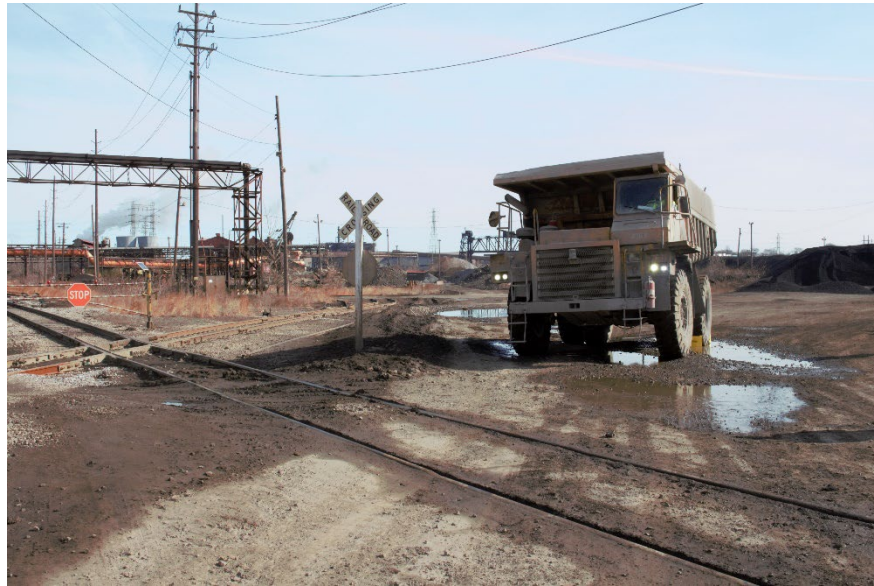
Figure 7 Photograph showing the angle of approach of the dump truck to the crossing. (Source: NTSB)

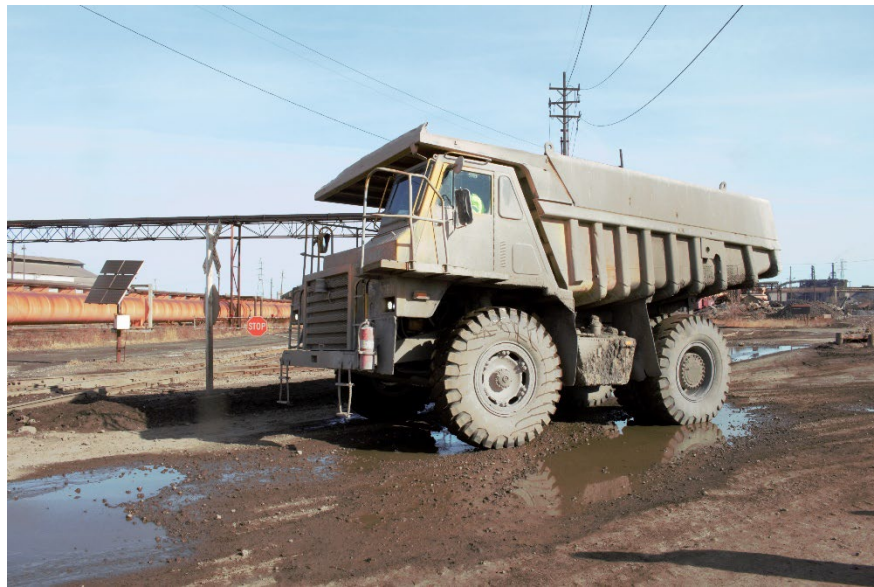
Figure 8 Photograph showing the line of sight of the driver and the angle of the track as the train approaches from the east traveling west (from right to left in the photo). (Source: NTSB)

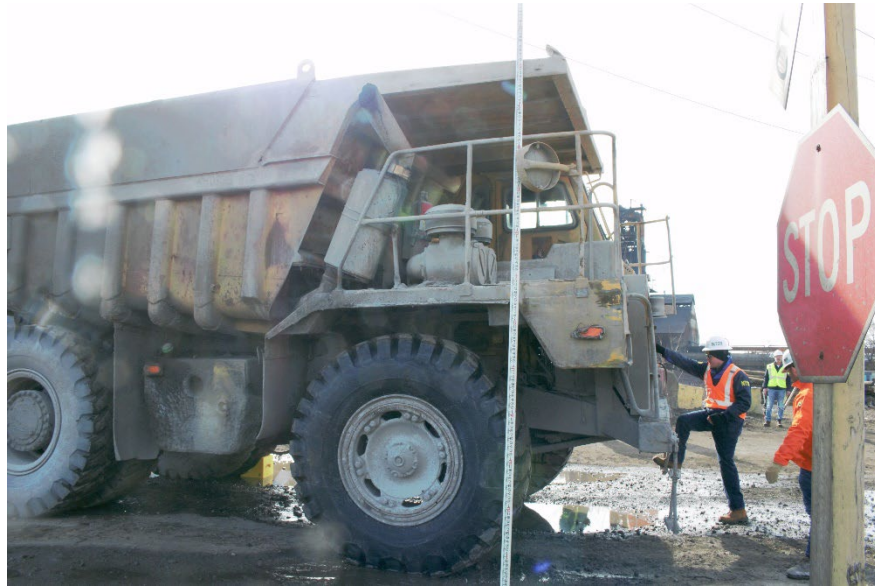
Figure 9 Photograph showing the right side of the dump truck and the obstacles limiting the driver's ability to see the train approaching from the right. (Source: NTSB)
