**Survival Factors- Crashworthiness Investigation Attachment**

**Photographs**

**Chicago, IL**

**RRD24MR002**

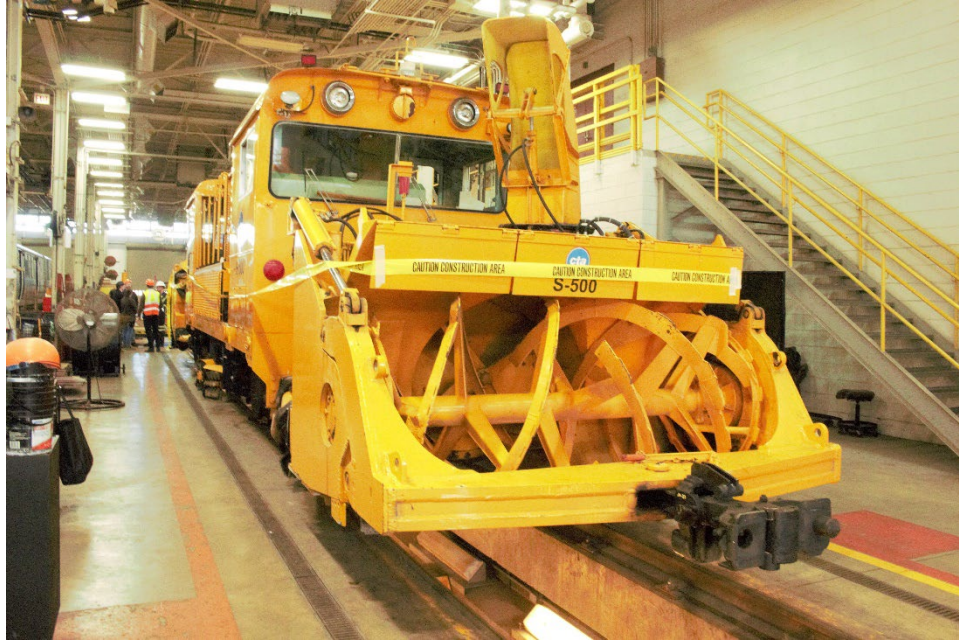
Photo 1 Close-up photograph of the snowplow attachment, located on No. 1 End of the rail borne snow removal vehicle taken at the Skokie yard. (Source: NTSB)

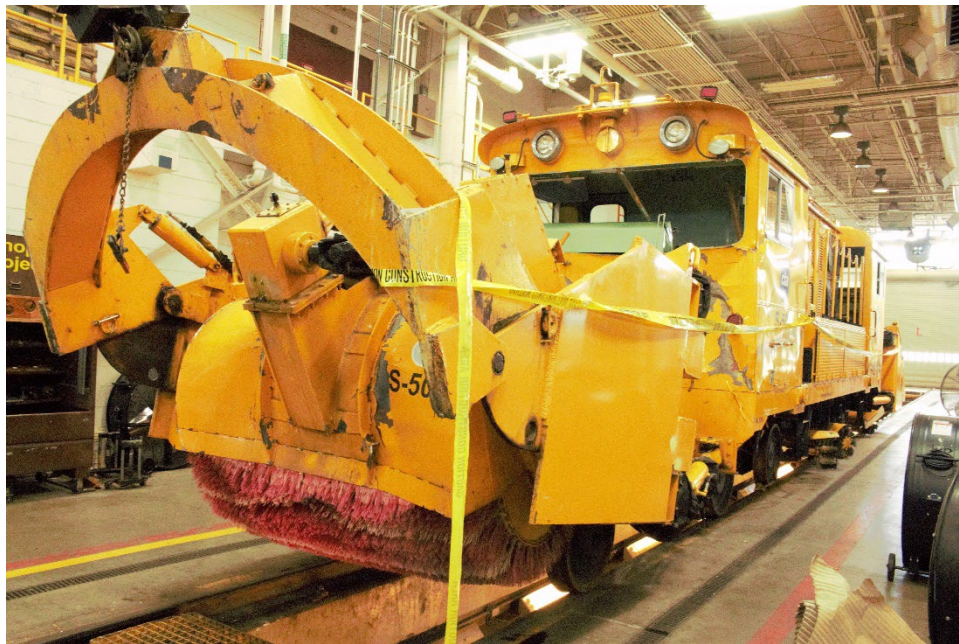
Photo 2 Close-up photograph of the brush attachment located on End No. 2 of the rail borne snow removal vehicle. (Source: NTSB)

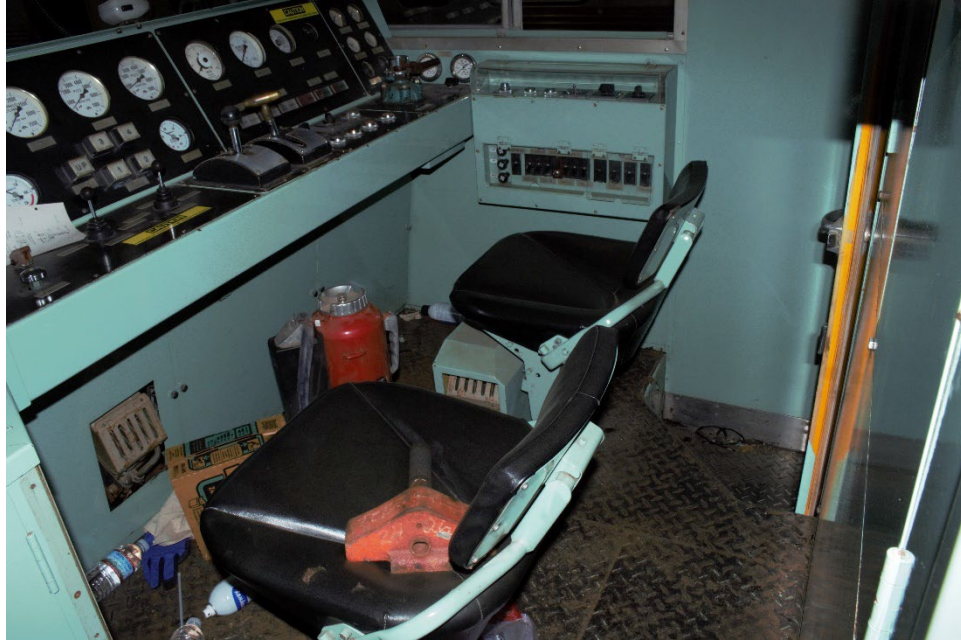
Photo 3 Photograph of the interior of the snow removal vehicle cab showing the proximity of the operator's seat to the control console and the entrance door behind the seat in the background. (Source: NTSB)

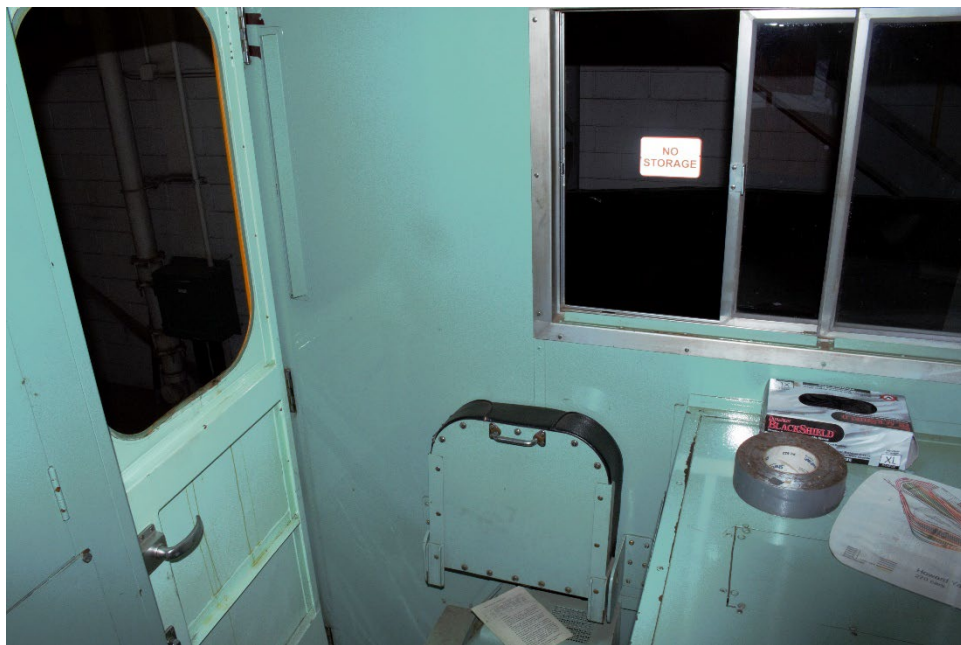
Photo 4 Photograph showing one of the fold-down seats in the cab of the snow removal vehicle and the proximity to the entrance door located at the rear of the cab. (Source: NTSB)

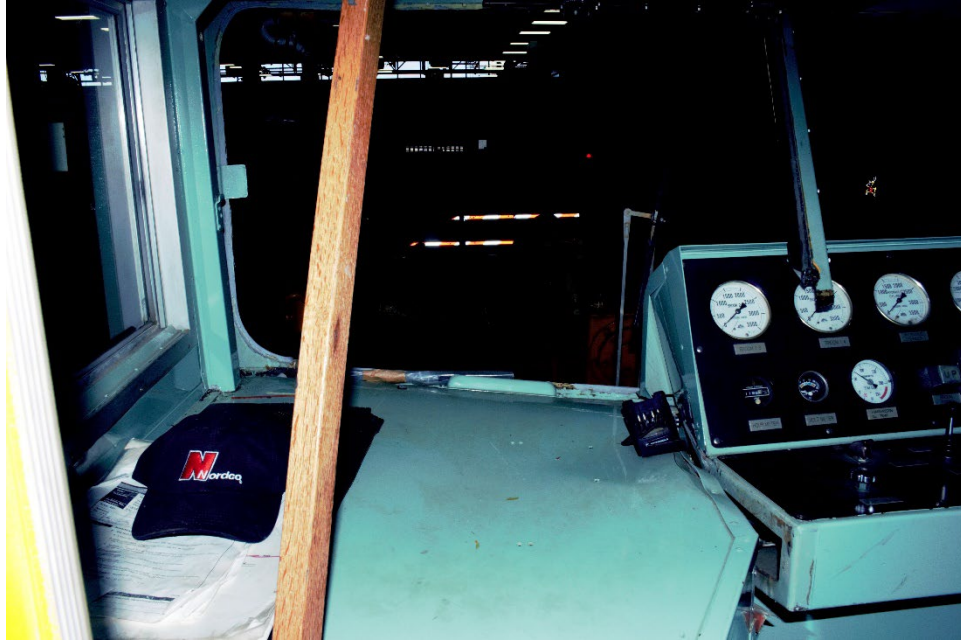
Photo 5 Close-up photograph of the location where the CTA employee was ejected through the windshield. The photograph shows the damage to the top of the equipment box and the missing glass caused by contact with the employee's body. (Source: NTSB)

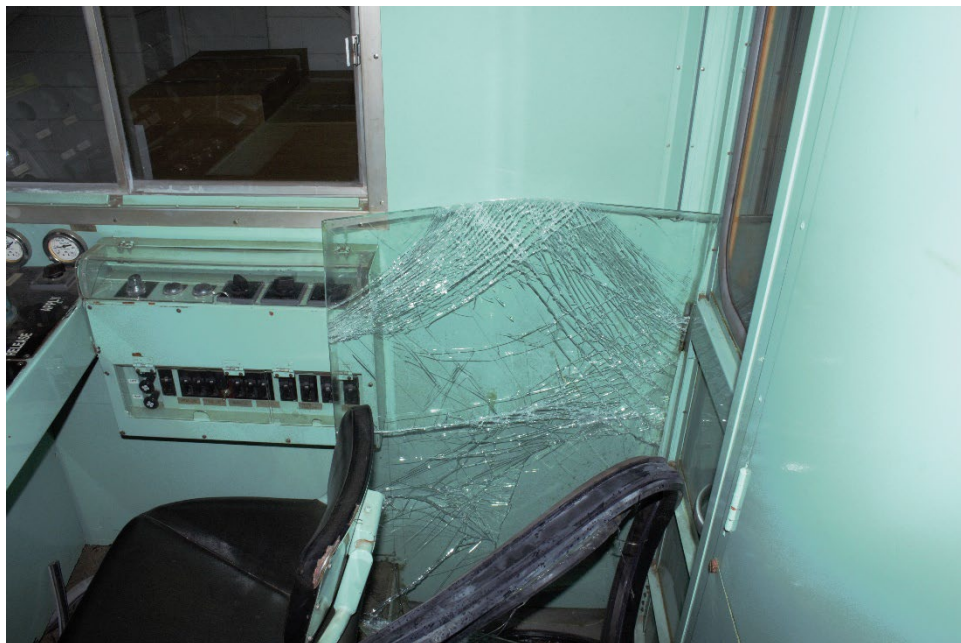
Photo 6 Photograph of the windshield broken out by the ejection of the employee from the vehicle, laying inside of the End No. 2 cab, after it was recovered from the scene. (Source: NTSB)

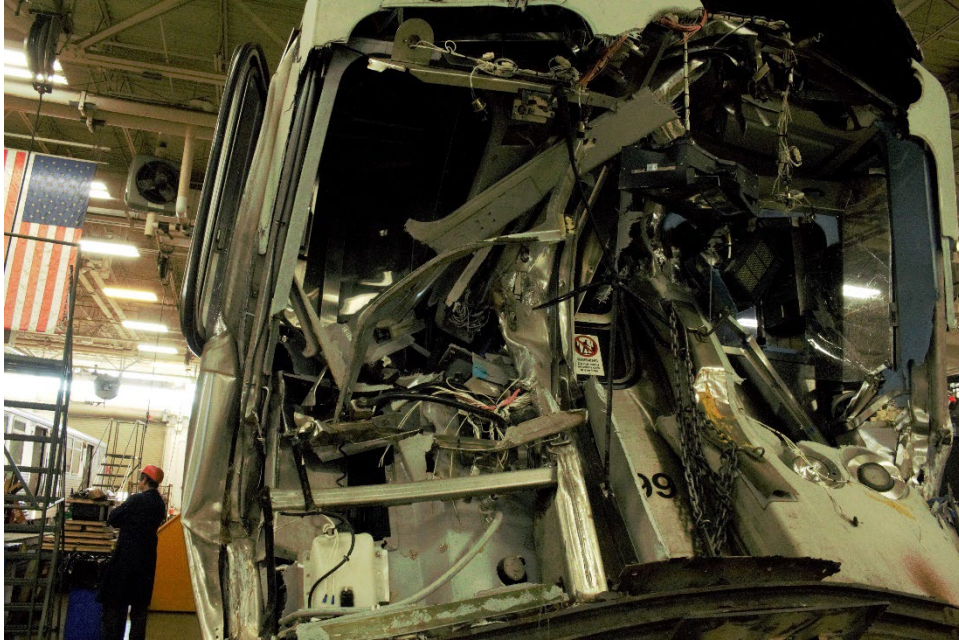
Photo 7 Photograph showing a close-up of the exterior damage to the lead train car and the loss of survival space caused by the extensive intrusion into the space resulting from the collision with the snow removal vehicle. (Source: NTSB)

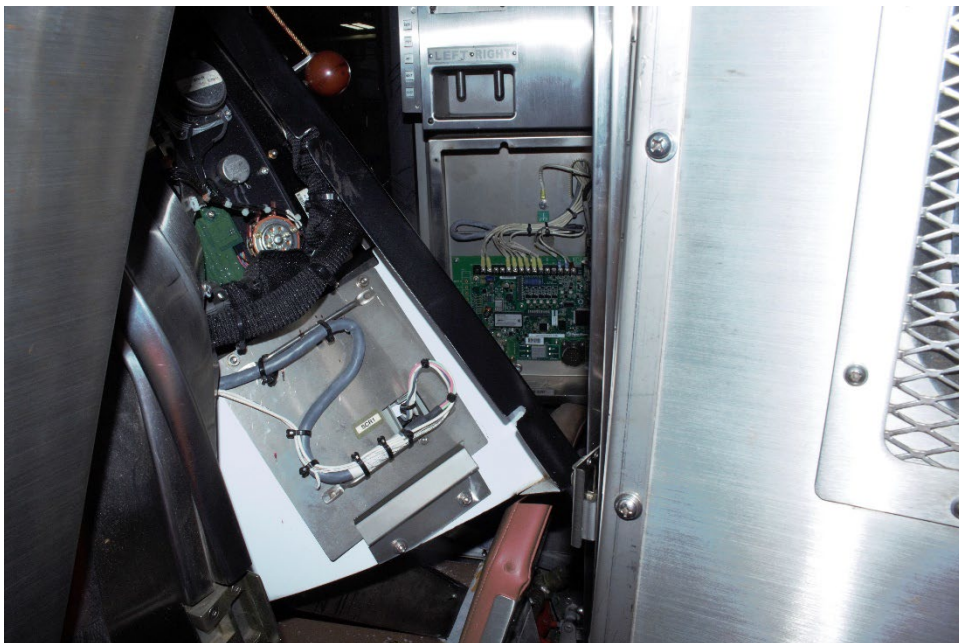
Photo 8 A close-up of the interior of lead train car showing the damage to the operator's cab and the loss of survival space due to the collision with the snow removal vehicle. (Source: NTSB)

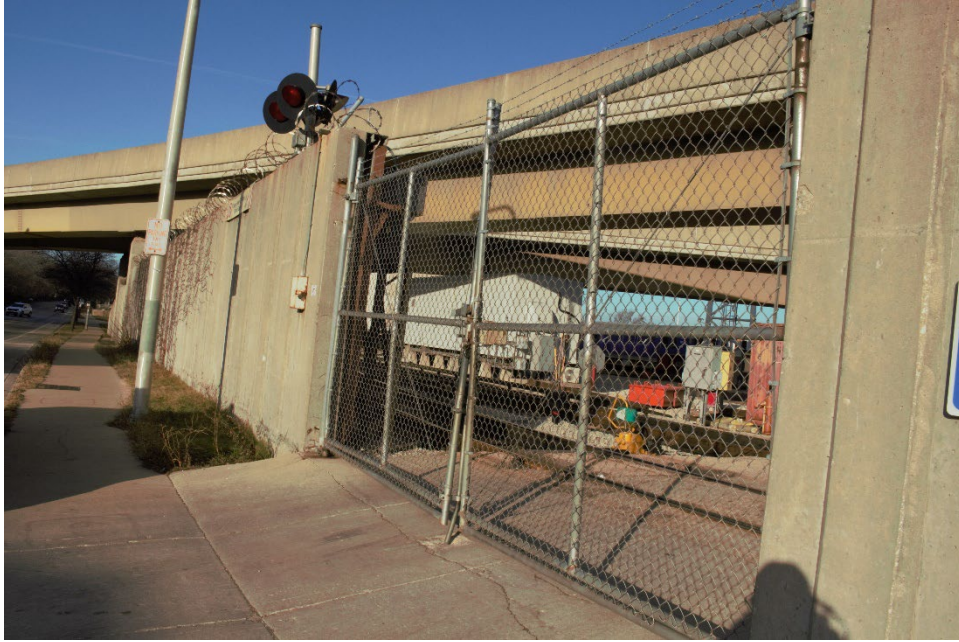
Photo 9 Photograph showing the Chicago Avenue entrance to the Howard Rail Yard. (Source: NTSB)

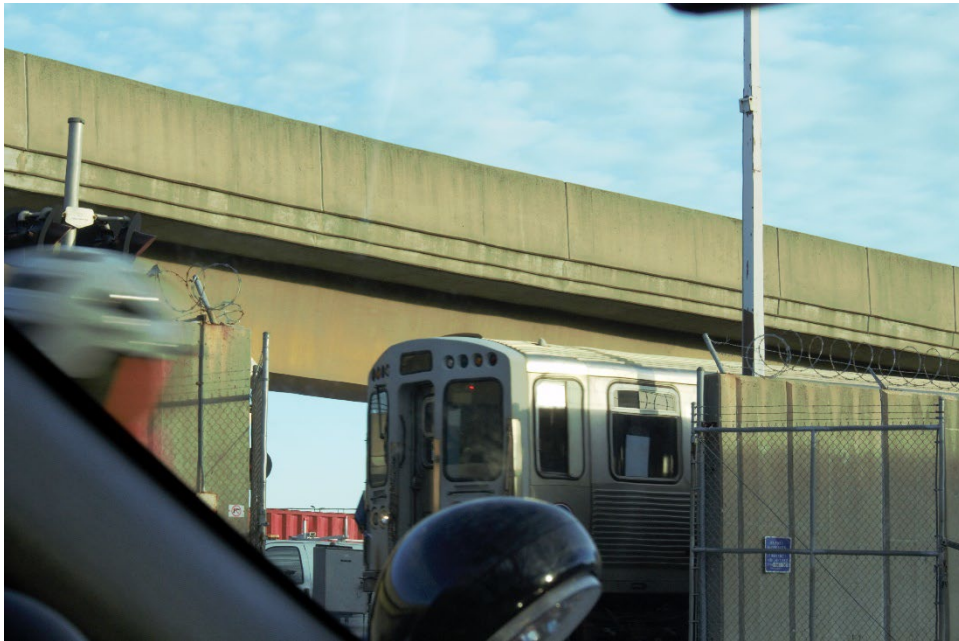
Photo 10 Photograph showing a passing train inside of the Howard Yard and the proximity to the public sidewalk when the entrance gate is open. (Source: NTSB)
