# National Transportation Safety Board

HWY23FH005

## **SURVIVAL FACTORS**

Group Chair's Factual Report

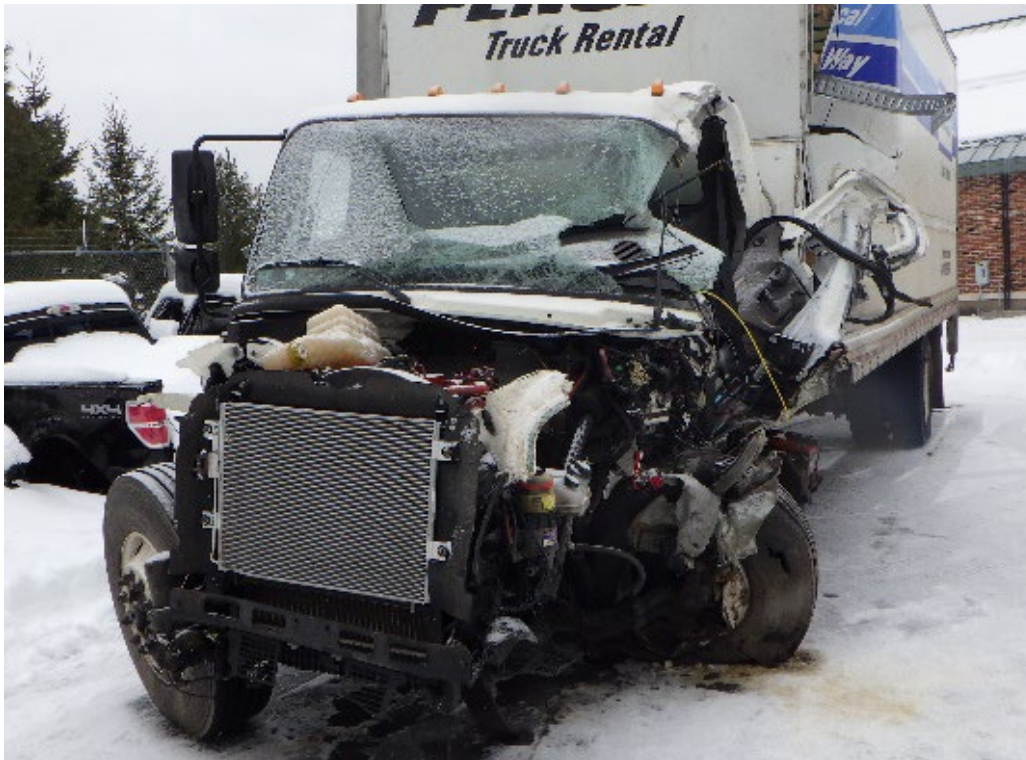
The Freightliner sustained extensive damage to the front left bumper corner with contact damage extending past the front-left wheel assembly down the left-side

into the A-pillar, windshield, occupant seating compartment and front-left side of the 24-foot cargo area, as shown in **Figures 1-2**. Contact damage to the front-left bumper corner was 19 inches wide and extended aft 303 inches with contact to driver's A-pillar and driver door. The left-front wheel assembly was deformed aft approximately 33 inches. The wheelbase on the left side was measured at 237 inches with the right side measuring 288 inches (original wheelbase is 270 inches). The passenger side window was broken out by first responders while extricating the driver. The left-side of the windshield was separated from the header and A-pillar with the A-pillar being torn from the roof header. The driver's door panel was peeled back into the B-pillar, with the door window frame displaced downward and rearward. The diesel fuel tank (located on the vehicle left side, behind the driver's door and below the cargo area) was punctured. Measurements and additional damage descriptions are in the *Vehicle Group Chairman's Factual Report*.

**Figure 1.** Front-left view of damage to 2021 Freightliner box truck.

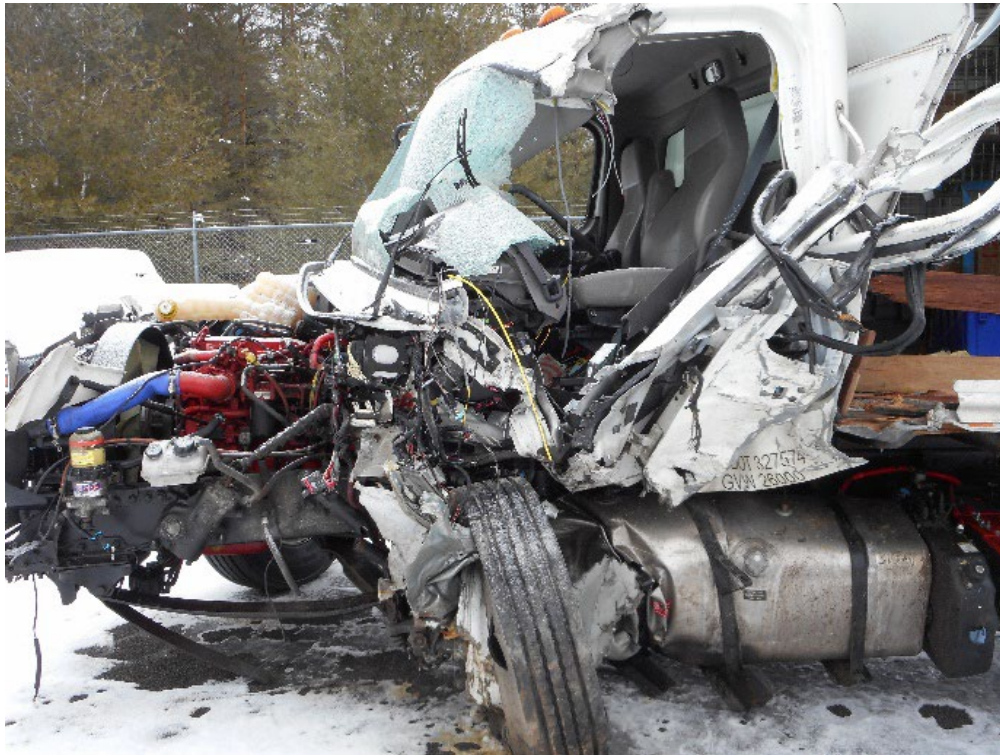
**Figure 2.** Left side view of damage to 2021 Freightliner box truck.

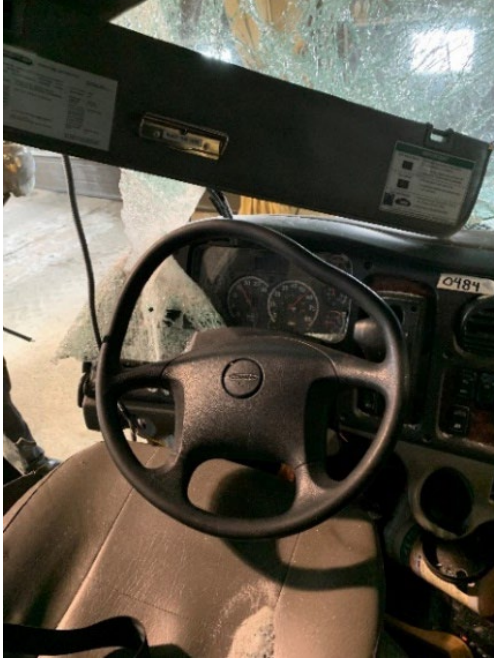
The truck was equipped with a tilt and telescoping steering column. The interior examination showed there was deformation to the steering wheel at the 1 o'clock sector. The post-crash measurement of the steering wheel was 16.5 X 18 inches (original steering wheel diameter was 18 inches). The lower dashboard at the truck driver's knee level showed scuffing. Examination to the driver's D-ring, latchplate and seat belt webbing revealed visible evidence of usage. The D-ring exhibited a heat abrasion and the webbing above and below the latchplate had a large area of heat

**Figure 3.** Interior view of deformed steering wheel.

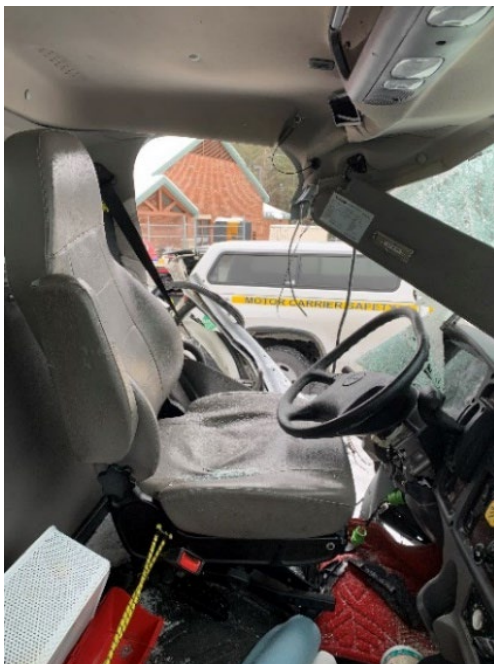
Examination of the interior of the cab revealed extensive damage and intrusion to the driver's seating area of the Freightliner starting at the driver's A-pillar. Intrusion was approximately 3-inches longitudinally at the driver's A-pillar and windshield header and no less than 2 inches laterally through the driver's door panel. The driver's seat was shifted laterally to the right approximately 8 inches. According to the vehicle build sheet, the driver's seat was an air suspension high back with an integral headrest, lumbar, and integrated cushion extension. As shown in **Figures 3-4**, the left-side dashboard and steering wheel were damaged and the driver's seating compartment was intruded from the front and rear.

**Figure 4.** View of driver seating area.

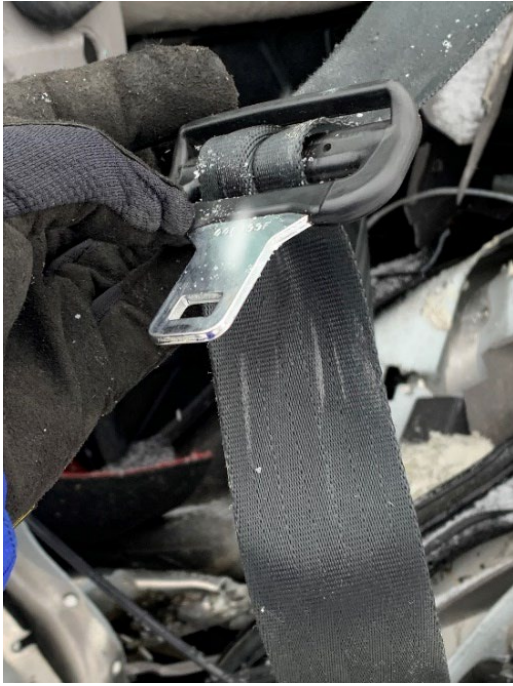
abrasion as shown in **Figures 5-6**. Additionally, the webbing was twisted in the latch plate.

**Figure 5.** View of loading evidence on latchplate and webbing.

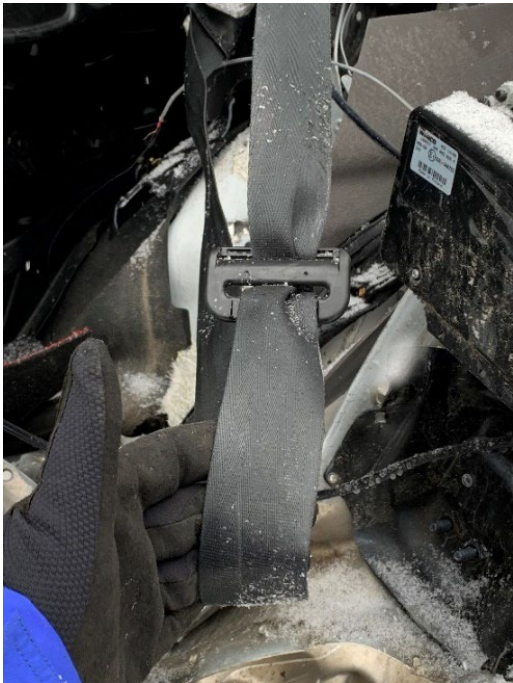
**Figure 6.** View of backside of latchplate.

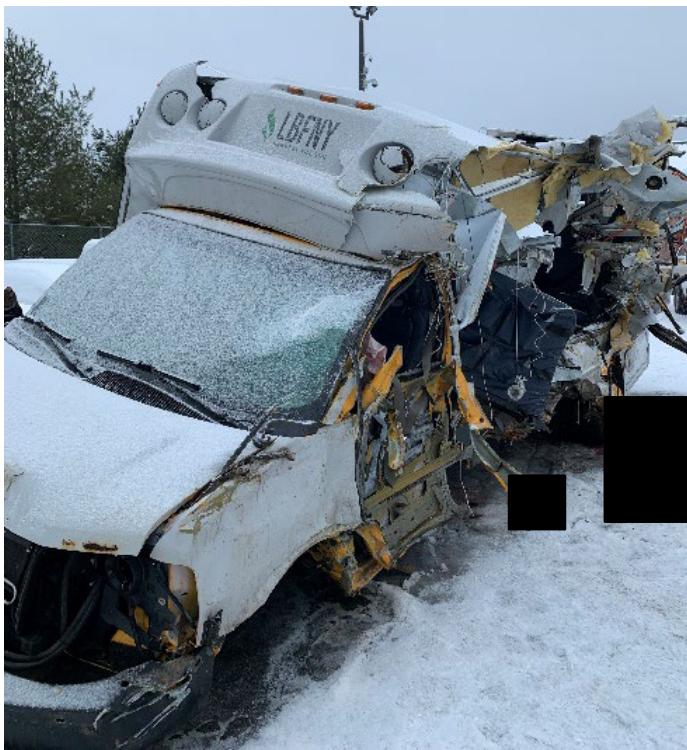
inches wide and the damage extended aft approximately 182 inches. The front-left wheel assembly was completely torn away from the bus and the left-rear dually wheels were both flattened. The contact damage extended vertically to the driver-side A-pillar and above into the fiberglass front fascia attached to the thin sheet metal roof, as shown in **Figures 7-8**. The windshield on the driver's side was shattered and separated from the header and A-pillar. The driver's door panel was peeled aft and exposed the underlying school bus yellow paint. The driver's door window was displaced. Behind the driver's door, starting rearward of the B-pillar, the 2<sup>nd</sup> stage passenger compartment extended outward approximately 10.5 inches.<sup>3</sup> The passenger occupant compartment sustained integrity loss down the left side of the passenger seating compartment. The integrity loss started behind the B-pillar and measured approximately 5 feet high x 7 feet wide. The roof's rail and roof bows were deformed, and the entire roof sustained a combination of contact (left side) and induced damage. The roof line on the right side was buckle inwards. There was a wheelchair lift door located in the rear portion of the bus on the right side, behind seat row three. The exterior handle for the wheelchair lift door was removed from the inside which made it inoperable. The modification was completed precrash by the LBFNY mechanic.

**Figure 7.** Front-left angle view of damage to 2013 Chevrolet Express bus.

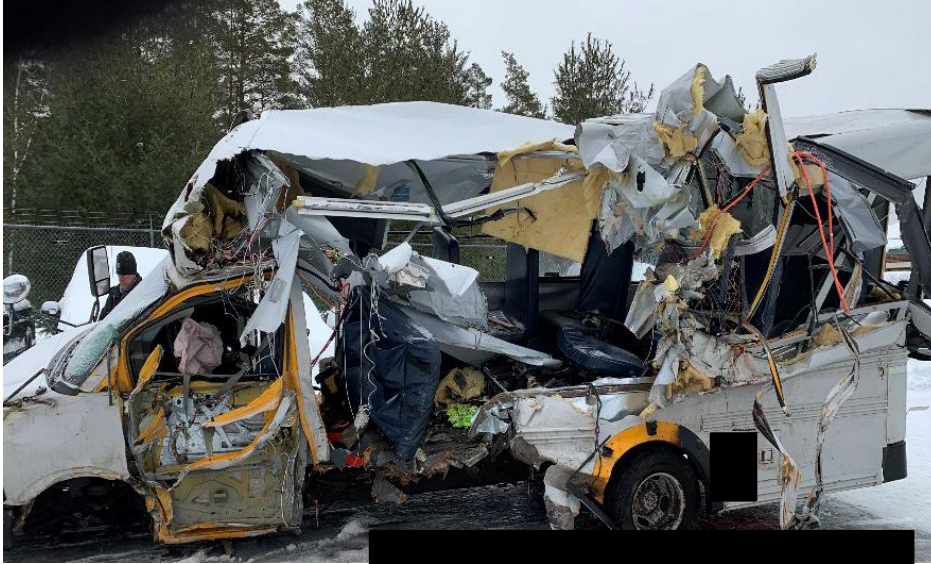
**Figure 8.** Left-side view of damage showing integrity loss to passenger seating compartment.

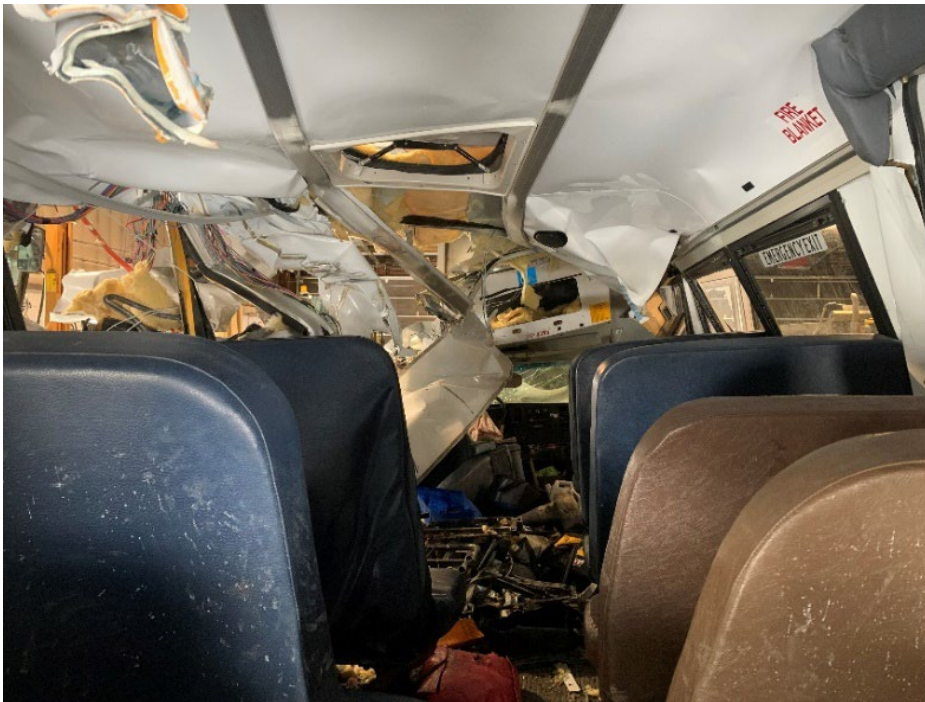
The bus interior damage was primarily concentrated to the left-side at the driver door and progressed aft into three of the five rows of passenger seats behind the driver, as shown in **Figure 9**. There were privacy panels behind the driver seat and adjacent to the entry stairs on the right-side in front of the first seat row. At examination, the driver's door was jammed closed and could not open due to vehicle damage. There was minor intrusion of approximately 2 inches, which started at the driver's door and increased aft behind the B-pillar into the left-side seat rows. Subsequently, there was approximately 14 inches of intrusion into the left-side of the passenger compartment which extended aft to row four. Emergency responder cut and removed seat frames and seat backs in row 1-3 on the left side behind the driver. The fourth row on the left-side was shifted laterally to the right as well. The torn sheet metal roof was partially collapsed resulting in vertical intrusion of approximately 30 inches into the passenger seating area directly above rows 2-3 on the left and right side as shown in **Figure 9**.

**Figure 9.** Interior view looking rear to front at intrusion to interior of 2013 Chevrolet Express.

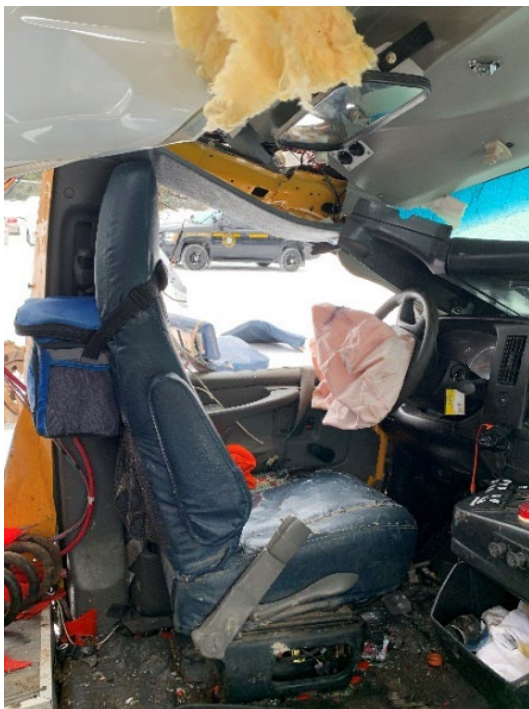
**Figure 10.** View of driver seating area in 2013 Chevrolet Express.

The bus was equipped with an adjustable high-back bucket seat with integral headrest for the driver seat position, as shown in **Figure 10**. Behind the driver seating position were 5 rows of 29.5 inch high-back bench seats on each side. Behind the 5<sup>th</sup> row on the left side the bus was still equipped with the Q'Straint wheelchair tie-downs and lap and shoulder belts which were stored in a bag. The last two rows of seats on the right side were installed by the LBFNY mechanic after the bus was purchased in November 2021. The two seat rows were installed in the area normally left open for the wheelchair lift door operation. The seat manufacturer is unknown. The wheelchair lift mechanism had been removed by the LBFNY mechanic and the wheelchair lift door was secured to the floor with a locking slide bolt and attached to a piece of angle iron that went longitudinally across the door face, forward and aft of the door and made the lift door inoperable. The two seat rows were attached to the piece of angle iron that was spot welded to the exterior side wall and wheelchair lift door. The seat legs were attached to the floor using four tap screws. Post-crash examination showed that both sets of seats remained firmly attached to the floor and sidewall. The three rows of seats forward on the right-side and the five rows of seats on the left-side were original equipment on the bus. Dimensions of the bench seats for the last two right rear seats that were "Add on" seats are shown in **Figure 11** and the original bench seats in **Figure 12**.

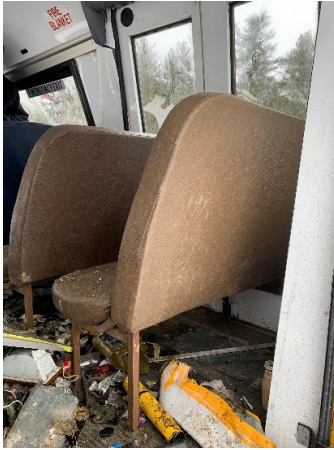
The bus was also equipped with three lap belts (maroon, brown, and dark blue) in all seat rows except the two rows on the rear-right (added post manufacturing), as shown in **Figure 13**. Examination of the seat belts found that almost all were pushed between the seat pan and seatback and suspended behind the seats or wrapped around seat legs, as shown in **Figure 14**. There was only one lap belt found to be in use during the collision which was located in the aisle seat of Row 1 behind the driver. The seat belt was found on the seat pan with the webbing of both the latch plate and buckle portions covered in bodily fluids.

**Figure 13.** View of two added seat rows.

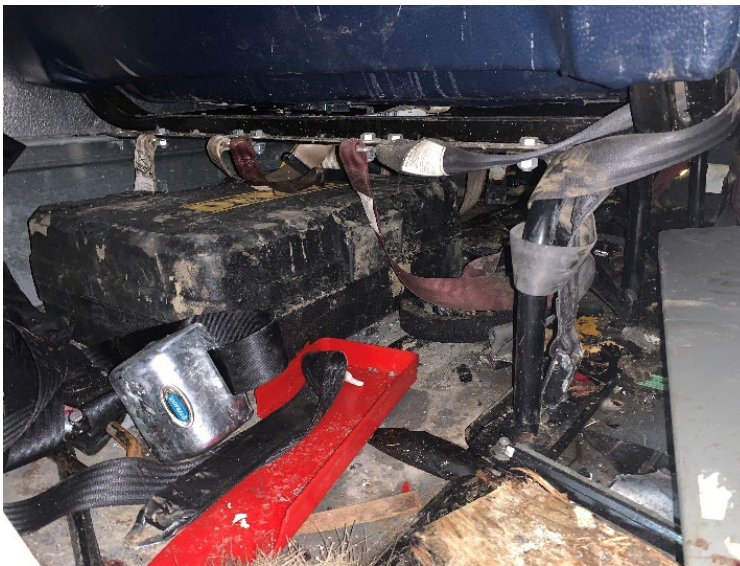
**Figure 14.** View of lap belts hanging underneath seats and wrapped around seat legs.
