**NATIONAL TRANSPORTATION SAFETY BOARD
OFFICE OF HIGHWAY SAFETY
WASHINGTON, D.C.**

**SURVIVAL FACTORS GROUP CHAIRMAN'S
FACTUAL REPORT**

PHOENIX, ARIZONA – HWY21MH008

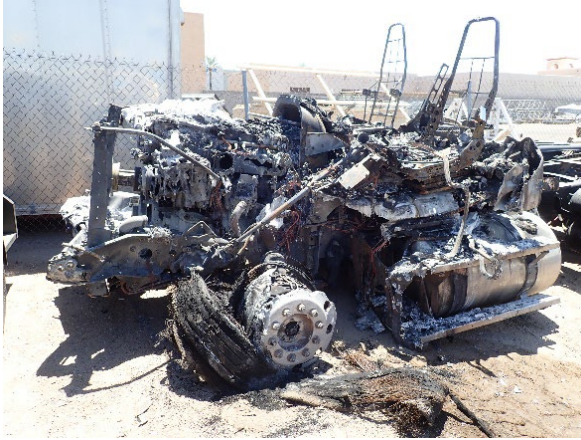
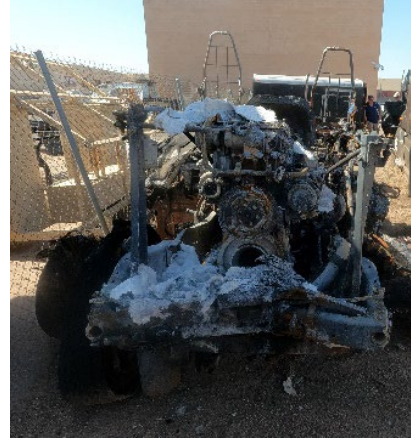
The Freightliner sustained extensive damage to the front end, as shown in **Figures 1** and **2**. A post-crash fire consumed the Freightliner truck-tractor cab. The examination of the Freightliner found that the side saddle fuel tanks were not compromised in the post-crash fire. The 2015 Walker tank-trailer became detached during the crash sequence and was also damaged in the crash. Additional damage descriptions of the Freightliner truck-tractor and tank-trailer are located in the *Vehicle Group Chairman's Factual Report*.

Figure 1. Front left angle view of damage to Freightliner. **Figure 2.** Frontal view of damage to Freightliner.

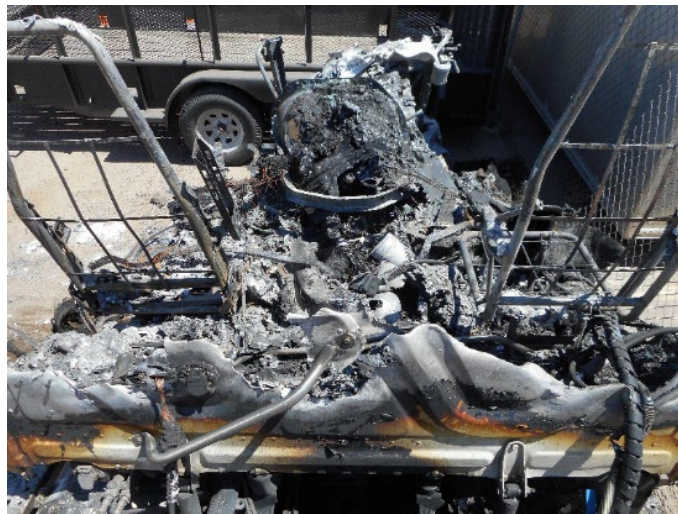
The cab of the Freightliner was consumed in the post-crash fire as shown in **Figure 3**. There did not appear to be any deformation to the driver's seat frame.

Figure 3. Interior view looking from rear to front at the burnt Freightliner.

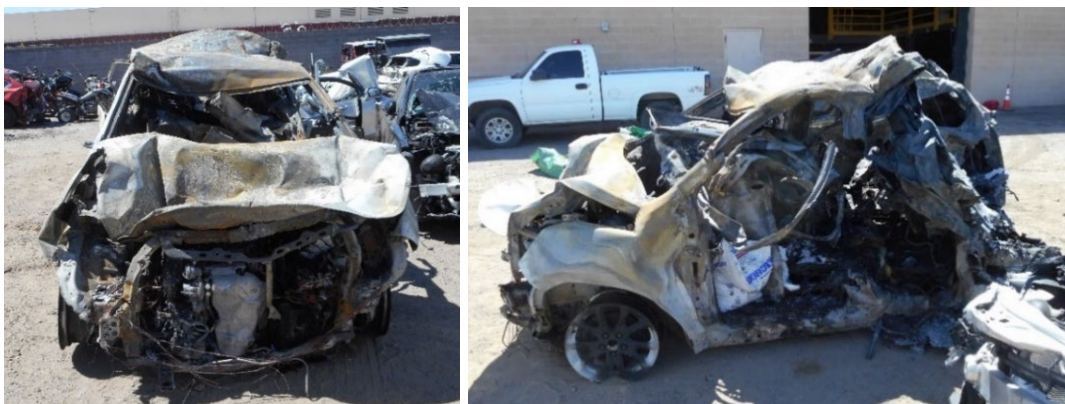
The Equinox sustained significant deformation to both the rear and front end and was consumed in the post-crash fire as shown in **Figures 4-5**. There was a significant reduction of the left side postcrash wheelbase of almost 26-inches (original wheelbase is 107.3-inches, postcrash

was 81.6-inches). The vehicles High-Density Polyethylene (HDPE) gas tank was significantly damaged in the post-crash fire.

Figure 4. Frontal view of Equinox deformation. **Figure 5.** Left side view of Equinox deformation.

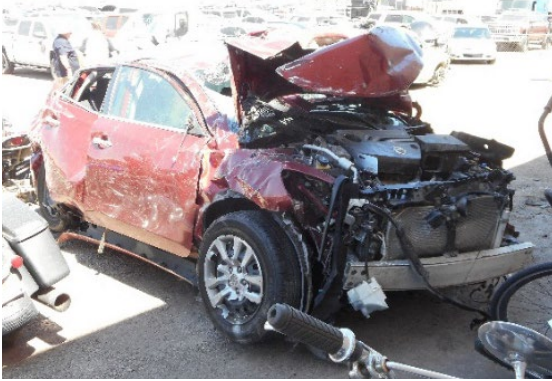
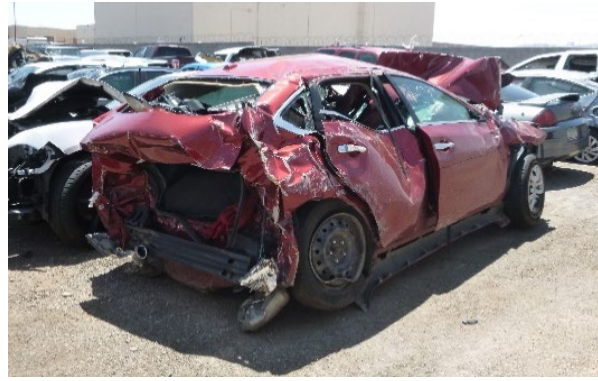
The Altima sustained significant deformation to the front and rear as shown in **Figures 6-7**. The vehicle's subsequent rollover also resulted in roof damage. The rearview window was broken out. The left side postcrash wheelbase was reduced almost 13-inches from the original (original wheelbase is 109.3-inches, postcrash was 96.5-inches). Additional damage descriptions are located in the *Vehicle Group Chairman's Factual Report*.

Figure 6. Front right-angle view of deformation. **Figure 7.** Rear right-angle view of deformation.

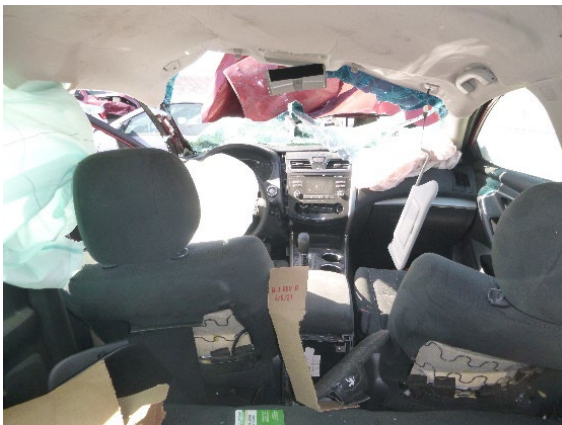
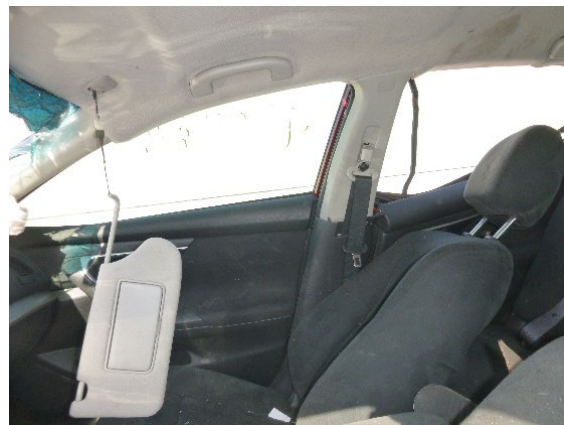
Photographs show that there was a significant amount of intrusion into the rear seat area due to the rear impact. Interior photographs show that the driver's side curtain airbag and both frontal airbags deployed in the crash. The deployed driver side curtain airbag extended from upper interior roof panel at window and door edge down to the top of the door sill and front to rear covering the entire driver window. The front airbag deployed the steering wheel and front right passenger frontal airbag deployed from the dashboard. On-scene photographs taken by the AZDPS show the Altima at final rest with the windshield shattered but still intact with the right front passenger door open. The rear bench seat was pushed forward, and the rearview window was broken out. The driver's side door window and right rear passenger door windows were all broken out. Both the driver and front right seatbacks were displaced aft (approximately 65 degrees and 55 degrees respectively) as shown in **Figures 8-9**. The Altima was equipped with an Active Head Restraint (AHR) which appeared to be activated by extending upward above the seatback in the front right passenger seat position.¹

Figure 8. Interior view of damage looking rear to front. **Figure 9.** Interior view of front passenger seating area.

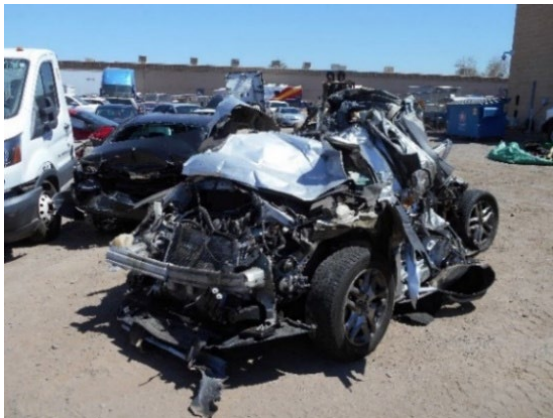
The Fusion sustained significant damage as a result of the front and rear impacts as shown in **Figures 10-11**. The roof of the Fusion had rubber tire transfer marks along the left side. The vehicle's left side postcrash wheelbase was reduced 9-inches from the original (original wheelbase is 112.2-inches, postcrash was 103.2-inches). Additional damage descriptions are located in the *Vehicle Group Chairman's Factual Report*.

Figure 10. Rear view of catastrophic damage.

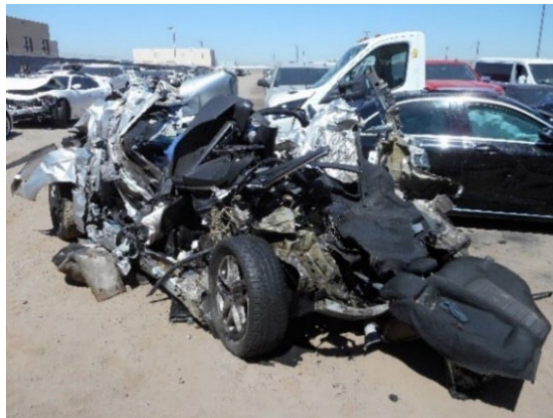
Figure 11. Frontal view of deformation.

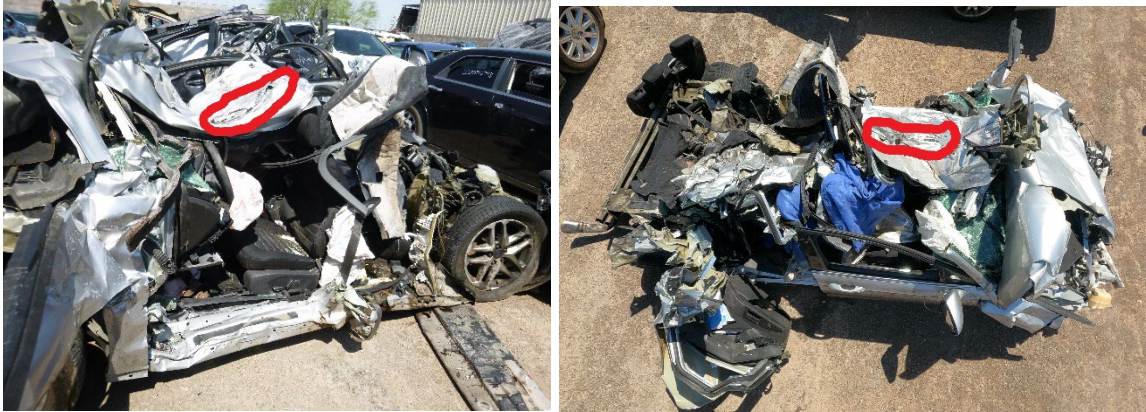
As shown in **Figures 12-13** there was a significant loss of occupant survival space to the Fusion due to the rear and frontal impacts with Freightliner tire transfer marks along the left top side of the roof. Photographs show the roof collapsed below the interior headrests. The rear seats had been torn from the vehicle and were found hanging out the rear of the Fusion. On-scene photographs taken by the AZDPS show the right front passenger seatback bent aft. The interior examination showed that both frontal airbags deployed during the crash and the driver's seatbelt appeared to be abraded and cut by first responders.

Figure 12. Exterior view showing rubber transfer to roof. **Figure 13.** Overhead view of Ford Fusion.

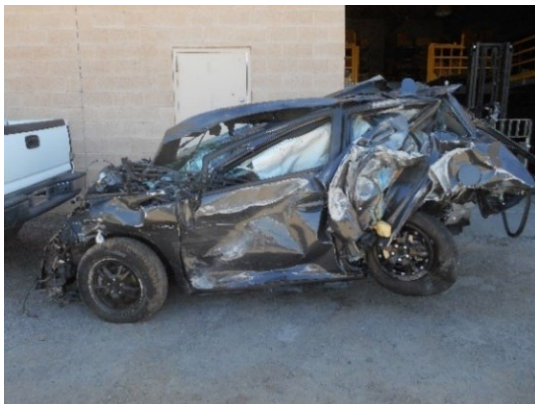
The Prius sustained extensive deformation to both the rear and front end as shown in **Figures 14-15**. The vehicle's left side postcrash wheelbase was reduced almost 30-inches from the original (original wheelbase was 106.3-inches, postcrash was 76.8-inches). Additional damage descriptions are located in the *Vehicle Group Chairman's Factual Report*.

Figure 14. Left side view of deformation to Prius.

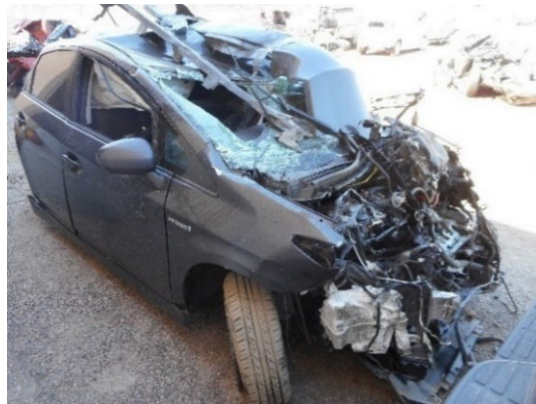
Figure 15. Front right-angle view of Prius deformation.

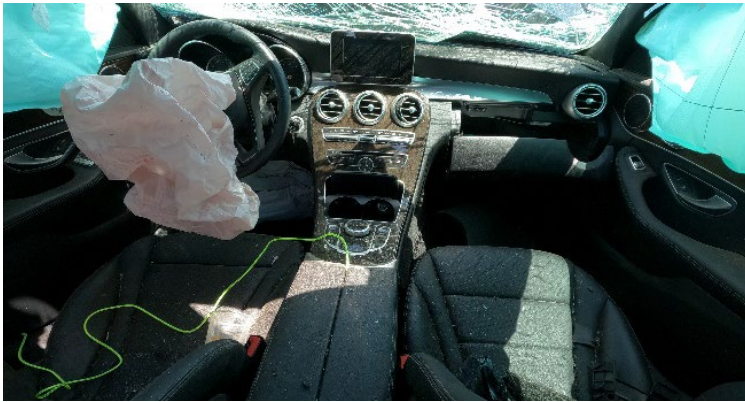
Interior photographs show a moderate amount of intrusion to the front driver seating area and the rear seat area. As shown in **Figure 16**, the driver's frontal airbag and both side curtain airbags deployed during the crash. Interior photographs appear to show the driver's seatback being broken back (approximately 50 degrees) and the headrest missing. The Prius was equipped with an AHR which based on an interior photograph did not activate in the crash. The driver airbag and both side curtain airbags deployed in the crash. The driver's seatbelt pretensioner fired as well. The windshield was cracked, and the rearview window backlight was partially broken out. Additionally, the sunroof was broken out.

Figure 16. Interior view of driver seating area.

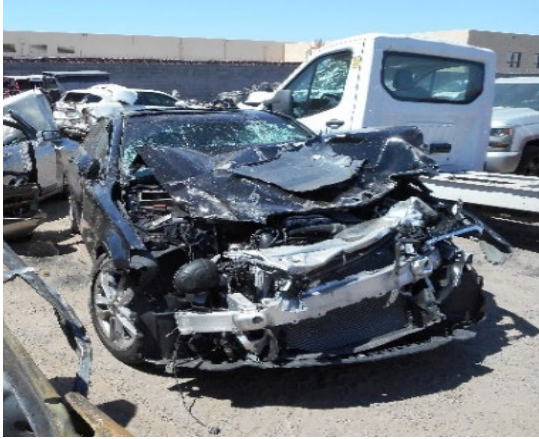
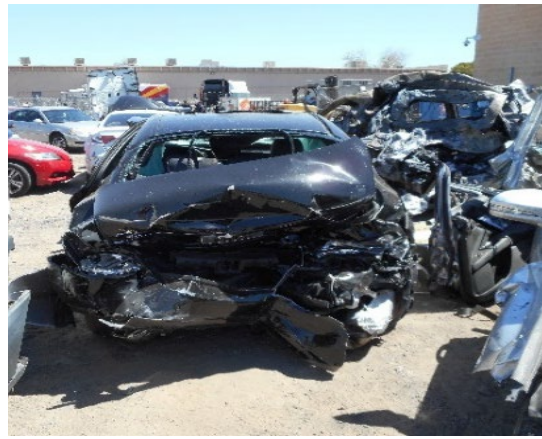
The Mercedes sustained impacts to the front and the rear bumper, as shown in **Figures 17-18**. The rearview window was broken out, the sunroof was totally displaced, and the front windshield was holed and shattered. Additional damage descriptions are located in the *Vehicle Group Chairman's Factual Report*.

Figure 17. Frontal view of deformation to Mercedes. **Figure 18.** Rear view of deformation to Mercedes.

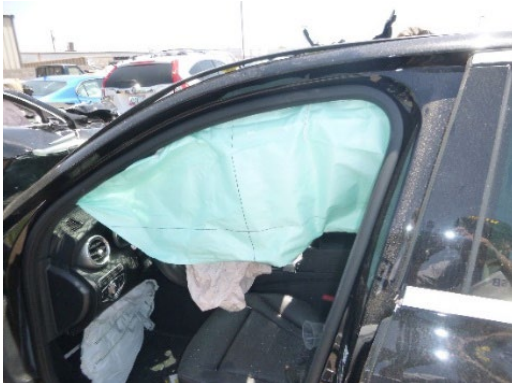
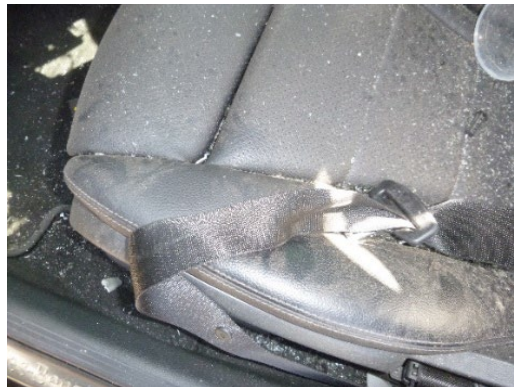
Interior photographs indicated that the vehicles front, side curtains, and the driver's knee airbag all deployed during the crash as shown in **Figure 19**. The ACM also indicated that the driver's seat belt pretensioner fired and the seatbelt was found in the extended and locked position as shown in **Figure 20**. Interior photographs show that the driver's seatback was bent aft (approximately 60 degrees). The Mercedes was equipped with an AHR.

Figure 19. View of deployed airbags from outside driver's door. **Figure 20.** View of extended and locked seatbelt.

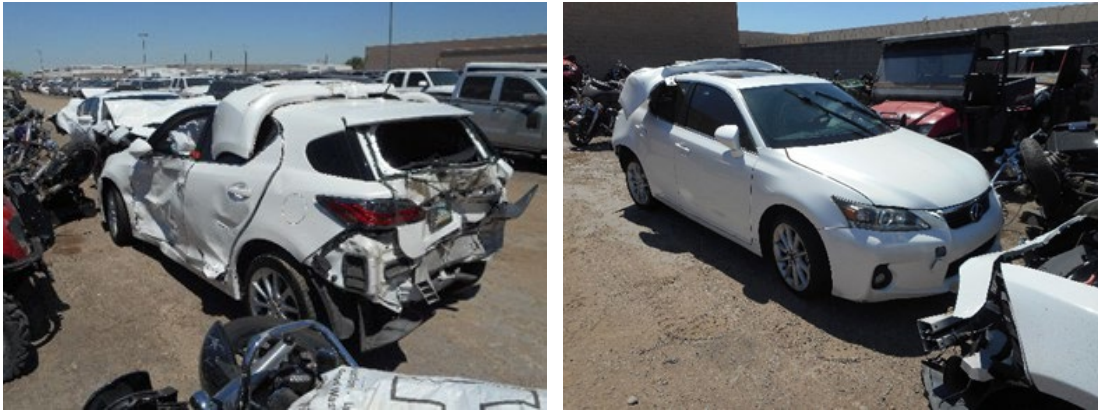
The Lexus sustained deformation to the rear end and the driver's door as shown in **Figures 21-22**. Additional damage descriptions are in the *Vehicle Group Chairman's Factual Report*.

Figure 21. Rear left angle view of deformation. **Figure 22.** Front right-angle view of undamaged front end.

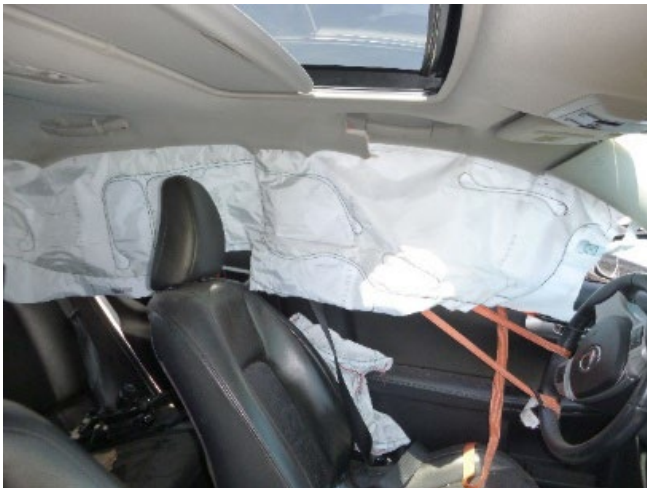
As shown in **Figure 23**, the vehicle's side curtain and torso airbags deployed during the crash. The driver's front airbag did not deploy. The ACM also indicated that the driver's seat belt pretensioner fired. The rearview window was broken out and there is intrusion into the rear hatchback area. The vehicle was equipped with an AHR that did not activate.

Figure 23. Interior view of side curtain and driver torso airbags deployed.

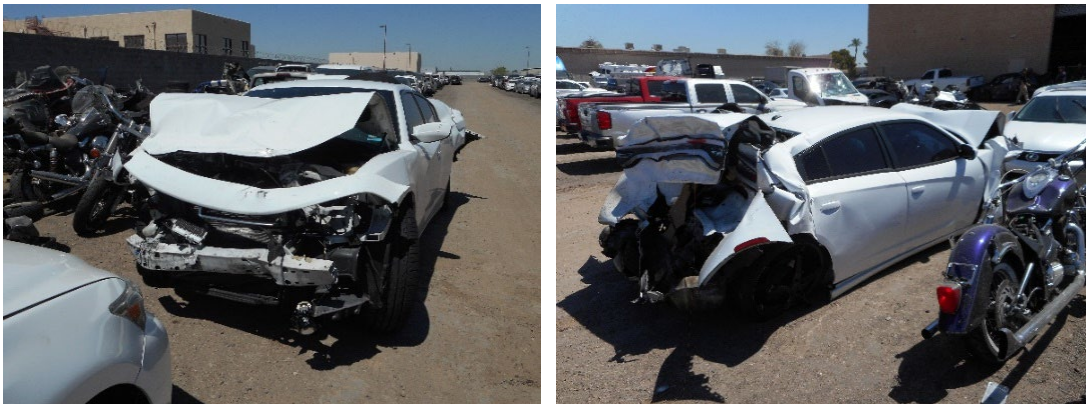
The Dodge sustained front and rear end deformation in the crash as shown in **Figures 24-25**. The vehicles left side postcrash wheelbase was shortened less than 2-inches but there appears to be some override to the rear bumper (postcrash wheelbase was 118.7-inches and the original wheelbase is 120.2-inches). The rearview window was broken out. Additional measurements and damage descriptions are located in the *Vehicle Group Chairman's Factual Report*.

Figure 24. Frontal view of deformation. **Figure 25.** Rear angle view of deformation.

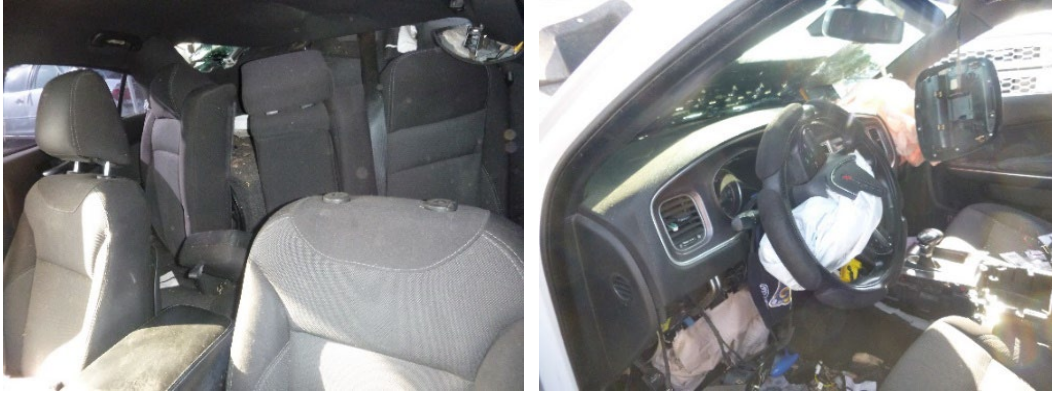
As shown in **Figure 26** there was extensive intrusion into back seat area. Additionally, interior photographs showed both frontal airbags and the driver's knee airbag deployed during the crash as shown in **Figure 27**. The Charger was equipped with manual anti-whiplash adjustable front head restraints in which the driver's anti-whiplash headrest was missing. The front right passenger seatback appears to be bent slightly aft (approximately 65 degrees).

Figure 26. Interior view showing intrusion into back seat. **Figure 27.** Frontal view of deployed airbags.
