National Transportation Safety Board

RRD22LR003

SYSTEM SAFETY

Group Chair's Factual Report

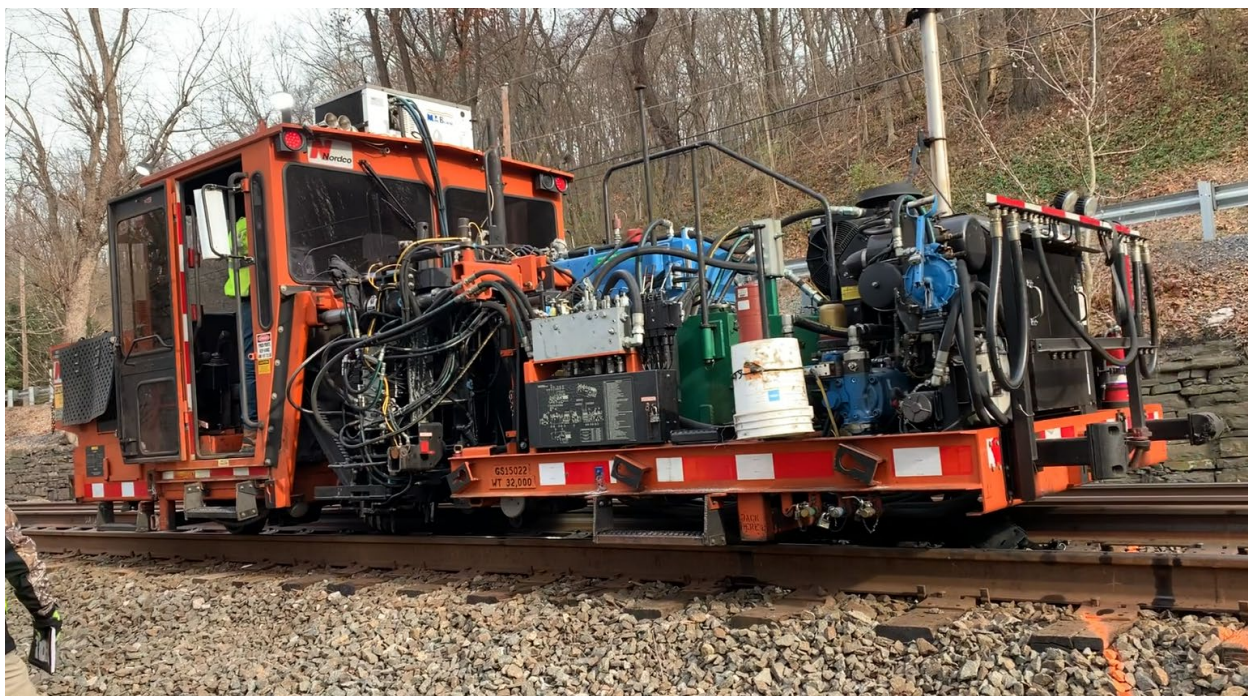
Spiker 2 Exterior - NTSB photograph shows the roadway maintenance machine (Spiker 2) involved in the accident on Norfolk Southern's main track Buffalo line in Reed, PA.

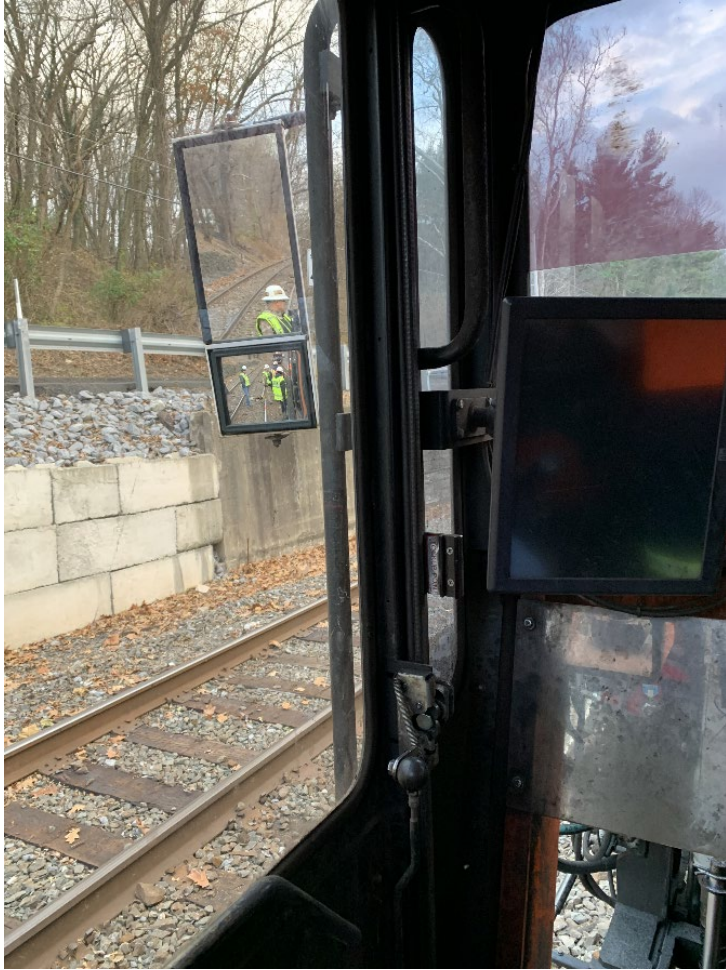
Visibility observations were undertaken at the accident site.¹⁹ One person sat in the cab of Spiker 2 (which was facing south) and looked out the left rear-view mirror while sitting in the left seat. The right mirror is not visible from this position. Another person who was of a similar height as the National Salvage contract worker moved to different positions behind the spiker. Specifically, they stood on the left (east) side of the track (on the tie - outside the gauge) and walked north (away from the spiker) until partially visible, then fully visible to the person in the cab. These distances were recorded (see chart below). The same observations were recorded with the person standing in the center of the track, and then the right (west) side of the track.

Spiker 2 Mirror - NTSB photograph that shows the left rear-view mirror of Spiker 2 from the perspective of the left operator seat.

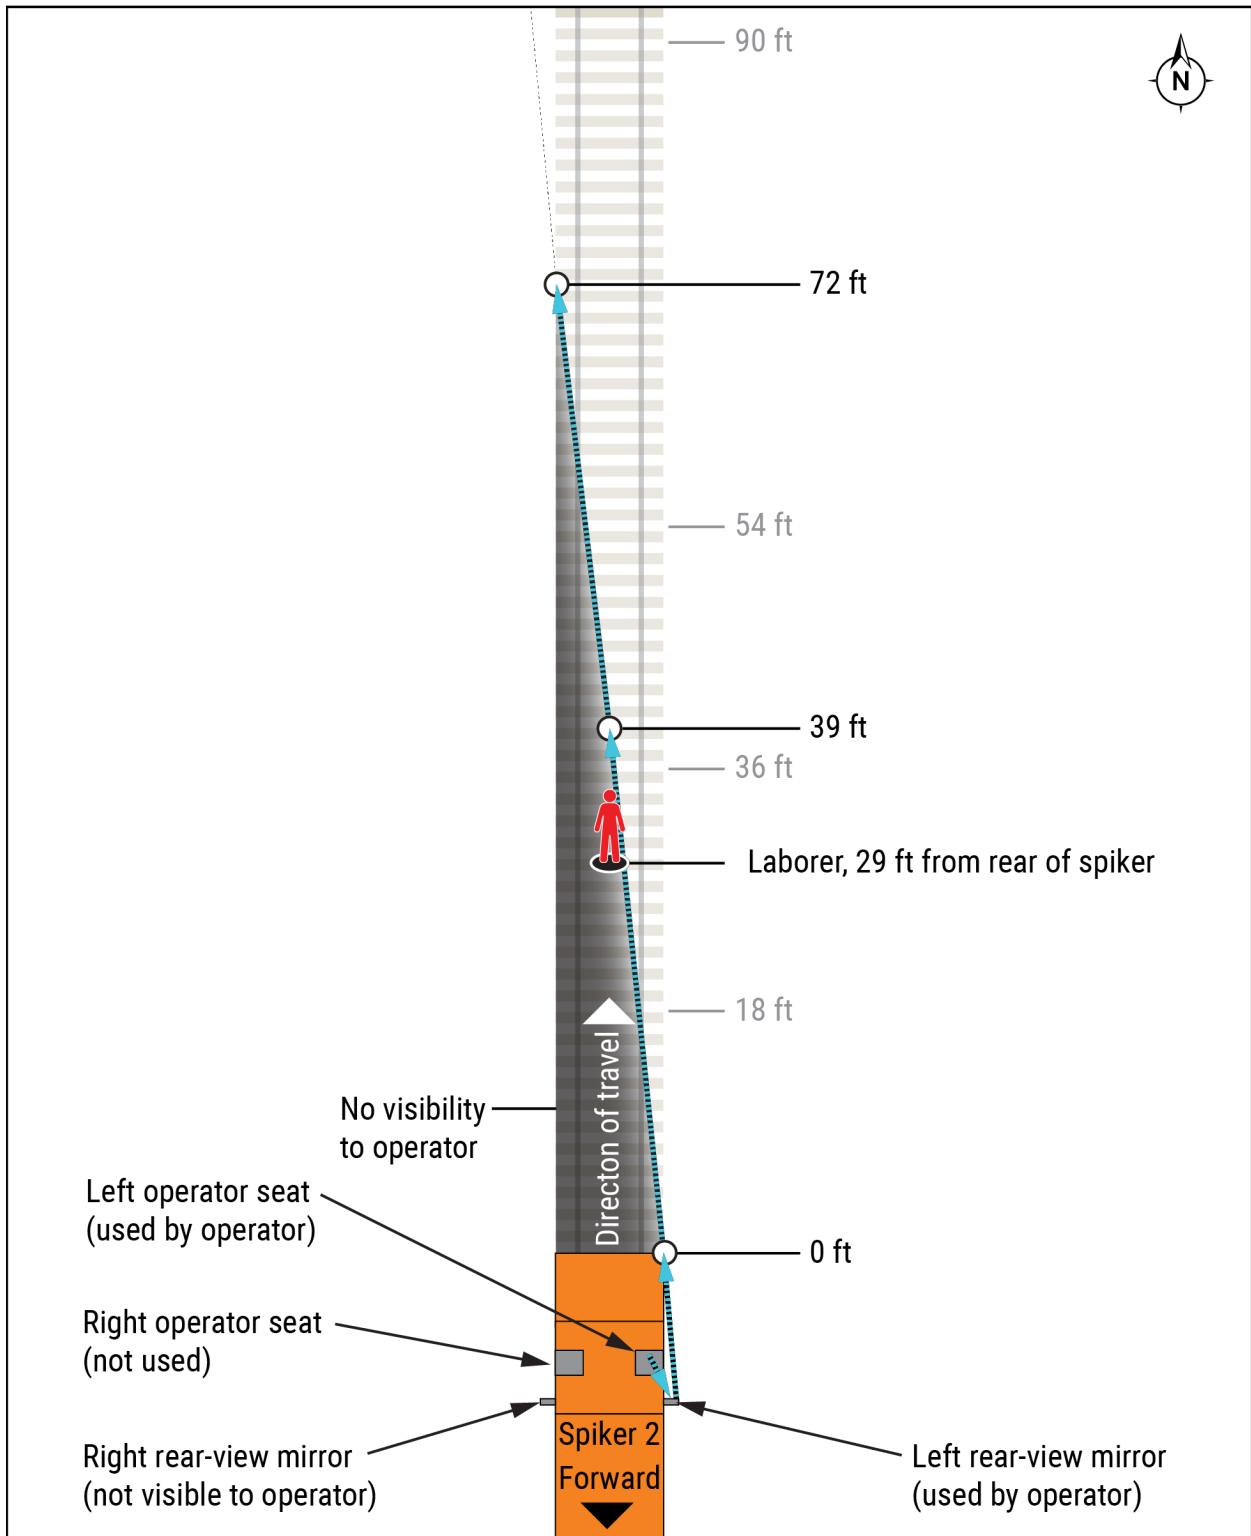
Track Position	First Visible	Fully Visible
Left (east)	0 feet	9 feet 6 inches
Middle	39 feet	43 feet 5 inches
Right (west)	72 feet	76 feet 6 inches

Spiker 2 Visibility Diagram - NTSB diagram of view from Spiker 2 left rear-view mirror based on measurements from visibility observations with location of contract worker (a laborer) at start of accident sequence indicated.
