National Transportation Safety Board

RRD23FR002

SYSTEM SAFETY

Group Chair's Factual Report

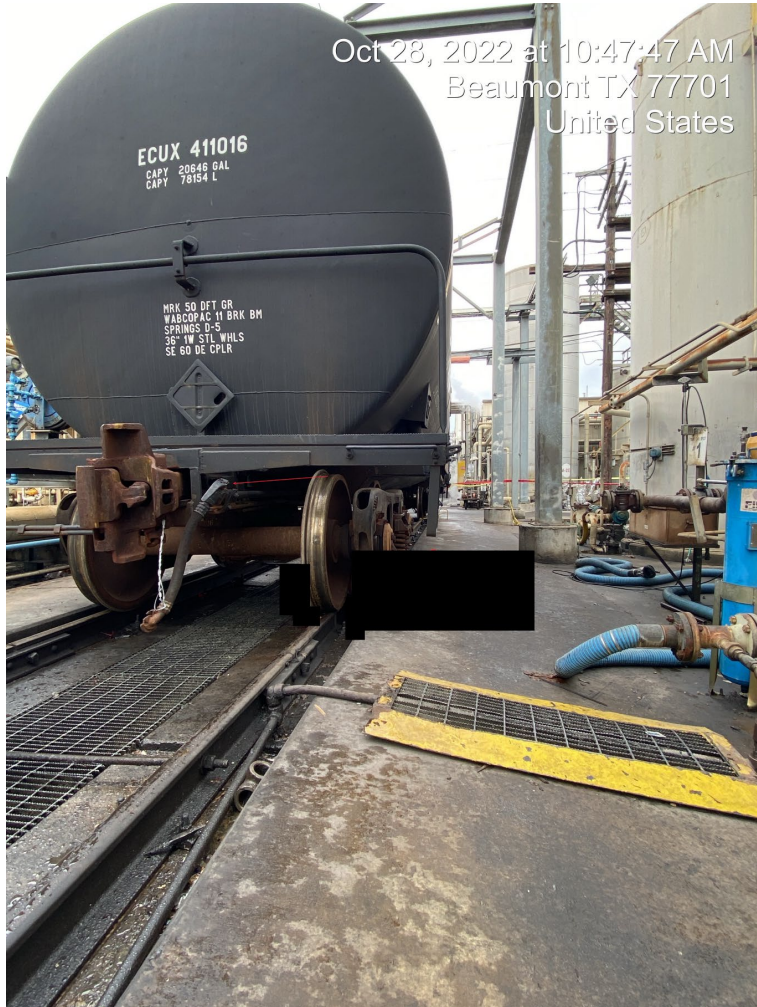
After the accident, the angle cock valve on the last rail car (at the front of the shove movement) was found to be in the open position.

Figure 1. In the above photo, the angle cock valve (pointed to with a thin red arrow) is shown in the open position. The body of the conductor is redacted.
