National Transportation Safety Board

RRD23LR007

SYSTEM SAFETY GROUP

Group Chair's Factual Report

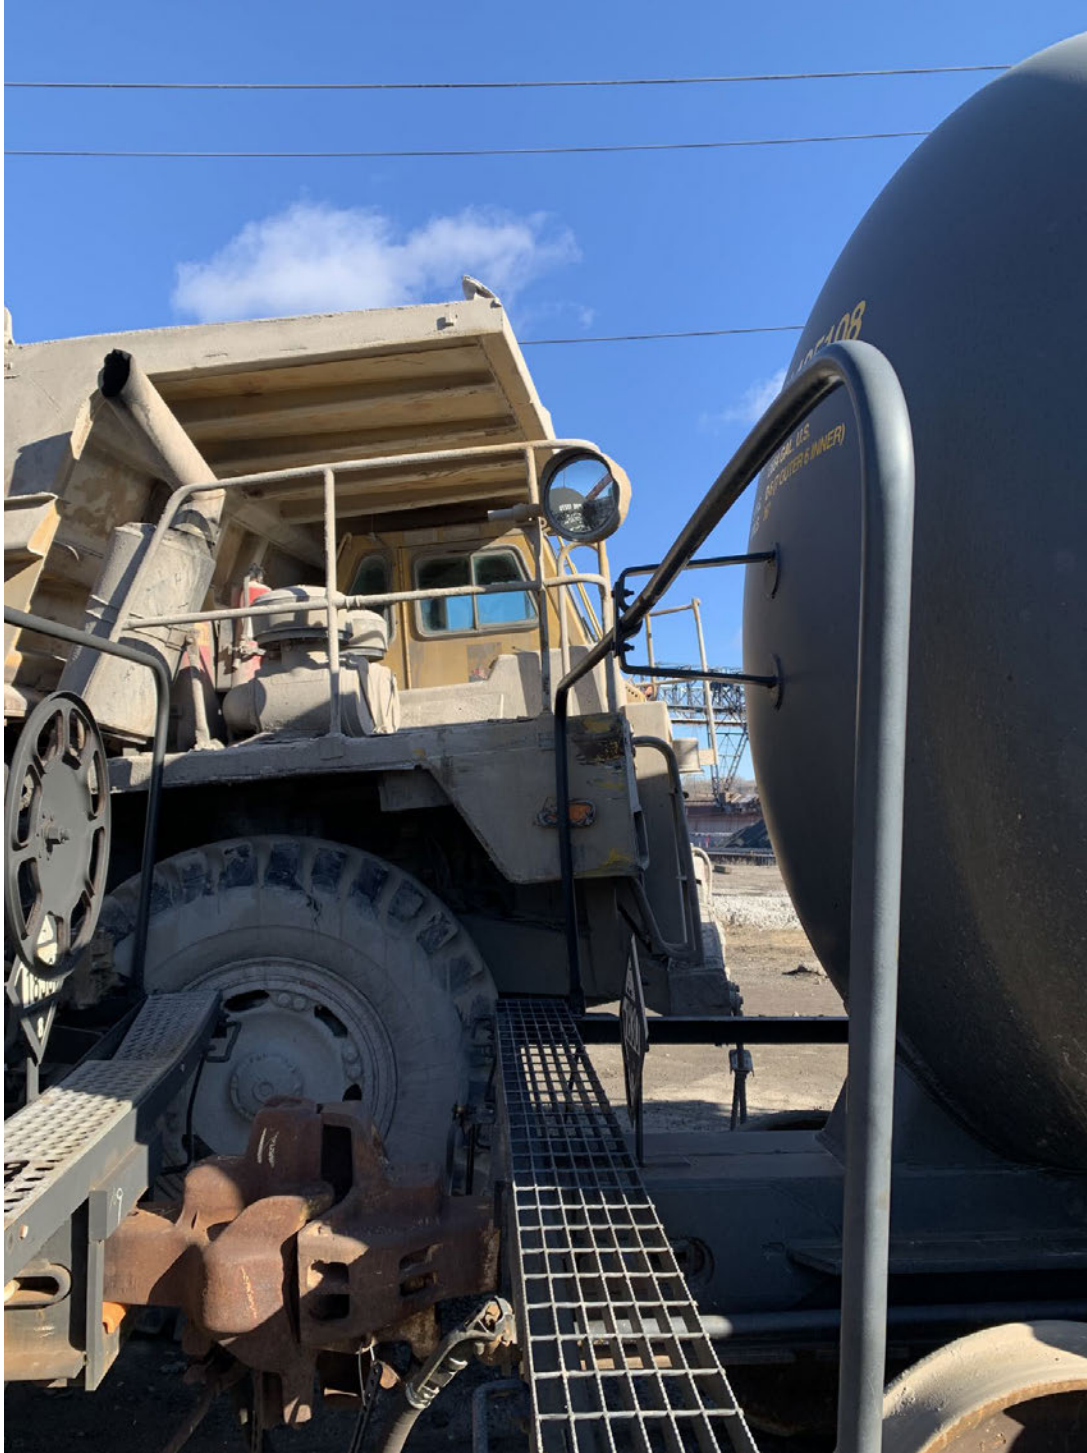
Figure 1. This photo was taken by the system safety group chairman during the on-scene portion of the investigation. It shows the final resting place of the truck and train. The front right of the truck contacts the side of a railcar.

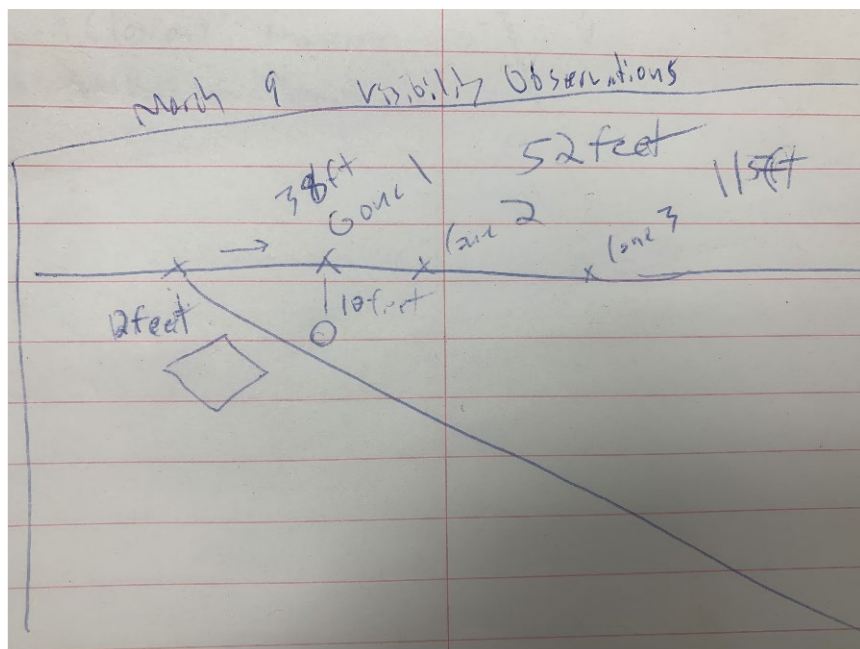
Investigators went to the scene of the accident and took visibility observations from the cab of the truck to determine the approximate field of view that the driver would have had at the time of the accident.¹⁹ The truck was first placed in a 'conservative' position, with the front bumper parallel to the stop sign.²⁰ From this location, observers leaned forward in the seat, and looked out the right window to see how far down the railroad tracks was visible. From this 'conservative' position, a driver can see about 115 feet to the right of the crossing (this point is indicated as Cone 3 in the figure below). Note that the 'crossing' was identified as the approximate location that the front right corner of the truck was estimated to first reach the rail.

Figure 2. The above figure is a photo of a hand drawn sketch by the system safety group chairman. The rail is depicted by a horizontal line, and the road is depicted by an angled line that intersects it from below. Three cones were placed to indicate measurements from the crossing, as described in this section of the report. The square represents the truck, and the circle represents the stop sign with crossbucks. Note that the figure is not drawn to scale.

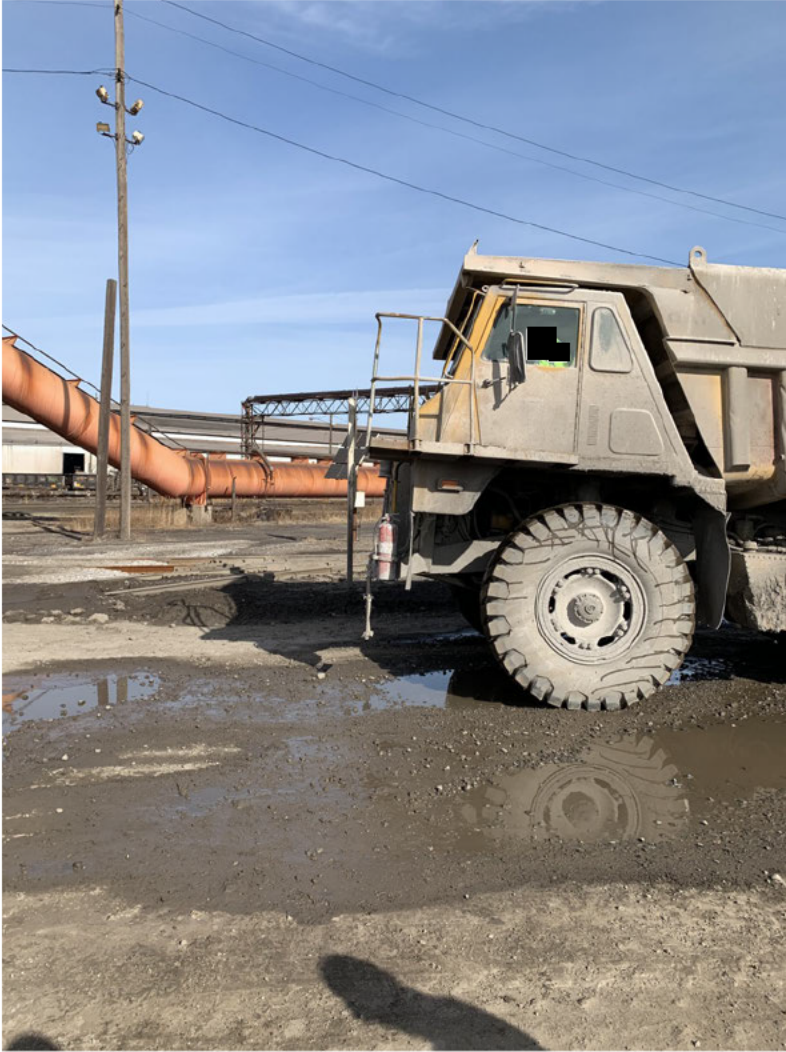
Figure 3. This photo shows the 'conservative' truck location behind the stop sign.

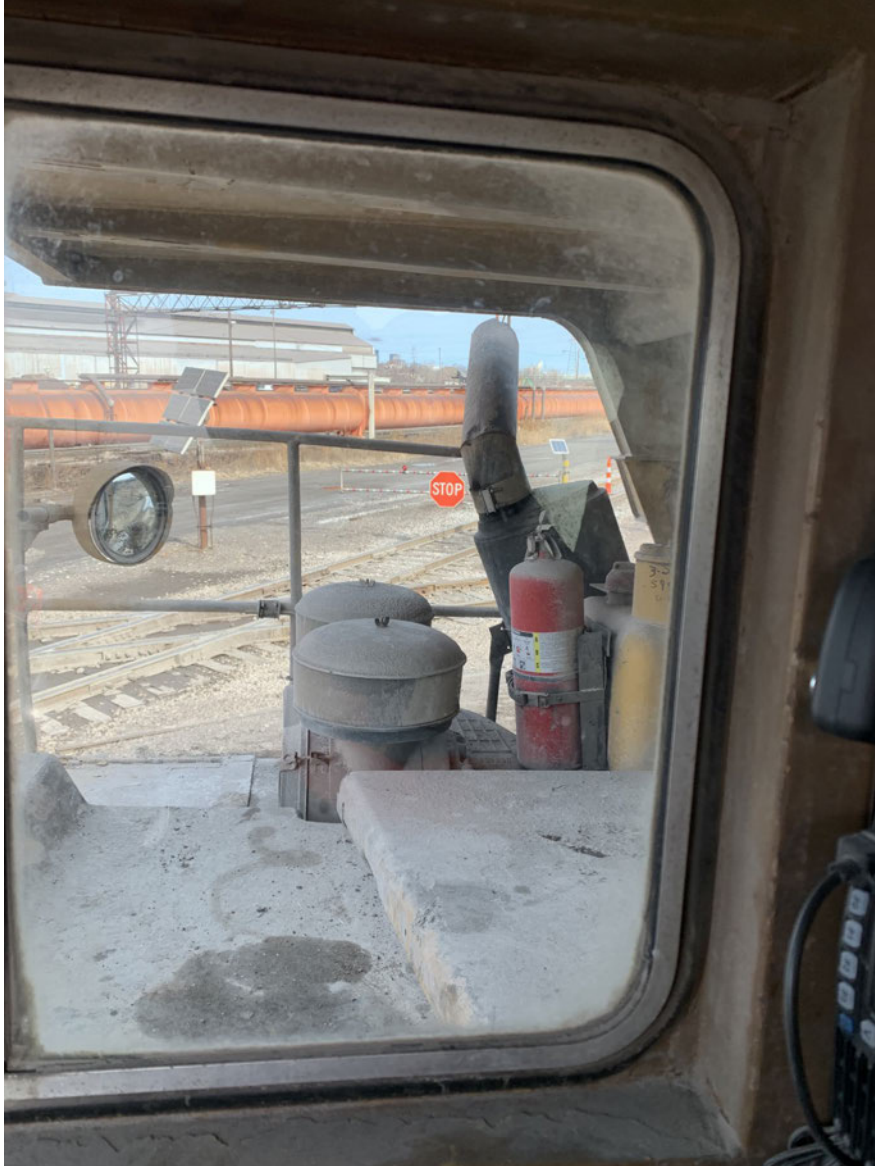
Figure 4. In this photo, the cone is 'Cone 3' in the sketch. It shows the view from the right window (note that there are two windows on the right side, this is the larger one toward the front).

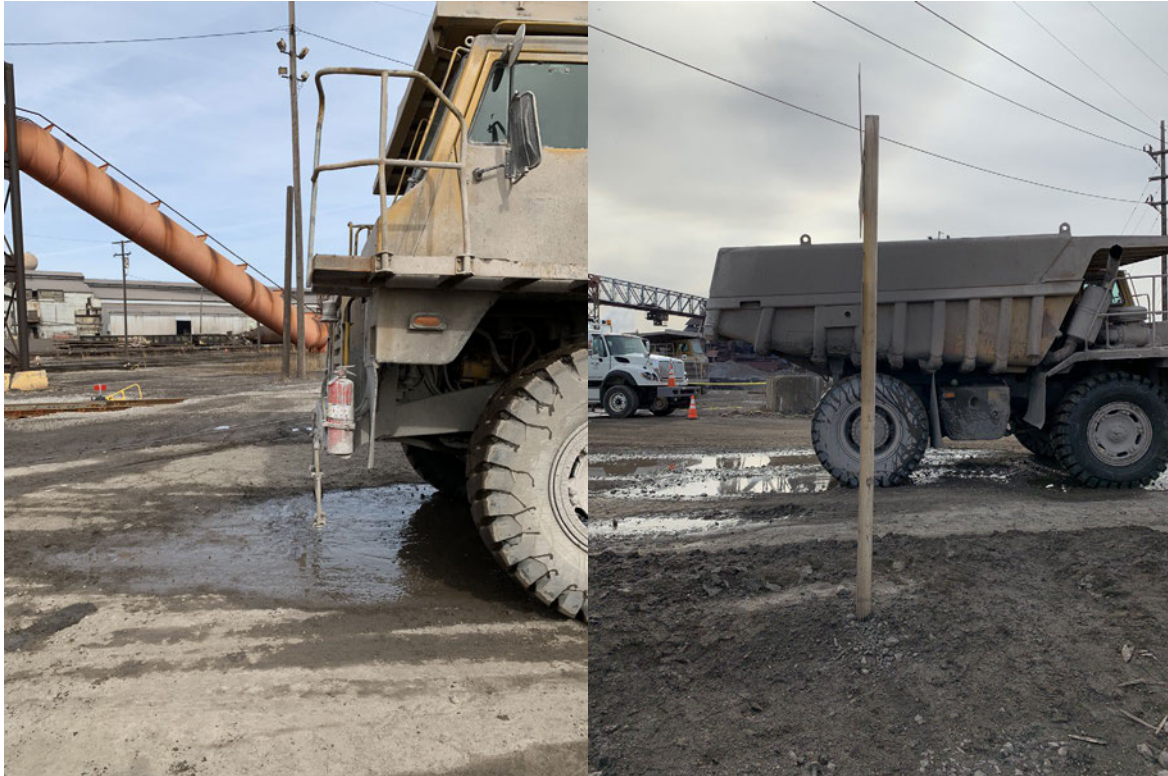
After reviewing surveillance video provided by Cleveland-Cliffs, the system safety investigative group estimated that the truck driver had pulled the truck up past the stop sign before stopping on the night of the accident. To approximately recreate this position, the truck was pulled up closer to the crossing (the 'estimated' position). From this position, leaning forward in the seat and looking between the truck exhaust and the bed of the truck, a driver can see about 52 feet to the right of the crossing (see 'Cone 2' in Figure 2).

Figure 5. These photos show the 'estimated' truck position.

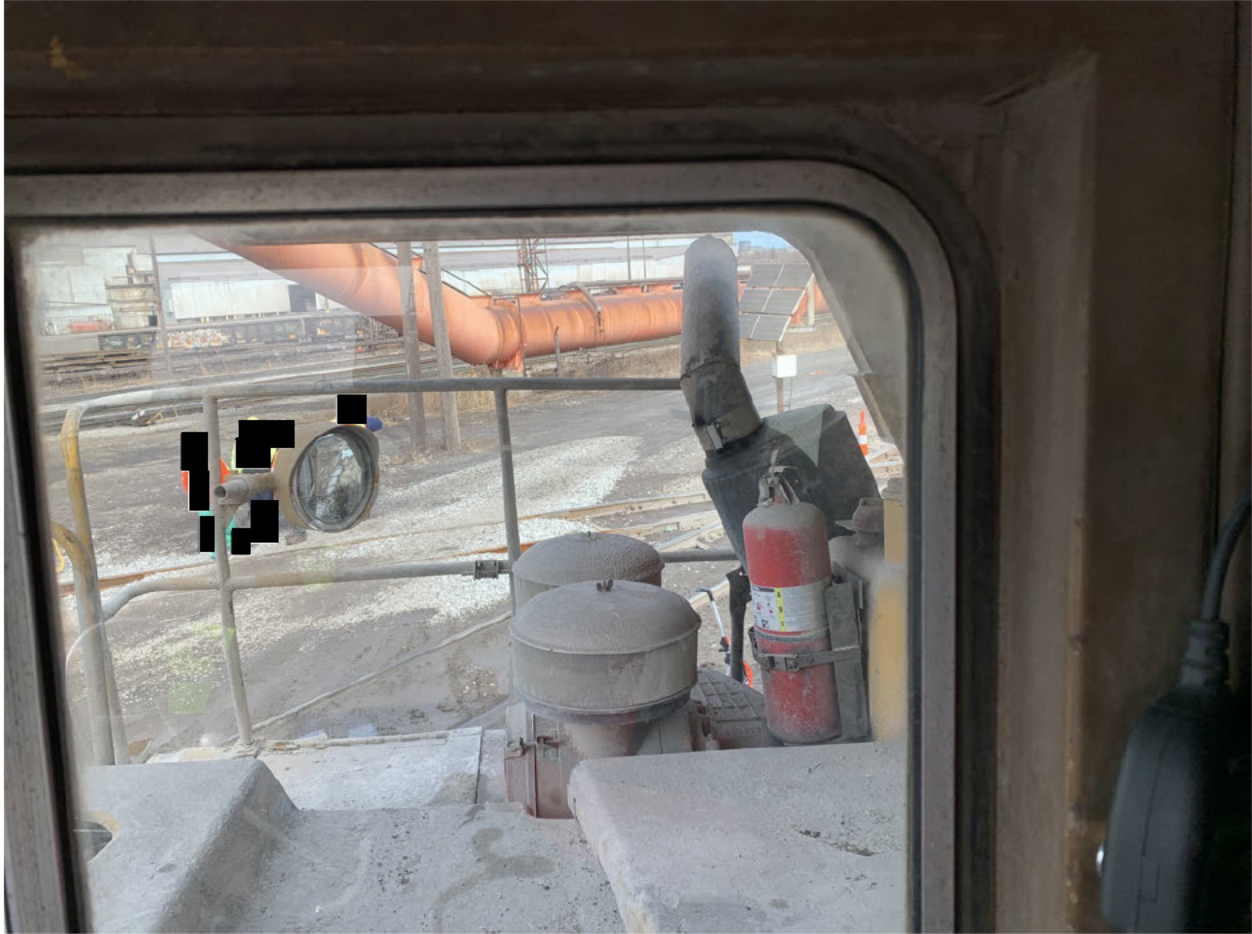
Figure 6. This photo shows 'Cone 2' from Figure 2. The cone can be seen between the bed of the truck and the exhaust from the right window (note that there are two windows on the right side, this is the larger one toward the front).

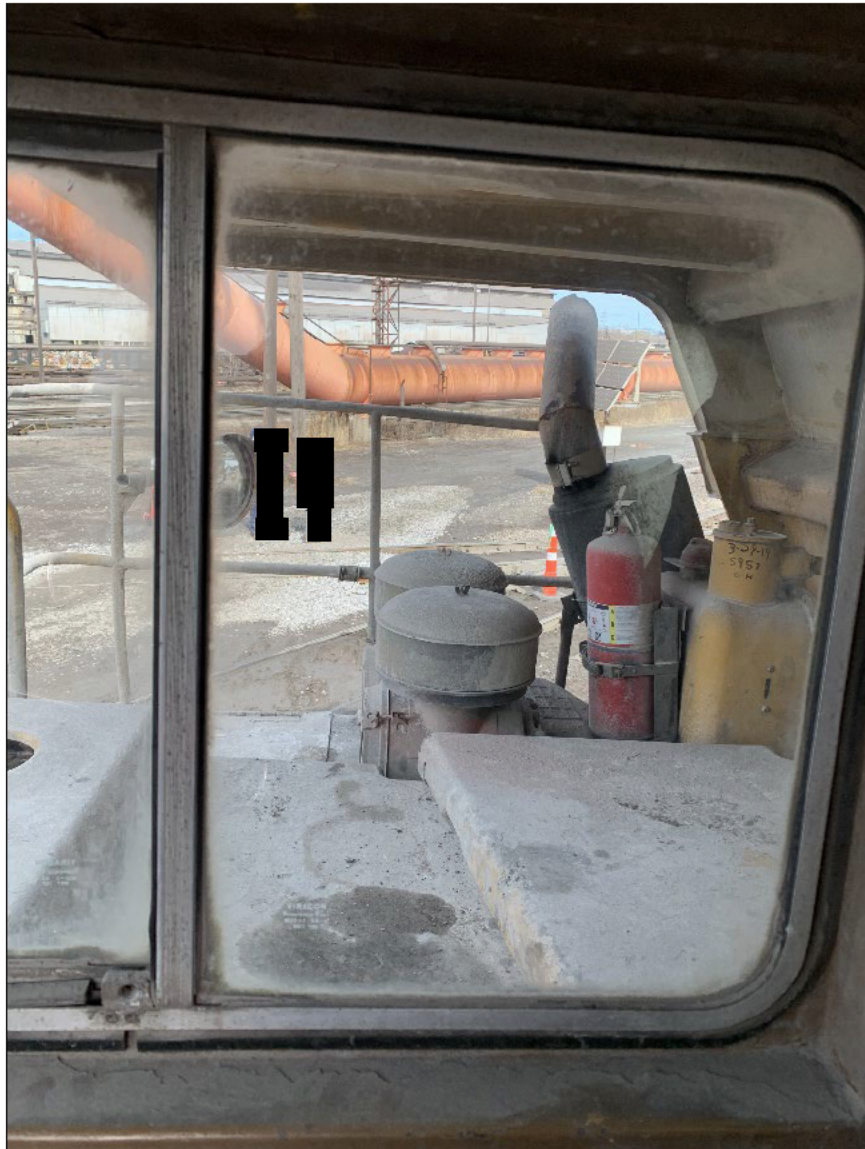
An additional observation was taken from the 'estimated' truck position. For this measurement, the observer did not lean forward, nor look between the exhaust and the bed of the truck. This observed distance from the crossing was noted as about 38-feet (indicated by 'Cone 1' in the Figure 2). The investigative group determined that of the three observations, this field of view best approximated that of the truck driver on the night of the accident.

Figure 7. This photo shows the general view of the track from the right window (note that there are two windows on the right side, this is the larger one toward the front) with the truck located in the 'estimated' position. The cone with the green marking is 'Cone 1' in the Figure 2. The cone is placed to the left of the truck exhaust.

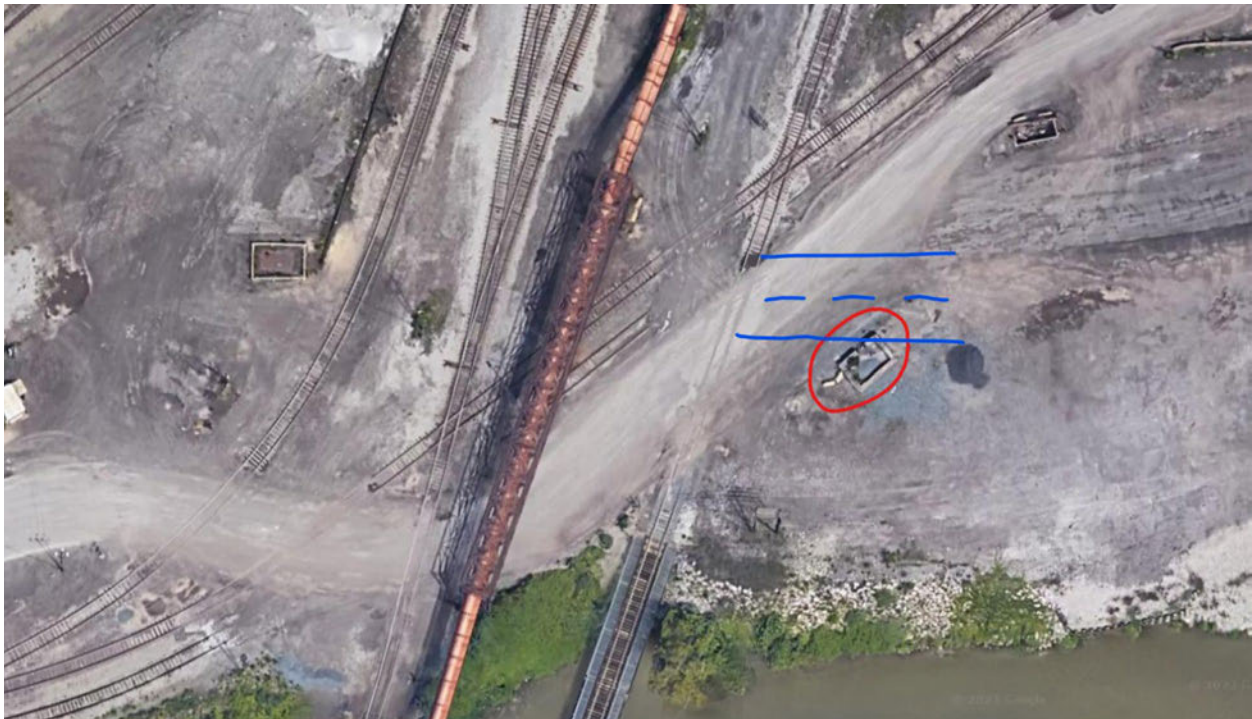
Figure 8. The above image was provided by Stein, LLC. It shows the crossing where the accident occurred from a top-down view. A red circle surrounds a square structure to the east of the railroad track. A road is drawn in blue showing the general location of the new road.

“After the accident, Stein asked Cliffs to remove a concrete structure that prevented us from crossing the NS rail crossing at a 90 degree angle. It was about 15’x10’x5’ and looked like it was a foundation of an old building that is no longer there. The attached picture is a Google Maps screenshot from before the structure was removed. I circled the structure in red that was removed and the blue roadway shows the new crossing angle for the track if traveling from east to west. Since Cliffs made this change and added additional lighting, our equipment operators’ line of sight in the area of the NS track has improved. Prior to operations starting back up, Stein site management met with Stein employees who worked in this area and reiterated the company’s rail safety practices and procedures and commitment to safety. Stein also audited and surveyed all of the rail crossings within the Cleveland plant post-accident and shared its findings with Cliffs.”
