**NATIONAL TRANSPORTATION SAFETY BOARD**

**Group Chairman's Factual Report**

**SYSTEMS GROUP CHAIRMANS'S FACTUAL REPORT ADDENDUM**  
**REGARDING DME INDICATOR**

**DCA05MA004**

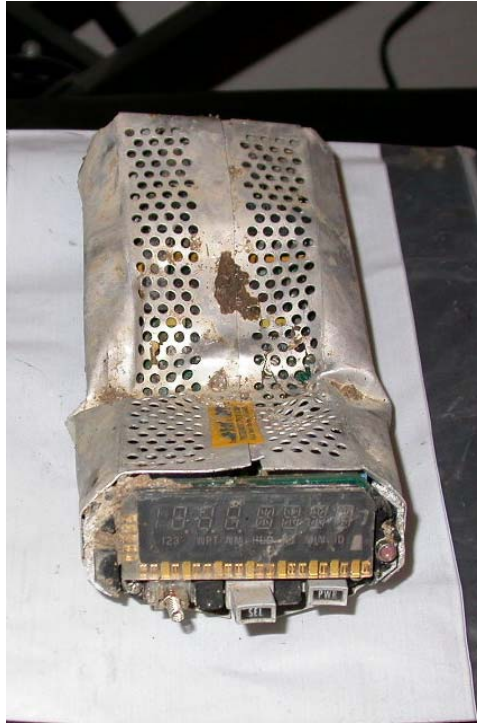
**Figure 1 - DME Indicator**

Visual examination of the indicator found it to be bent, as well as having experienced crush damage (See Figure 1). The display itself was not cracked and was removed from the indicator. A date code of "9648" was noted on the back of the display.

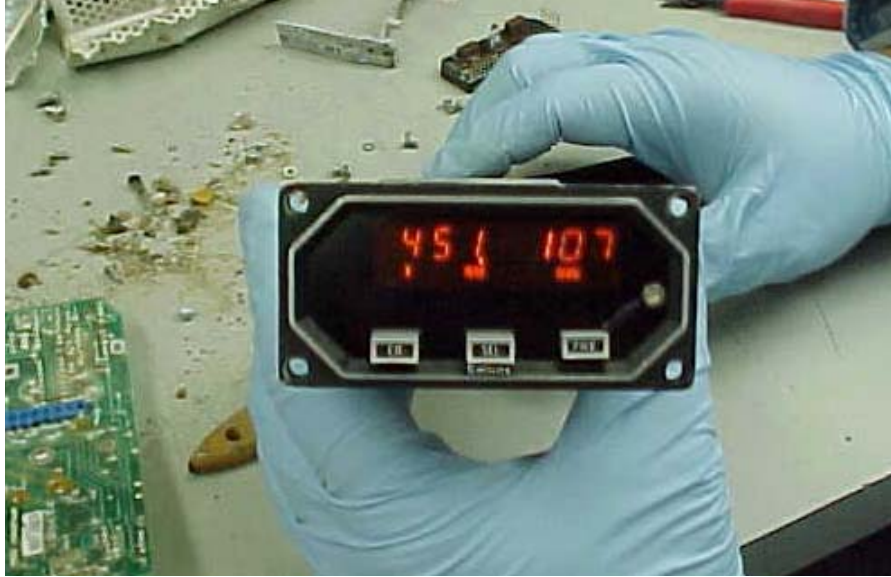
**Figure 2 - Accident Display Installed in Slave Unit**

The push button switch operated freely with no binding. The display was cleaned with a brush and installed in a known good unit. Power was applied to the good unit and the display was found to operate correctly with all segments clear and legible (See Figure 2). The A1 card was then installed in the known good unit, along with the display from the accident unit, and found to operate correctly.
