Alaska Airlines Flight 1282

Boeing 737-9, N704AL

Left Mid Exit Door Plug Separation in Portland, OR

Systems Group Chair's Factual Report

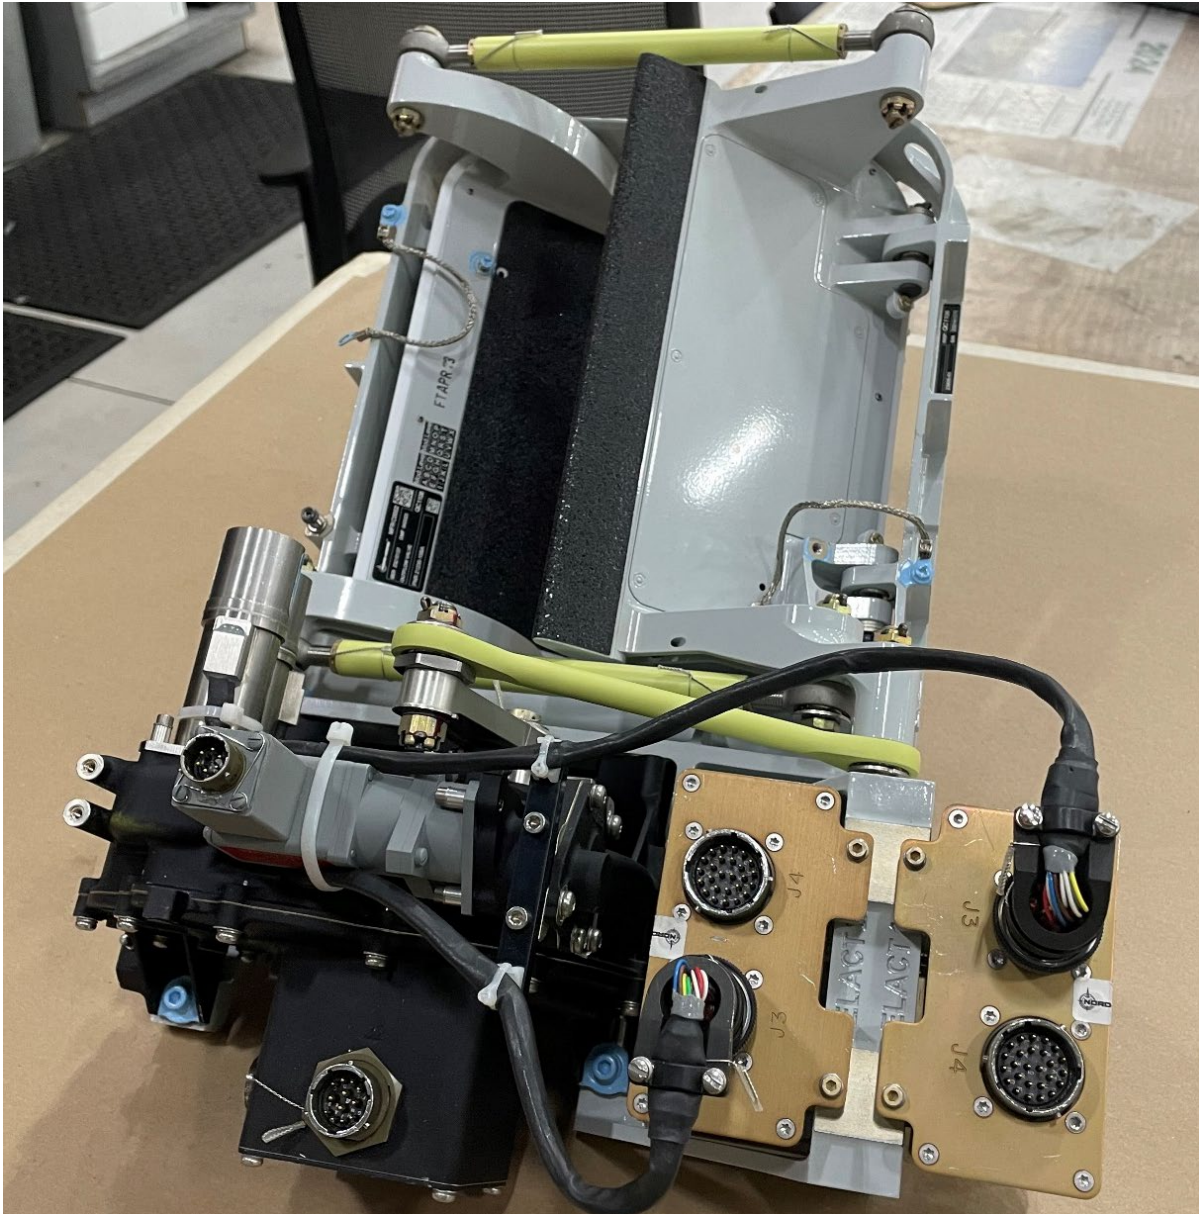
The outflow valve was visually examined. Protective shipping caps were present over all connectors and the tamper seals on both electronic boxes remained intact. The manual motor connector (J5) shell was damaged. Part of the connector shell was broken and missing, and the connector pins were bent. The J3 connector (with attached mating connector and wire) on electronic box 1 was also bent and the mounting plate for the connector was slightly deformed. Damage to both connectors occurred during shipping and was verified by comparing the damage to pictures taken prior to shipping. All other connectors were undamaged with pins that were straight and clean. The bonding strap was disconnected at the forward gate and the bonding strap remained connected but the connection bolt was loose at the aft gate. These bolts were unscrewed by maintenance to facilitate the removal of the outflow valve from the aircraft. The Teflon seals were intact and appeared to be undamaged. All linkages were securely connected. No other damage or anomalies were identified on the outflow valve (see Figure 7).

Figure 7. Condition of outflow valve following removal from the accident airplane. (Note picture was taken prior to shipping to the manufacturer.)

The shell for the manual motor connector had to be partially removed to facilitate rebending of the connector pins so that the unit could be connected to the test bench. The non-volatile memory was downloaded from both electronic boxes. With the exception of pre-delivery flights, there were six combined faults recorded in the memory of both units. Four of the faults were labeled "RS422_CTR_OFV_ACTIVITY_FAIL" and corresponded to the "074 OFV_RS422_CTR_TO_OFV_ACTIV_FAIL" faults that were recorded in the CPC memory. The other two faults were labeled "CAB_PRESS_SWITCH_ACTIVATED", and corresponded to the "090 OFV_CAB_PRESS_SWITCH_STATUS" faults that were recorded in the CPC memory that occurred shortly after the accident flight

The test stand for the memory download also performed a basic incoming functional test which the outflow valve passed. The unit was then subjected to the ATP test per document PVA-21230-10. The unit passed all portions of the test except step 5.6. In this test, the unit leakage was 2.5 kg/min at a differential pressure of 550.1 mbar (allowable 2.4 kg/min at differential pressure greater 548.5 mbar). According to the manufacturer this condition may allow for a slight increase in leakage when the valve is commanded fully closed at high differential pressures, and would have little, if any, effect on the performance of the valve in flight.
