**NATIONAL TRANSPORTATION SAFETY BOARD**  
Office of Aviation Safety  
Washington, D.C. 20594

August 6, 2020

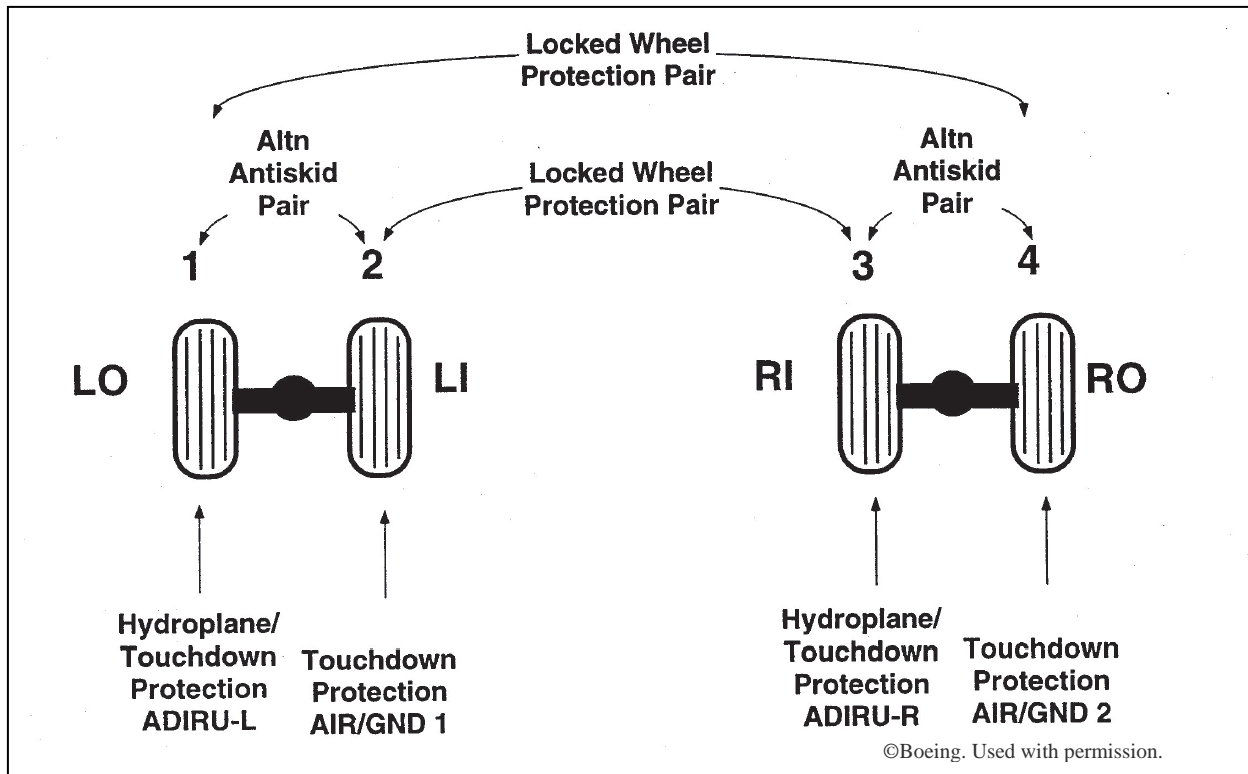
Figure 2: Antiskid Functions
