National Transportation Safety Board

DCA20LA138

SYSTEMS

Group Chair's Factual Report

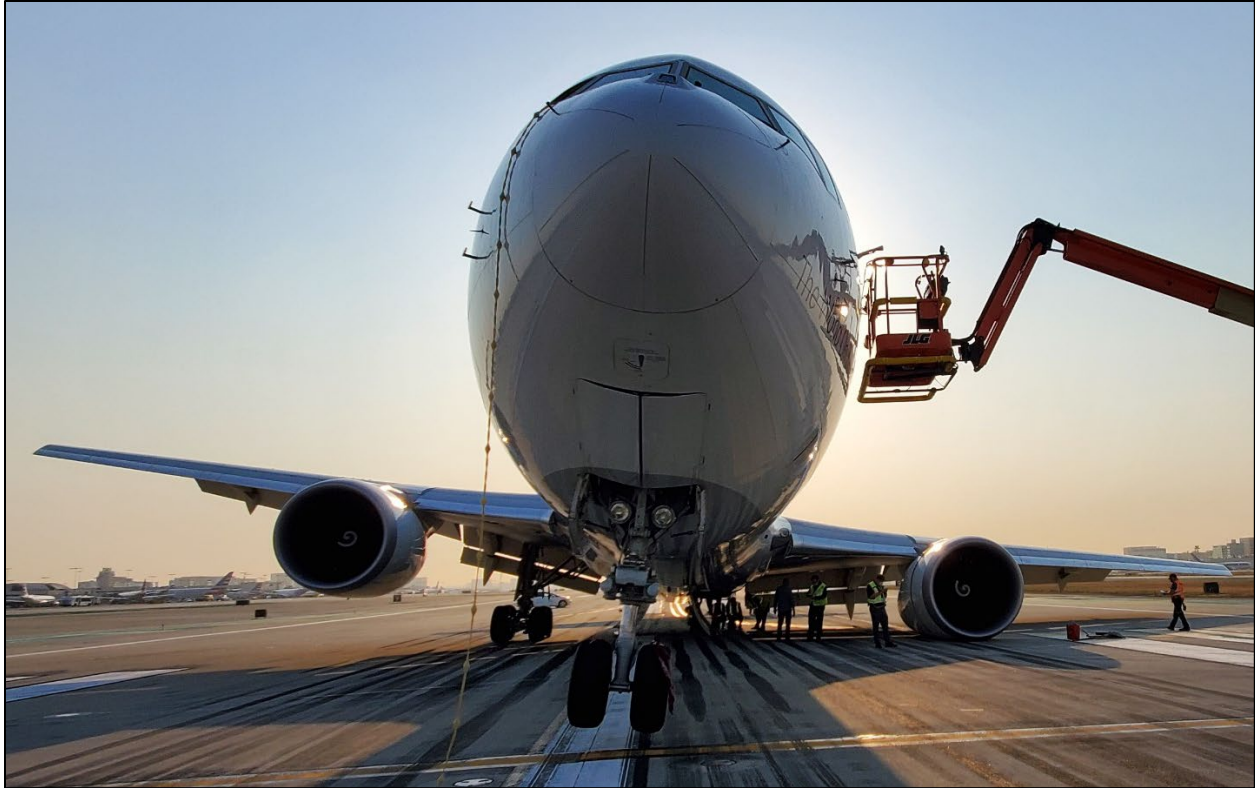
Initial inspection found that the left main landing gear door was open, but the landing gear did not deploy. The aircraft was found resting on the left engine nacelle and the right main landing gear, while the nose gear and tail were suspended in the air (see Figure 4). The left engine cowling and left main landing gear door were damaged due to contact with the runway during the landing, and later aircraft examination revealed deformation of the left engine pylon structure such that several structural clearances were out of tolerance. Some cracking on the left engine pylon structure was also identified.

Figure 4. Airplane condition after accident landing. Courtesy of Boeing.

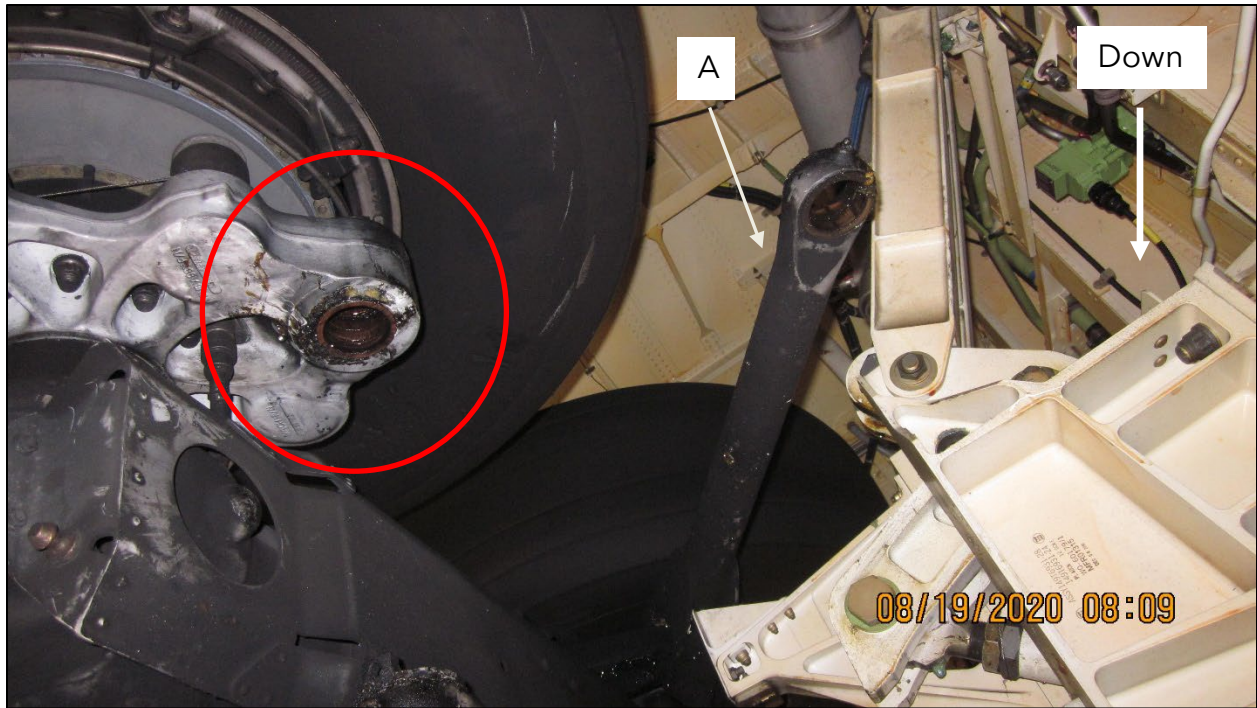
The left side of the aircraft was lifted using airbags. Inspection of the left main landing gear assembly revealed that the #6 brake rod (corresponding to the aft inboard wheel position) was not connected to the torque arm on the #6 brake assembly housing and that all attaching hardware was missing. The brake rod, which remained connected to the lugs on the shock strut, was swung out of position and hung up on the landing gear upstop (see Figure 5 and Figure 6). No damage was found to the brake assembly or associated hydraulic line.

Figure 5. Photograph of the landing gear with the brake rod hung up on the landing gear upstop. Arrow "A" points to the brake rod. The red circle highlights the location where the brake rod should have been secured by the attaching hardware detailed in Figure 3. Courtesy of FedEx.

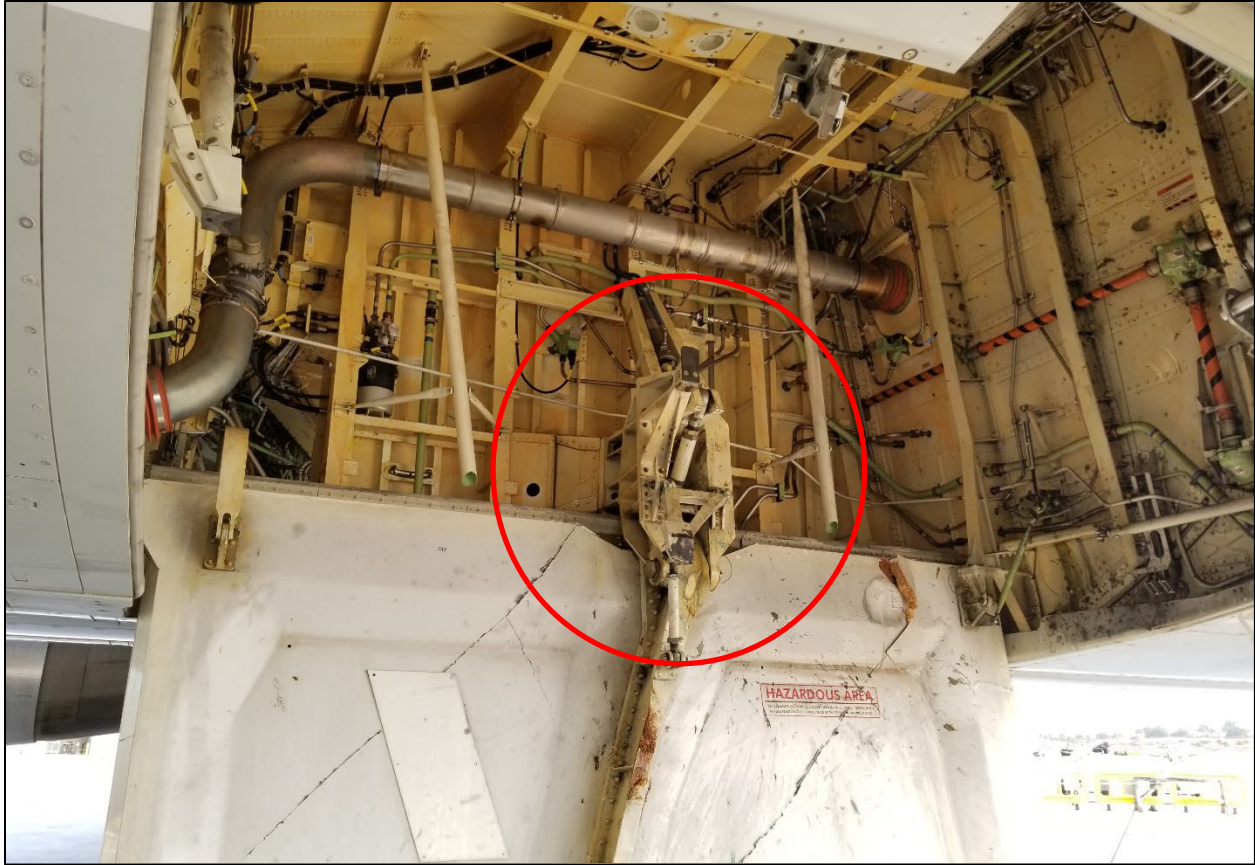
Figure 6. View of the left landing gear bay after the left main landing gear was extended. The landing gear upstop is circled in red. Courtesy of Boeing.

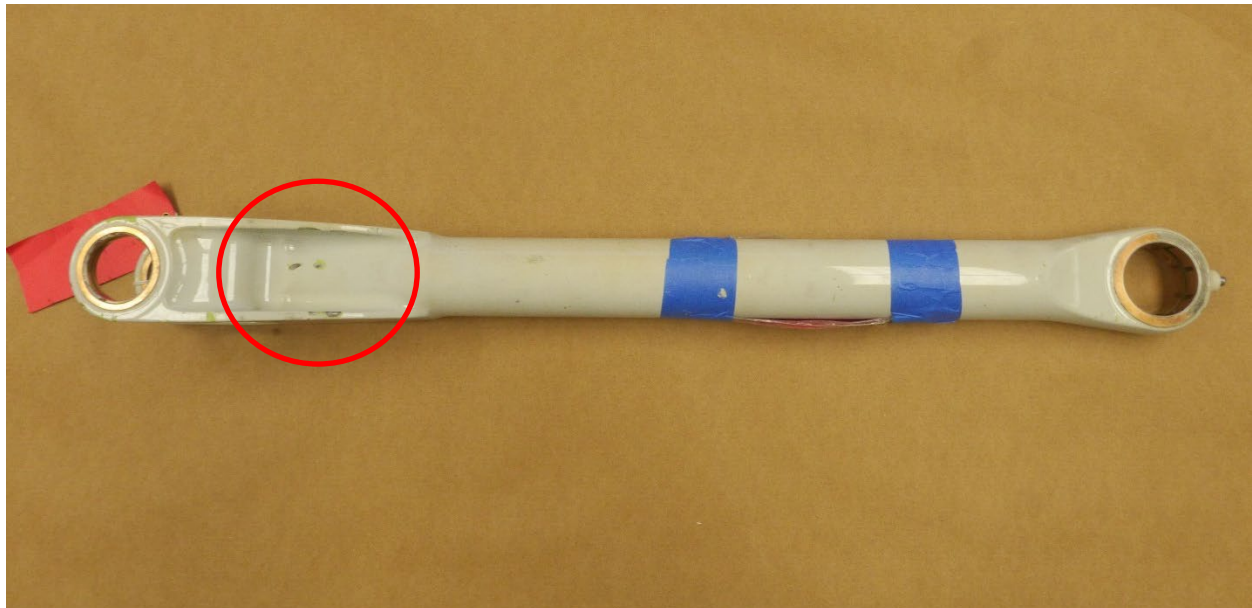
A visual inspection of the #6 brake rod (P/N 161T1136-17, S/N RD0131) was performed. The only observed damage were shallow gouges and chipped paint on the forked end consistent with where the brake rod was contacting and hung up on the landing gear upstop during the accident sequence (see Figure 7). There were no scrape marks or gouging that indicated that the brake rod had made contact with the runway during a previous takeoff or landing. Precision measurements of the brake rod fork end bores and rod end bore were captured using a calibrated SmartScope Quest 450, with all measurements found to be within drawing limits.

Figure 7. #6 brake rod as received at the Boeing Equipment Quality Analysis Laboratory. The red circle highlights the damage consistent with contact with the landing gear upstop. Courtesy of Boeing.

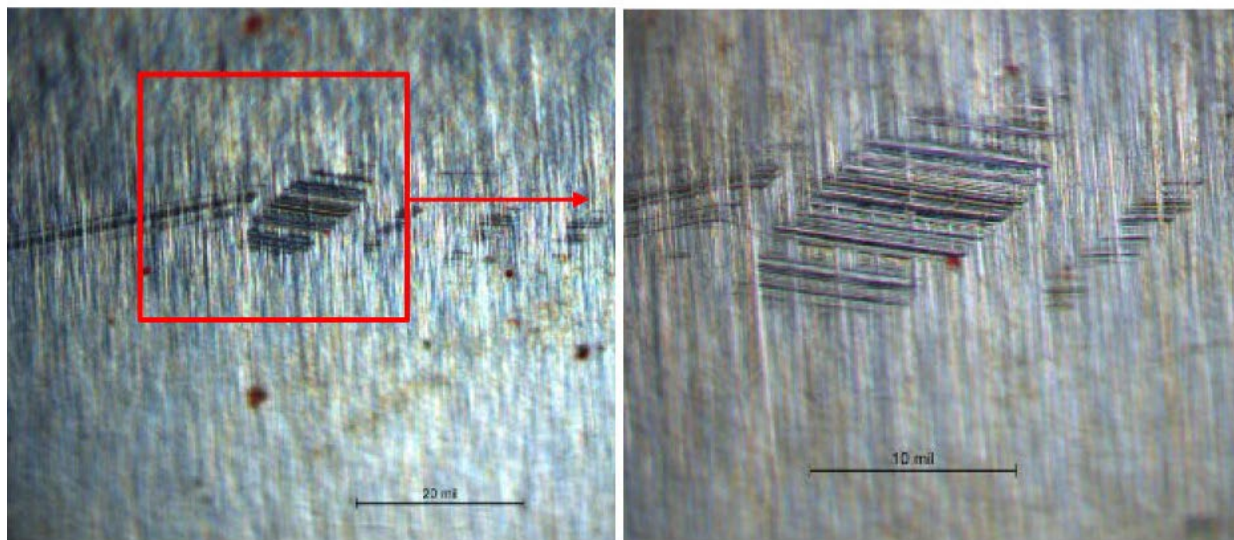
Fluorescent penetrant inspection was performed on all 7 brake rod pins, with the #4 brake rod pin showing a small, rounded surface indication and the #5 brake rod pin showing a small scoring indication. Magnetic particle inspection was performed on all 7 brake rod pins, with only the #4 brake rod pin showing an anomaly. This anomaly was the same small, rounded surface indication discovered during the fluorescent penetrant inspection. Wide field photography was used to further look at the indications identified on the #4 and #5 brake rod pins (see Figures 8 and 9, respectively). The damage on the #4 brake rod pin was consistent with mechanical damage. The damage on the #5 brake rod pin appeared as localized minor surface roughness with some small scratches in the surface plating. In both cases, the indications did not cause significant distress in the chrome plating and were consistent with minor handling damage. Precision measurements of brake rod pin #4 and brake rod pin #5 were captured using a calibrated SmartScope Quest 450 with all measurements found to be within drawing limits.

Figure 8. Wide field image showing the indications from brake rod pin #4. The indication is within the red box in the left picture and is shown at greater magnification in the right picture. Courtesy of Boeing.

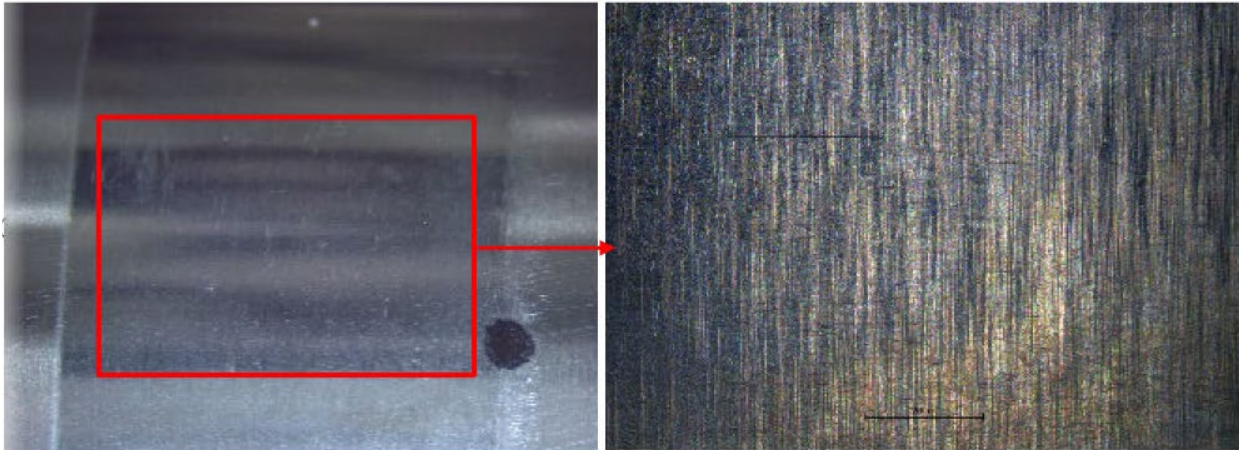
Figure 9. Wide field image showing the indications from brake rod pin #5. The indication is within the red box in the left picture and is shown at greater magnification in the right picture. Courtesy of Boeing.
