NATIONAL TRANSPORTATION SAFETY BOARD
Office of Aviation Safety
Washington, D.C. 20594

System's Group Chairman's Factual Report

NTSB No: CEN20MA044

Operator: Cheyenne Partners LLC
Aircraft: Piper PA-31T, registration number N42CV
Location: Lafayette, Louisiana
Date: December 28, 2019
Time: 0921 Central Daylight Time

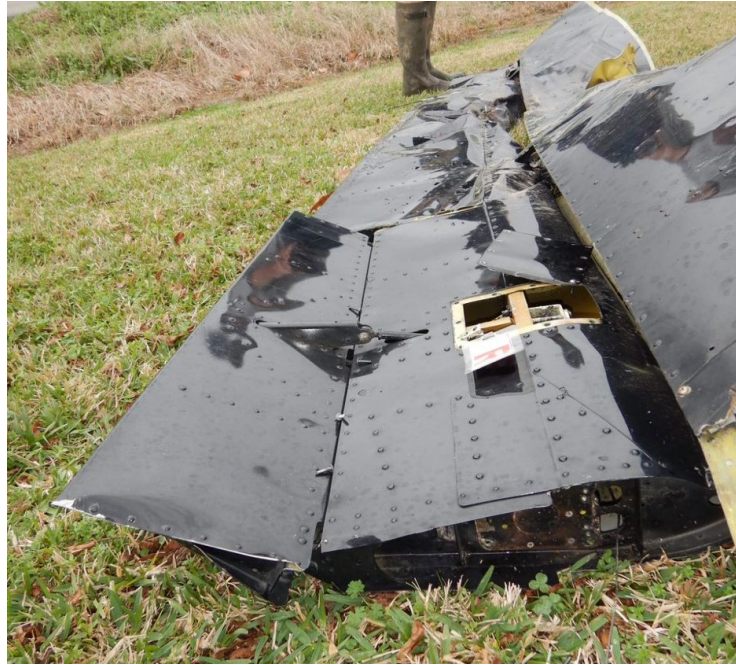
Figure 1 Right elevator and tab

of the exposed screw on each actuator. It was found that both actuators were extended about 1.25 inches (about 11 threads). Figure 1 shows the right elevator and tab assembly, and Figure 2 shows a measurement being taken on the right elevator trim tab drum/screw. Figure 3 shows the left elevator and tab assembly, and Figure 4 shows a measurement being taken on the left elevator trim tab drum/screw. According to Piper Aircraft, a dimension of 1.25 inches is consistent with the elevator tab positioned 20° trailing edge down (at its stop – or a full aircraft nose up trim setting).

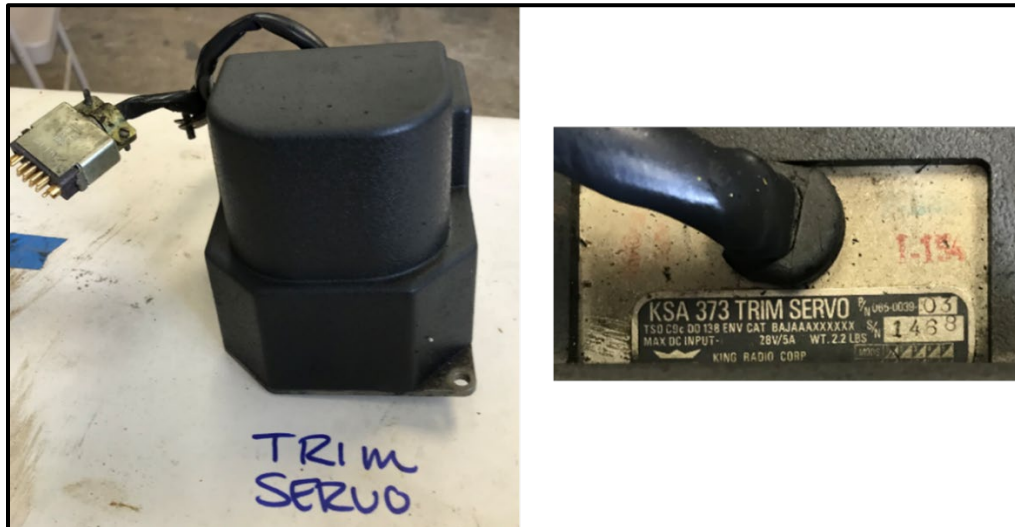
Figure 5 Pitch trim servo after removal from airplane

The KSA 373 pitch trim servo, part number 065-0039-03, serial number 1468, was located and recovered during the wreckage examination (Figure 5). The unit was placed in a shipping container and sent to the NTSB for further examination. The unit was then shipped to the Duncan Aviation facility in Lincoln, Nebraska, for examination. The servo was held in secured storage while at Duncan Aviation.

The servo’s cover was removed, and a visual inspection was completed. The servo appeared to be in good condition, except for some small surface scratches and dents. No internal or external physical damage was noted that would prevent testing.

Additional voltage checks were conducted at the servo's solenoid. A measurement of 28 Volts was noted across the solenoid when applied from the test stand. A measurement of 15.54 Volts was measured across one of the solenoid's coils, but since the solenoid had two coils, about one-half of the applied 28 V was expected.

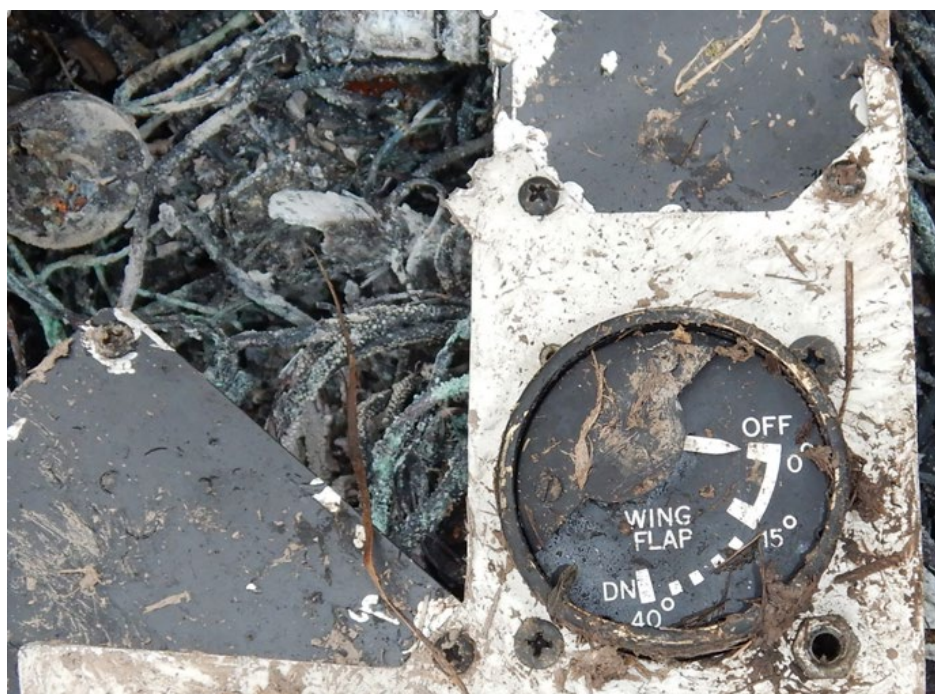
Figure 6 Flap position indicator

The right flap assembly came to rest in the field; its flap jackscrew was found separated from the flap assembly. Visual inspection of the jackscrew found that no threads were visible. According to Piper Aircraft, this is consistent with the flaps being in their fully retracted position. The inboard portion of the left wing including a portion of the left flap and the left nacelle, came to rest adjacent the fuselage and empennage. A visual inspection of the left flap jackscrew found that no threads were visible consistent with the flaps being fully retracted.

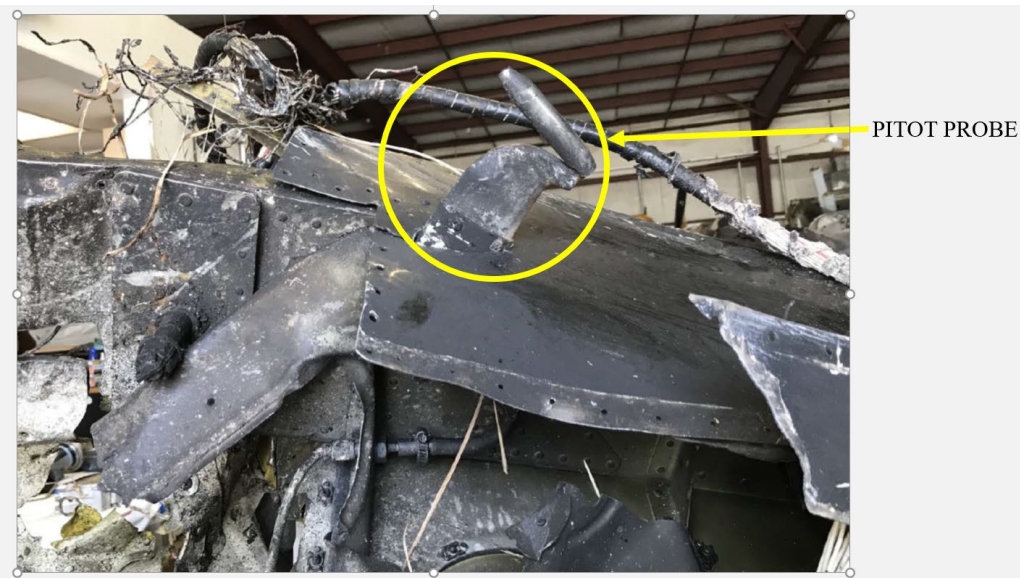
Figure 7 Pitot probe at found at wreckage examination

A visual inspection of the pitot probe during the wreckage examination revealed that the probe along with its mounting bracket remained loosely contained within the nose structure; it was impact damaged and folded aft (Figure 7). Normally, a flexible hose and two electrical “heating element” wires are connected to the probe assembly. Inspection revealed that neither the flexible hose nor the two heating element wires remained connected to the probe assembly.

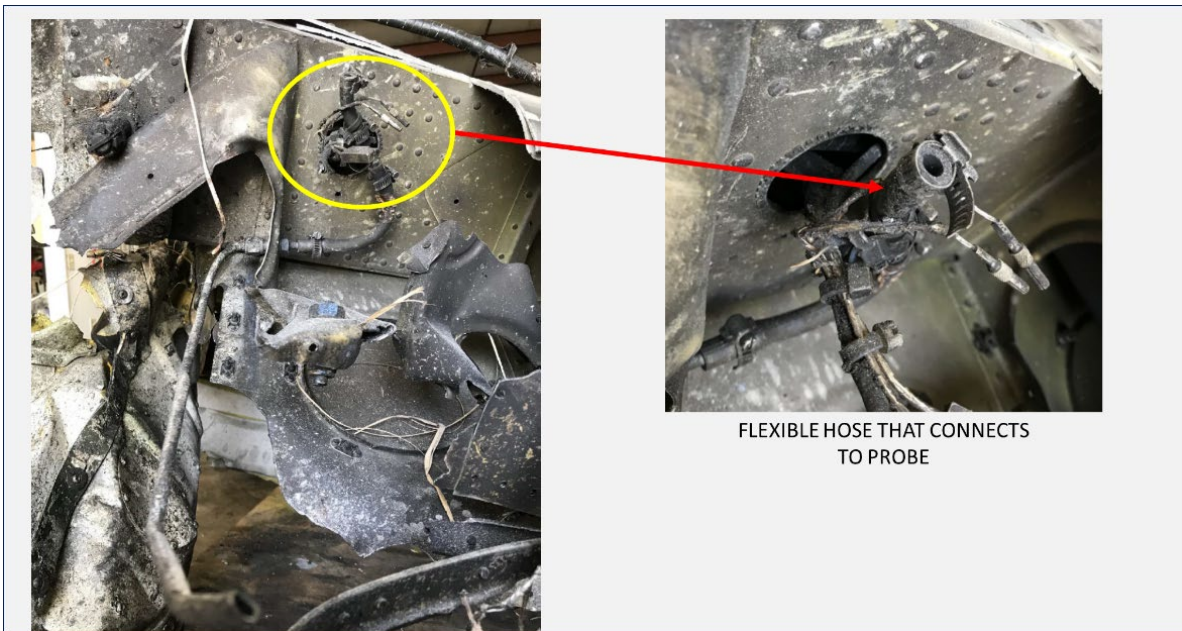
Figure 8 Flexible hosing to pitot probe

Using hand pressure, the probe assembly was easily removed from its mounting position within the fuselage nose structure. To better observe the flexible hose and two electrical “heating element” wires, a small portion of the metal structure around the pitot tube mounting hole was cut and removed from the fuselage. A visual inspection was performed, and the following observations were noted and shown in the figure 8:

- A clamp remained firmly attached to the flexible hose.
- The pitot line branched into a 2 foot 8 inch section of flexible hose and a 1 foot 6 inch section of aluminum tube.
- The flexible hose terminated in a clean cut, and when tested with light air pressure, revealed no blockages. The aluminum tube was found crushed and folded in several places, and light air pressure could not flow through it.

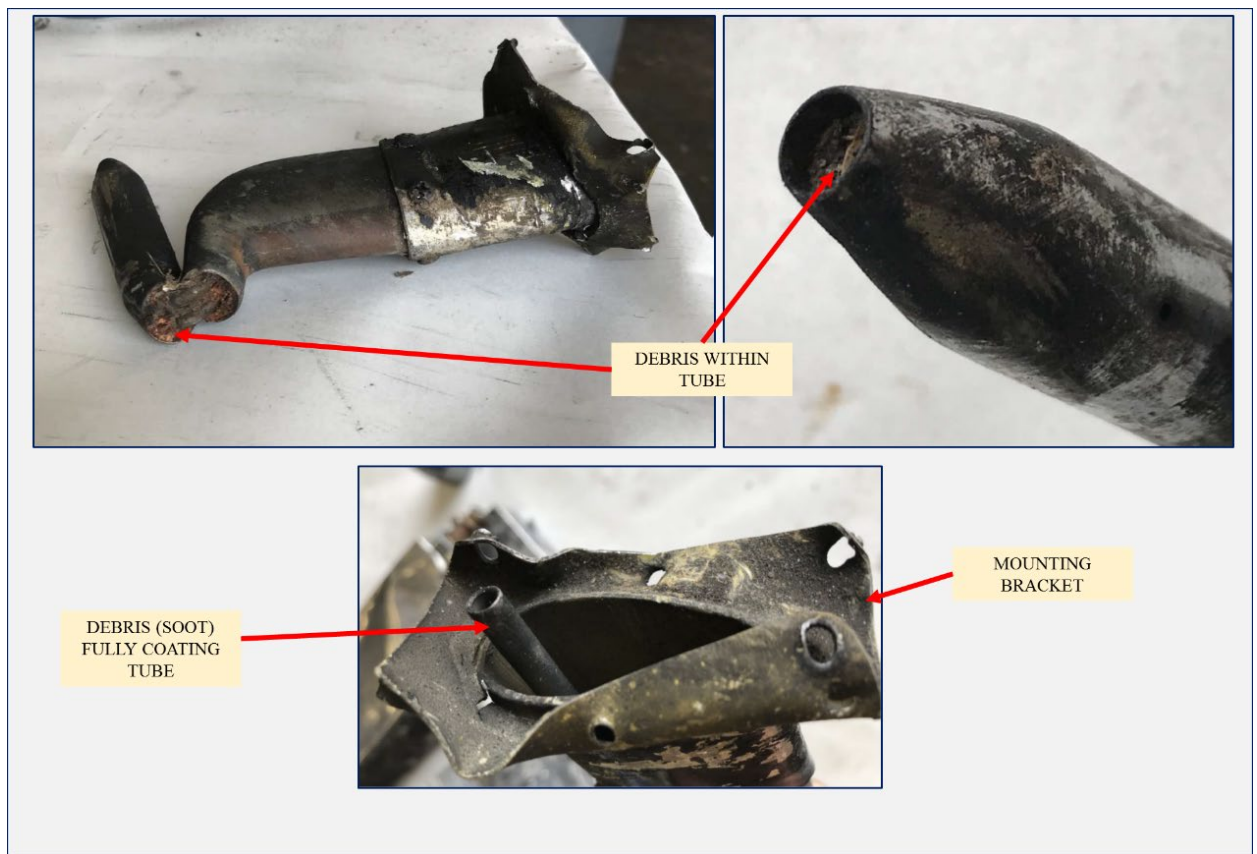
Figure 9 Photographs of the pitot probe

A visual inspection of the probe was performed, and the following observations were noted and shown in figure 9:

- Debris was found imbedded in the pitot tube port and the break.
- The metal “pressure” tube coming out of the probe was fully coated in black debris (soot).
- The mounting bracket was deformed and the holes for the attachment hardware were all found damaged (pull through or elongated).

A continuity test of the heating element was performed by checking the continuity between the two pins. The continuity was found open.

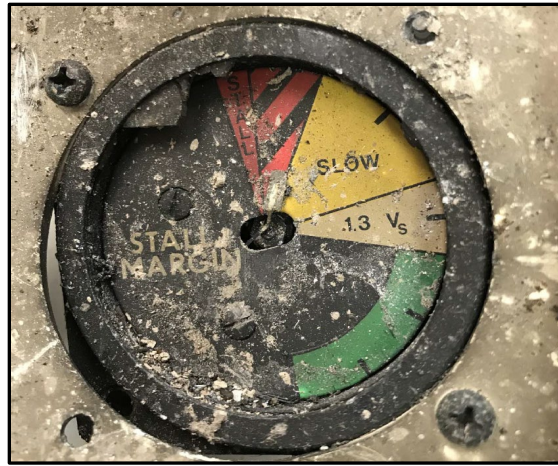
Figure 10 Stall margin indicator

The stall margin indicator was located within the wreckage at the accident site and as shown in Figure 10, the remaining portion of the indicator needle was positioned within the red area.

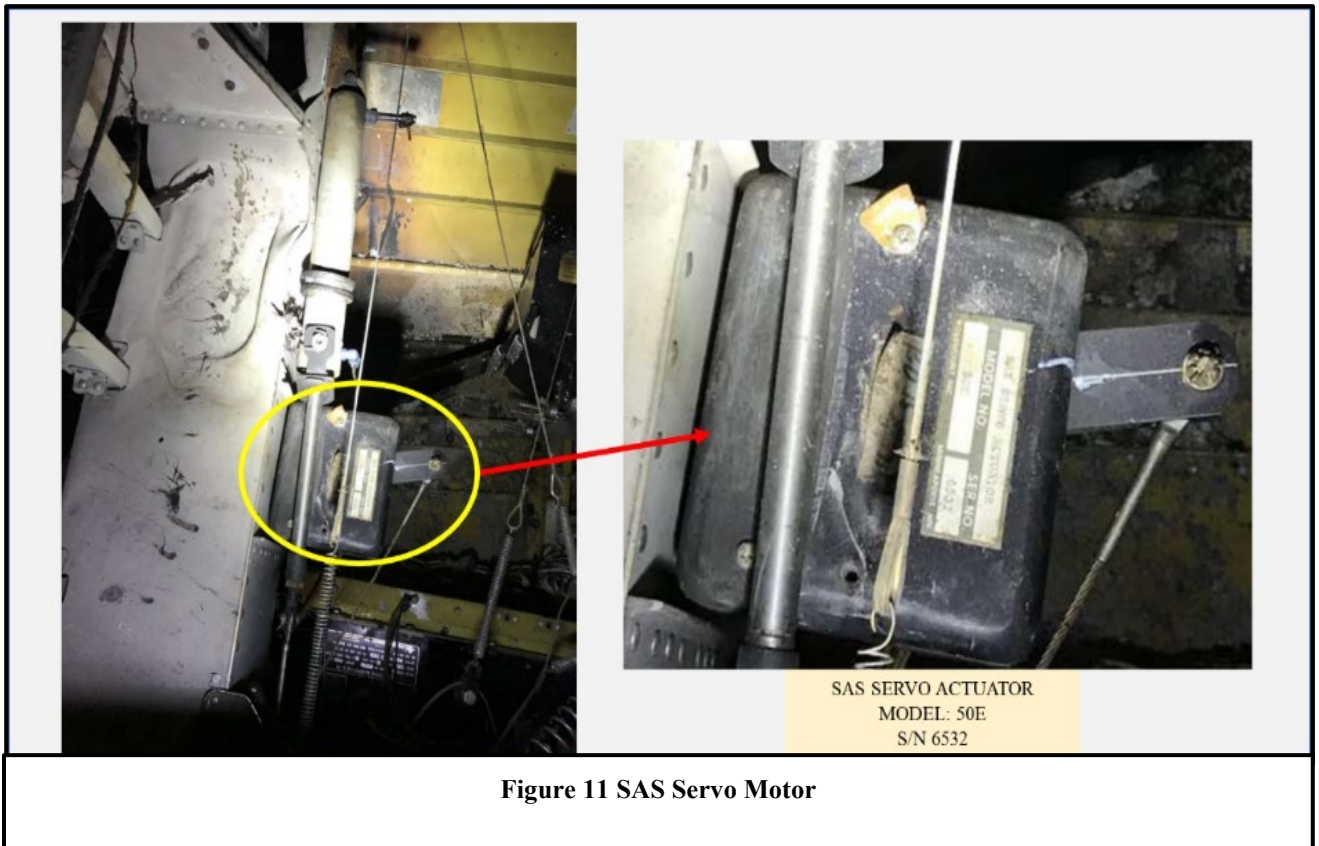
Figure 11 SAS Servo Motor

At the accident site, the condition and position of the stability augmentation system servo was documented; it remained mounted in the aft fuselage with its servo arm positioned up. According to Piper Aircraft, its position is consistent with system activation. During the wreckage examination at the Southern Aircraft Recovery facility in Baton Rouge, Louisiana, a photograph of the servo actuator was taken Reference Figure 11.

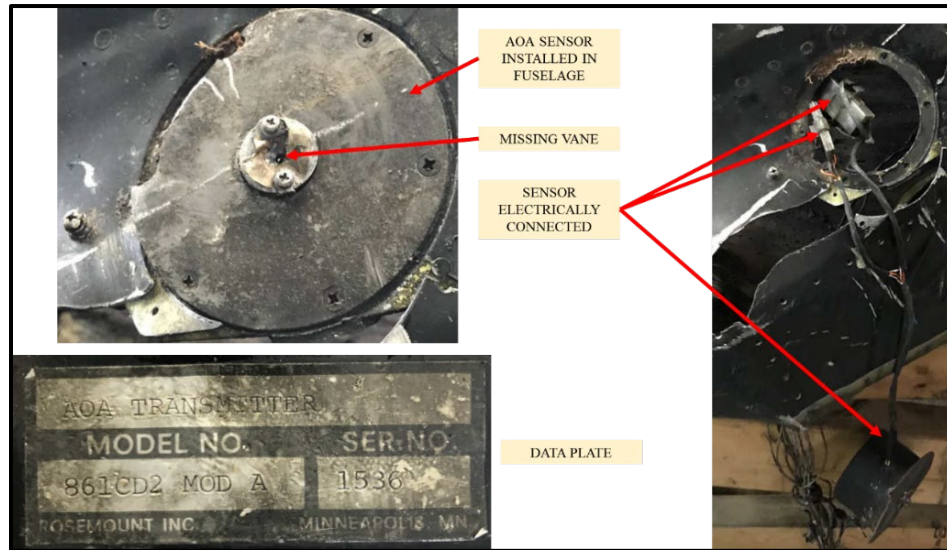
Figure 12 AOA Installation

During the wreckage examination, the AOA Sensor (without vane) remained installed in the fuselage and electrically connected via its two electrical connectors (Figure 12). The sensor was removed from the fuselage by removing its attachment screws and cutting the electrical wiring aft (airplane side) of the connectors. The data plate indicated the following: “AOA transmitter, Model number 861CD2 (Mod A), Serial Number 1536”.

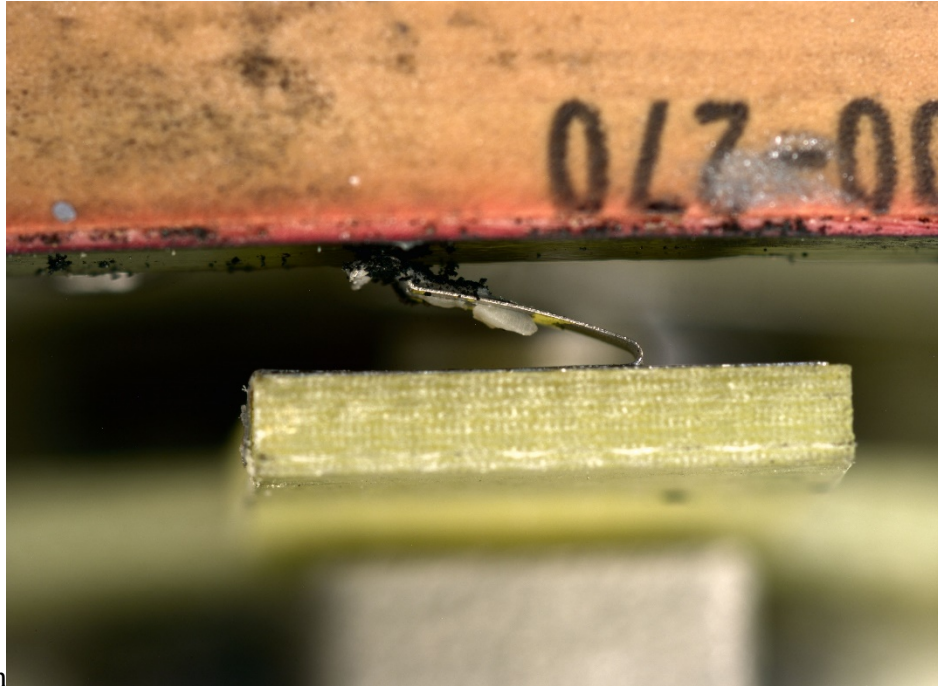
Figure 13 Wiper 1 contact with Potentiometer Number 1

The wiper located on Potentiometer 1 did not appear to make good contact with potentiometer 1. Figure 13. Potentiometer 1 is located on the side of the AOAS with the most damage.

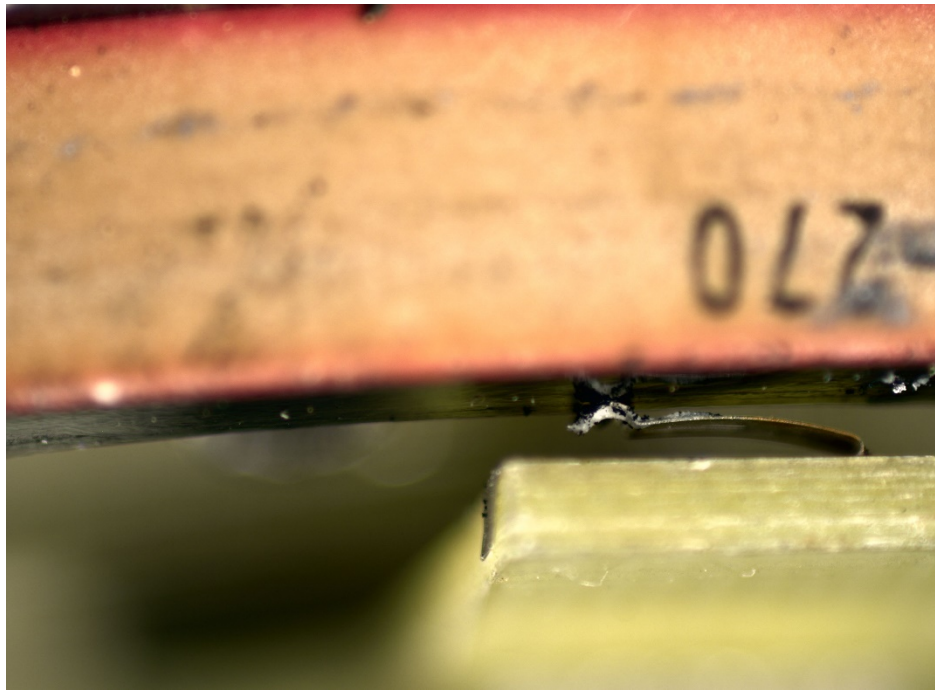
Figure 14 Wiper 2 contact with Potentiometer Number 2

The wiper located on Potentiometer 2 appeared to make sufficient contact with Potentiometer Number 2. [Figure 14](#).

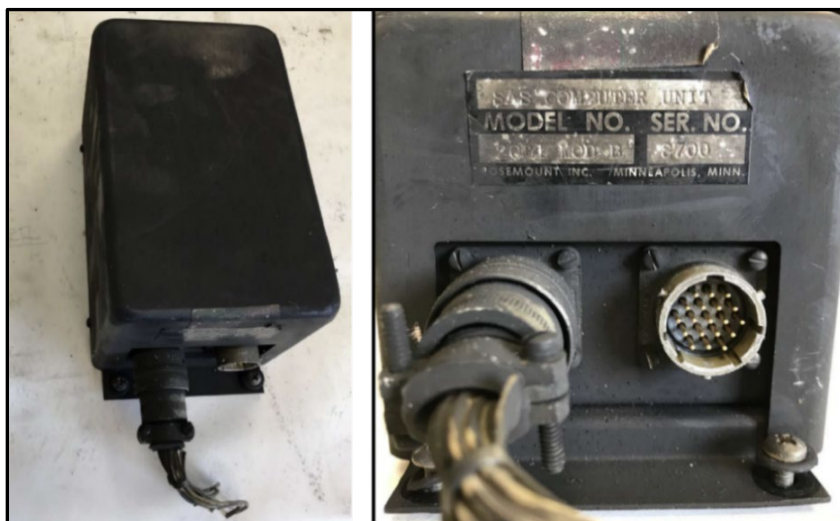
Figure 15 SAS Computer

During the wreckage examination, the SAS computer remained installed in the fuselage by its mounting hardware (4 screws) and electrically connected via its two electrical connectors (Figure 15). The computer was removed from the fuselage for further examination. During the removal, the right electrical connector had to be disconnected from the computer in order to remove the unit. The data plate indicated the following:

The SAS computer was removed from its shipping container and visually examined. The computer's part and serial numbers were confirmed. The unit appeared to be in good condition, with the exception of some small surface scratches and dents on the top cover.

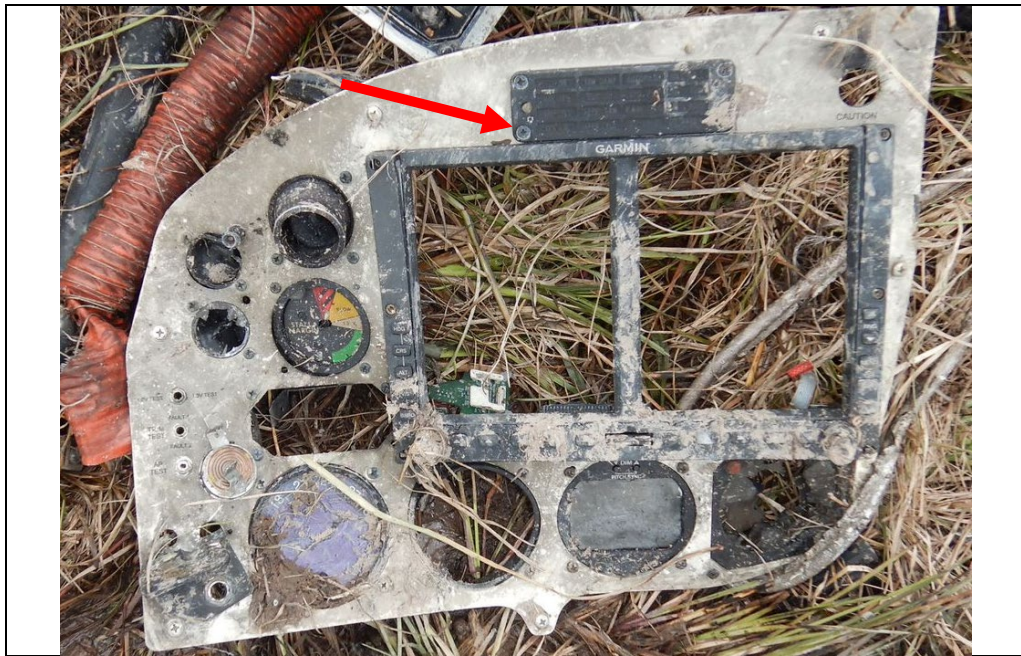
Figure 18 KAP 315 annunciator panel found on-scene

The KAP 315 annunciator panel was recovered from the wreckage at the accident site (Figure 18) and was submitted to the NTSB Materials Laboratory for examination of the bulb filaments in each of the annunciator lights. There are two light bulbs present for each annunciator position.

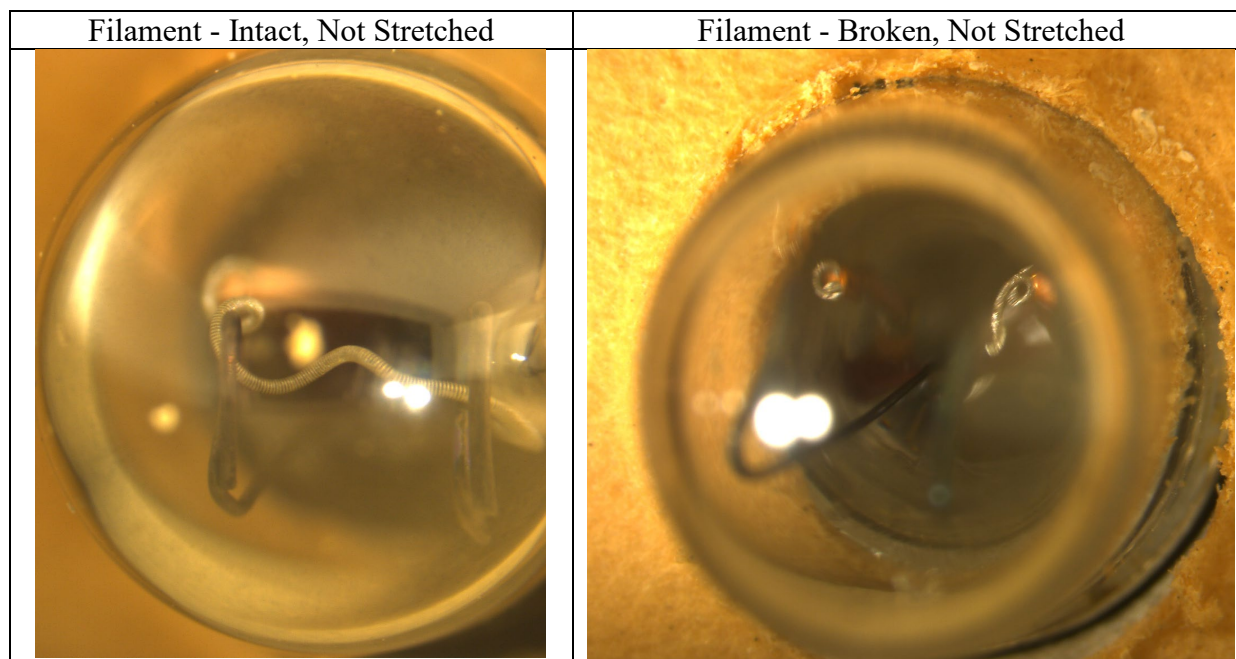
Figure 19 Autopilot lightbulbs

On 1/14/2020, a light bulb filament analysis was conducted on the annunciator panel at the NTSB Materials Laboratory by a Materials specialist. The front cover was removed from the autopilot panel in order to visualize the bulbs inside. The individual bulb filaments were examined using a stereomicroscope. The status of each filament is listed in Table 4. Photographs of the **AUTOPILOT** bulb filaments are provided in Figure 19

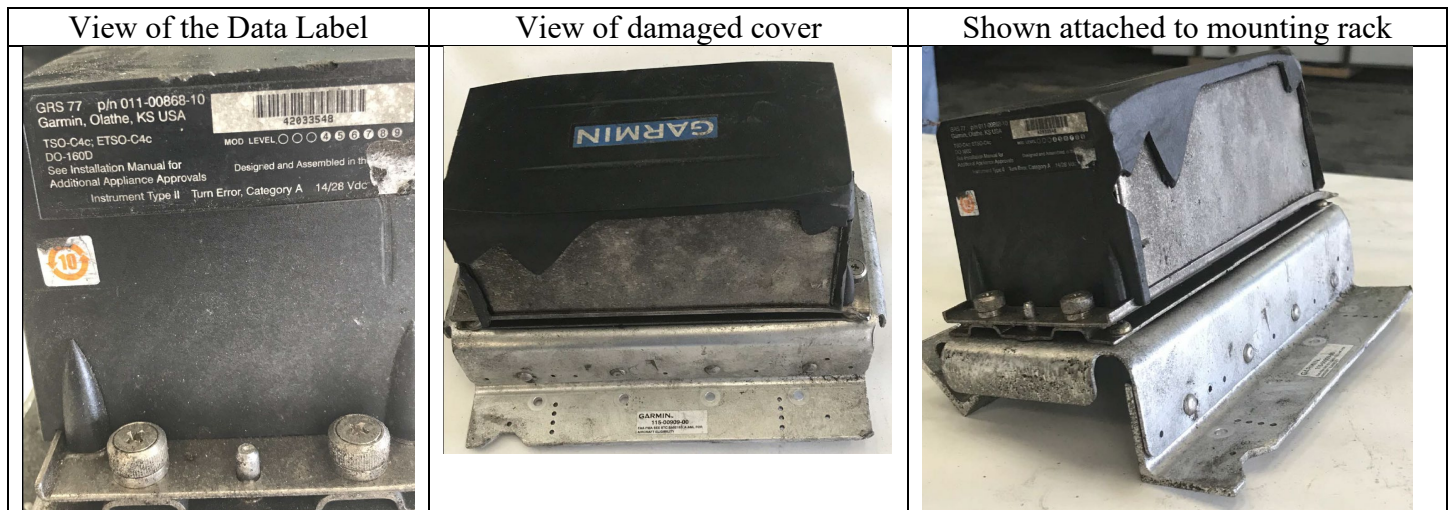
Figure 22 Photographs of the AHRS unit

The GRS 77 AHRS unit, P/N 011-00868-10, S/N 42033548, was located and recovered during the wreckage examination on February 11th (Figure 22). Visual inspection of the unit found that it remained structurally connected to its flat plate “mounting rack” and its black plastic cover was damaged; it was fractured and partially missing on one side. Although the unit’s black plastic cover was damaged, the unit appeared to be structurally intact. The unit was carefully moved by hand to determine if any of the internal components had broken loose. Based on this cursory check, none of the components appeared to be loose. The electrical connector visually appeared to be structurally intact; trace amounts of fine debris (ash, dirt etc..) was observed around and within the pin holes. The unit was placed in a shipping container and sent to the NTSB laboratory for further examination.

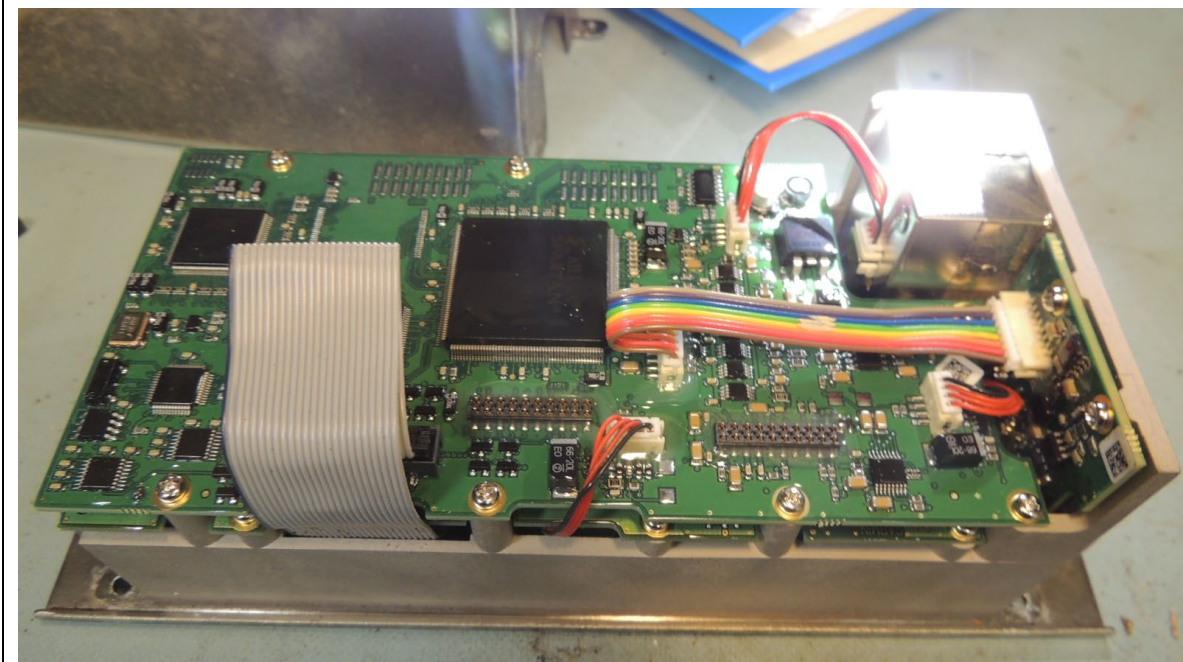
Figure 23 AHRS with cover removed

On June 29, 2021, GRS 77 AHRS unit, P/N 011-00868-10, S/N 42033548, was submitted to the NTSB laboratory in Washington DC for an internal visual inspection by an Electronics Engineer to non-invasively check for any broken or damaged components that would prevent it from being electrically tested at its manufacturer. The unit’s cover was removed, and the visual inspection did not identify any anomalies, see Figure 23. Other than the mounting plate and the cover, no additional items were removed or disconnected. After the inspection, the cover was replaced and the unit was returned to its shipping container.

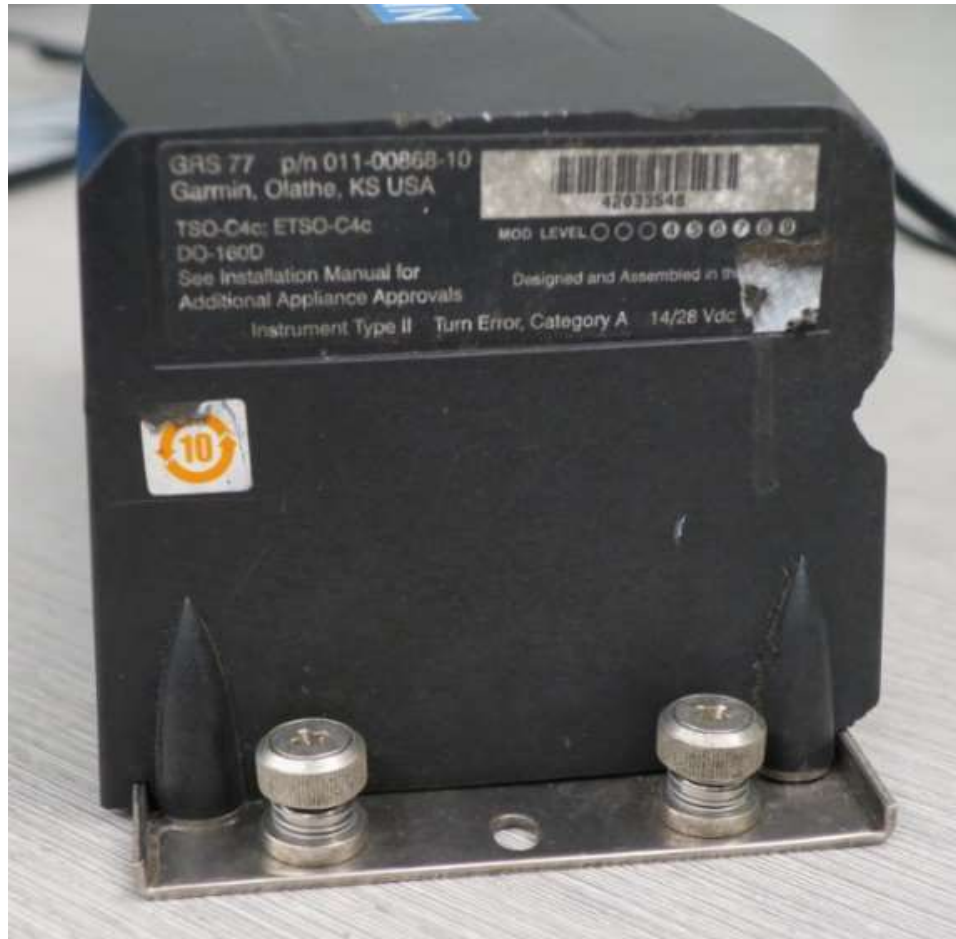
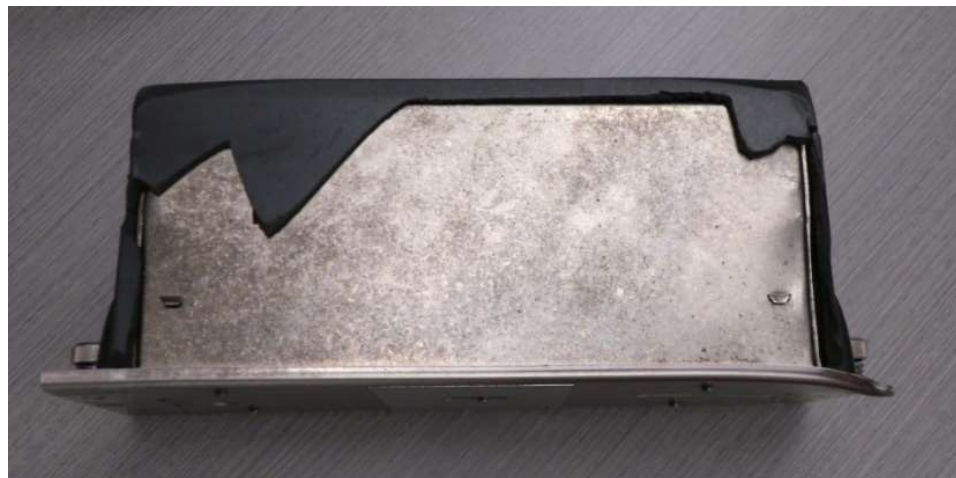
- a. The exterior was noted to be in fair physical condition (Figure 24 and 25). Some exterior areas were noted with missing areas of the plastic, protective cover, which the group concluded was a result of the accident impact sequence. The chassis case exhibited some minor damage but did not prevent the case from having been previously removed by the NTSB.
- b. The unit's part number and serial number were verified.
- c. The connector exhibited some debris but did not appear to be deformed.
- d. The unit's base plate was bent in one corner; the unit may not be able to be installed onto the rotation table for testing.
