Air Safety Investigations Aircraft Incident/Accident Technical Report

Aircraft Incident/ Accident Information	Year: 1978	Make: Cessna	Model: R182
	Serial number: R18200334		Registration: N4166C
Location: Grand Canyon, AZ		Date: 04-19-23	Time: 1400 MST
Aircraft Owner		Aircraft Operator	
Edwards Construction Group Llc [REDACTED] [REDACTED]		Scott E Gross [REDACTED] [REDACTED]	
Report Information			
Air Safety Investigator: Kurt A. Gibson		Report #: ASI-23-BQ-T	Report date: 11-02-23

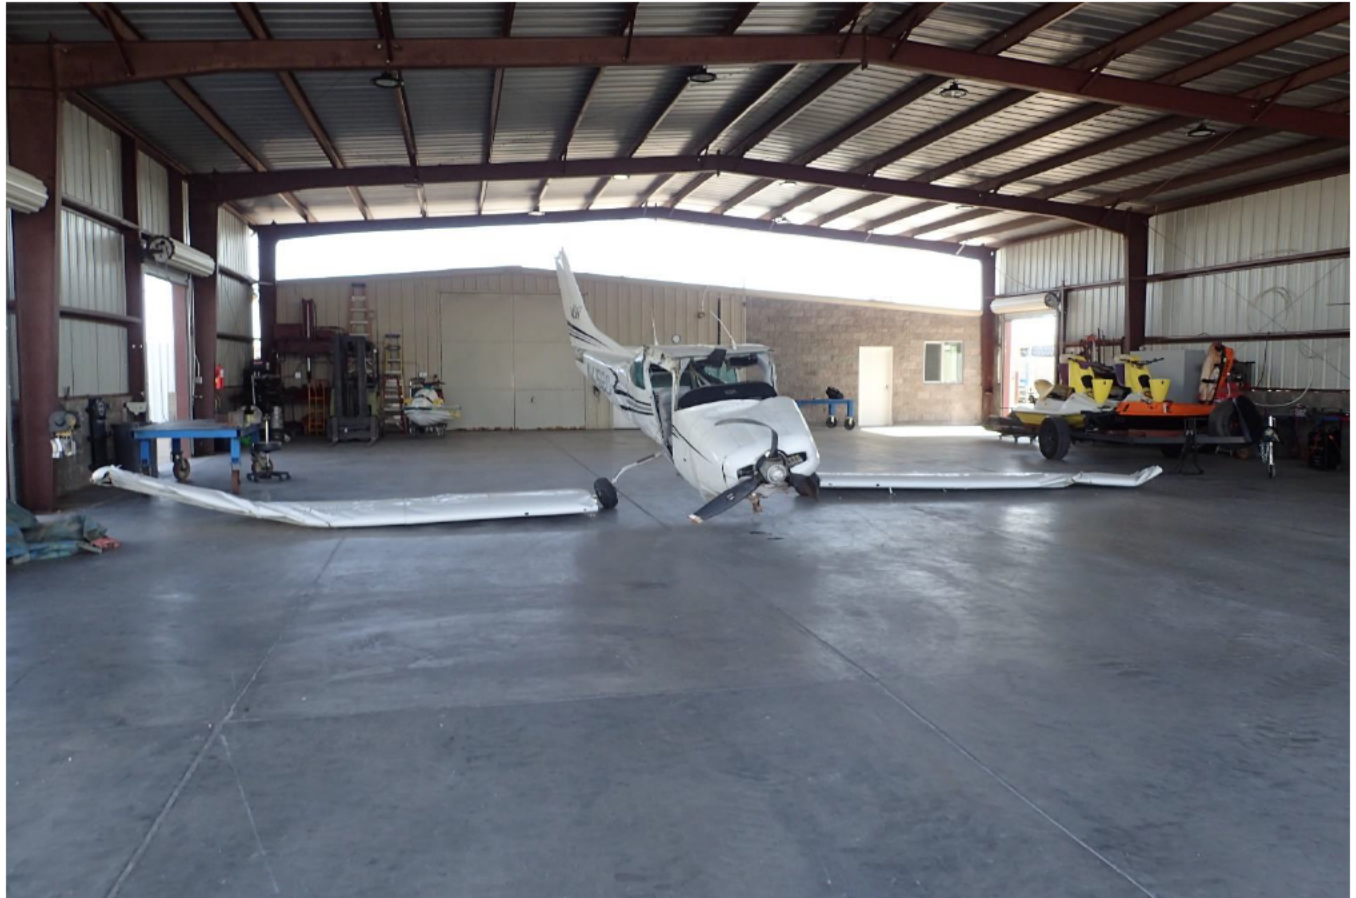
Aircraft after Recovery (ASI-23-BQ (6).jpg)

Both wings displayed impact signatures concentrated to the outboard portions of the wings. The right wing displayed upward deformation and aft crushing damage; the left wing displayed aft crushing deformation on the outboard section of the wing. The fuselage displayed crushing damage concentrated at the forward section as well as around the main landing gear attachment areas. The empennage was undamaged.

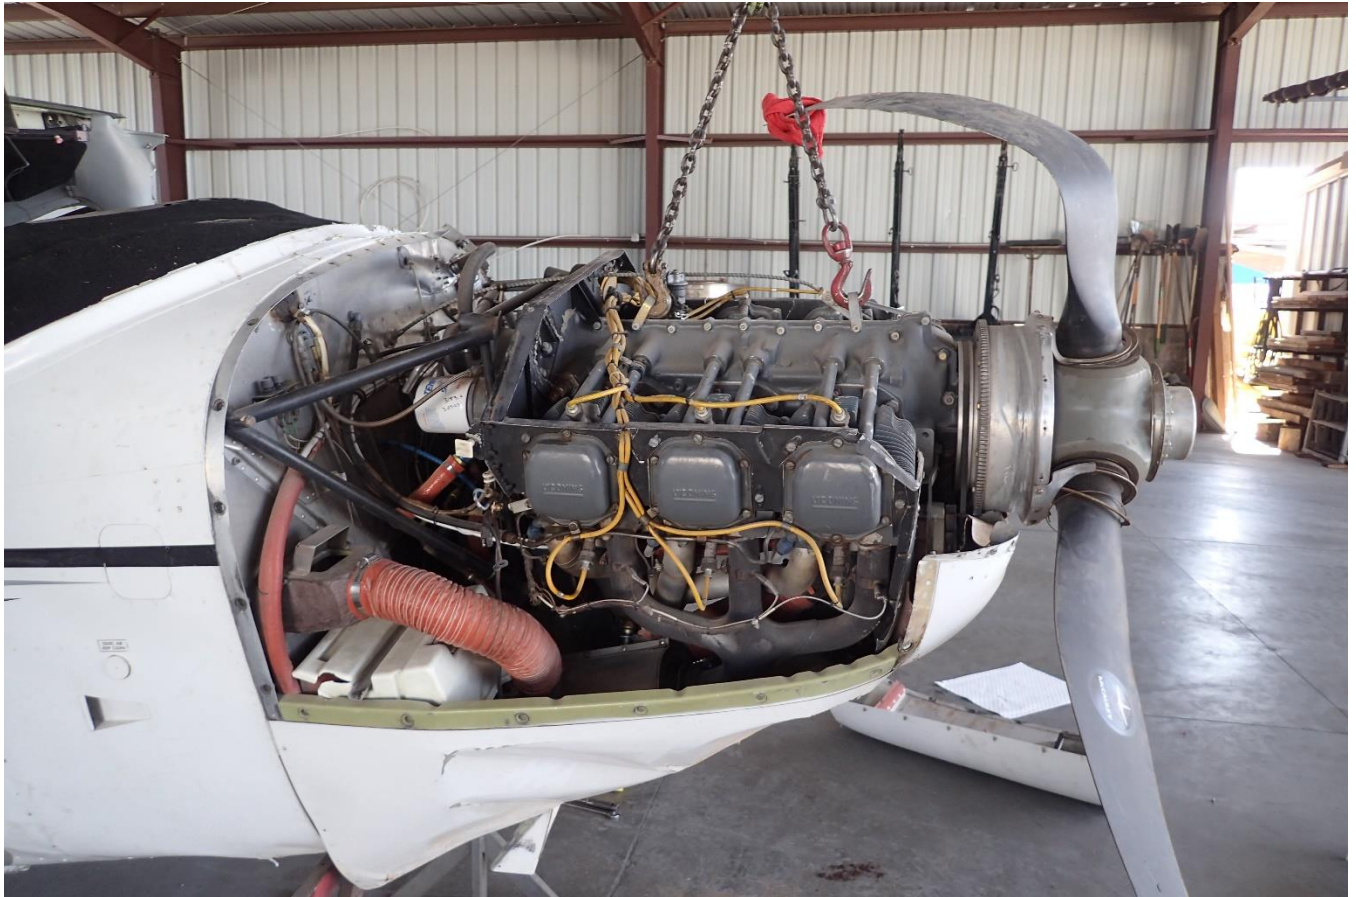
Engine Overview (ASI-23-BQ (71).jpg)

The engine was examined by this investigator under the supervision of the NTSB-IIC. Continuity was established between the crankshaft, camshaft, and associated components by rotating the crankshaft by hand. All six cylinders displayed good thumb compression and suction during crankshaft rotation. All of the overhead components (valves, springs, rocker arms) displayed normal operating and lubrication signatures and operated normally during crankshaft rotation.

The induction system was inspected and there were no signs of induction leaks or obstructions. The exhaust flame cones were examined and were found to remain intact and there were no signs of obstructions in the exhaust system.

The engine driven fuel pump was removed and the drive lever remained intact. The fuel pump inlet line was placed into a bucket full of 100LL fuel and the fuel pump drive lever was actuated by hand, the fuel pump was capable of pumping fuel and there were no signs of leaks around the fuel pump. The carburetor was noted to be undamaged, and all of the fuel lines were secure. The carburetor was retained by the NTSB for testing and examination by an overhaul facility. As of this report's writing, the examination had not taken place.

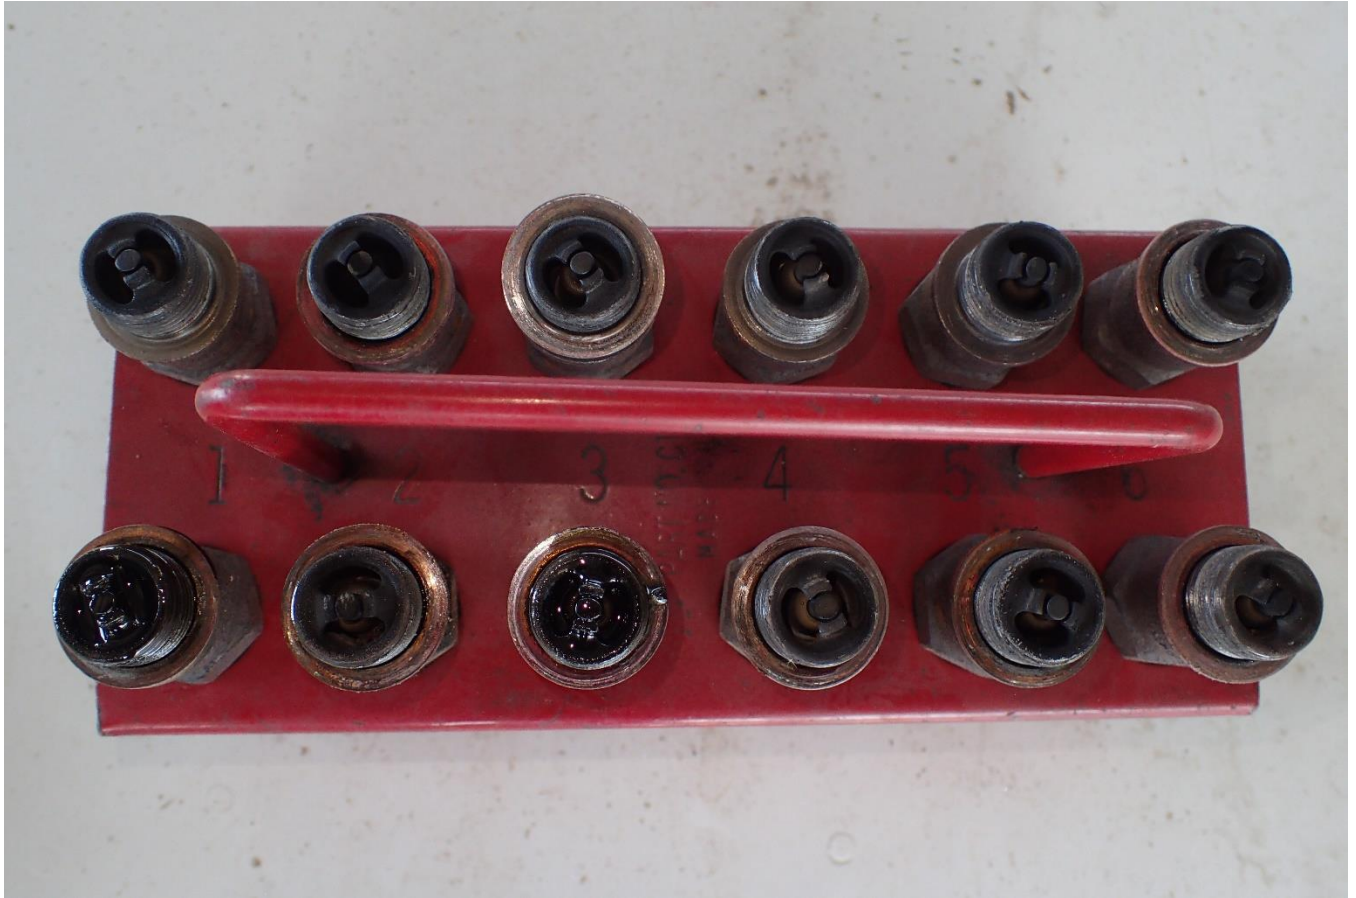
Spark Plugs (ASI-23-BQ (107).jpg)

Dual drive magneto spark:	All leads						
Spark Plug Condition (per Champion Check-A-Plug Card)							
	1	2	3	4	5	6	
Top	Carbon fouled	Carbon fouled	Carbon fouled	Carbon fouled	Carbon fouled	Carbon fouled	
Bottom	See below	Carbon fouled	See below	Carbon fouled	See below	Carbon fouled

The single drive, dual magneto remained attached to its installation point and was undamaged. During crankshaft rotation the magneto was capable of producing a spark on all ignition leads in the correct firing order. All the spark plugs were removed and visually examined. The #1, #3, and #5 bottom spark plugs were oil soaked which was consistent with post-accident accumulation. The rest of the spark plugs were heavily sooted which is consistent with an overly rich mixture during engine operation.

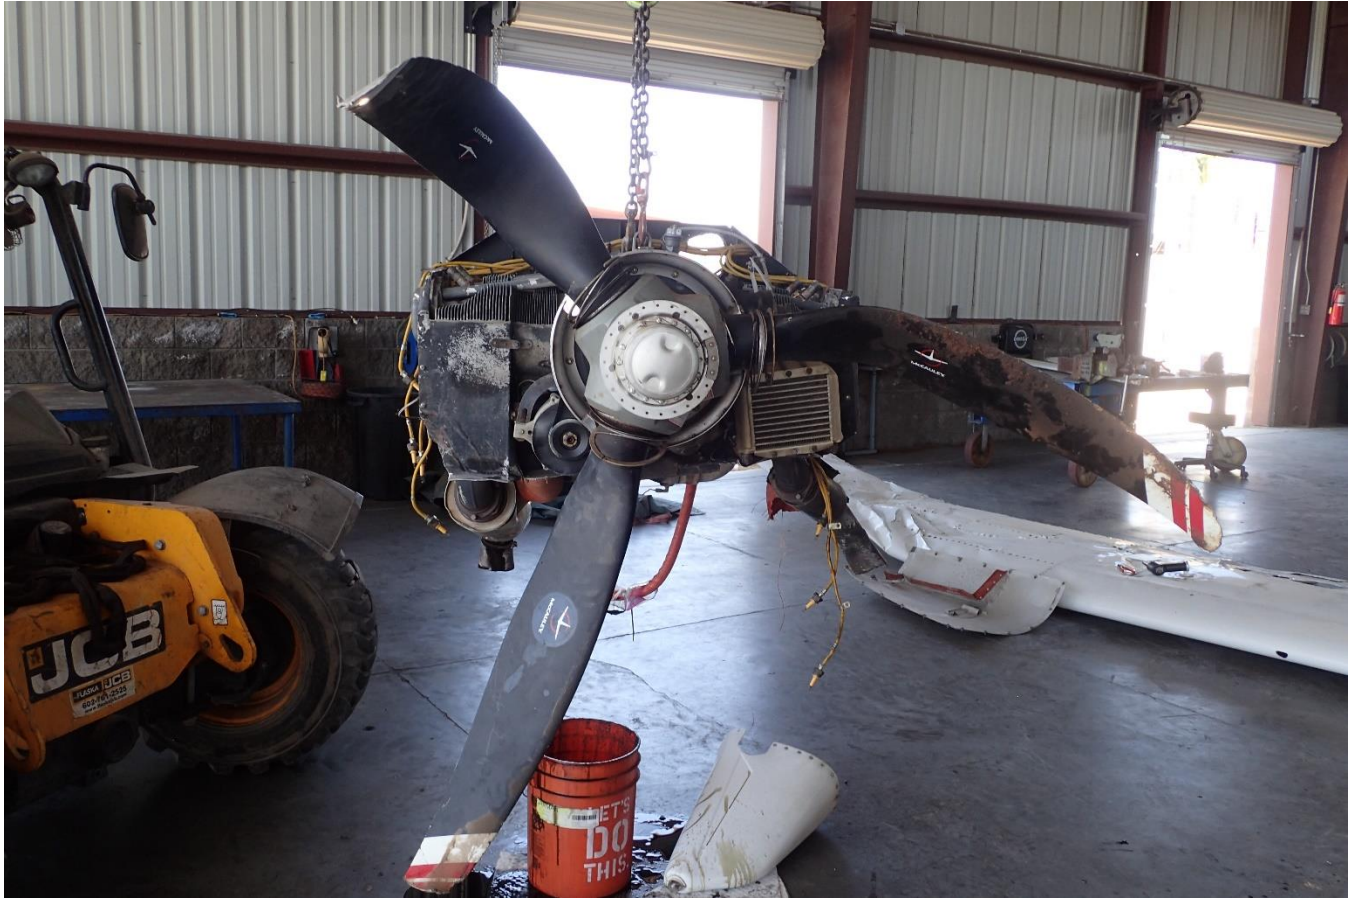
Propeller Overview (ASI-23-BQ (121).jpg)

The three blade, constant speed propeller remained attached to the engine and displayed impact damage signatures. Propeller blade #1 displayed minor forward bending deformation, and several gouges in the leading edge near the blade tip and a portion of the blade tip had fracture separated from the rest of the blade. Propeller blade #2 exhibited significant forward bending deformation and had several large gouges at the propeller blade tip. Propeller blade #3 displayed forward bending deformation and leading edge gouges at the blade tip. All three propeller blades displayed chordwise scratches on the aft side of the propeller blades.
