**NATIONAL TRANSPORTATION SAFETY BOARD  
OFFICE OF HIGHWAY SAFETY  
WASHINGTON, D.C.**

**TECHNICAL RECONSTRUCTION GROUP CHAIRMAN'S  
FACTUAL REPORT**

Location: Intersection of State Route 30A and State Route 30, Schoharie,  
Schoharie County, New York

NTSB #: **HWY19MH001**

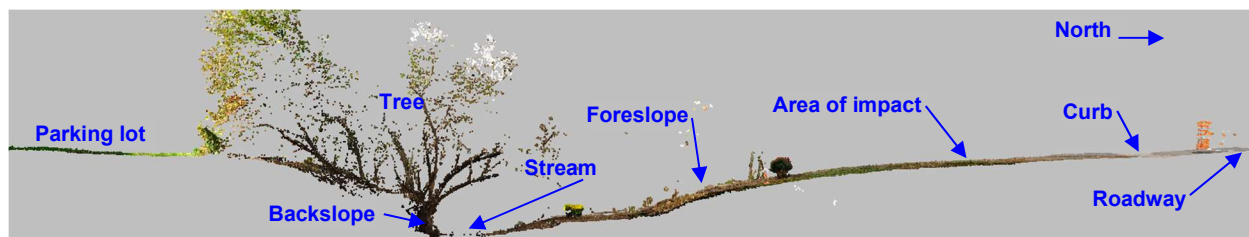
At final rest the Ford was in a stream bed, roughly facing west, with its driver's side against the southern embankment or backslope of the ravine. The ravine backslope is about 86 feet from the pavement edge of the highway and 43-53 feet southward from the area of impact. The backslope features a very steep rise to a height of more than 8.5 feet above the stream bed. The crest of the backslope levels and joins the parking lot for the Apple Barrel Country Store. **Figure 1** depicts a cross section of the three-dimensional scan to illustrate the terrain profile.

Figure 1: Cross section of 3D site scan depicting the terrain profile from north (right) to south (left). Also depicted is a tree impacted by the Ford.

Rising from near the base of the backslope were several trees. Although numerous branches had been trimmed and removed to facilitate access to the Ford, the remaining tree trunks exhibited evidence of having been impacted by the Ford several feet above the stream bed. NYSP scene photographs depicted additional evidence of contact to overhanging branches that had been removed. The heading exhibited by the surface furrows was consistent with the Ford's impact into the trees.

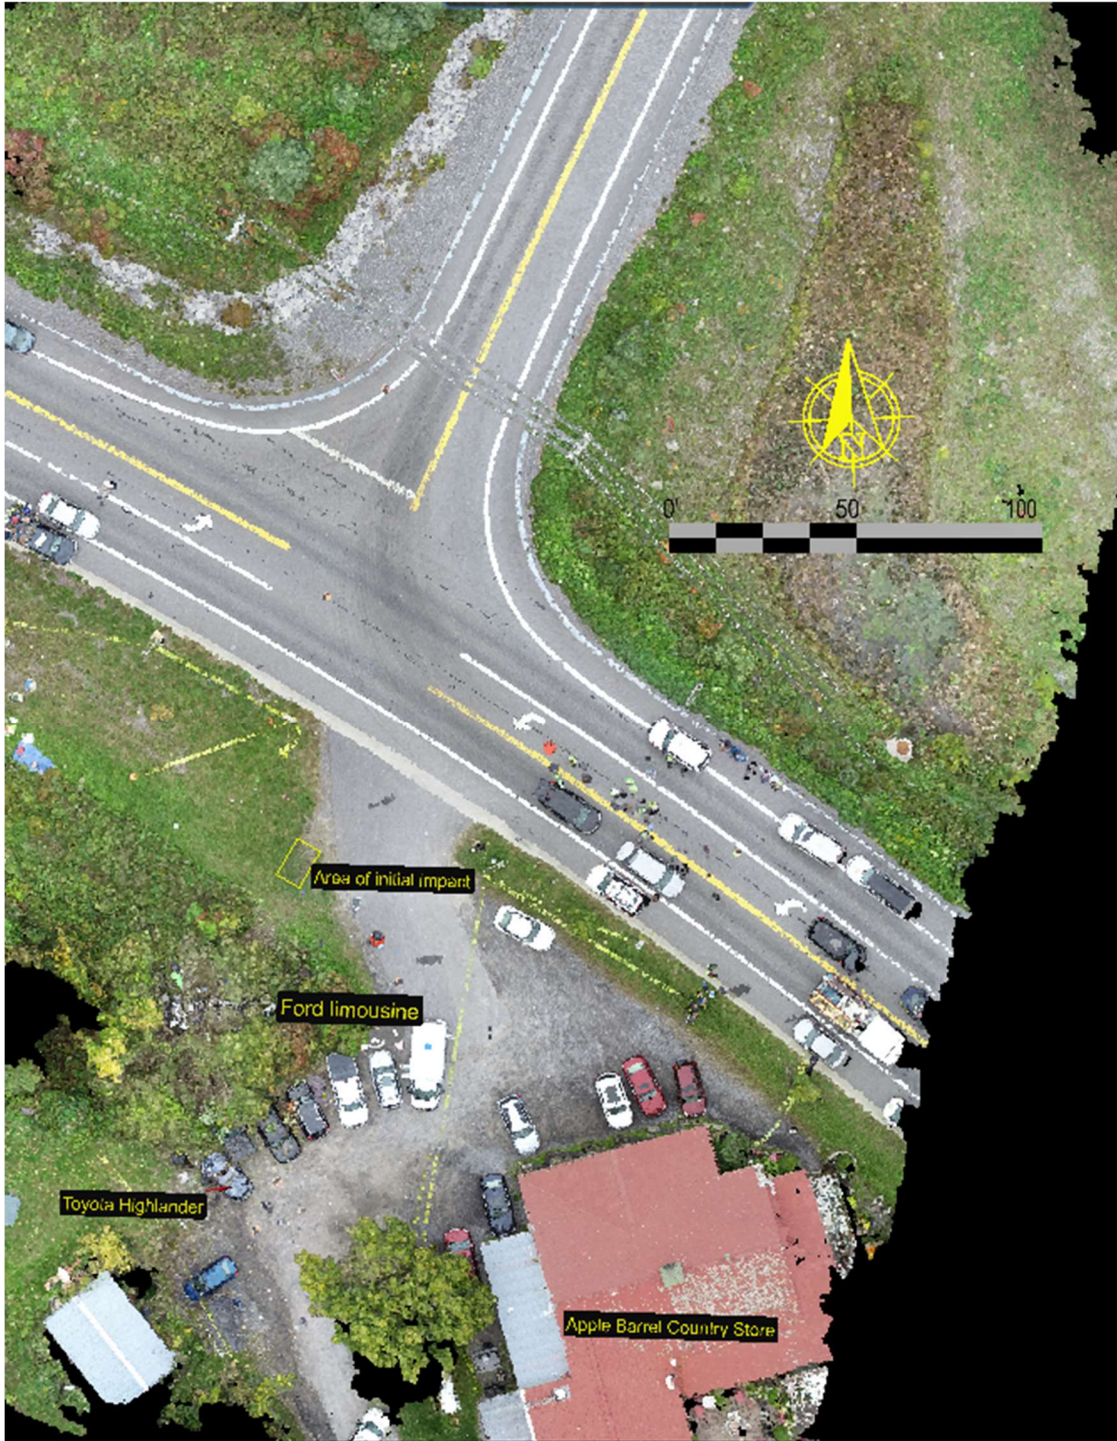
No collision related evidence was observed on the highway. **Figure 2** depicts an image of the three-dimensional point cloud rendered from the sUAS photographs taken by the NYSP.<sup>6</sup>

Figure 2: Screen capture image of 3D point cloud rendered from NYSP sUAS photographs.

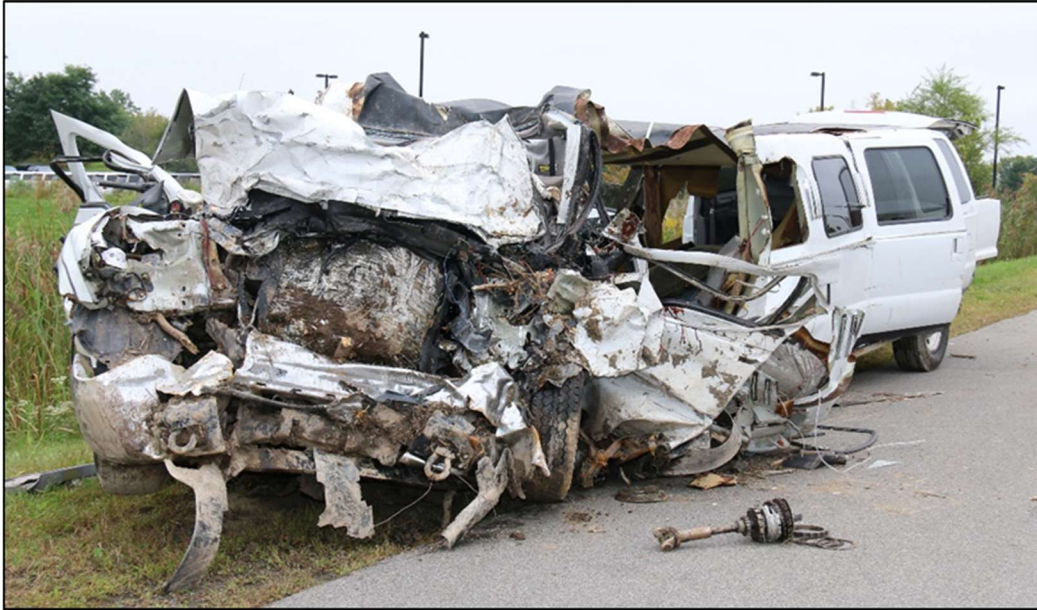
The Ford exhibited extensive front-end damage consistent with a high energy impact into a rigid surface. As depicted in **Figures 3** and **4**, the frontal structures were substantially displaced rearward. The rearward displacement of the frontal structures included the firewall and floor pan at the front seats. The frontal surface of the vehicle exhibited a distinct vertical and leftward shift that resulted in the leading edge being oriented about 36° relative to an undamaged plane. Impact damage covered the full width of the vehicle. This shift and rearward displacement resulted in a decrease to the left (driver's) side wheelbase of almost 48 inches with some compression of the body structure about the driver's seating area. This was countered on the right (passenger's) side where the wheelbase was slightly extended by about nine inches. The front passenger seating position also exhibited substantial floor pan intrusion.

Figure 3: Photograph depicting front-end damage to the Ford as viewed from the left front.

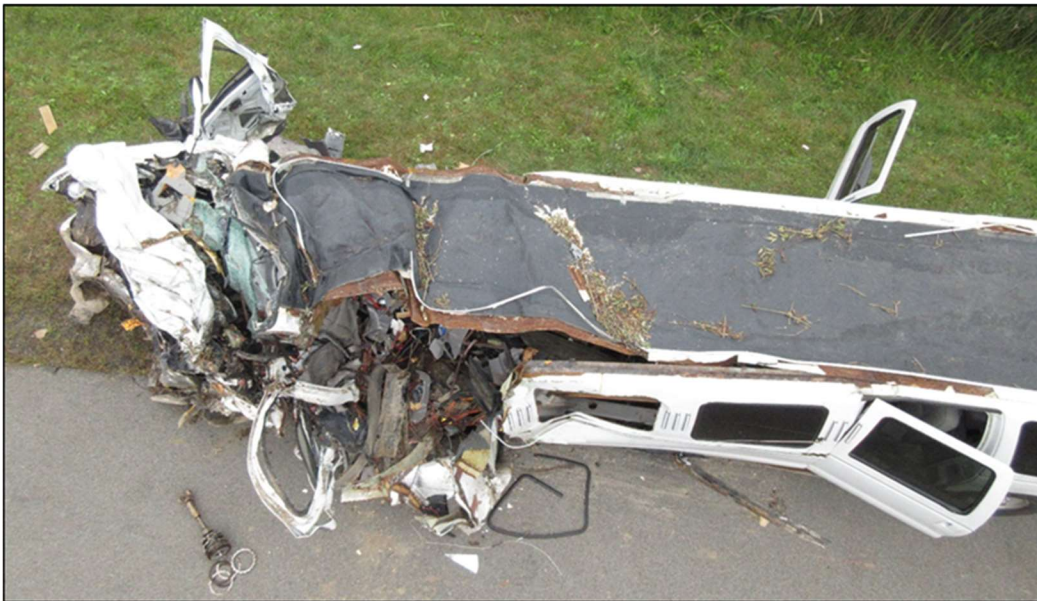
Figure 4: Photograph depicting overhead view of Ford between the front-end and rear axle.

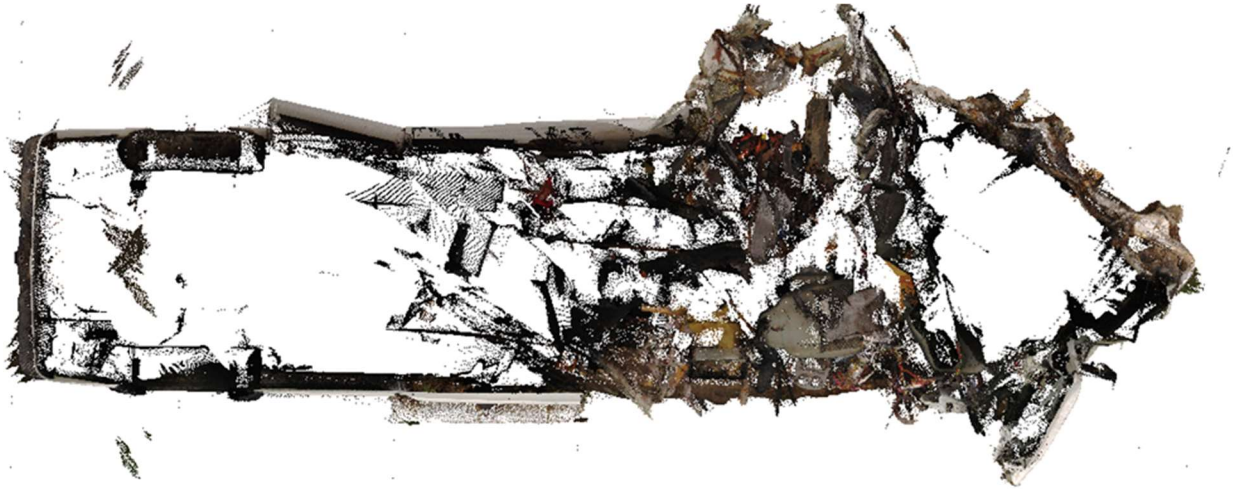
Examination of the 3D scans revealed no apparent displacement of the rear axle or body structure aft of the rear axle. **Figures 5 and 6** depict cross-sectioning of the three-dimensional scans of the vehicle exterior that depict an area extending vertically about 12 inches from the axle hubs.

Figure 5: Image depicting a longitudinal cross section of the exterior 3D scan of the Ford limousine. The area depicted extends vertically about 12 inches above the axle hubs.

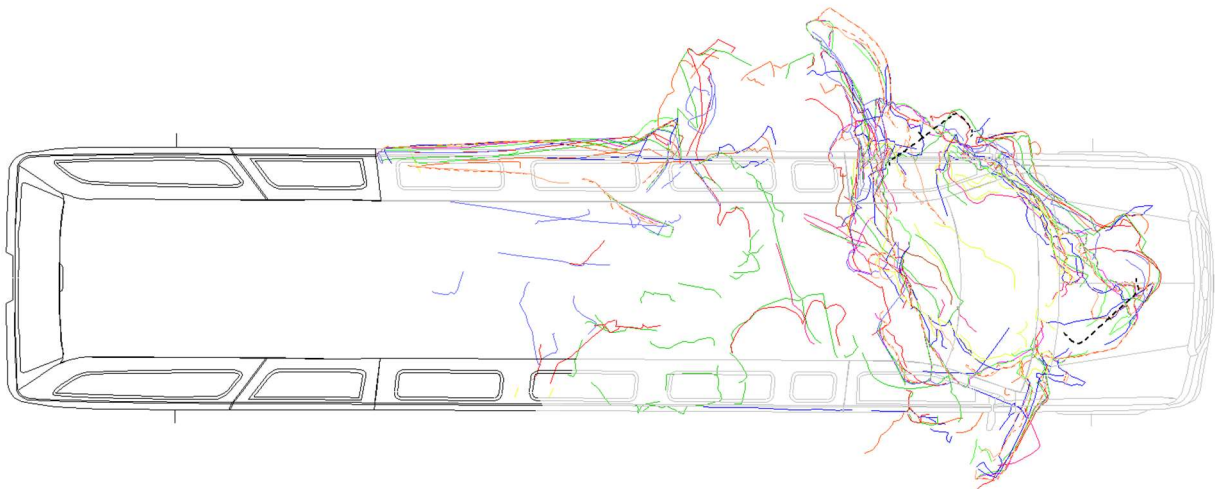
Figure 6: Image depicts the overall damage profile as outlined at six-inch vertical intervals between the axle hubs and roof. The profile is overlaid atop a sketch of the undamaged vehicle.

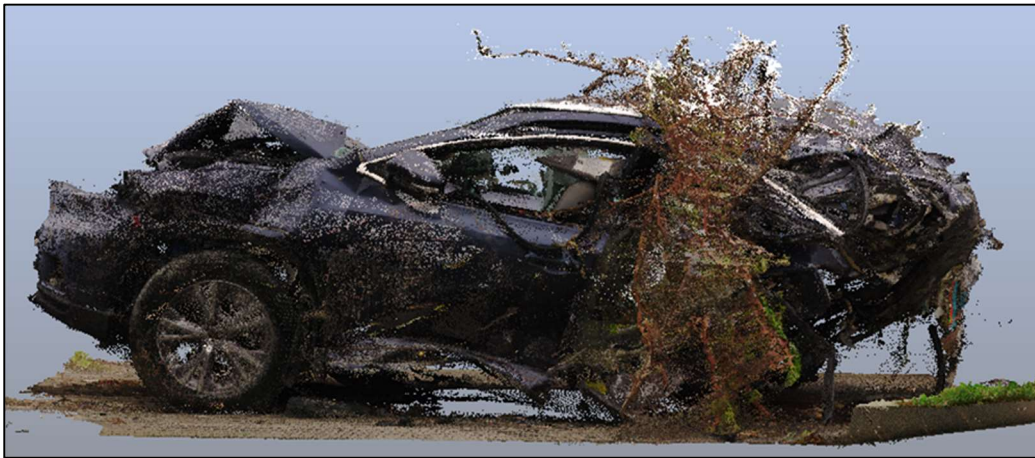
The parked vehicle struck by the Ford was identified as a 2015 Toyota Highlander all-wheel-drive, sport utility vehicle. Post collision the vehicle exhibited extensive rear-end impact damage. The rear axle positions and body structure at the bumper level were pushed forward resulting in a decrease from the vehicle's undamaged length of about 48 inches. The body structure and roof above the area of direct contact overhung the impact damage. While the area of contact covered the entire vehicle width, the driver's side exhibited greater forward displacement. **Figure 7** depicts an image of the 3D point cloud as viewed from the driver's side of the vehicle. **Figure 8** depicts a cross section of the vehicle scan covering about 16 inches of vertical height above the axle hubs.

Figure 7: Image depicting the 3D point cloud rendering of the Toyota Highlander as viewed from the driver side. Foliage debris that remained embedded in vehicle damage as a result of the collision were not removed pending inspection by NYSP investigators.

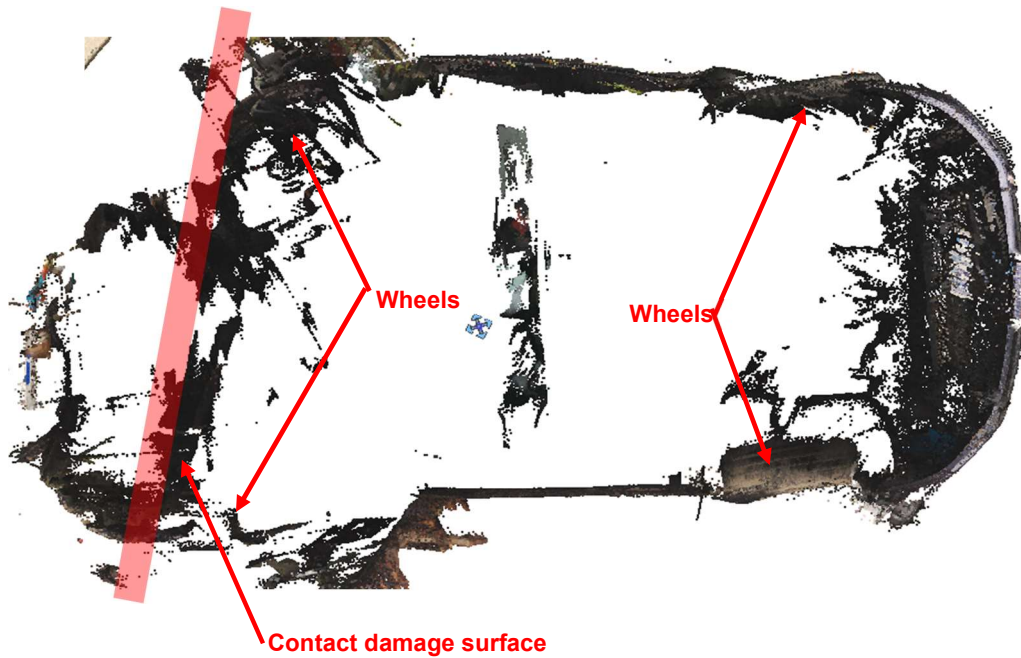
Manufacturer data indicated that the nominal overall vehicle length and wheelbase measured 191.04 inches (15.92 feet) and 110.04 inches (9.17 feet) respectively. Depending upon the reference source, the vehicle's curb weight ranged from 4,300 to 4,500 pounds. Measurements acquired from the 3D scan indicate a post-collision average overall length of about 143 inches (11.9 feet). The driver's side exhibited a slightly greater reduction in wheelbase than the passenger side. Post-collision the driver's side wheelbase measured about 82.8 inches, a decrease of 27.2 inches from the undamaged dimensions. The passenger side wheelbase measured 87.6 inches, a decrease of 22.4 inches.

Figure 8: Image depicting a longitudinal cross section of the exterior 3D scan of the Toyota Highlander. The area depicted extends vertically about 16 inches above the axle hubs. The red color shaded box indicates the area of direct contact and forward displacement of the rear-end. The structure extending further rearward is the body overhanging the area of contact.

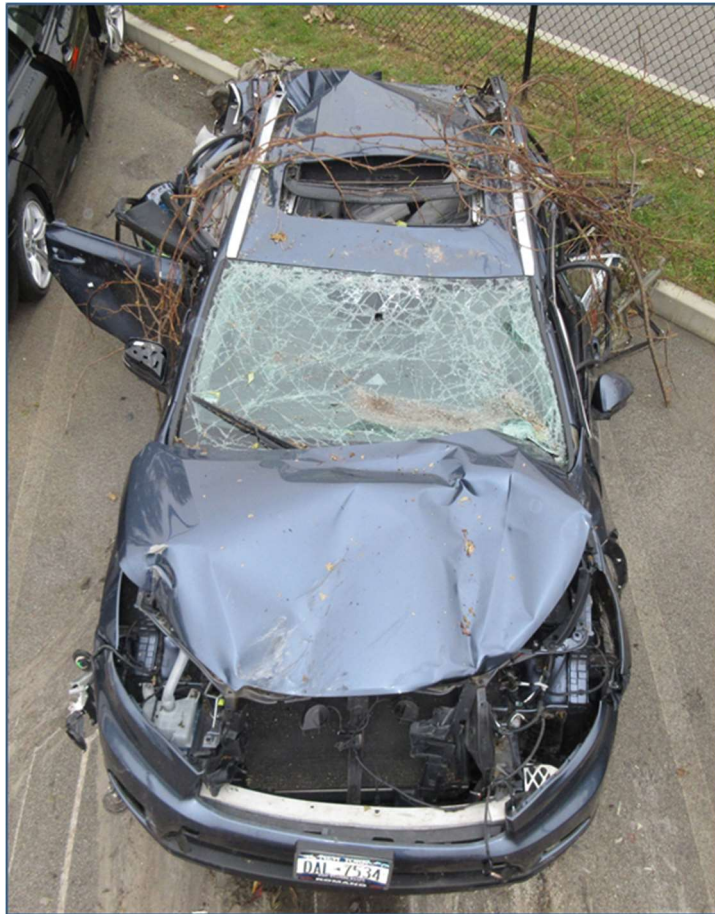
Additional contact damage was observed to the vehicle hood with the leading edge and upper surface exhibiting distinct areas of direct contact. The hood was displacement rearward with greater displacement visible at the driver side. The upper radiator support and surrounding features also exhibited rearward displacement. The front windshield was fractured with the fractures exhibiting characteristics of direct contact damage. The vehicle undercarriage rearward of the front suspension and axles displayed deposits of dirt. **Figure 9** depicts the damage to the vehicle hood and windshield.

Figure 9: Photograph depicting damage to the hood and windshield on the Toyota Highlander.

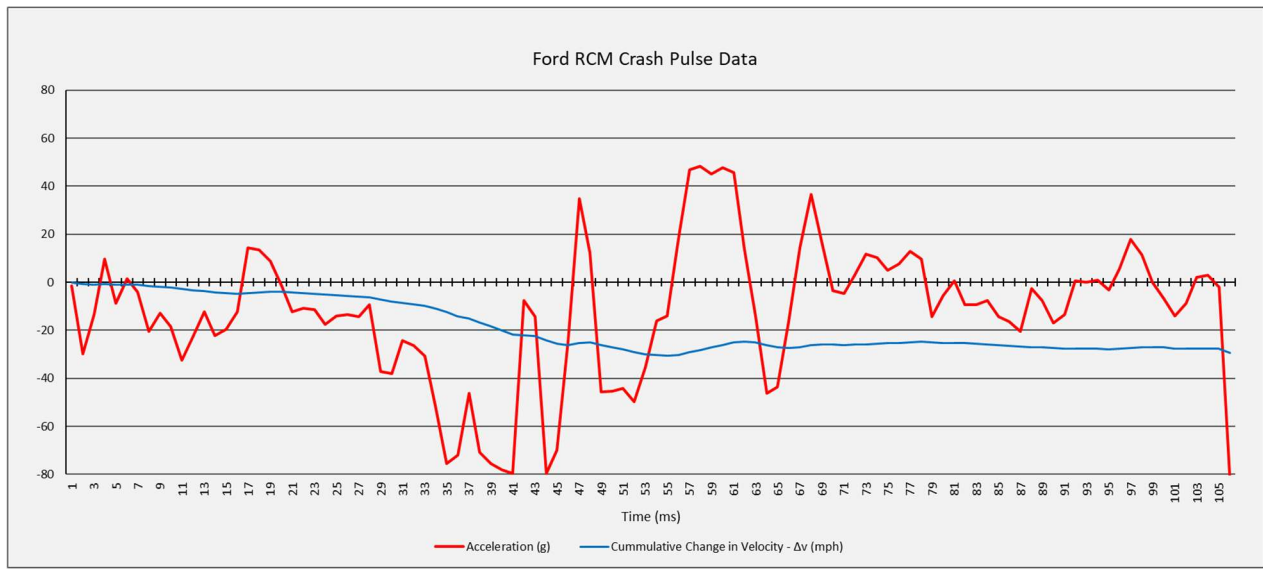
In the data report, the longitudinal acceleration and cumulative change in velocity ( $\Delta v$ ) were reported at one millisecond intervals. The data indicate that as the run time of the recording was nearing the end, the acceleration values, reported in g's or the equivalent of gravitation force, were approaching zero indicating the crash pulse was ending and the vehicles had attained maximum engagement. However, at the final data sample the acceleration value increased substantially. The computed cumulative change in velocity, expressed as a scalar quantity in miles per hour, peaked at 29.36 (mph) at the 106-millisecond point. Prior to the spike in acceleration at the final sample, the  $\Delta v$  had peaked at 27.79 mph at 95ms. At 105ms the cumulative  $\Delta v$  was 27.60 mph.

Figure 10: Graphical depiction of Ford ACM acceleration and cumulative change in velocity data. Time zero represents wake-up of the supplemental restraint system deployment command algorithm.

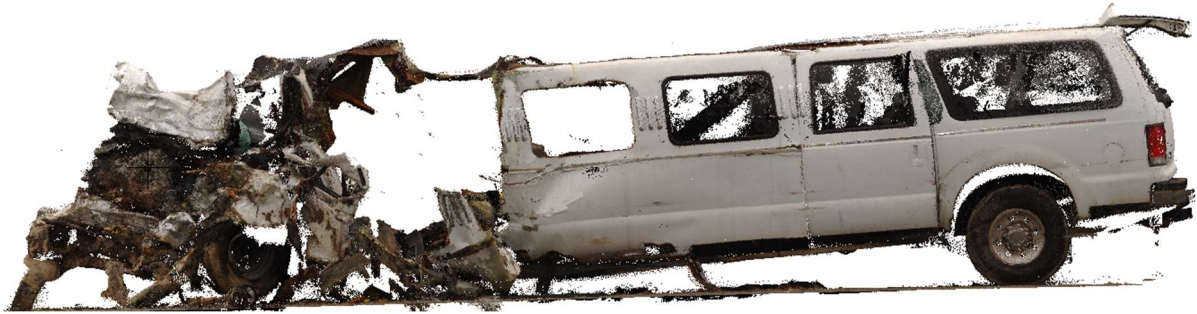
Figure 11: Image of 3D scan depicting left (driver) side of the Ford limousine.

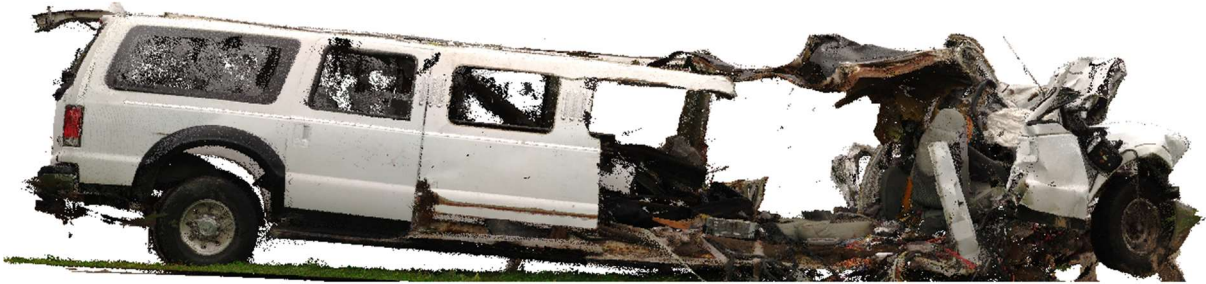
Figure 12: Image of 3D scan depicting left (driver) side of the Ford limousine.
