**NATIONAL TRANSPORTATION SAFETY BOARD
OFFICE OF HIGHWAY SAFETY
WASHINGTON, D.C.**

**TECHNICAL RECONSTRUCTION GROUP CHAIRMAN'S
FACTUAL REPORT**

PHOENIX, ARIZONA – HWY21MH008

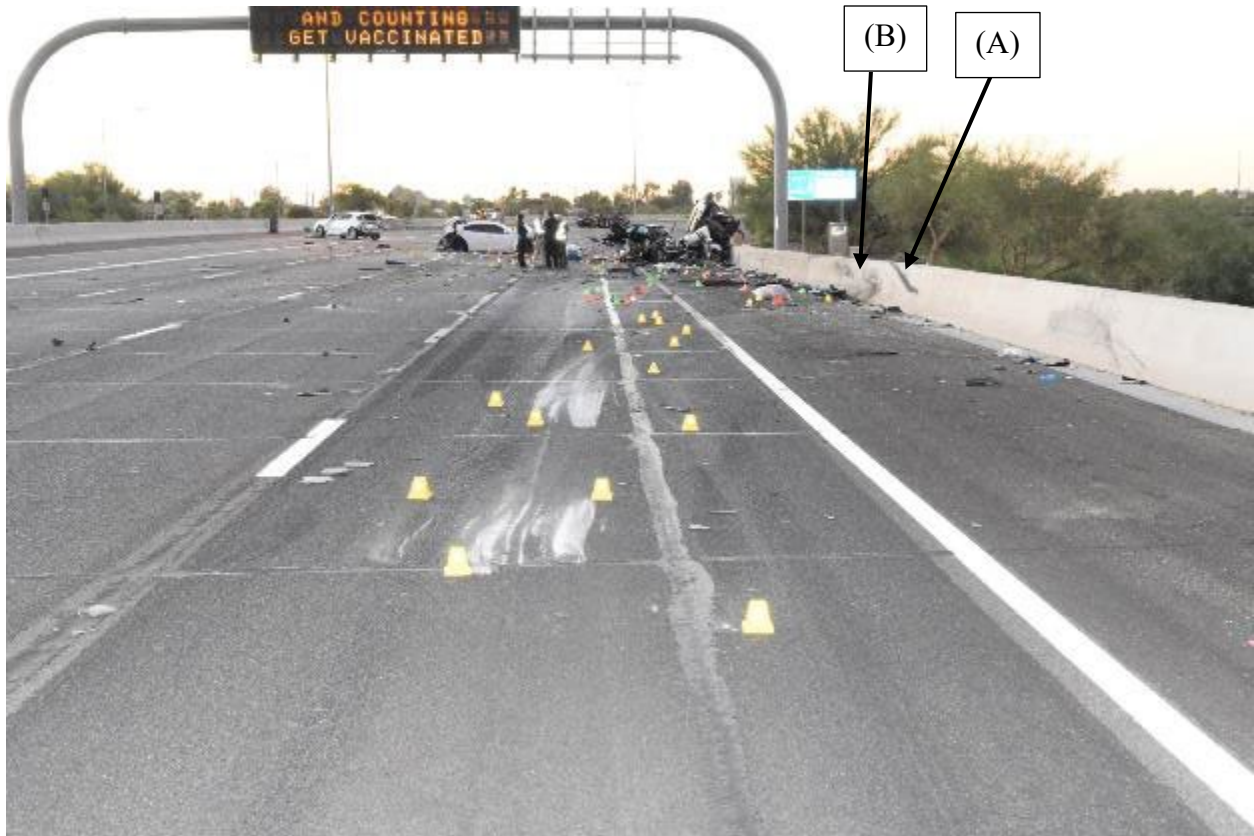
The first collision between the Freightliner combination and the Ford occurred in the right lane, lane 5⁴ of eastbound SR-202. The first area of contact was identified by an area of scrape marks which exhibited a white color on the asphalt surface. Located within the scrape marks was a large gouge. To the left of the gouge was a metal scar that measured approximately 3.4-feet in length and to the left of the metal scar was a tire friction mark which measured approximately 6.2-feet. The initial area of scrape marks extended east for approximately 6.2-feet in length. See **Figure 8**.

Approximately 12.2-feet east of the initial evidentiary marks, was another significant area of scrape and gouge marks. The marks began in the eastbound travel lane and progressed eastward for approximately 40-feet where they began to arc to the right transitioning to the right shoulder.

Figure 8: Photograph of eastbound SR-202 depicting area of impact. (Photograph courtesy of Arizona Department of Public Safety.)

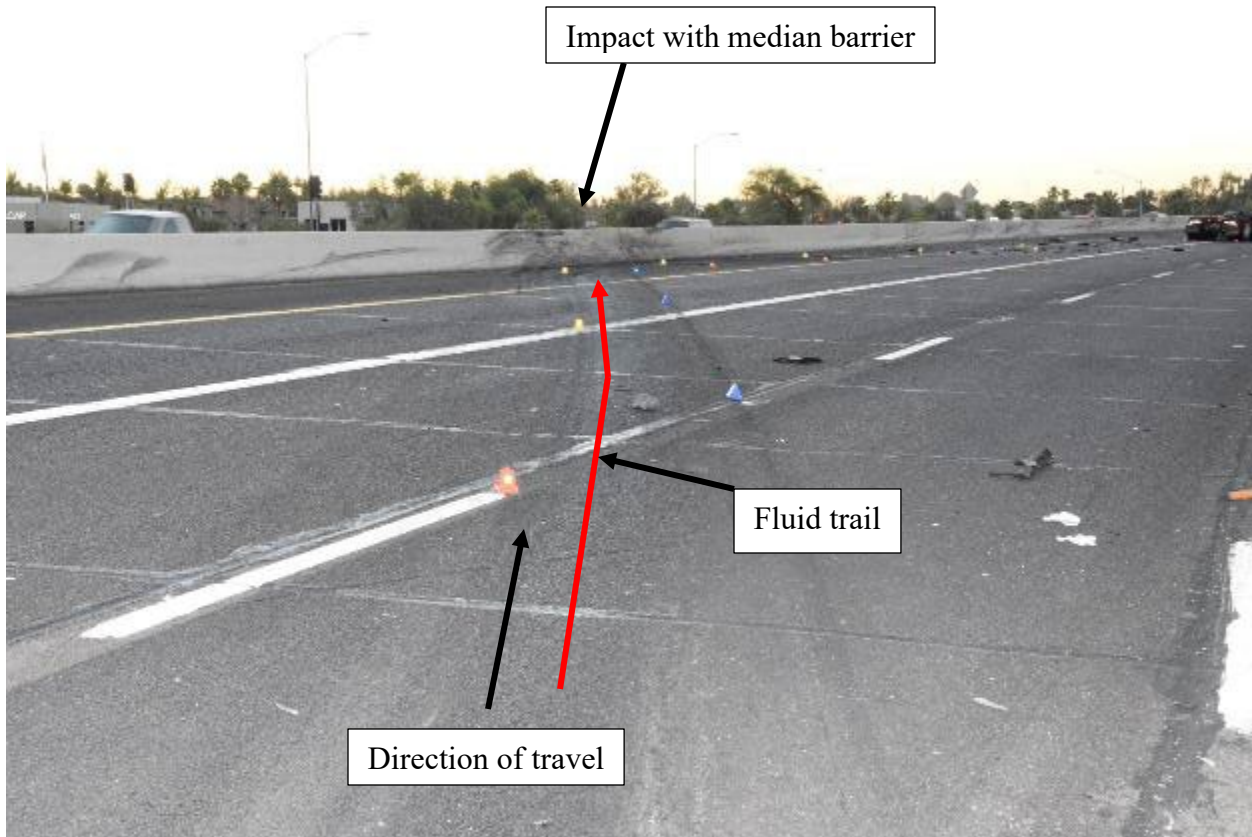
Located in the eastbound right lane, approximately 55-feet east of the initial collision evidence, began a fluid trail. The fluid trail initially extended from the dashed white line to the white shoulder line. As the fluid trail continued eastbound it narrowed. The fluid trail extended east in the right lane for about 184-feet where it transitioned to a northeasterly direction traversing

all five travel lanes and the left shoulder. The fluid trail was measured at an angle of 26° relative to the direction of the roadway. At the concrete barrier the fluid trail changed direction to the east for approximately 25-feet where it began a southeasterly direction. The fluid trail continued southeast for about 160-feet terminating at the final rest positions of the Freightliner and Chevrolet. The collision site measured approximately 608-feet in length from the area of impact to the final rest of the Freightliner and Chevrolet.

Figure 9 - Photograph depicting fluid trail, indicated by the red line, from Freightliner combination and Chevrolet leading to impact with concrete median barrier. (Photograph courtesy of Arizona Department of Public Safety.)

A second fluid trail appeared about 96-feet east of the beginning of the of the first fluid trail in the right lane. **See Figure 9.** The second fluid trail traveled northeast from the right lane, lane 5, traversed lane 4 and entered lane 3. The fluid trail continued east in lane 3 for about 43-feet where it turned southeast entering back into lane 4. The fluid trail terminated at the final resting position of the Dodge. There were two tire friction marks that originated at the final rest of the Dodge. Onset of the tire friction mark was visible in lane 4. As the mark continued northeast it transitioned into lane 3 where it ended. The tire friction mark exhibited an overall length of about 30-feet. There was a second tire friction mark offset north about 8-feet. It had originated in lane 3 and extended over a length of about 11-feet. The two described tire friction marks traveled towards the final resting position of the Lexus which was located approximately 67-feet northeast of the Dodge. **Figure 10** is a 2D diagram created from the 3D point cloud. The diagram shows the position of rest for the involved vehicles.

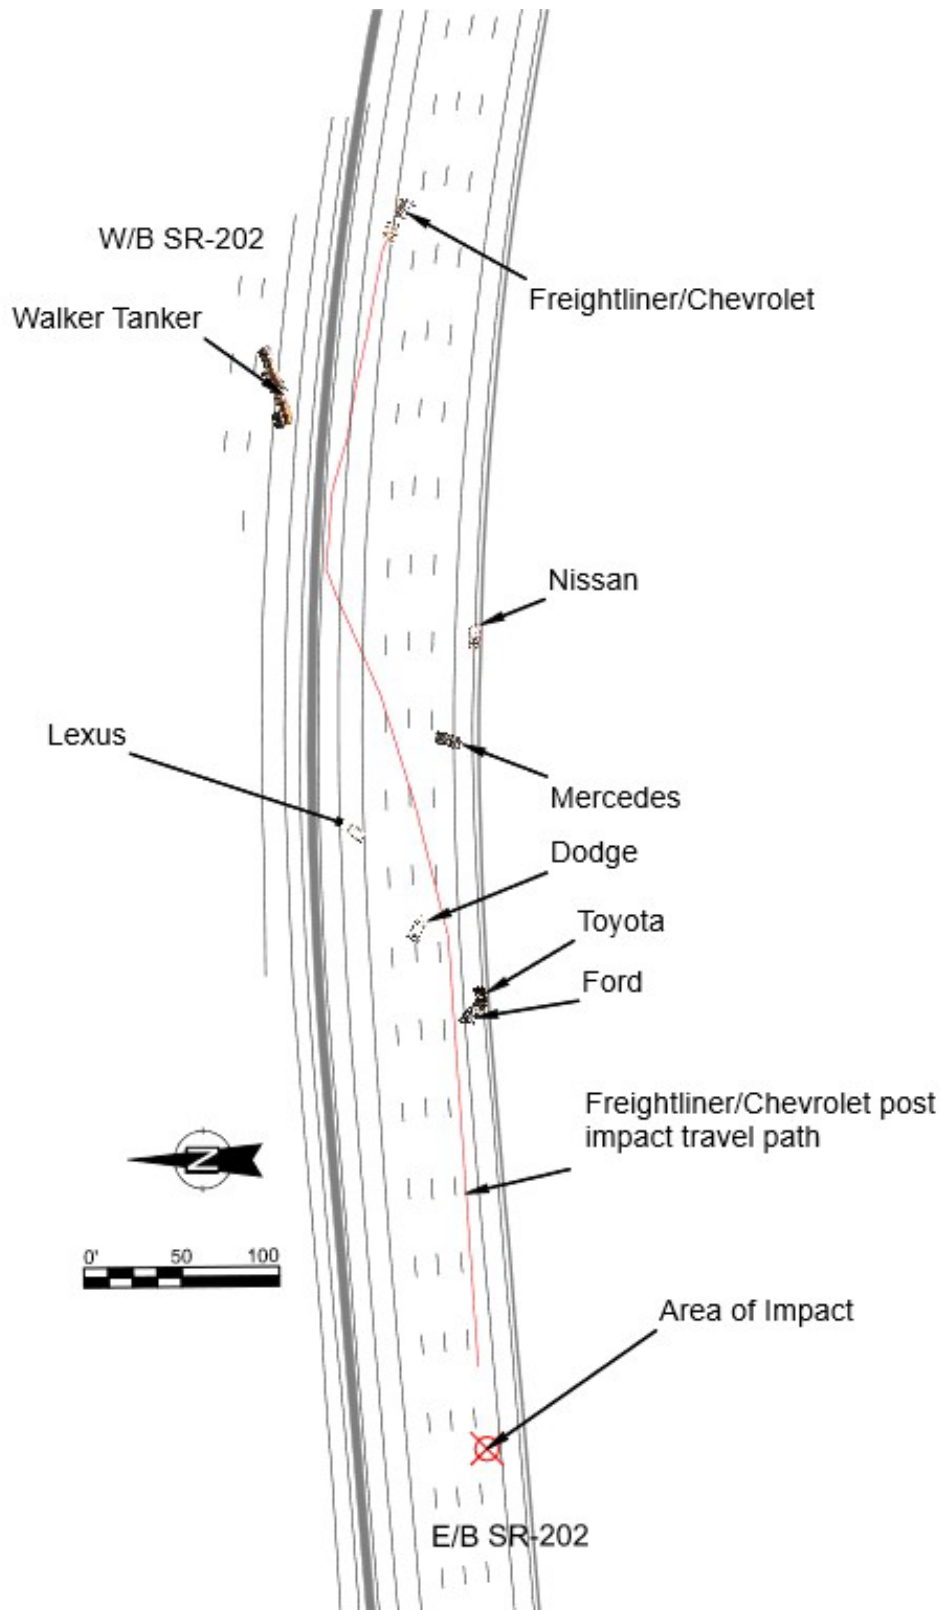
Figure 10: 2D diagram created from the 3D point cloud. Diagram depicts the final resting positions of the involved vehicles. The redline follows the physical evidence created by the Freightliner and Chevrolet.

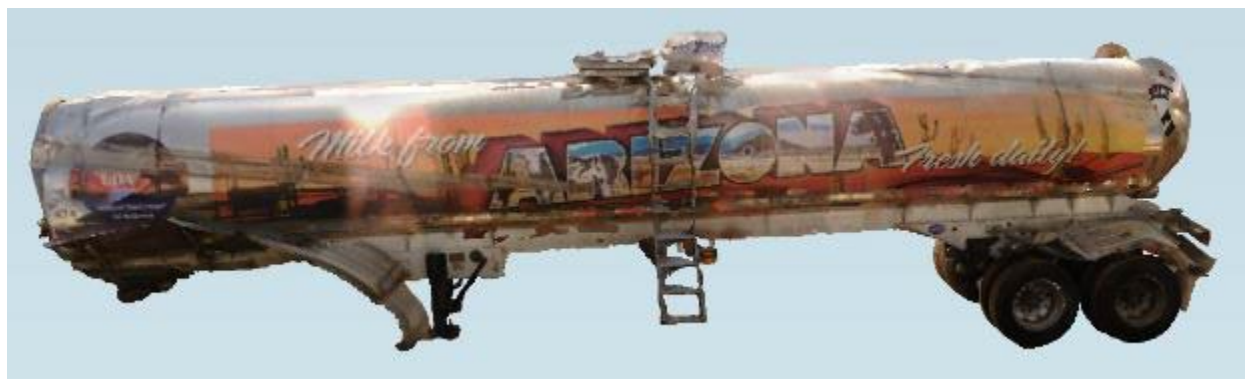
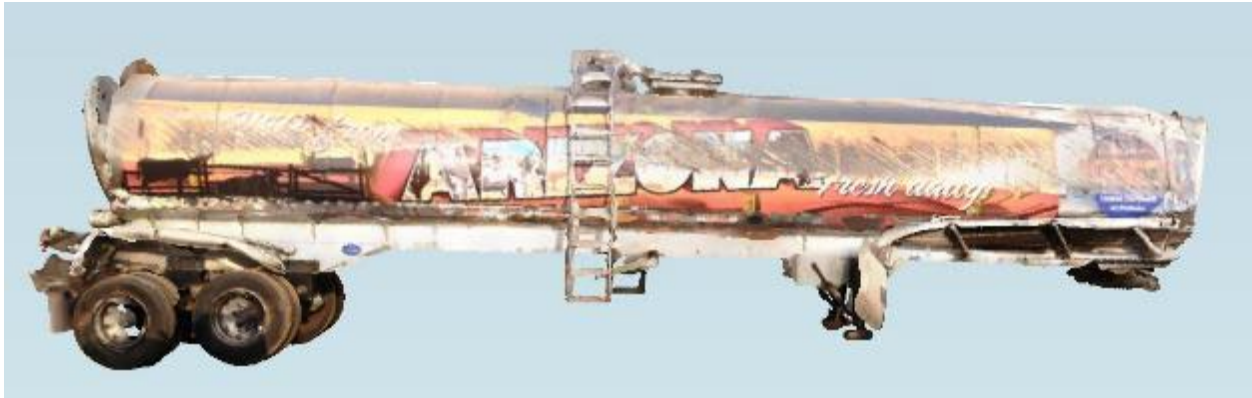
The tank-trailer exhibited overall damage due to the barrier impact, rollover, and slide. When examined at the storage facility the front cap had separated from the cladding of the trailer at the top. Along the right-side of the trailer were angled scrape marks that extended from the front to the rear. The right front and rear fender were bent upwards. The right-side outside wheels on the duals were damaged. The front wheel exhibited scrapes around the circumference of the wheel and the tire was scuffed. There was a small section of the rear wheel that had been bent inwards toward the center hub and the edges were scraped around the circumference of the wheel. Much like the front tire the tire itself was scuffed. The end cap had separated from the cladding and had a significant dent on the left side.

Along the tank-trailer left side were two separate and significant scrape marks. The first scrape mark began at the front of the tank-trailer about midway up. Where the scrape mark initiated, at the front about midway up, the tank-trailer was dented inward. The scrape mark extended at a downward angle ending at the middle of the tank-trailer. There was a ladder attached to the tank-trailer in the middle. The ladder was bent inward toward the tank in line with the scrape mark. The second scrape mark initiated at the top in the middle of the tank. In that location was the cap area, where the tank-trailer would have been loaded as well as a metal standing platform. The metal platform had been bent inwards towards the top to the tank, the scrape extended from the metal platform down around the left side of the tank ending at the rear of the tank-trailer. Just like the first described scrape mark at the end of the second mark there was a dent that pushed inwards.

The trailer king pin was intact, and the fifth wheel coupler was still attached to the kingpin.

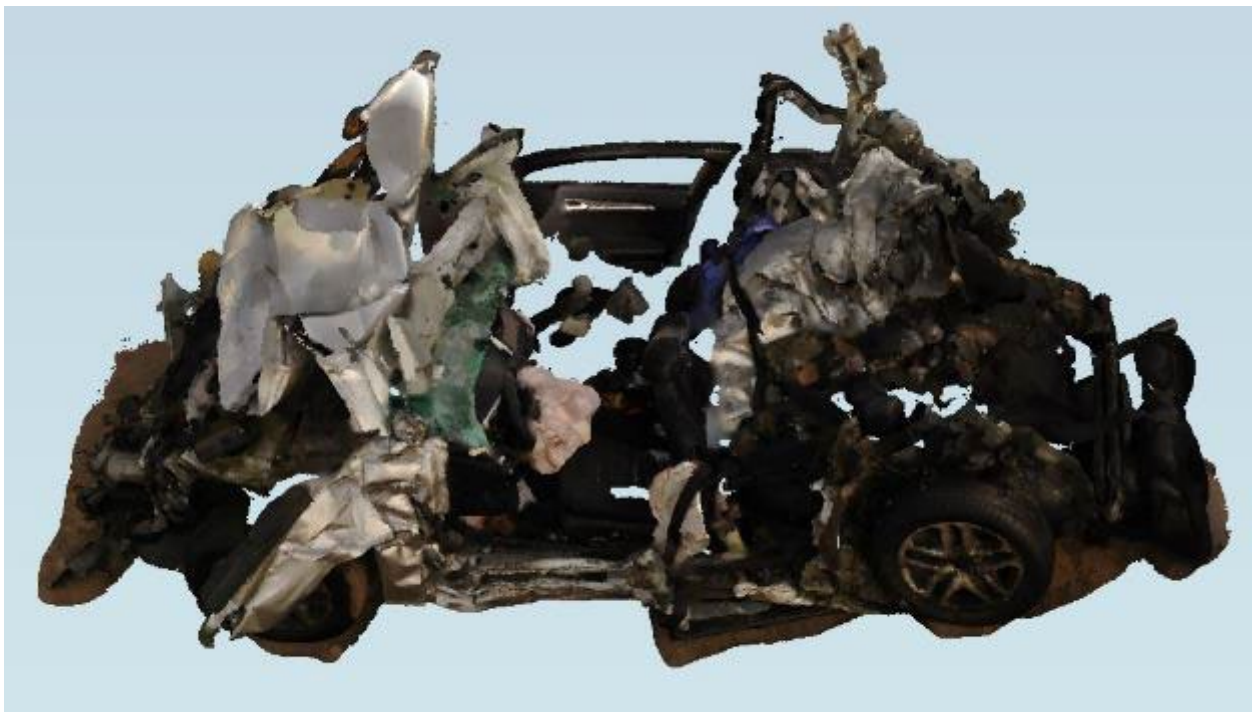
Overall, the vehicle exhibited catastrophic damage. The rear trunk area had been pushed forward into the rear area of the passenger compartment. The rear seat backs were pushed forward and down and were laying on the rear seat.

The front of the vehicle exhibited impact damage as well. The hood had been pushed up and rearward into the windshield. The top of the radiator was pushed inward towards the motor and the left and right fenders were damaged and pulled away from the Ford.

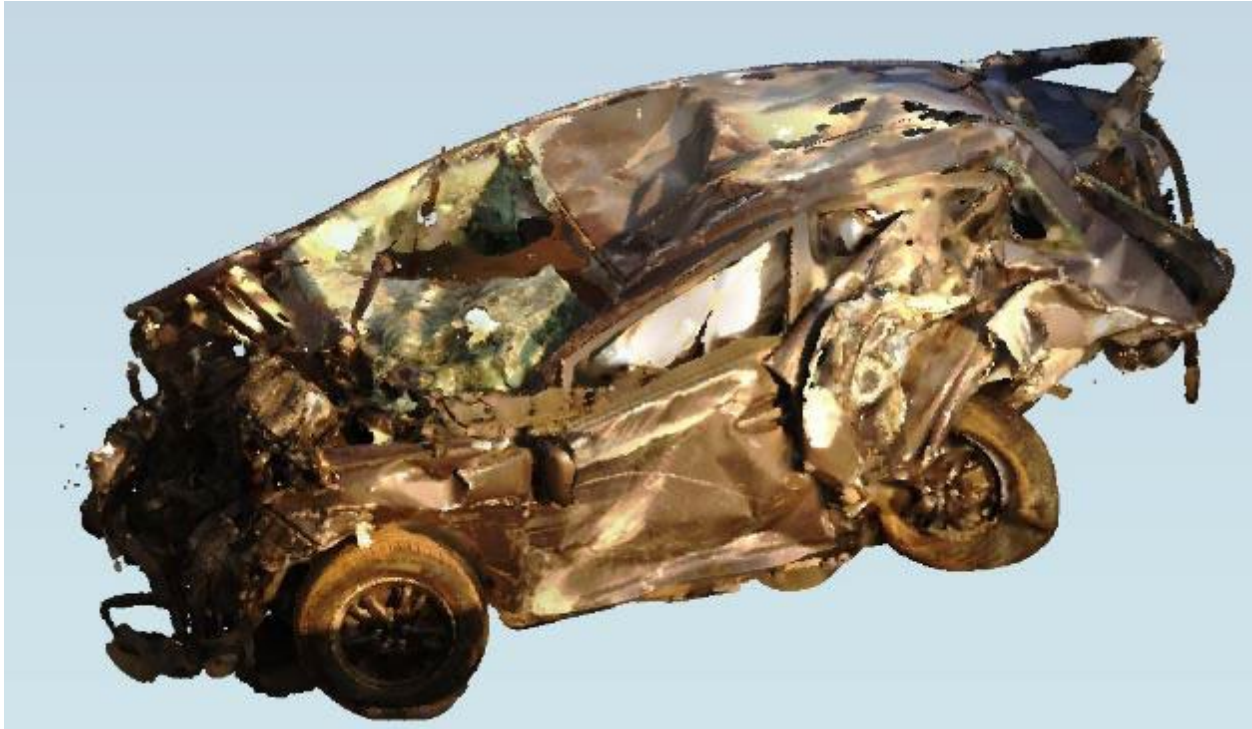
The Toyota exhibited severe damage to both the front and the rear of the vehicle. The damage to the rear of the vehicle extended the width of the rear of the vehicle. The heaviest damage was localized to the left side. The rear of the Toyota was under-rode and the bumper was down and inward towards the center of the vehicle. The left wheel assembly was pushed forward, reducing the left side wheelbase, and upward. The right-side wheel assembly had also been pushed forward slightly. There was impact damage encompassing the left side of the vehicle.

The damage to the front of the Toyota extended the full width. The front bumper and lower portion of the engine had been pushed down towards the ground. From about the middle of the engine upward had been pushed rearward towards the firewall. The windshield had broken and was collapsed inward. The roofline and drivers side “A” pillar had been pushed inward towards the passenger compartment.

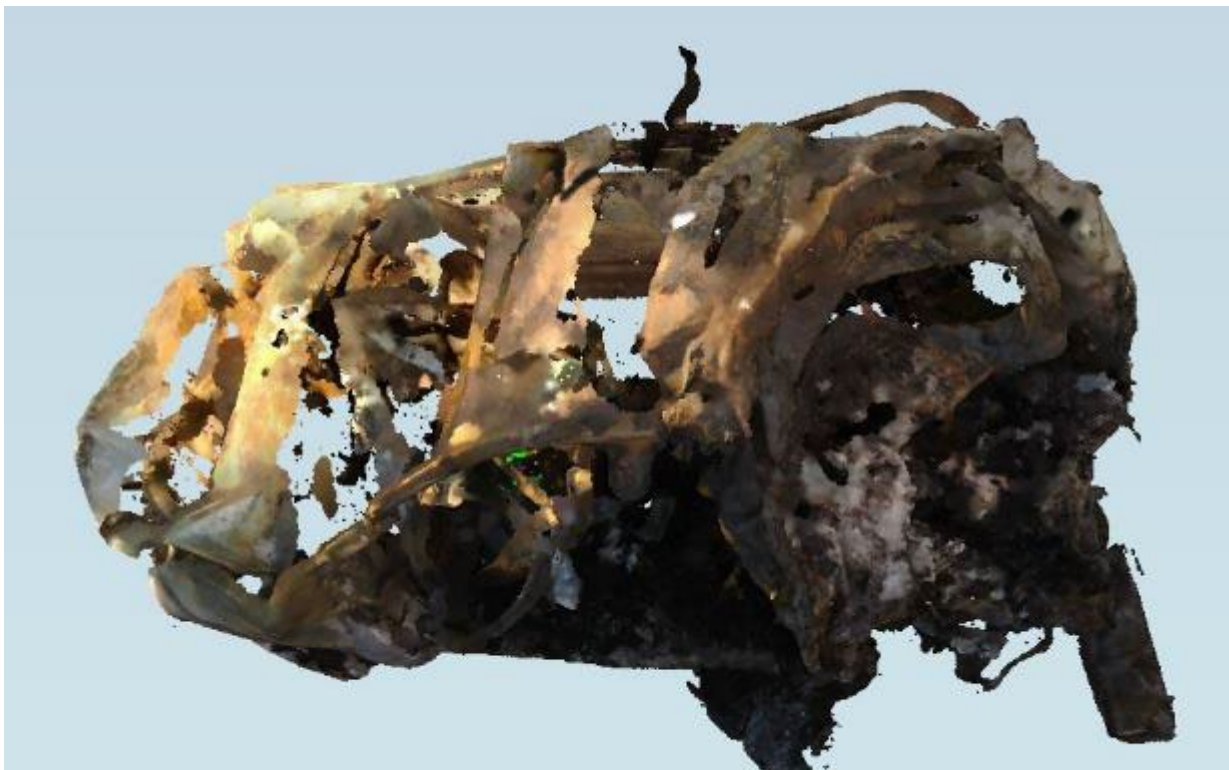
The Chevrolet exhibited severe impact damage to the rear and additional impact damage to the front. It had also suffered catastrophic fire damage. The damage to rear was about 4-feet in width as measured from the left side. The rear of the vehicle had been pushed forward into the rear seating area.

The damage to the front of the Chevrolet extended the full width. The hood was buckled with the leading edge of the hood bent upwards. The left rear wheel assembly had been torn off the vehicle while the right wheel assembly was bent under the rear of the Chevrolet.

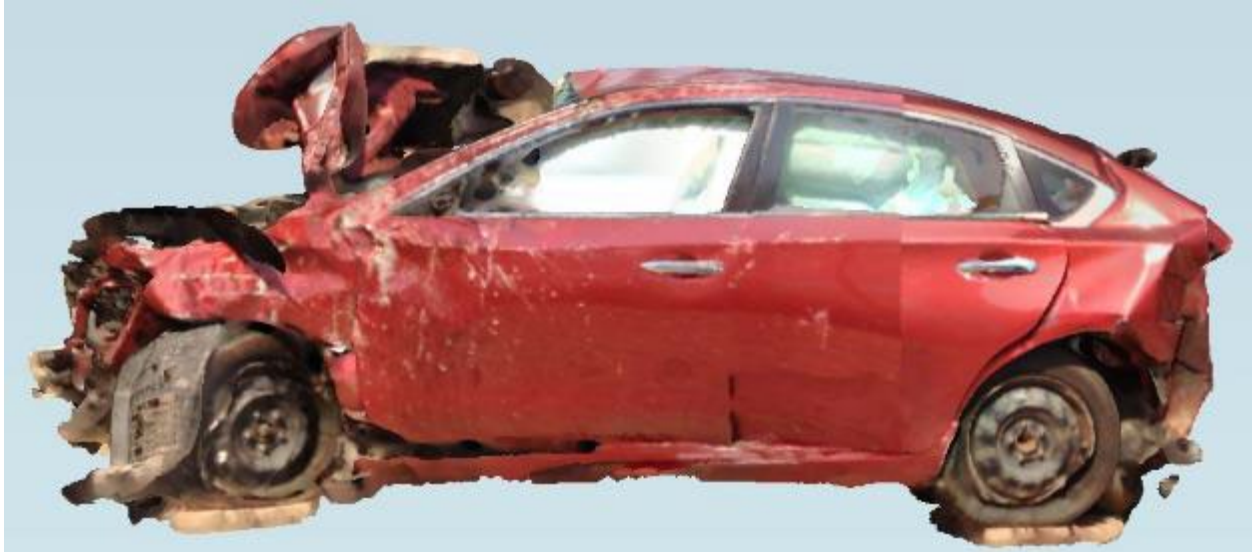
The Nissan exhibited severe damage to the rear as well as significant damage the front of the vehicle. There were scrape marks identified on both the left and right side of the vehicle, right fender, and right side of the hood. The front bumper cover, and grille had been torn from the vehicle. The fenders were pushed inwards toward the motor and exhibited scrape marks. The hood had bent rearward into the windshield. There were scrape marks along the right side “A” pillar, roofline, rear passenger door and quarter panel. Scrape marks along the left side of the Nissan were on the “A” pillar and roofline.

The damage to the rear extended the width of the vehicle. The rear of the vehicle had been uniformly pushed inward collapsing the trunk area.

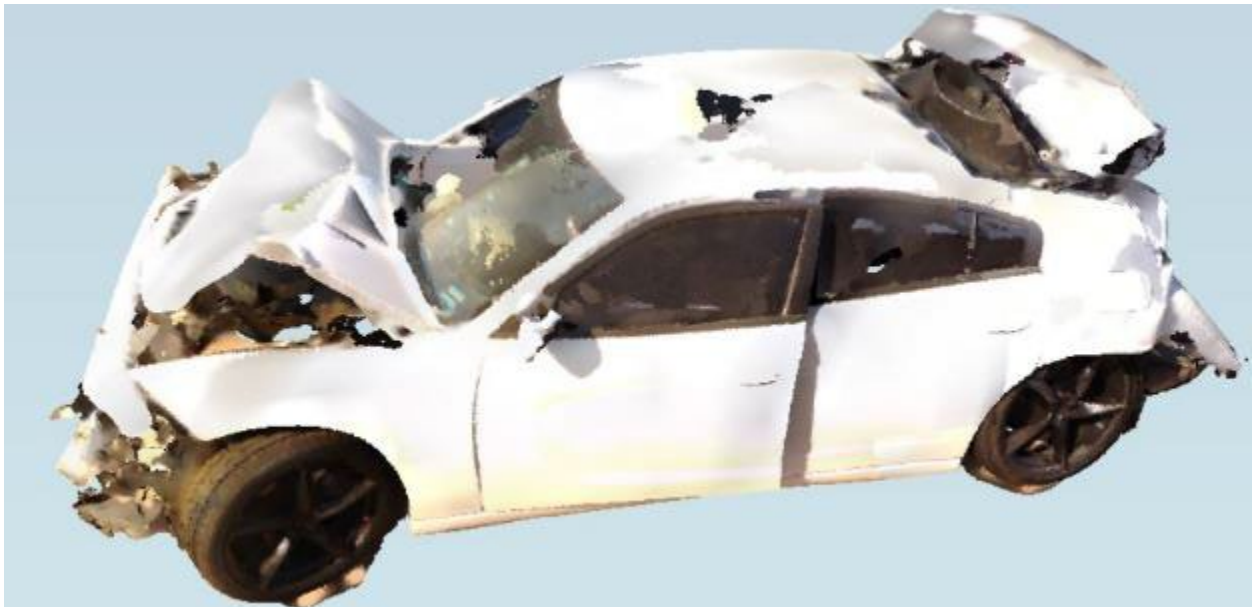
The Dodge exhibited severe damage to both the front and rear of the vehicle. The rear trunk and bumper area of the Dodge exhibited direct contact. The rear bumper cover was torn from the bumper and pushed inward into the rear storage compartment. The rear of the trunk lid was dented inward and the lid itself was displaced upward. Both rear quarter-panels were also pushed forward

and upward. The rear axle appeared to be shifted forward reducing the wheelbase of the Dodge. Located on the rear bumper cover was blue paint transfer which consisted of reverse lettering (EA0). The (EA0) matched the first three digits of the Nissan Altima registration plate. Also, located on the lower edge of the trunk lid were areas of red paint transfer.

The front of the Dodge exhibited evidence of direct damage. The front bumper cover, grille, and headlight assemblies were all missing from the vehicle. The center of the bumper was bent inwards towards the engine compartment and exhibited signs of material transfer. The right corner of the bumper, from the frame rail outward, was bent inwards towards the right front tire. The front upper trim piece was pushed down and offset to the left of center was a black scuff mark that was aligned with black paint transfer located on the leading edge of the hood. The hood had been displaced rearward and had crumpled upward along the lateral center line. **Figure 18** depicts the three-dimensional scan of the Dodge.

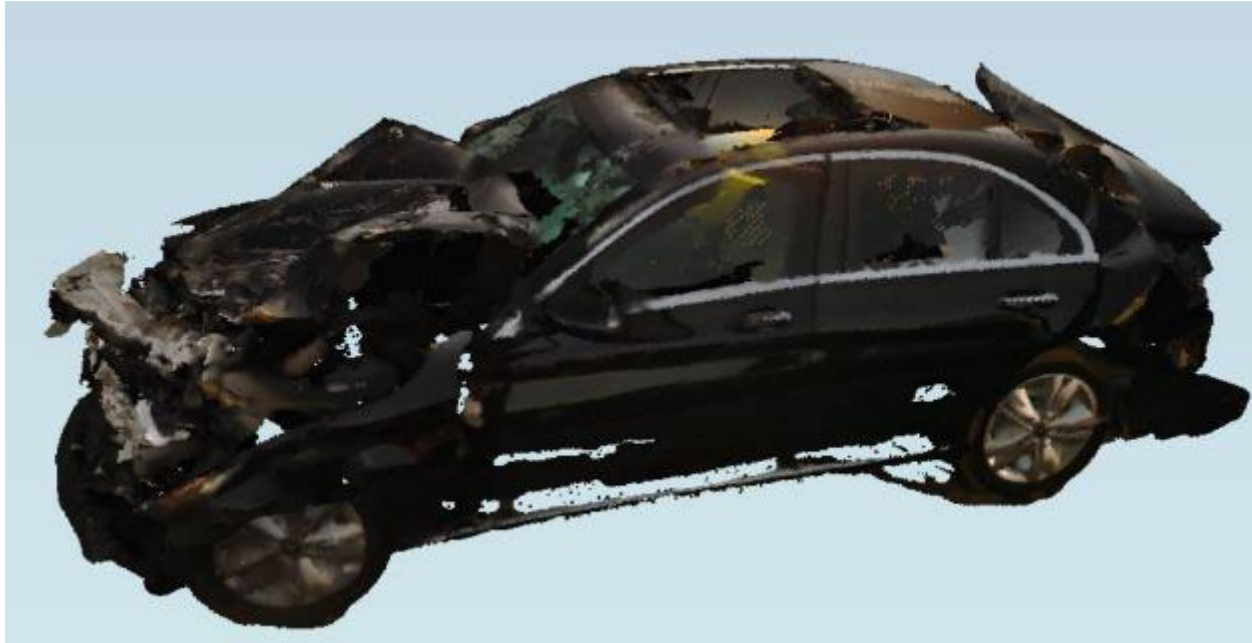
The Mercedes exhibited evidence of contact damage to the front and rear. On the rear of the Mercedes, the bumper cover, bumper, and trunk area were pushed inward towards the passenger compartment. The rear of the trunk lid was pushed inward causing the decklid to be displaced upward. The right quarter-panel, and right rear wheel was pushed forward, and the right-side exhaust was exposed. There was evidence of paint transfer on the rear bumper cover along with the leading edge of the decklid.

The contact damage exhibited on the front of the Mercedes extended the width of the vehicle. The bumper cover, grille, and facia were all missing from the front of the vehicle. The bumper was pushed rearward and upward into the radiator. The hood had been pushed towards the

windshield. The hood displayed severe scrapes and scratches. Scratch evidence extended onto the roofline and both the hood and roofline exhibited evidence of paint transfer.

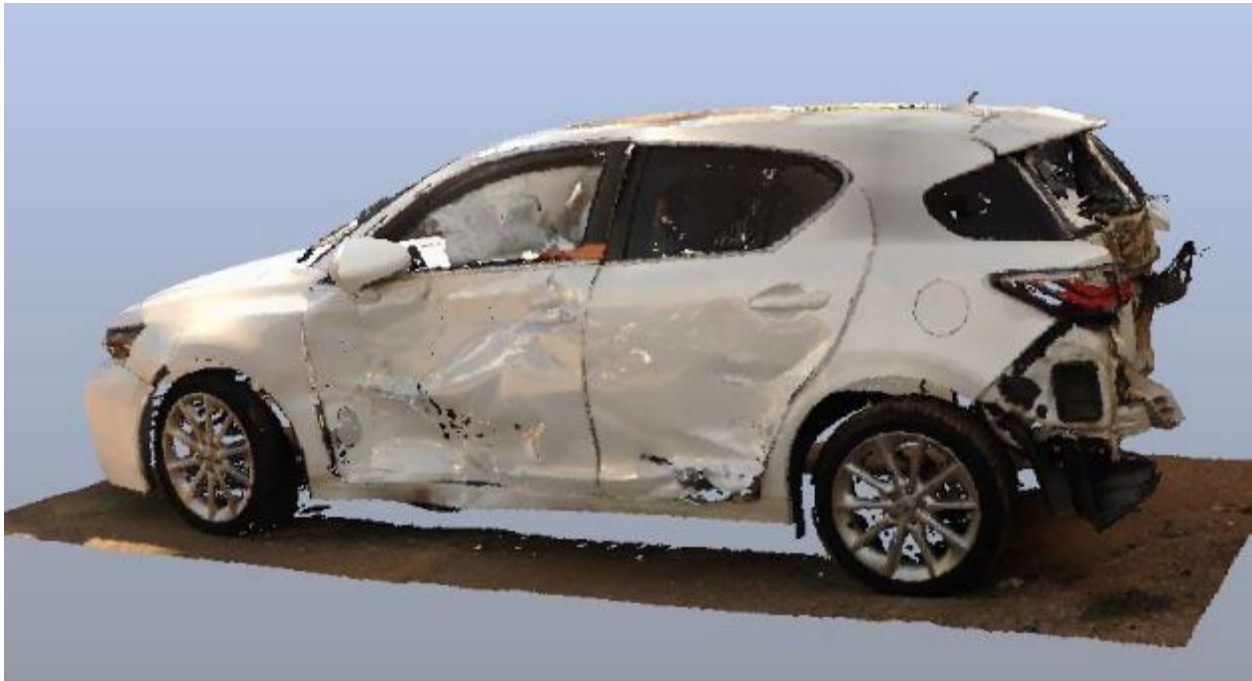
The Lexus exhibited evidence of contact damage on the left side and rear. The driver's door was pushed inwards covering the entire door including the sill. The front of the door had been pulled rearward from the fender. The driver's side passenger door also exhibited evidence of contact damage. In the lower section extending from before the midline of the door to the sill was a large tear in the sheet metal exposing the interior of the door.

The damage to the rear of the Lexus extended the width of the vehicle as well as the height extending from the bottom of the bumper to the bottom of the rear window. The deformation was greater on the right side. The right quarter-panel was deformed forward into contact with the tire.
