**TECHNICAL RECONSTRUCTION GROUP CHAIRMAN'S
FACTUAL REPORT**

HWY14MH012

Location: New Jersey Turnpike (I-95) northbound near Milepost 71.4
Cranbury, Middlesex County, New Jersey

NTSB #: **HWY14MH012**

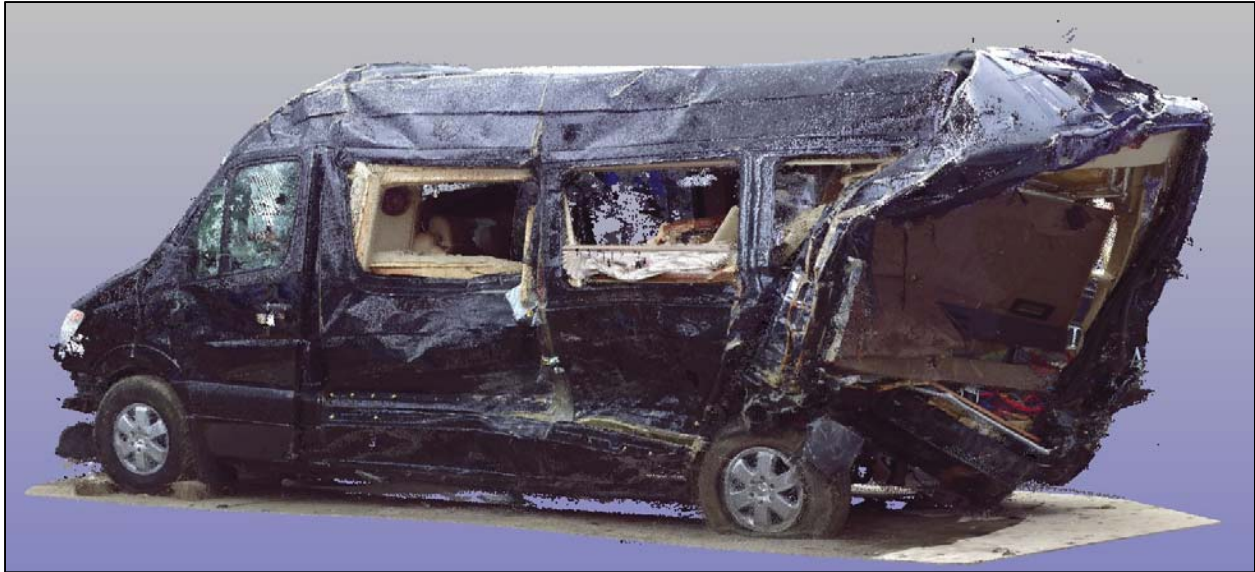
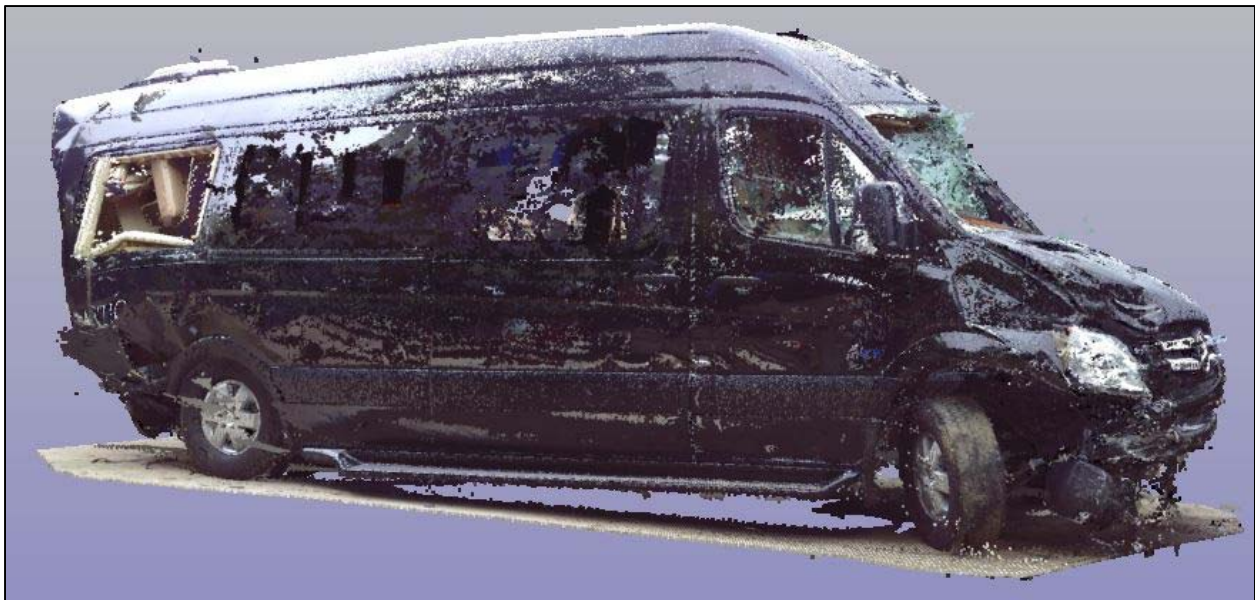
Figure 1: Screen capture of colorized, linked 3D scans of Mercedes-Benz Sprinter from the driver's side.

Figure 2: Screen capture of colorized, linked 3D scans of Mercedes-Benz Sprinter from the passenger's side.

The vehicle exhibited three distinct areas of impact damage that included the rear, left (driver's) side, and right front. The most severe collision damage was observed at the rear of the vehicle where there was substantial forward displacement of the structure, particularly about the left side. The damage extended vertically from the floor pan to the roof line with the greatest forward displacement occurring at the bumper level. In addition to the forward displacement of the structure, the aft end of the vehicle body exhibited a lateral shift toward the left.

Contact damage to the left side was observed in an area between the aft edge of the driver's door (B-pillar) and the rear axle. A distinct area of contact was located about 13 feet rearward of the vehicle front at a vertical height of about 1.8 feet (21–22 inches) above the ground. This area of contact continued rearward to the rear wheel well. Additional evidence of contact damage was observed to extend above this area to a height of about 5.6 feet and to encompass a side window. Paint damage superimposed additional damage on the left front fender and along the roof line.

A third area of impact damage was observed to the right (passenger's) front fender. Evidence of contact extended vertically from bumper height to about 3.6 to 4.8 feet (43–57 inches) above the ground. The area of damage was consistent with the contour of the hood. The damage trailed rearward to the vehicle A-pillar.

Postcollision, the right front wheel exhibited a significant clockwise rotation with tire scuff marks located inside the aft portion of the inner wheel well. The presence of gouges and scraping was observed to the undercarriage forward of the right front wheel.

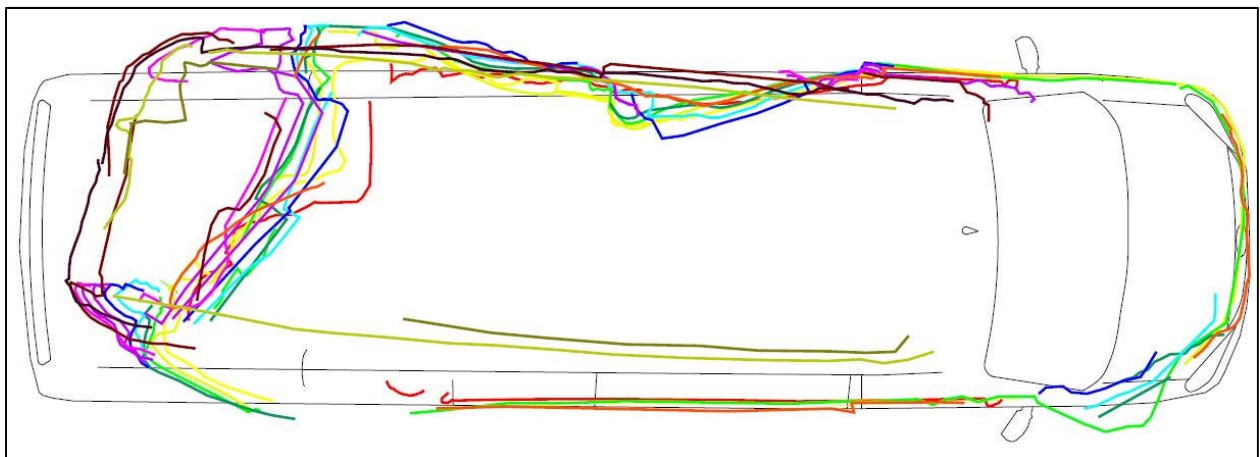
Figure 3: Vehicle body structure displacement depicted in 6-inch vertical increments upward from the axle line.

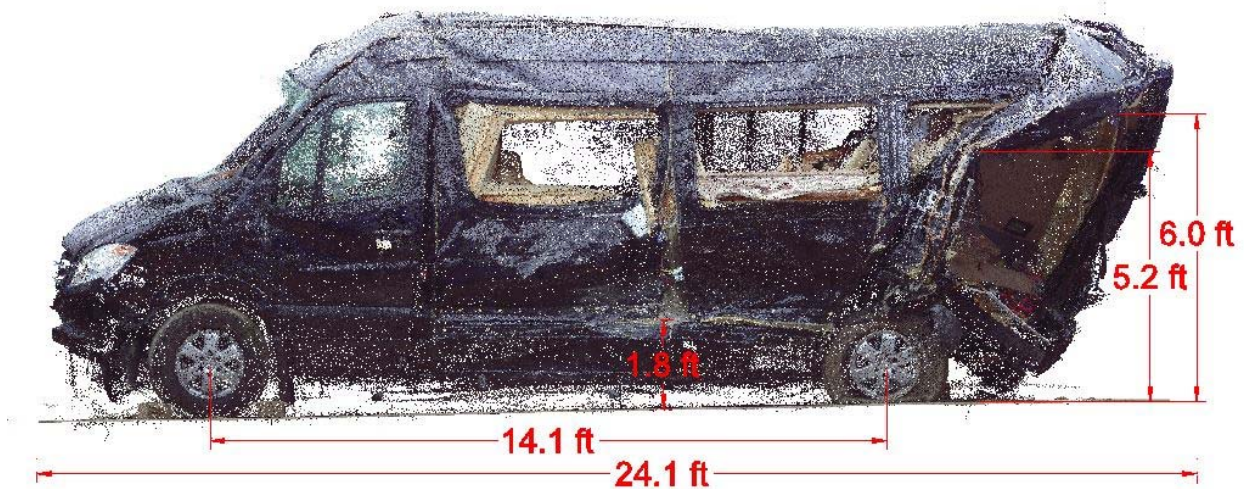
Figure 4: Dimensional information at various points along driver's side of Mercedes-Benz Sprinter.

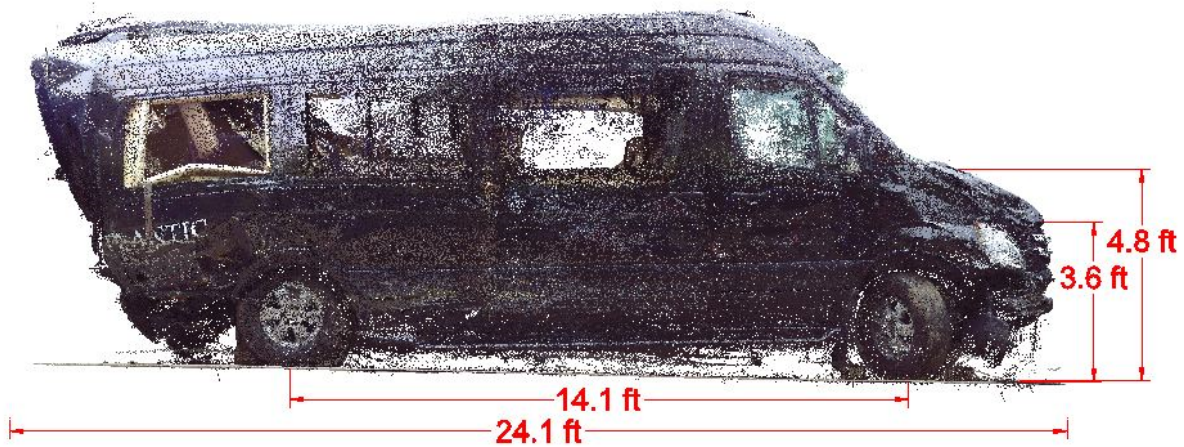
Figure 5: Dimensional information at various points along passenger's side of Mercedes-Benz Sprinter.

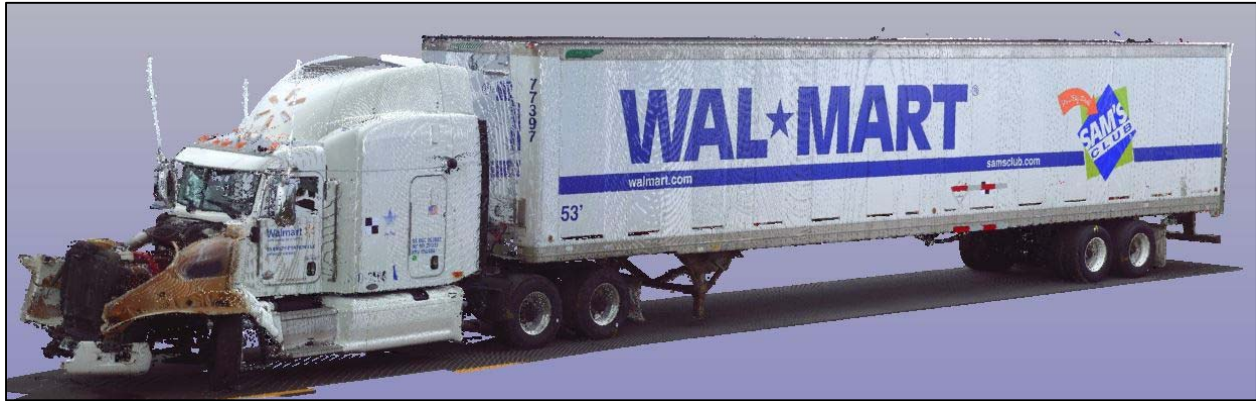
Figure 6: Screen capture of colorized, linked 3D scans of Peterbilt-Great Dane combination along driver's side.

The truck-tractor unit exhibited two distinct areas of impact damage that included the front end and left (driver's) front wheel assembly. With regard to the front end damage, the fiberglass (composite) hood and front bumper cover were displaced from the vehicle. Some leading end structural components, including the front bumper, lower radiator support, and radiator, were displaced rearward at a position approximately centered along the lateral width of the vehicle.

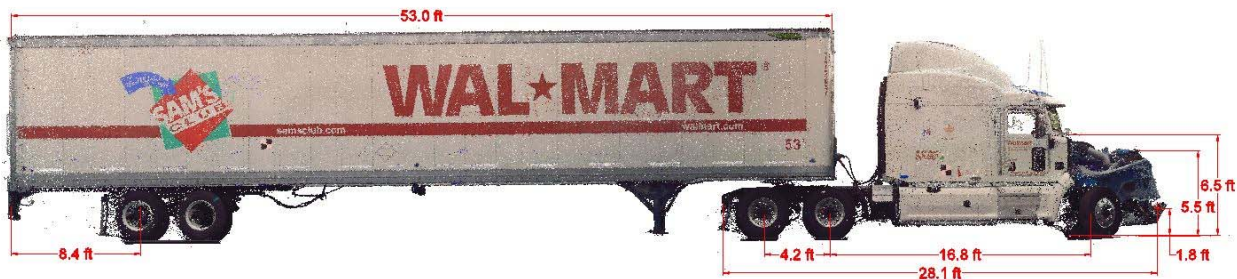
Figure 7: Dimensional information from 3D rendering of the Peterbilt–Great Dane combination vehicle. Dimensions are measured in feet. (Note-colors of the logos applied to the vehicle as shown are inaccurate as a function of how the point cloud colors were interpreted by the CAD software.)

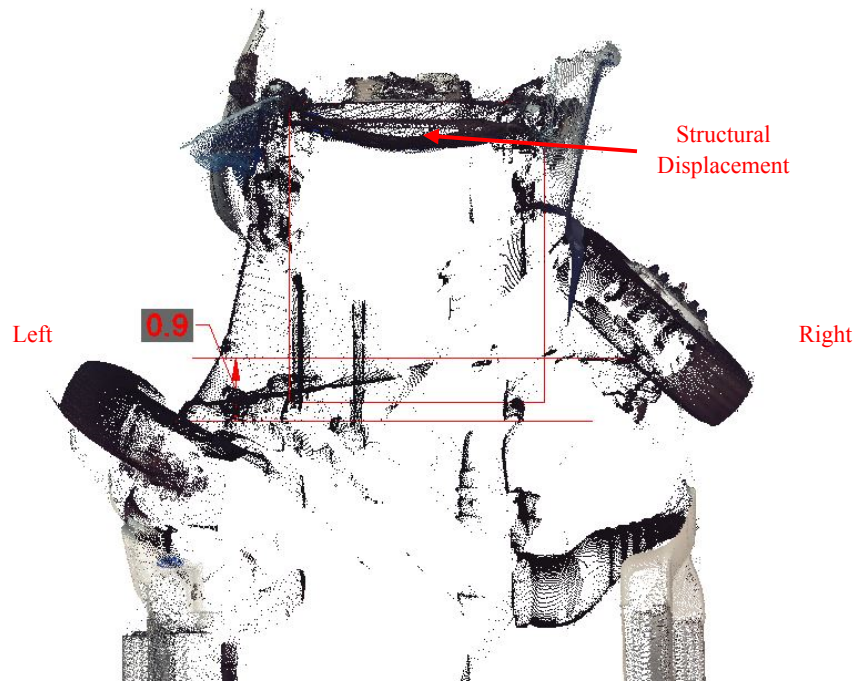
The left front (steer axle) wheel assembly exhibited an excessive leftward (counter-clockwise) orientation in addition to a rearward displacement of about 10–11 inches (0.9 feet).

Figure 8: Depiction of steer axle displacement on driver side of vehicle as portrayed from the 3D scan. Dimensions are measured in feet.

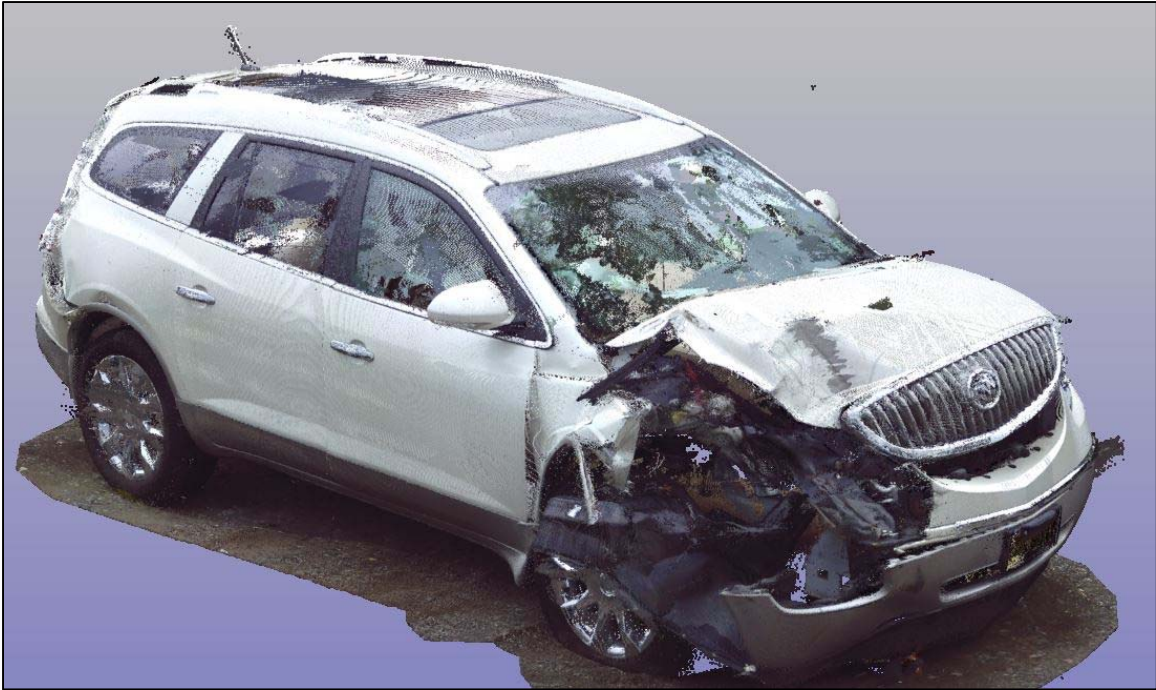
Damage to the right front quarter panel was directed longitudinally rearward from the bumper. The headlamp assembly was displaced from the vehicle while the fender was disfigured and crumpled rearward toward the A-pillar.

Figure 9: Screen capture of colorized, linked 3D scans depicting the right front area of damage on the Buick Enclave.

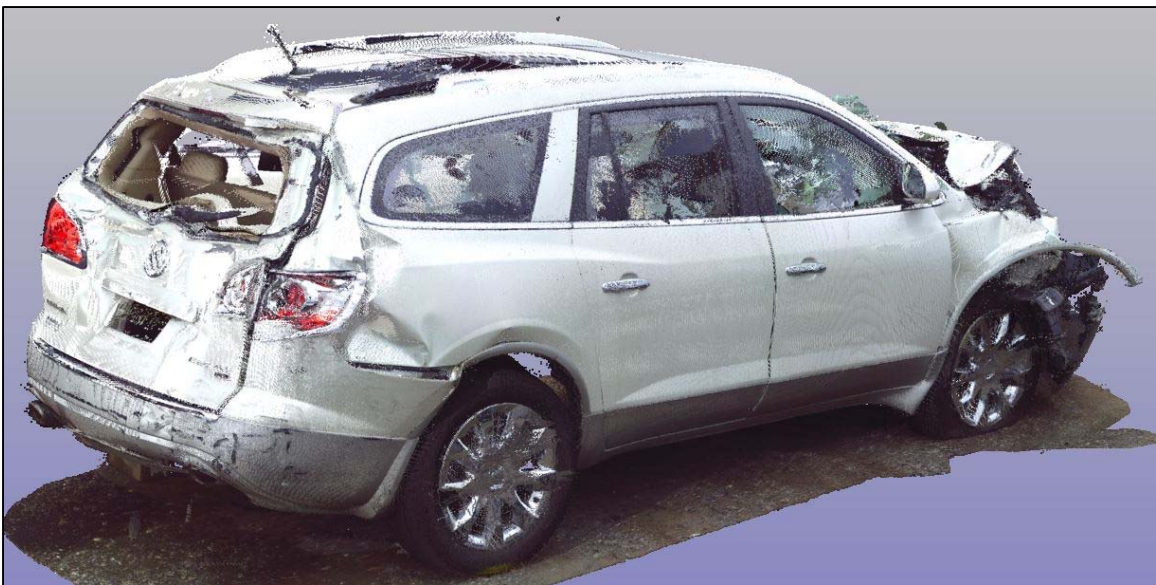
The Buick exhibited two distinct areas of impact damage that encompassed the rear and right front fender. Damage at the rear was more substantial toward the passenger side and extended vertically from the bumper to the roof line over an approximate range of 1.8 to 5.6 feet. The trailing end of the right rear quarter panel exhibited induced damage as the right rear corner of the vehicle was displaced forward. Evidence of contact damage extended laterally to the left of center along the bumper face and mid-level along the rear hatch.

Figure 10: Screen capture of colorized, linked 3D scans depicting the right rear area of damage on the Buick Enclave.

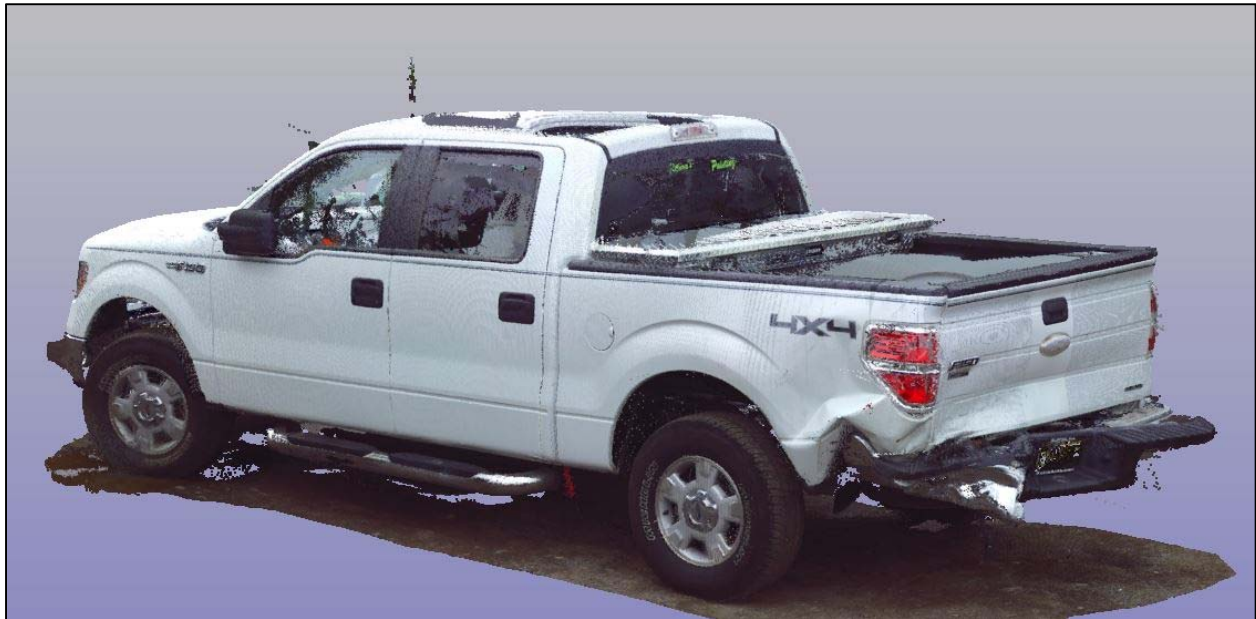
Figure 11: Screen capture of colorized, linked 3D scans depicting the left rear area of damage on the Ford F-150.

The Ford exhibited impact damage to the left rear bumper end and quarter panel. Contact damage at the rear extended upward to a vertical height of about 3 feet (35–36 inches) and inboard from the left side of the vehicle about 1.7 feet (20–21 inches).

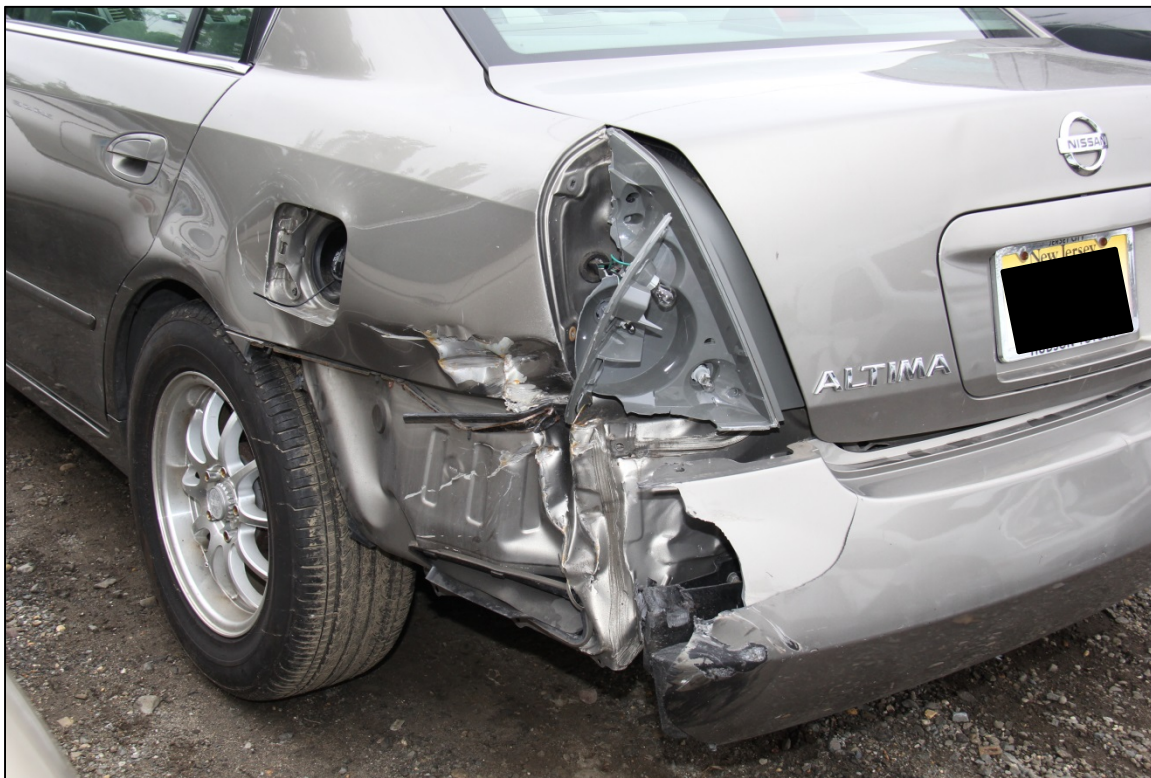
The Nissan was photographed while in storage on June 11, 2014 and is depicted in figure-13. The vehicle was identified as a model year 2005 four-door sedan. Impact damage was observed at the outboard edge of the rear bumper on the left (driver's) side of the vehicle. The tail lamp assembly and fiberglass bumper cover that extended from the wheel well to the bumper corner were displaced from the vehicle. Damage was also observed extending forward along the

quarter panel from the tail lamp assembly opening at about the height of the fuel fill port. The outer fuel fill door was missing and some additional minor damage was observed along the trailing edge of the wheel well lip.

Figure 13: Photograph of Nissan depicting impact damage to the driver's side rear.

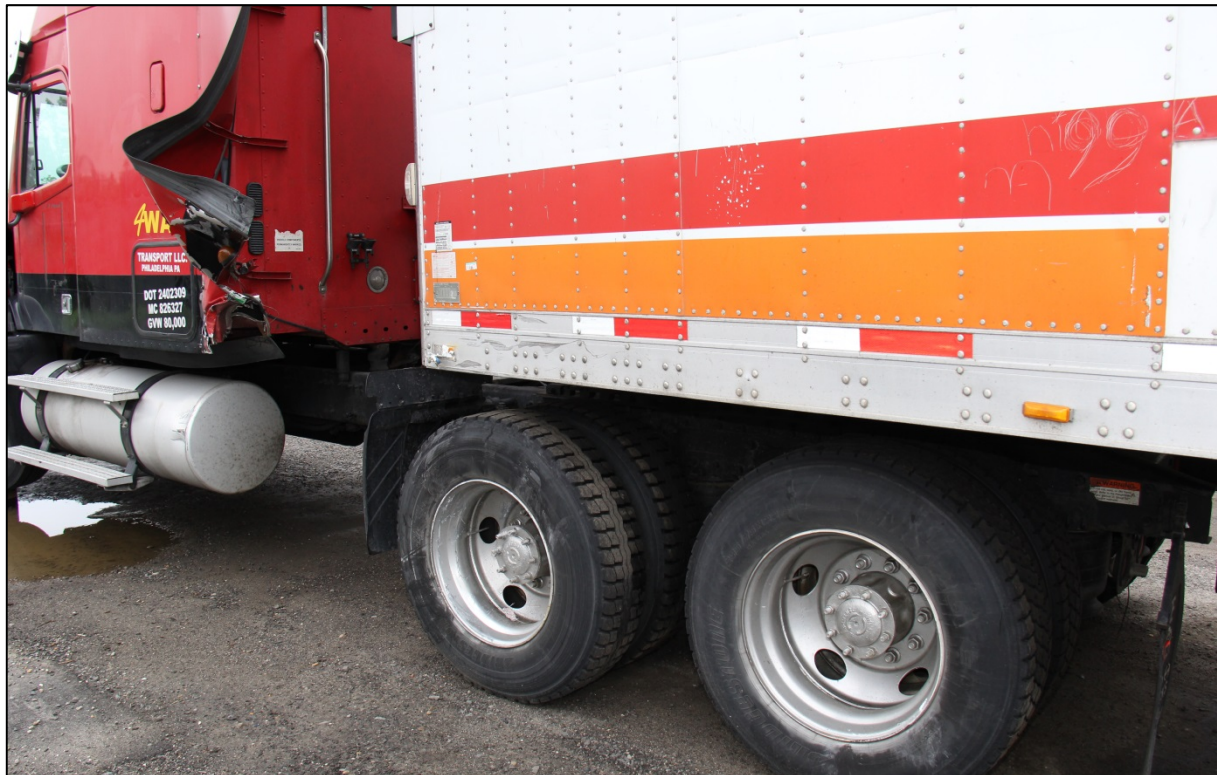
A second combination vehicle involved in the collision sequence was identified as a 2006 Freightliner Century Class CST 120 truck-tractor towing a 2001 Utility VS2RA van body refrigerated trailer. The combination unit was photographed and examined on June 11, 2014. While the vehicle exhibited several areas of damage, the area at the rear of the tractor cab on the left (driver's) side was significant to this collision. Contact evidence and impact damage were located on the left side of the combination beginning around the trailing end of the side fuel tank and continuing rearward to the trailer. Evidence of contact was also observed to the left side tractor drive axle tires and rim flanges. Vertical height of the contact damage ranged from about 2.4 feet (29 inches) at the trailing edge of the fuel tank to about 4.5 feet (50–54 inches) at the rear of the cab. Material transfer and scrapes extended rearward from the leading edge of the trailer rearward for a distance of about 3.3 feet (40 inches). Damage to the trailer extended vertically from the lower edge of the sidewall (~3.8 feet) to about 4.5 feet above the ground.

Figure 15: Photograph of driver's side impact damage to Freightliner-Utility combination.

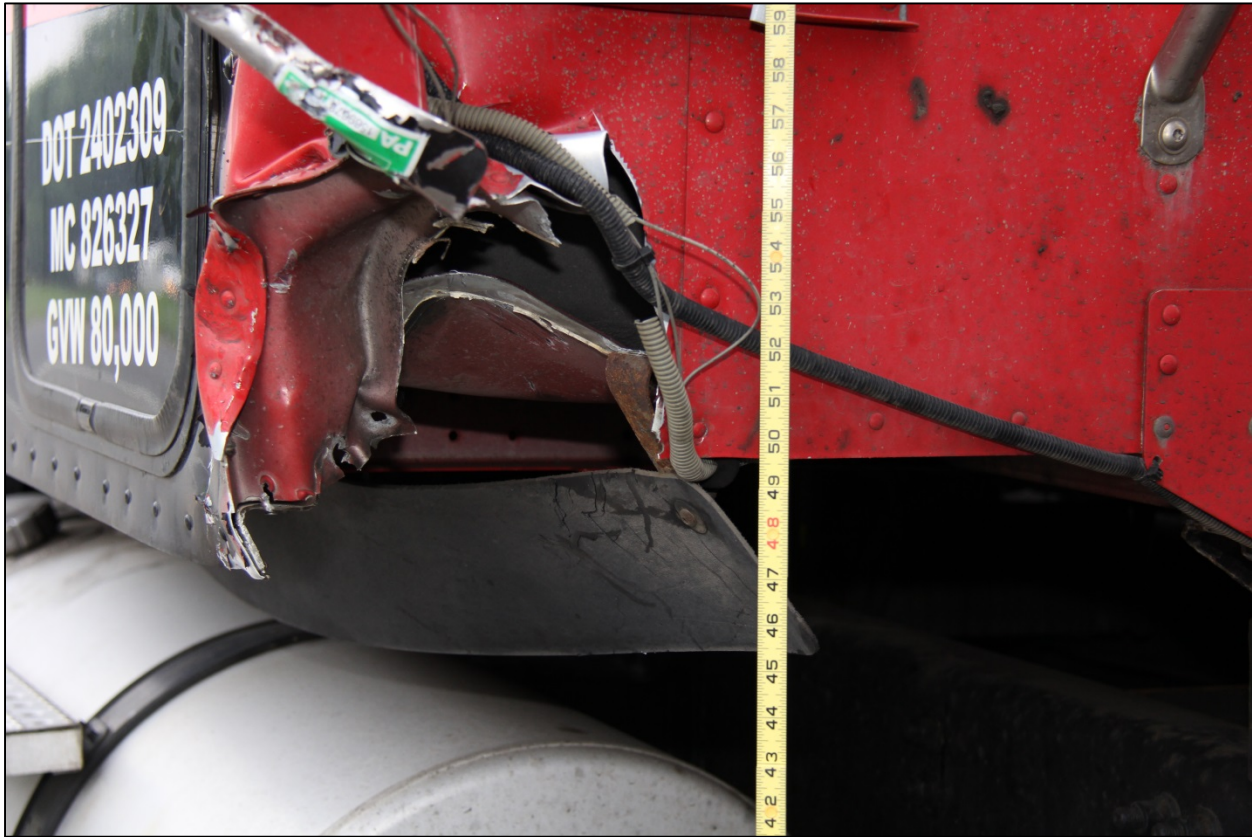
Figure 16: Photograph of Freightliner-Utility combination depicting impact damage on driver's side of vehicle.

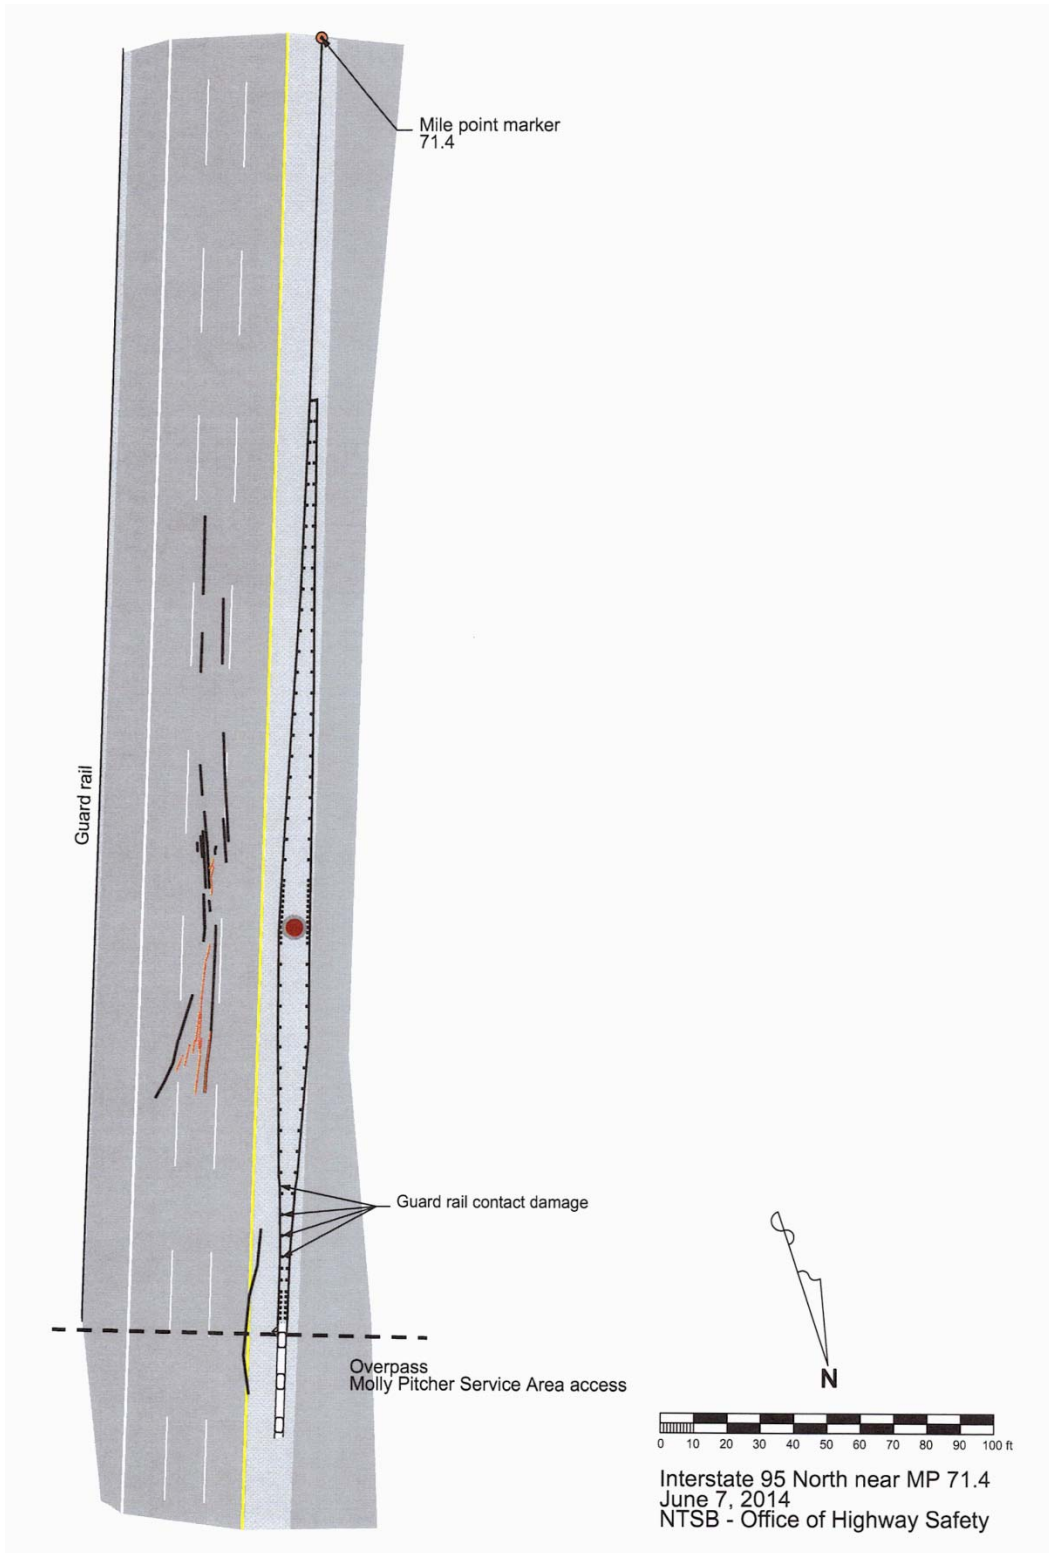
- The area of impact between the Mercedes-Benz and Peterbilt combination was identified by the presence of tire friction marks and road surface gouging located in the center travel lane approximately 239 feet north of mile point 71.4 or approximately 149 feet south of the end of the parapet below the overpass leading to the service area. The tire friction marks exhibited an overlap of linear tire marks and heavy scuff marks. The linear parallel marks (including those characteristic of dual tires) were oriented northwestward and continued into the left lane while the heavy scuff marks exhibited a northward heading within the center lane. Some road surface gouging and scraping were also present with the tire friction marks.

- Tire friction marks along the path of travel for the Peterbilt combination were oriented about 6° relative to the travel lane. Damage to both the Mercedes-Benz and Peterbilt tractor indicated a relative angle of approximately 16° between the two vehicles at impact.

- Extending northward and northwestward from the area of impact, the onset of additional tire friction marks, road surface scrapes and fluid debris was identified. The surface scrapes began about 10 feet south of the evidence at the area of impact and continued about 71 feet northward, terminating about 10 feet south of the position of rest (relative to the approximate center of gravity) for the Mercedes-Benz. Similarly, the heavy (tire) scuff marks extended northward within the center lane and likewise terminated about 10–12 feet before the final rest position of the Mercedes-Benz.

Diagram 1: Site diagram depicting documented roadway evidence.

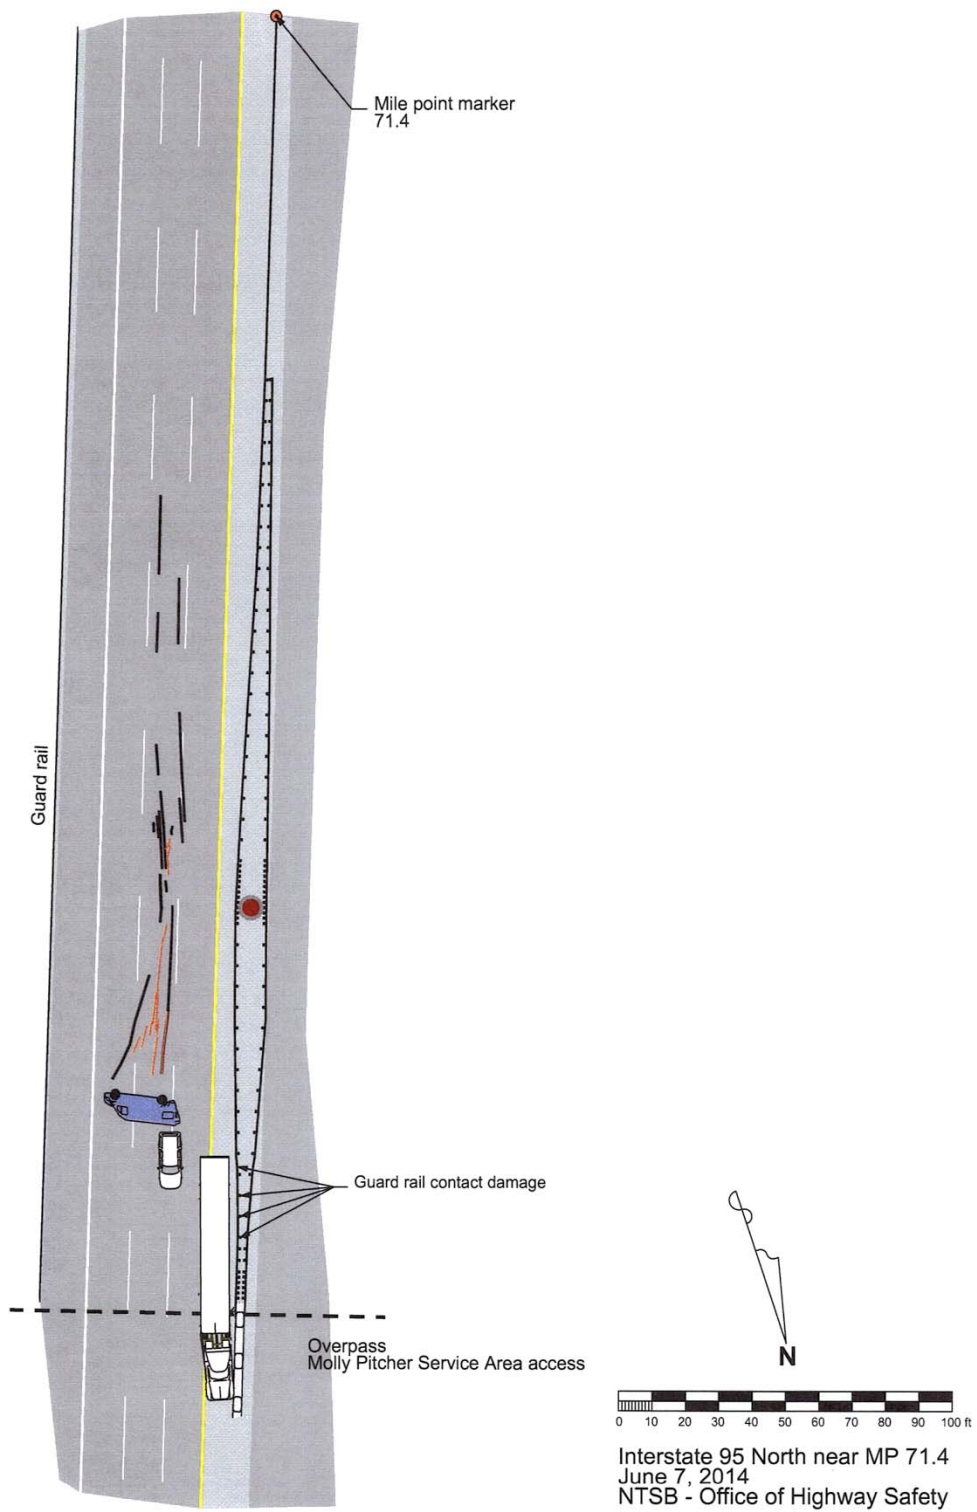
- At final rest, the Mercedes-Benz was overturned onto the driver's side, facing eastward (oriented about 90° to travel lane) approximately 90 feet⁴ north of the area of impact. The vehicle completely occupied the center lane with some overhang by the front into the right lane and slight overhang at the rear into the left lane.

- The Peterbilt combination came to rest approximately 177 feet north of the area of impact (as measured from the front of the tractor) atop the left shoulder. The tractor was located beneath the overpass against the concrete parapet. The vertical face of the

- The final rest position of the Buick Enclave was located approximately 103 feet north of the area of impact (as measured to the approximate center of mass). The vehicle primarily occupied the center travel lane with the driver's side of the vehicle partially in the left lane. At final rest, the vehicle was approximately 10–11 feet north of the Mercedes-Benz.

Diagram 2: Site diagram depicting documented positions of rest for the Mercedes, Buick, and Peterbilt combination.
