**NATIONAL TRANSPORTATION SAFETY BOARD
OFFICE OF HIGHWAY SAFETY
WASHINGTON, D.C.**

**TECHNICAL RECONSTRUCTION GROUP CHAIRMAN'S
FACTUAL REPORT**

Location: State Highway 2 (SH-2), Randolph, Coos County, New Hampshire

NTSB #: **HWY19MH010**

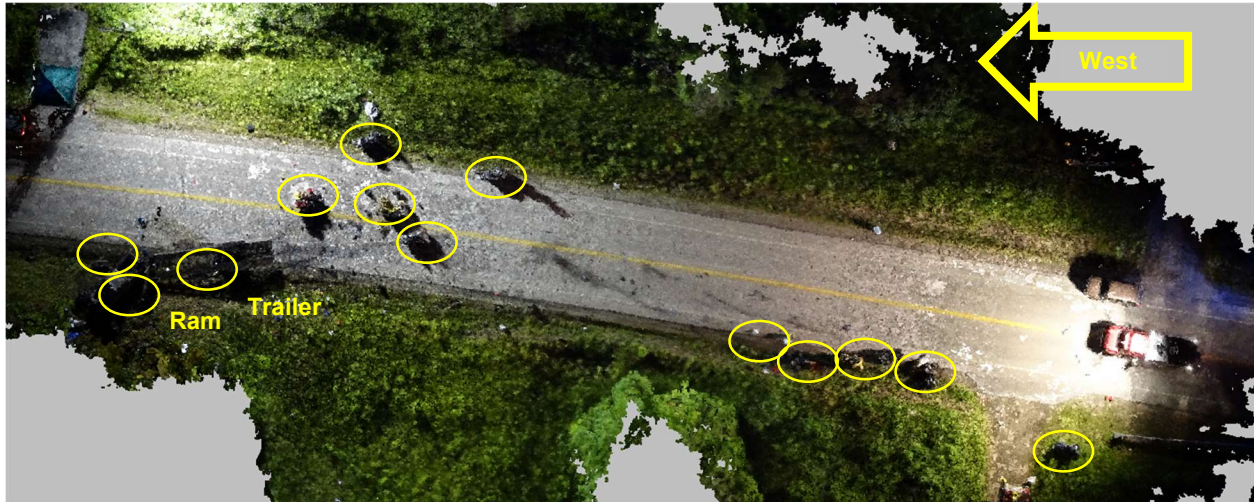
Figure 1: Screen capture of point cloud rendered from nighttime aerial photographs provided by NHSP. Supplemental location lighting was used to illuminate the scene but also created shadows. Motorcycle positions are highlighted for additional clarity.

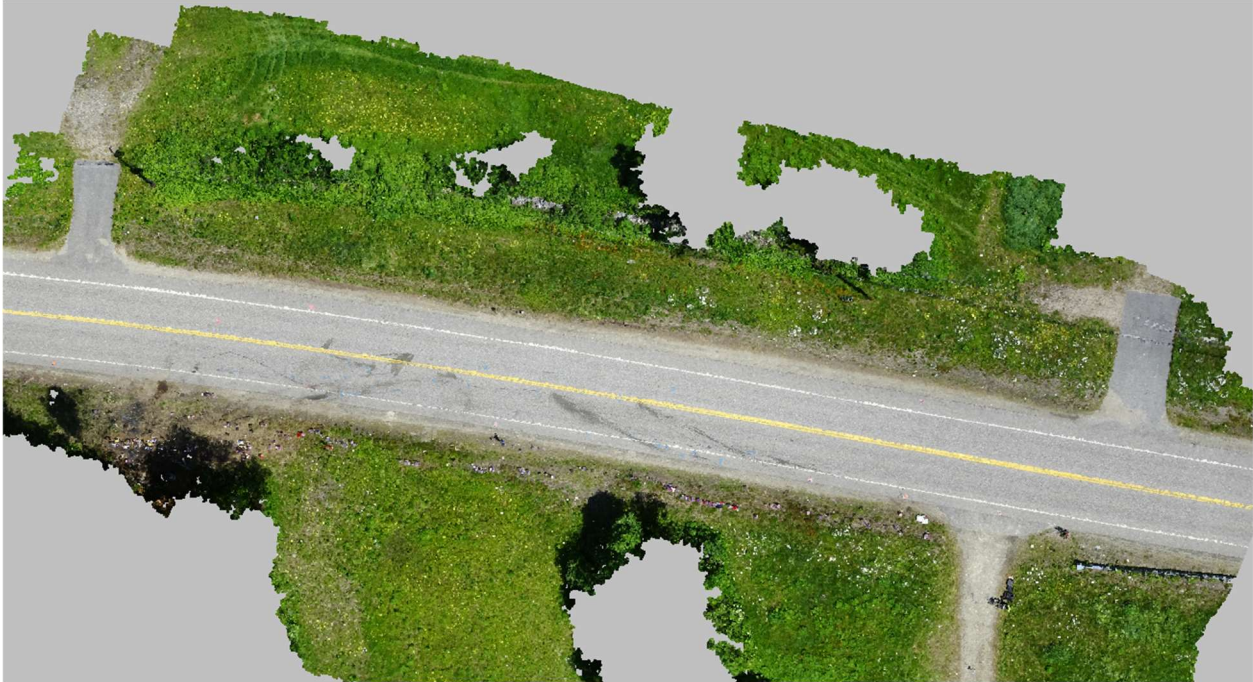
Figure 2: Screen capture of point cloud rendered from daytime aerial photographs provided by NHSP.

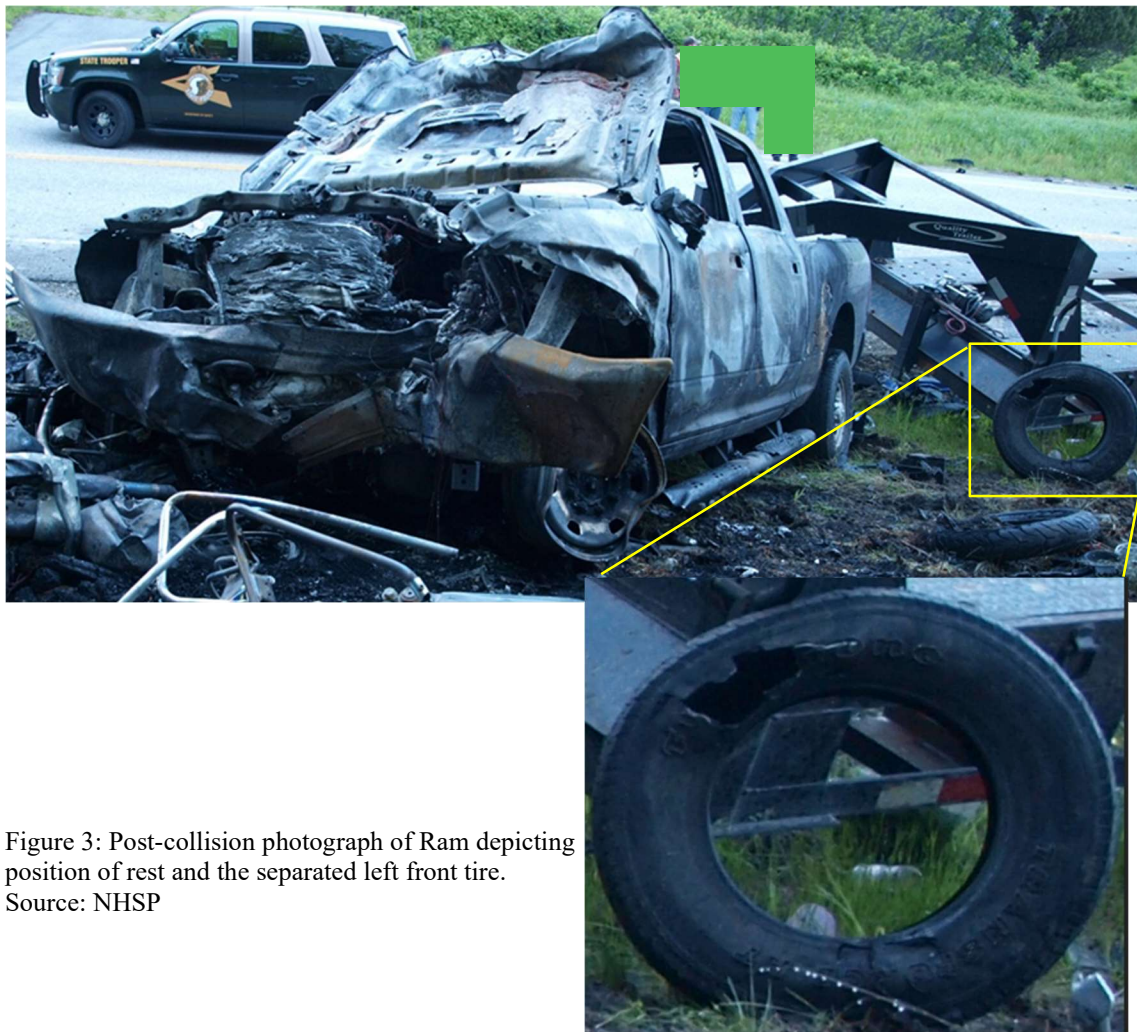
As the Ram departed the pavement it encountered a soil surface and a low embankment that was offset from the pavement about six (6) feet. As the Ram encountered the soil surface, evidence of wheel furrowing and additional counterclockwise rotation of the truck followed. Photographs depict that the left front tire had separated from the rim and came to rest against the left front corner of the trailer. As conveyed in the NTSB Vehicle Factors Group report, post-collision the steering tie rod of the Ram had been displaced from the vehicle. As observed in photographs and depicted in **Figure 3**, the left front tire sidewall exhibited two areas where it been breached. The truck body exhibited evidence of multiple points of direct contact or impact.

Figure 3: Post-collision photograph of Ram depicting position of rest and the separated left front tire.
Source: NHSP

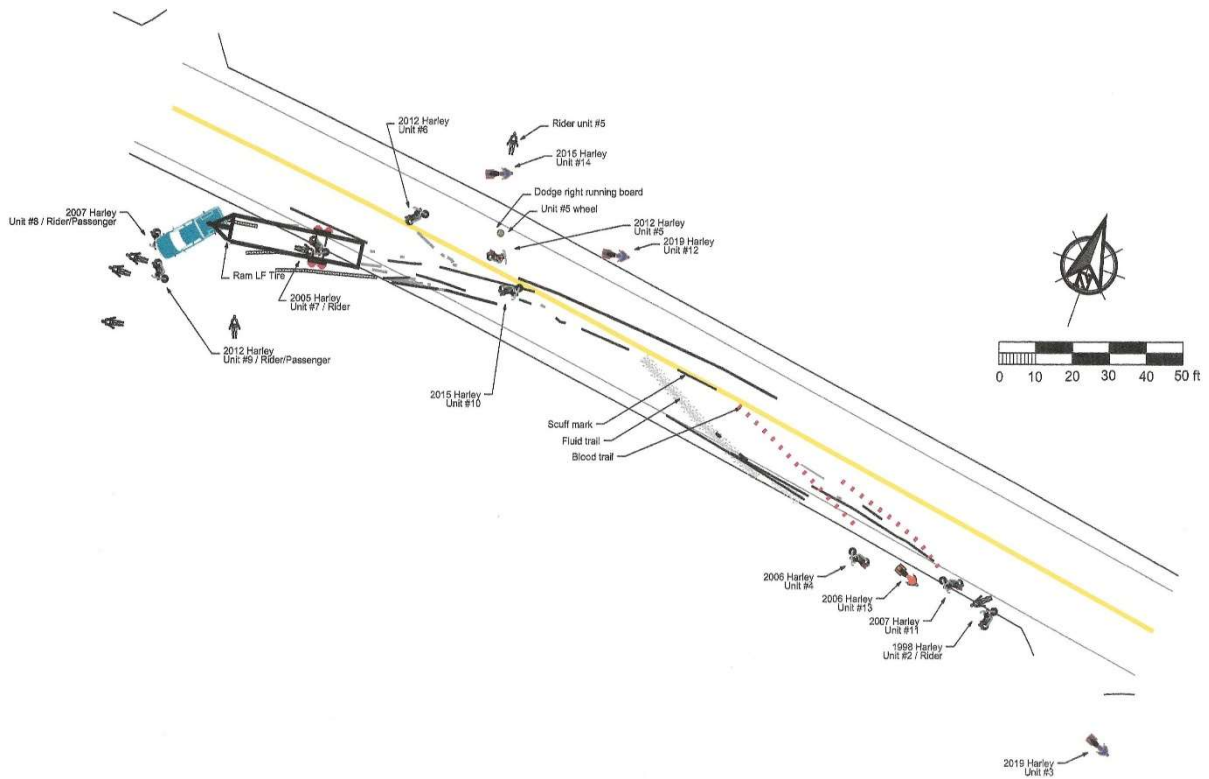
Figure 4 depicts a post-collision scaled diagram based on total station data collected by NHSP investigators. The data appear to represent most of the significant evidence although certain individual marks and vehicle debris were not captured.

Figure 4: Post-collision diagram based on total station documentation data provided by NHSP investigators. (Labeling convention follows vehicle identification in introduction.)
