Technical Reconstruction Group Factual Report

Avenal, CA

HWY21FH003

**TECHNICAL RECONSTRUCTION GROUP CHAIRMAN'S
FACTUAL REPORT**

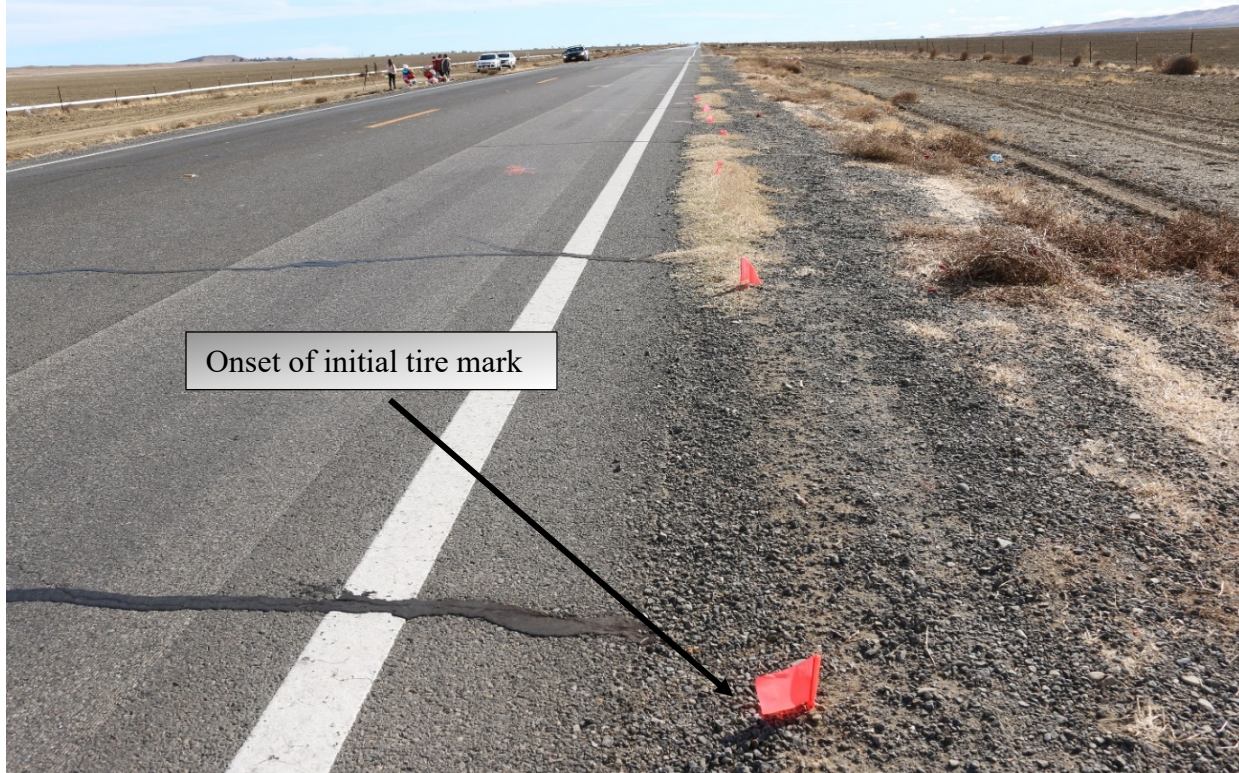
Preceding the collision, the Dodge had been traveling southbound. A single tire mark in the earthen material adjacent the southbound edge of the roadway was discovered approximately 193 feet⁴ north of the area of impact with the Ford. The mark was arcing in a southwesterly direction toward the southbound lane for approximately 81 feet where it transitioned onto the roadway. After entering the roadway, the mark continued in a leftward arc, crossing the southbound lane, leading to the area of impact in the northbound travel lane. Approximately 64 feet south of the first mark, a second tire mark appeared in the earthen material. The second mark arced to the left paralleling the first mark continuing to the area of impact. There were two additional tire friction marks discovered in the southbound lane. Both marks initiated at a vertex and separated as they continued toward the area of impact. Both marks arced to the left, the left mark continued for approximately 77 feet and the right mark for 54 feet. **Figure 4** is a photograph depicting the beginning of the first tire mark. The documentation of the tire mark can be seen in the photograph and is marked by the orange flags.

Figure 4: Southbound view of SR-33. Orange flags depict a tire mark deposited by the Dodge on the unimproved dirt/gravel. (Source: California Highway Patrol)

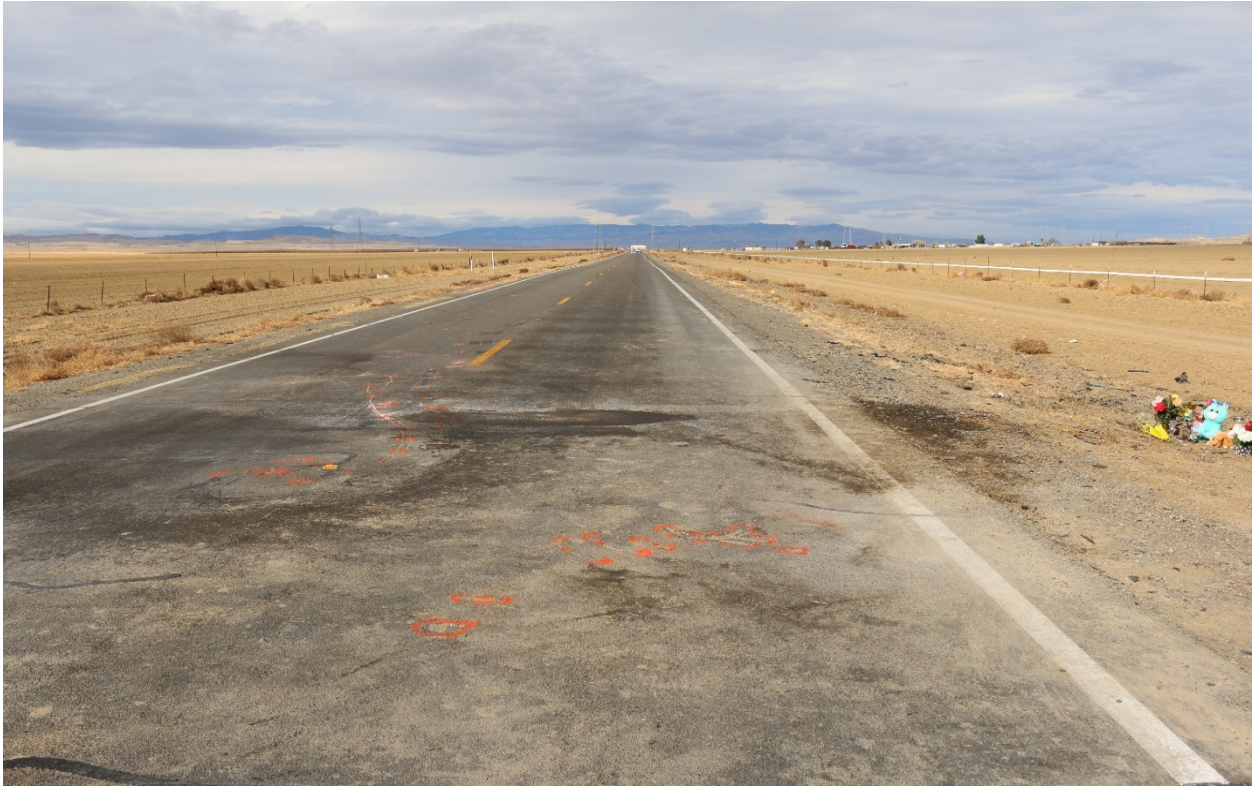
There was a circular fluid spray pattern that rotated counterclockwise a complete 360°. Located within the fluid pattern was multiple scrape marks (metal scars). Located in the “eye” of the fluid spray, offset approximately 2 feet, were two scrape marks that paralleled each other measuring approximately 8 feet in length⁷. The scrapes followed the same circular path as the fluid spray. There were also several other scrape marks located within the “eye” of the fluid that were consistent with the Dodge post impact travel. Additional scrape marks were located approximately 9 feet southeast of the area of impact, in the northbound travel lane. There were three marks that measured approximately 1 foot and were parallel to each other. **Figure 6** depicts the post impact marks deposited by both the Dodge as well as the area of impact in the northbound travel lane.

Figure 5: Northbound view of SR-33 depicting tire marks, fluid debris, scrapes, and gouges in the northbound lane. (Source: California Highway Patrol).

Identified in the northbound travel lane was another area of scrape/gouge marks. The marks were located approximately 12 feet southeast of the previously described marks and 7 feet from center lane line. Also located in the scrape marks was a small area of fluid spray.

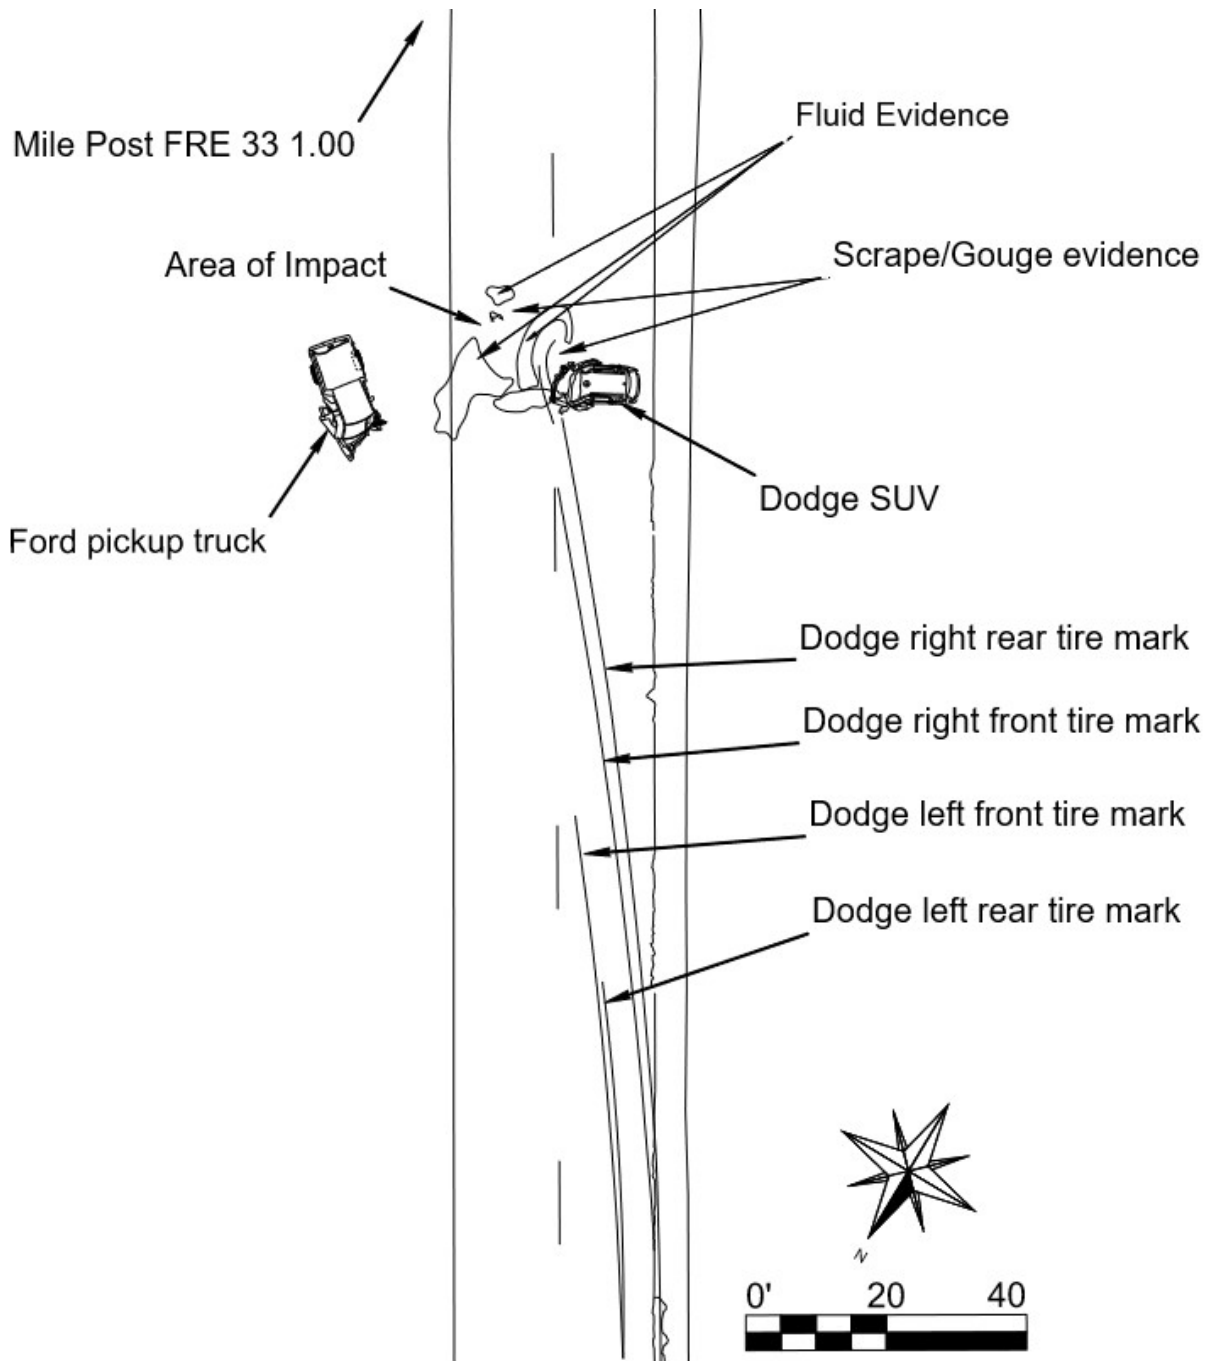
The Dodge came to rest nearest the area of impact. It had traveled approximately 14 feet to the northwest. It came to rest across the southbound travel lane facing in a northeasterly direction.

The Ford departed the roadway approximately 6 feet from the area of impact. At final rest the Ford was located off the roadway, adjacent the northbound lane, oriented northwesterly about 27 feet⁸ northeast of the area of impact.

As a result of the collision various components were displaced from the Dodge and Ford. The more substantial components included the left front wheel assembly and spare tire from the Ford. The left front wheel assembly was located to the northeast of the Ford final rest. The spare tire was located south of the final rest.

Figure 6: Diagram depicting post-collision positions of final rest for the Dodge SUV and Ford pickup truck. Also shown is the pre-collision and post-collision physical evidence marks.

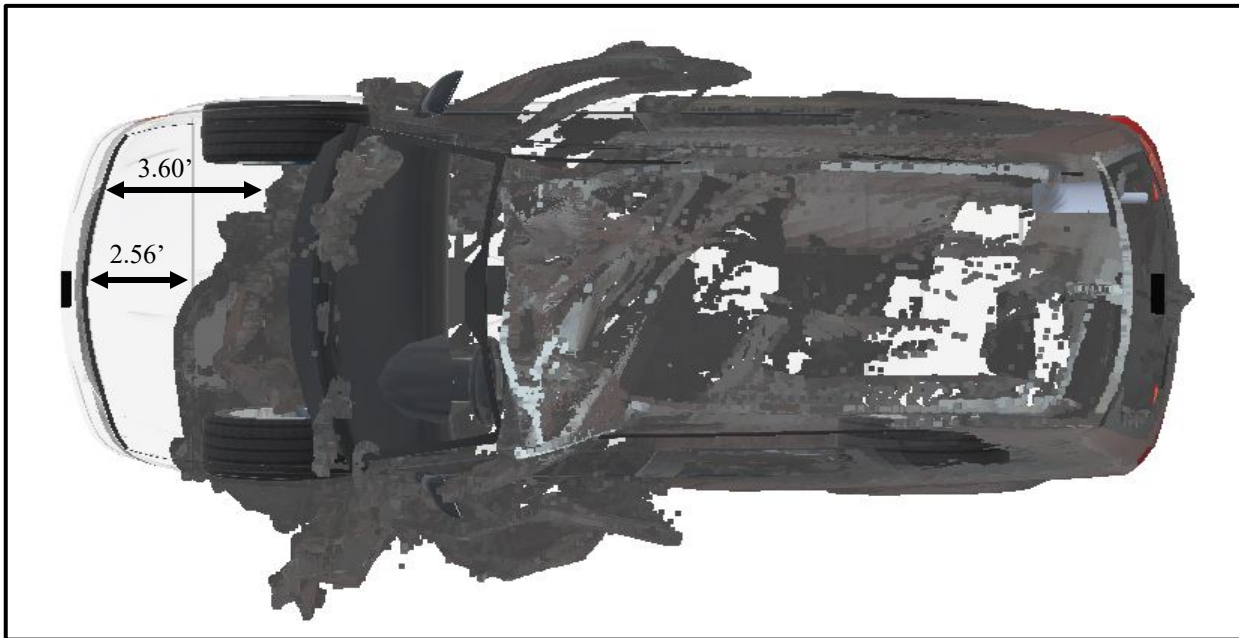
Figure 7: Overhead view of the 3D scan image of Dodge Journey overlaid on an exemplar vehicle. Measurements represent extent of crush damage and are for reference only. (Scan image source: California Highway Patrol).

At its position of final rest, the Dodge remained upright across the southbound travel lane. Overall, the vehicle exhibited impact evidence at the front which traveled up to the roof. The right-front (passenger side) had been pushed back to the front firewall. The right front tire was turned left with the top pushed inwards towards the engine compartment. The front bumper was pushed inwards and upwards along with other engine components. Both front roof support structures, and, “A” pillars, were bent down and inwards towards the passenger compartment. The front roofline was bent back and up. There was scraping to the paint on the right front fender, that had been pushed inwards against the firewall. Scrapes in the paint was also evidenced on both the “A” pillars as well as the roofline. The dashboard and steering column had been pushed downward and in towards the driver and front passenger seat. The back of the driver’s seat had shifted to the right toward the passenger seat because of the collision forces. The top of the dashboard, steering wheel, and the driver’s seatback had evidence of fire damage. There was also fire evidence along the front edge of the roofline. It was noted that oil and other fluids were on the ground underneath the engine. The tires mounted on the Dodge were Doral SDL 65A in size 215/55/R17. The original

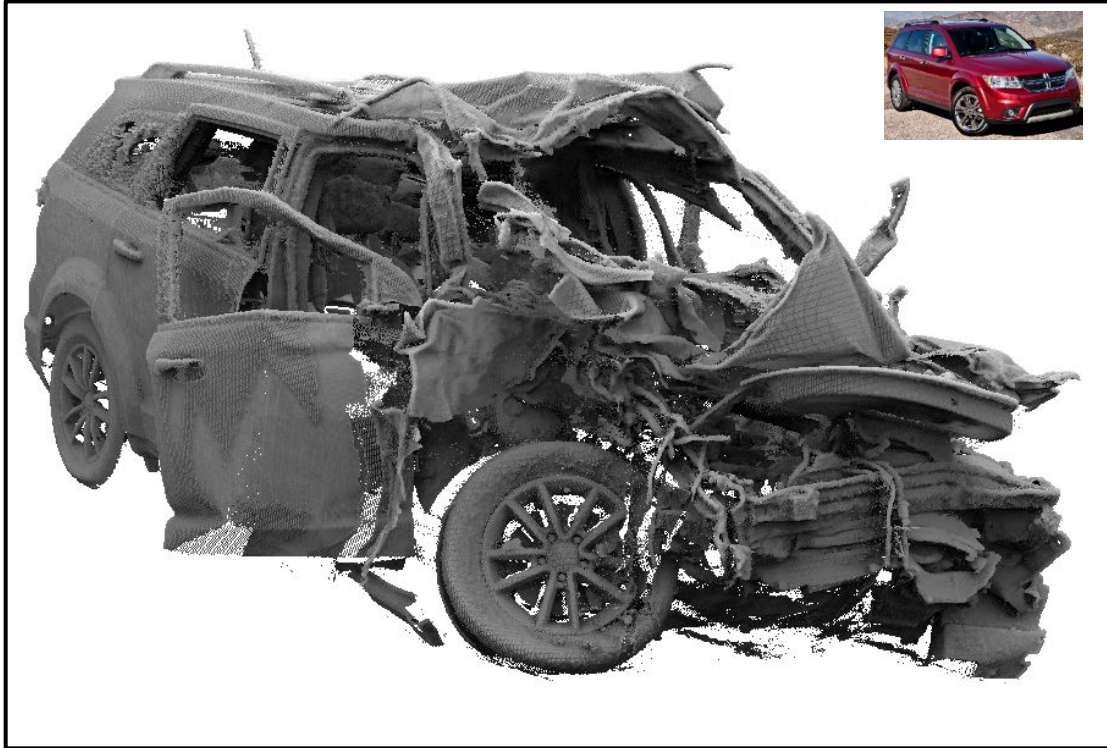
Figure 8: 3D scan image of the Dodge Journey depicting damage to front and right passenger side of the vehicle. An inset photo is included in the upper right-hand corner of the figure depicting an undamaged Dodge Journey. (Source: California Highway Patrol).

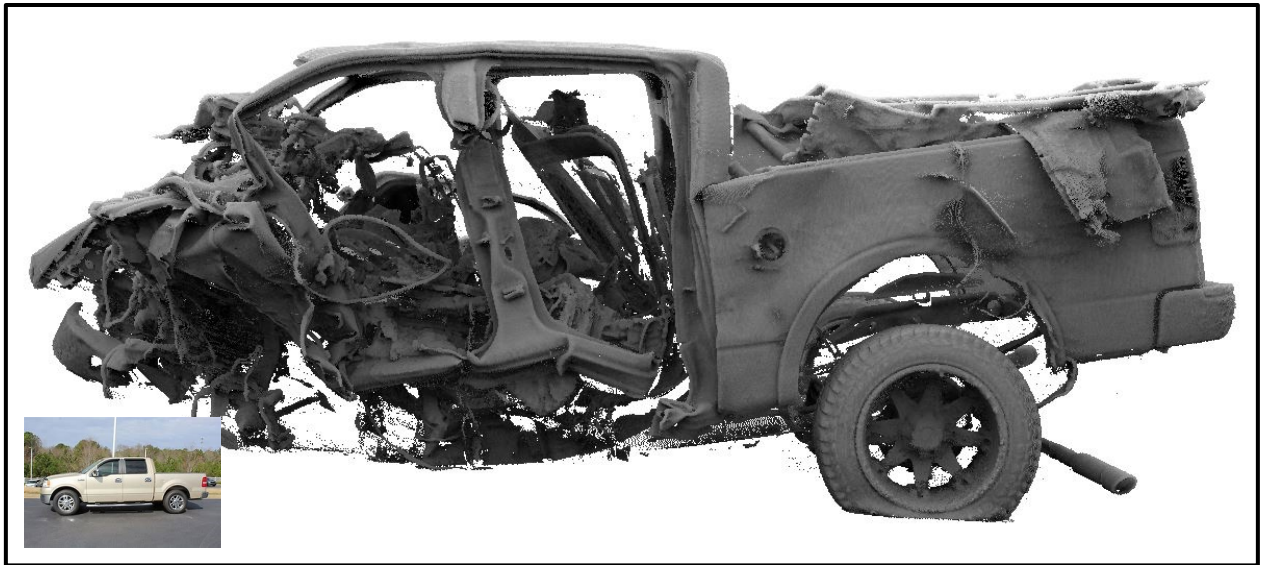
Figure 9: 3D scan image of the Ford pickup truck depicting damage to left side of the vehicle. An inset photo is included in the lower left-hand corner of the figure depicting an undamaged Ford. (Source: California Highway Patrol).

At its position of final rest, the Ford was upright, off the northbound side of the roadway. Overall, the Ford exhibited impact damage to the front, left (drivers) side and undercarriage.

The Ford had been completely burned. The front fascia parts of the Ford were torn from the frame. The front bumper was bent back towards the engine and downwards. The engine was displaced rearward and downward. The engine displacement caused the passenger compartment floor pan to deform upwards. The left front tire and wheel had been torn from the Ford and the left fender was torn back towards the firewall. The right fender was intact, however had been pushed outward from the Ford. The right front wheel was turned left with the bottom bent upwards under the undercarriage. The left side of the firewall and support for the “A” pillar had been pushed backwards towards the “B” pillar. The left side rocker panel was buckled and pushed upwards. The Ford bed was displaced from the frame and the distance between wheel well and tire was increased. It had sustained severe overall fire damage because of the collision.

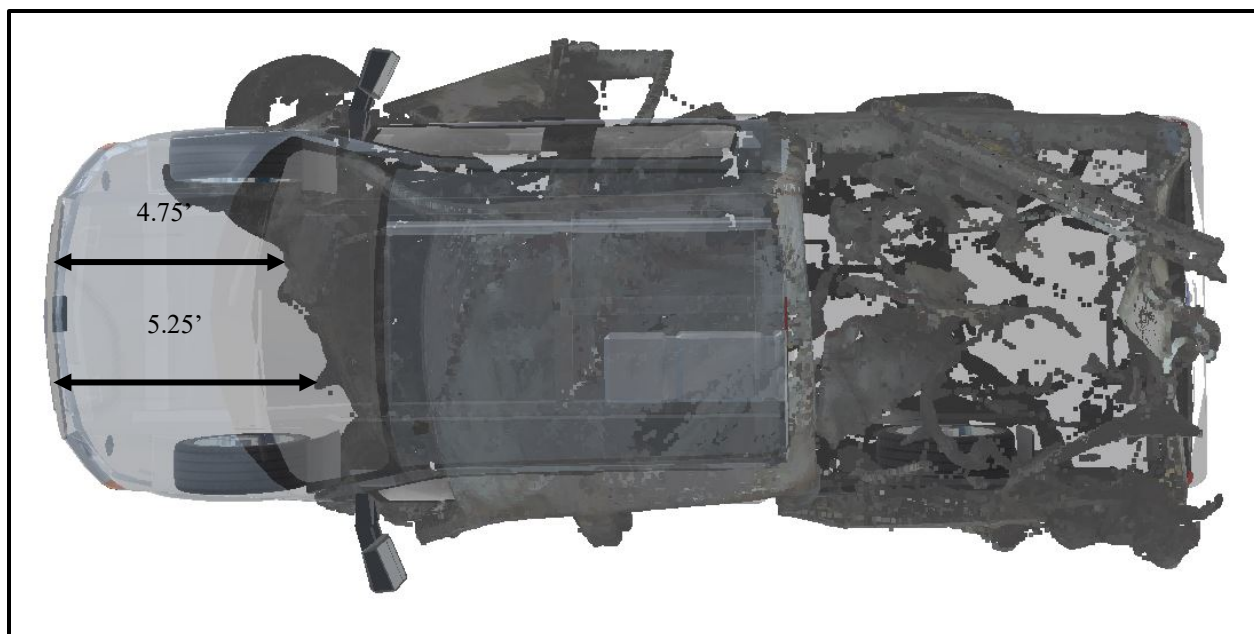
Figure 10: Overhead view of the 3D scan image of Ford pickup truck overlaid on an exemplar vehicle. Measurements represent extent of crush damage and are for reference only. (Scan image source: California Highway Patrol).

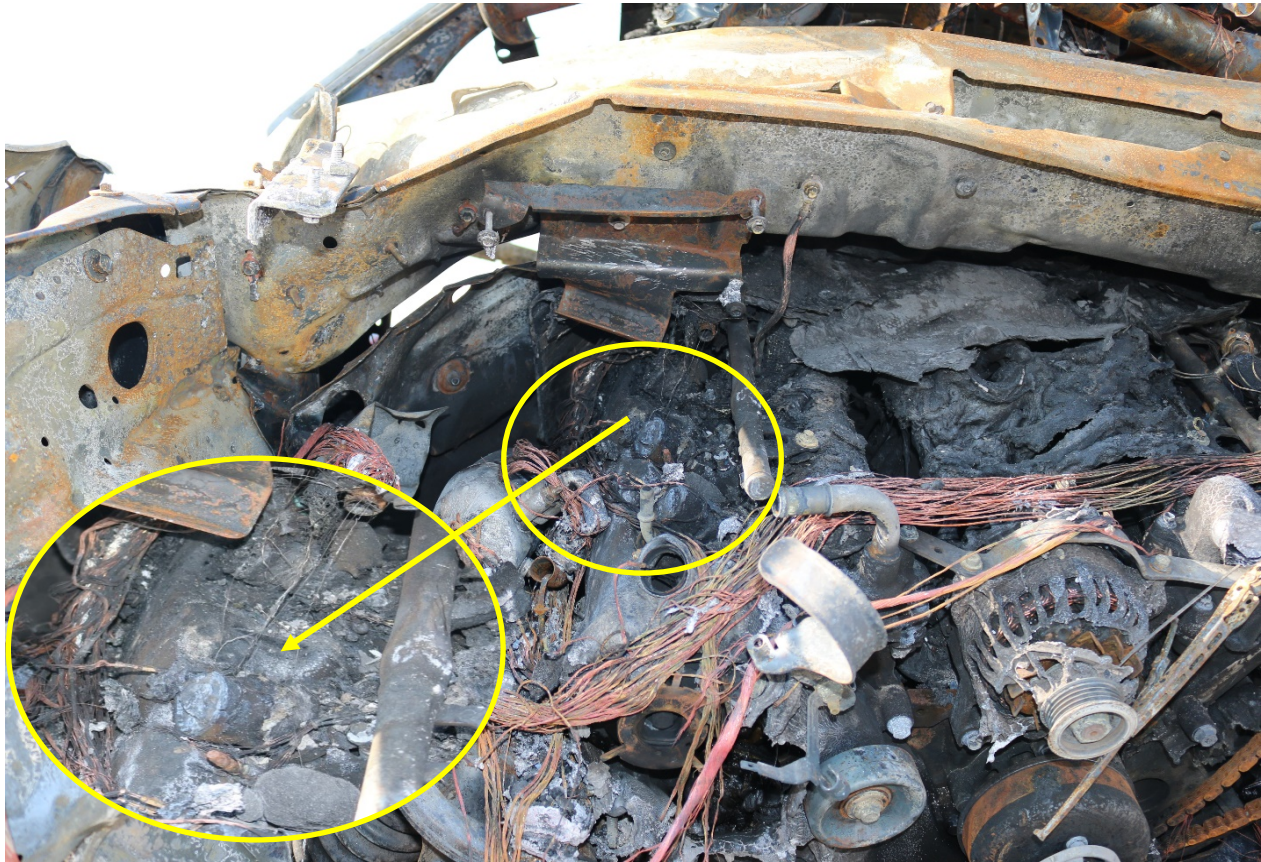
Figure 11: Image of engine compartment of Ford pickup truck. There is a zoomed window focusing on the PCM of the Ford. (Source: California Highway Patrol).

The PCM in the Ford was destroyed due to the fire caused by the collision damage. **Figure 11** shows the location of the PCM, the zoom window displays the damage extent of the PCM. Because of the extensive damage to the Ford PCM the data that the EDR would have recorded was not able to be imaged from the module.

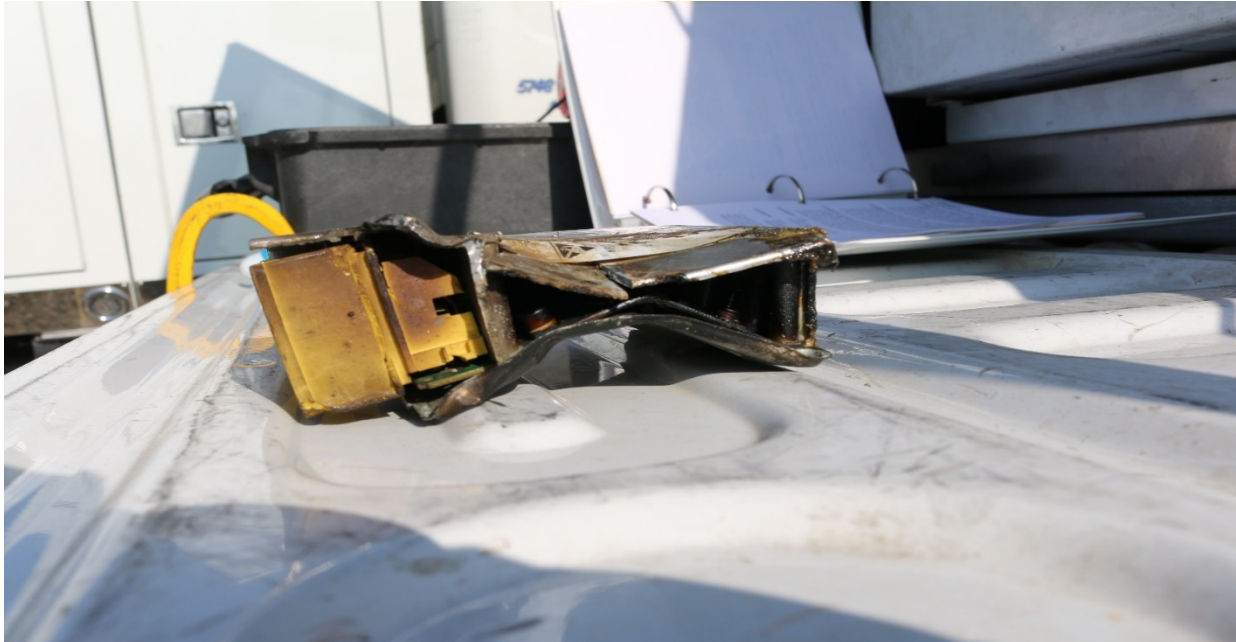
The EDR for the Dodge was in the ACM. For this vehicle the ACM was in the center tunnel. The module was removed from the vehicle by CHP. When the ACM was removed it was discovered that it had sustained significant damage as a result of the collision. The CHP investigators attempted an image of the ACM utilizing the Bosch Crash Data Retrieval tool version 21.0. During the imaging process an error message was received stating “Collect Data Failed!”. The error message is often likely the result of lack of communication between the software and the module. In this case it is apparent that the lack of communication between the software and the module was due to the damage sustained from the collision event. **Figure 12** shows the damage to the Dodge ACM.

Figure 12: Image of damaged ACM that had been removed from the Dodge Journey. (Source: California Highway Patrol).
