**NATIONAL TRANSPORTATION SAFETY BOARD
OFFICE OF HIGHWAY SAFETY
WASHINGTON, D.C.**

**TECHNICAL RECONSTRUCTION GROUP CHAIRMAN'S
FACTUAL REPORT**

Location: Interstate 70/76 (I-70/76) Pennsylvania Turnpike at mile-post marker 86.1 westbound, Mount Pleasant Township, in Westmoreland County, Pennsylvania

Date: January 5, 2020
Time: Approximately 3:30 a.m. local time
NTSB #: **HWY20MH002**

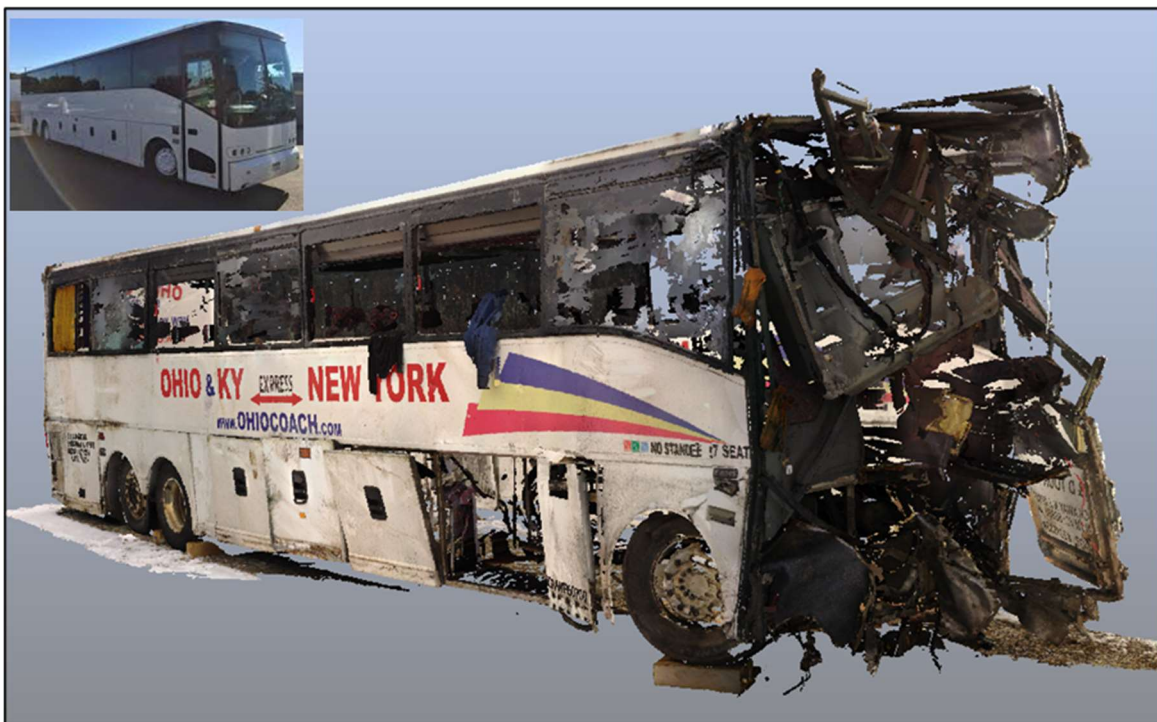
While not easily accessible for viewing while the motorcoach was upright, an area of impact was observed to the undercarriage just rearward of the right front wheel. The impact forced a portion of the undercarriage sheeting upward toward passenger compartment and there was some tearing of the frame tubing. The damage appeared to affect a single undercarriage panel within the undercarriage framing and the displaced panel only intruded into the cargo bay. There appeared to be some scarring but no damage to axle positioning components. Some of the rearward front axle-positioning components on the right side also exhibited deposits of dirt and grass. The orientation of the debris deposits appeared to be front to rear.

The right exterior sidewall of the vehicle exhibited some scraping to the painted surfaces. The scrapes generally appeared light or superficial although some heavier scrapes were observed about the cargo bay doors. Overlapping scrapes oriented diagonally and vertically were noted.

Figure 7: Screen capture depicting the vehicle’s right side and front as viewed in the point cloud rendered from the three-dimensional scans through the FARO Scene software. An image of an undamaged c2045 motorcoach is depicted in the upper left corner.

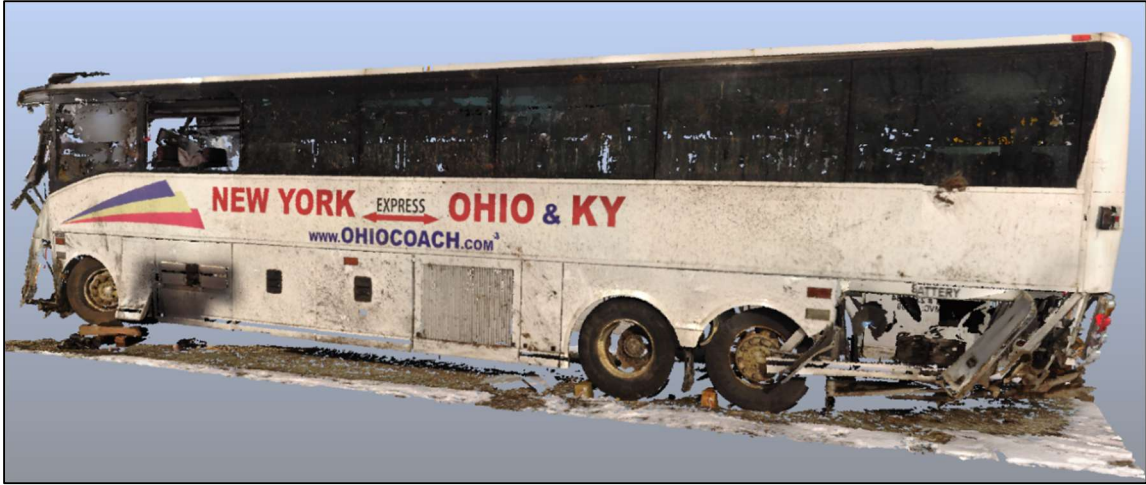
Regarding the left front lower sidewall panel, forward of the left front tire, dirt and grass deposits were observed embedded in trailing edges such that the debris were deposited in a rear to front direction.

Figure 8: Screen capture depicting the vehicle’s left side as viewed in the point cloud rendered from the three-dimensional scans through the FARO Scene software.

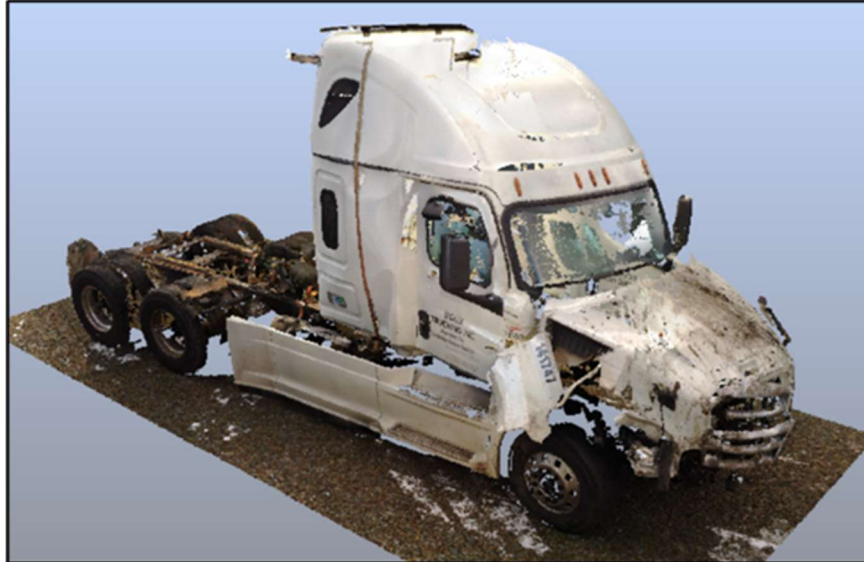
The truck-tractor exhibited frontal impact damage with greater damage observed to the hood and fender on the right side. The cab was no longer in line with the frame and appeared skewed toward the left at the rear. The fifth wheel coupler was a sliding type that allowed the coupler to be repositioned longitudinally along the tractor frame rails. Post collision, the entire coupler assembly had separated from the frame mounted rack and was displaced forward toward the rear of the cab. The coupler was observed wedged between the frame rails. Separation of the coupler from tractor frame appears to have released the trailer king pin, which remained intact, apparently undamaged, and securely attached to the trailer.

Figure 9: Screen capture depicting the tractor’s right side as viewed in the point cloud rendered from the three-dimensional scans through the FARO Scene software.

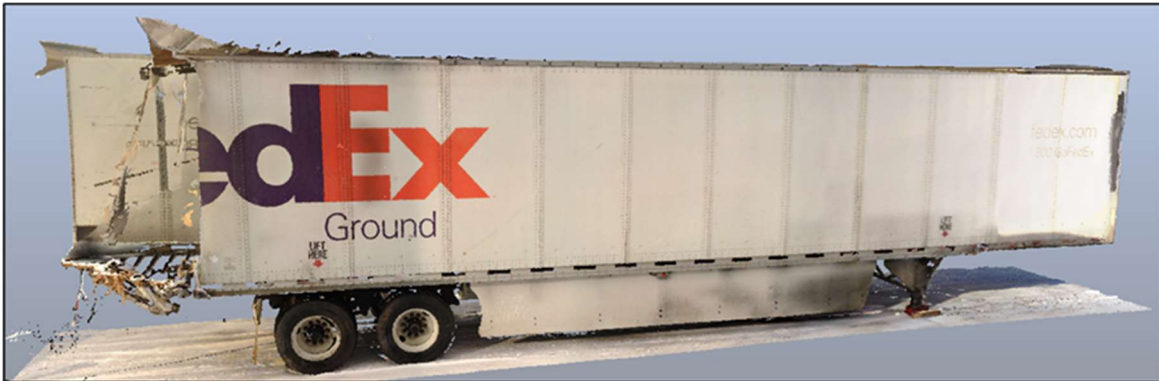
The semitrailer exhibited significant impact damage at the rear. When examined at the storage facility the steel structure that framed the trailer rear and included the roll-up door components and rear impact protection (underride guard) had been separated from the body. Scene photographs depicted this structure as having experienced significant impact deformation toward the right half causing most of the structure to separate from the trailer and hang precariously from the vehicle. The structure, which was likely removed for recovery transport, was examined while stored on a flatbed trailer at the storage facility.

Impact to the rear of the trailer was offset toward the right side. Additional contact damage that exhibited less deformation was observed at the right front corner edge of the trailer. Indentations to the corner edge appeared at numerous locations and covered the full height of the corner.

Figure 10: Screen capture depicting the trailer's right side as viewed in the point cloud rendered from the three-dimensional scans through the FARO Scene software.

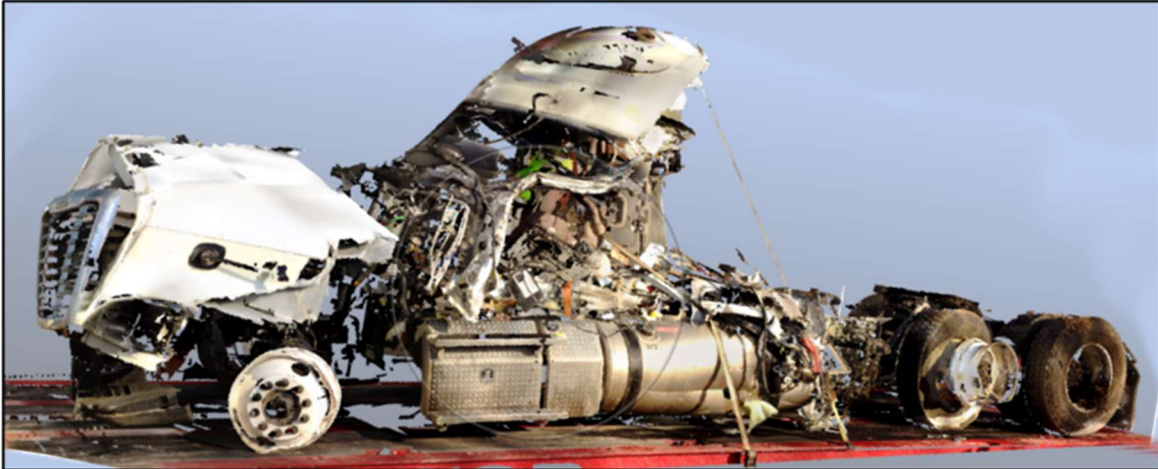
The truck-tractor exhibited catastrophic damage with evidence of having sustained an offset frontal impact at the left side that displaced the cab A-pillar. Impact damage extended along the left side fuel tank and wheel assemblies. The entire left side of the cab and sleeper berth had been torn open with the remaining cab shell skewed toward to the right. At final rest, the trailer had intruded into the tractor sleeper berth.

Figure 11: Screen capture depicting the trailer's left side as viewed in the point cloud rendered from the three-dimensional scans through the FARO Scene software.

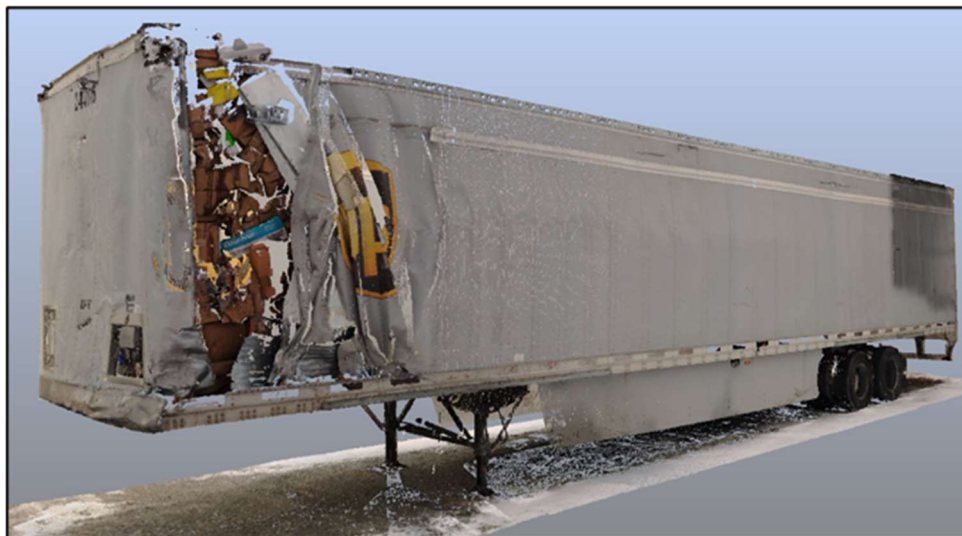
The semitrailer exhibited impact damage to the left leading edge that included an opening having been torn in the sidewall. The opening extended vertically from the bottom frame rail to the roof and included the corner structure. The overall sidewall deformation extended about nine feet rearward from the front of the trailer. Two additional tears to the sidewall, measuring about two to three feet in length, were observed about 12 inches downward from the roof near the middle and further rearward on the trailer.

Figure 12: Screen capture depicting the trailer's left side as viewed in the point cloud rendered from the three-dimensional scans through the FARO Scene software.

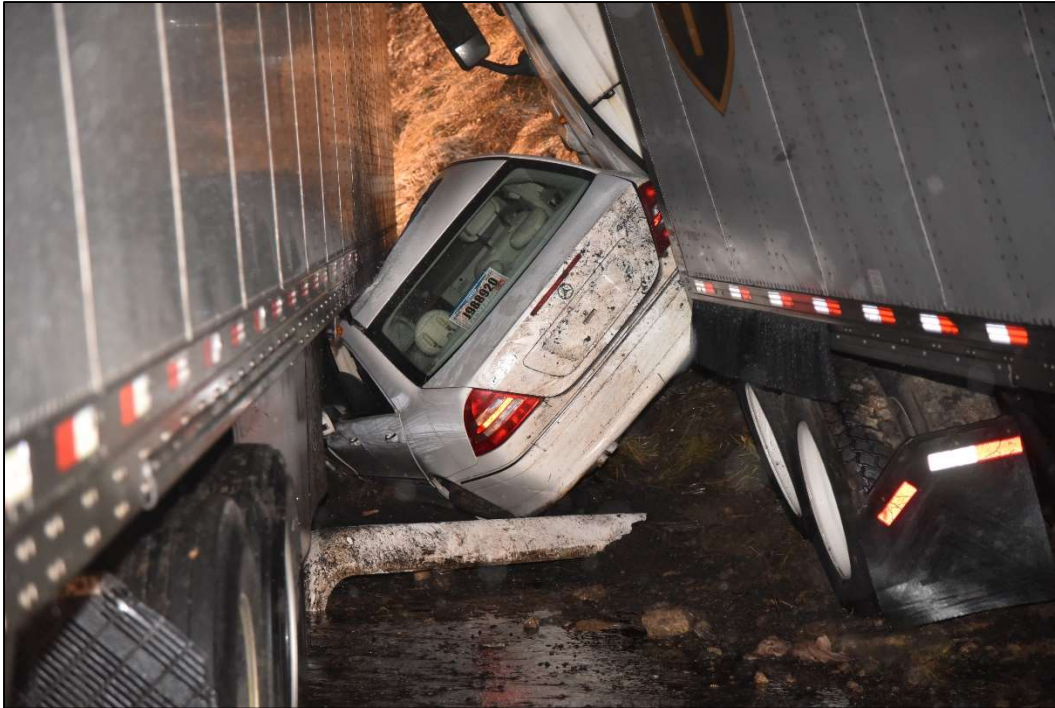
At final rest, the vehicle was observed oriented northwestward, parallel with and between the UPS-1 semitrailer and UPS-2 truck-tractor. As depicted in **Figure 13**, the forward driver's side roof area of the Mercedes had under-ridden the lower frame rail of the UPS-1 trailer. The right rear quarter panel was in contact with the UPS-2 left fuel tank and trailing corner of the cab.

Figure 13: Photograph provided by PSP depicting the position of final for the Mercedes Benz between the UPS-2 tractor (right) and FedEx trailer (left) – PA State Police.

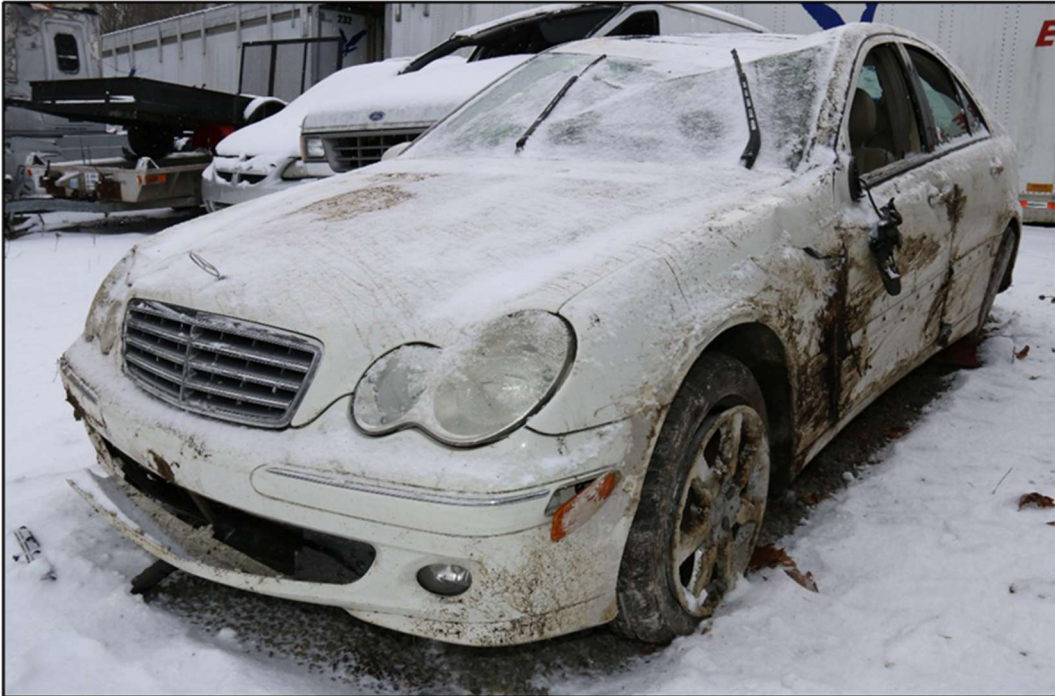
A Mercedes Benz C280, four-door sedan was the only passenger vehicle involved in the collision events. In general, the vehicle exhibited areas of impact to the right (passenger) side rear quarter panel, the roof and sideswipe contact along the left (driver) side. Some minor deformation was observed to the trailing edge of the left front fender in relation to the sideswipe evidence.

Figure 14: Photograph depicting left front and left side of Mercedes Benz.

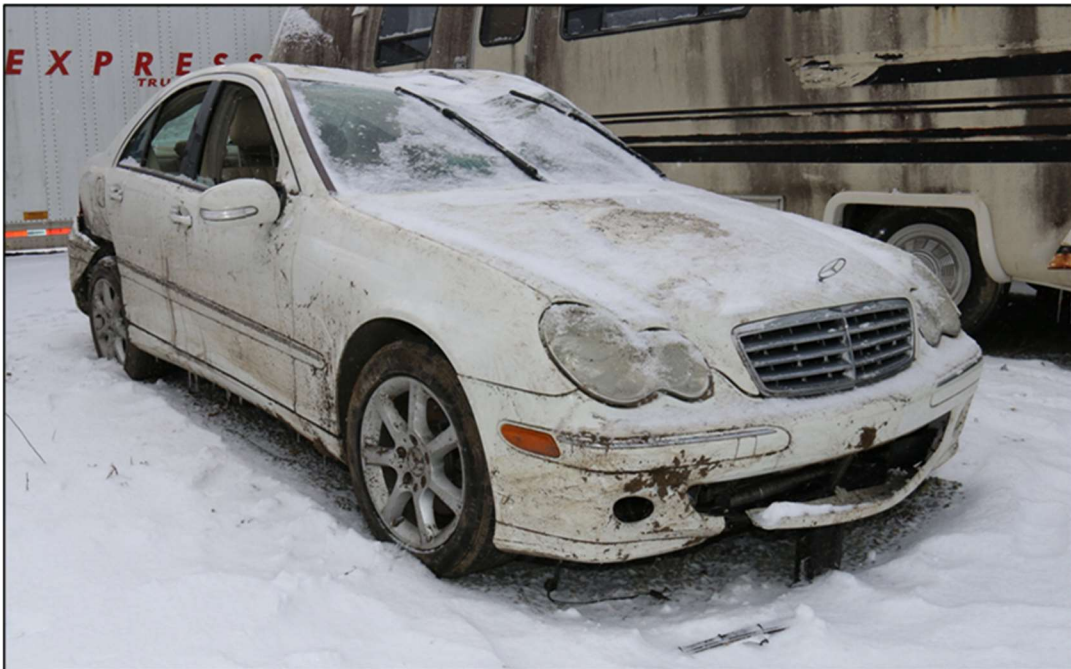
Figure 15: Photograph depicting right front and right side of Mercedes Benz.

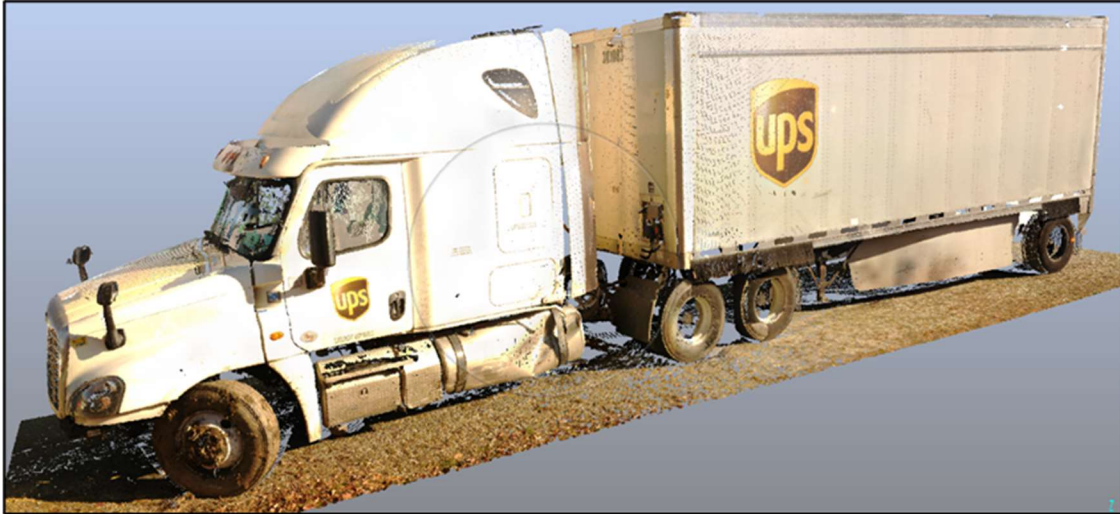
The truck-tractor exhibited evidence of contact damage on the left side beginning just below the driver's door and trailing rearward to the end of the saddle-mount fuel tank and cab. The front bumper cover was found detached when the vehicle was examined at the storage facility. Crash scene photographs depict the cover partially buried in the embankment as a result of the vehicle running off the pavement. Soil and grass were observed embedded about the steer axle wheels and suspension forward of the axle.

Figure 16: Screen capture depicting the tractor-trailer combination from the left side as viewed in the point cloud rendered from the three-dimensional scans through the FARO Scene software

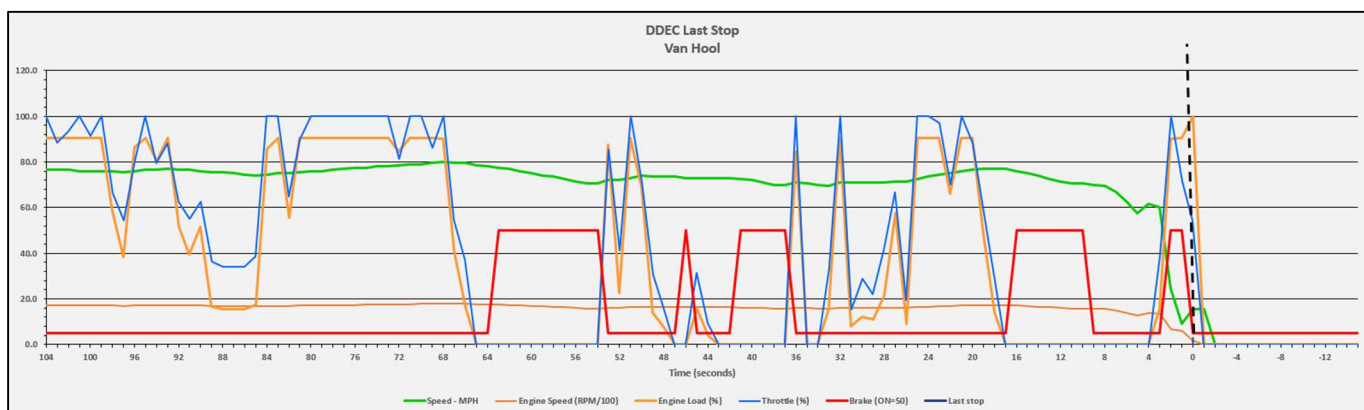
Data reported with the *last stop* event included vehicle speed (mph), engine speed (revolutions per minute-RPM), brake (signal lamp switch activation), clutch (pedal switch activation), percent engine load, percent throttle, cruise control (“on”/“off”) and fault code (present “yes”/“no”), all reported at one second intervals. **Figure 17** depicts a graph based on the DDEC Report data table – note that brake status was assigned an arbitrary value to be depicted as “on” or “off” (“off”=5, “on”=50). An image of the data table is presented in an appendix to this report. Also see the NTSB *Vehicle Factors Group Factual Report* for additional information regarding the recovered data report and inclusion of this data in the docket.

Figure 17: Graph depicting the Van Hool’s last stop record acquired from the engine ECM through DDEC Reports software.

After adjusting for the ECM clock time drift (04h:12m:44s), the last stop record, as recorded, was triggered at 03:29:02 AM (EDT) on 01/05/2020.²⁴ While two hard brake events

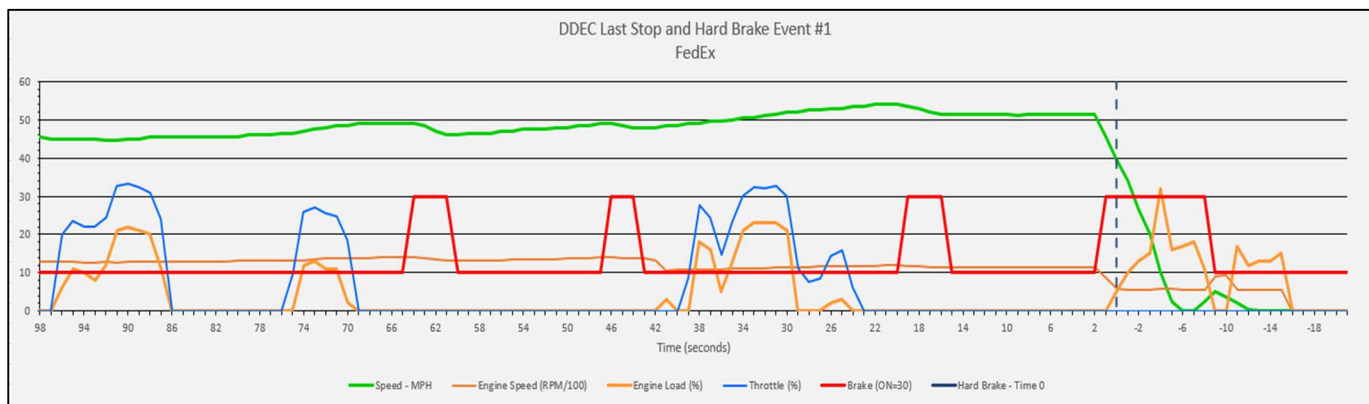
Figure 18: Graph depicting the combination of the FedEx unit’s hard brake and last stop record acquired from the engine ECM through DDEC Reports software. The hard brake and last stop records have been combined.

Examining the data preceding the crash, the data indicate an overall average speed of 48.7 mph with a maximum speed of 54 mph. The combined last stop and hard brake data records covered about 1.36 miles of the truck’s travel before the crash.

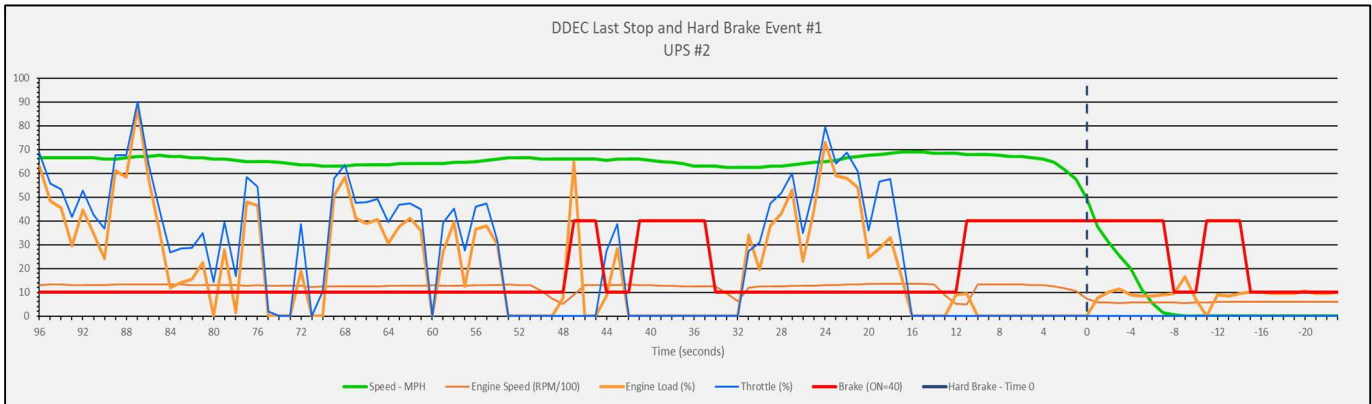
Figure 20: Graph depicting the combination of the UPS-2 unit’s hard brake and last stop record acquired from the engine ECM through DDEC Reports software. The hard brake and last stop records have been combined.

Examination of the data preceding the crash indicated an overall average speed of approximately 65.5 mph with a maximum speed of 69 mph. The combined last stop and hard brake data records covered about 1.78 miles of the truck’s travel before the crash.
