NATIONAL TRANSPORTATION SAFETY BOARD
Office of Railroad, Pipeline, and Hazardous Materials Investigations
Washington, D.C. 20594

Survival Factors

Group Chairman's Factual Report of the Investigation¹

NTSB Accident Number:	RRD20LR005
Location (accident reference):	Tempe, Arizona (AZ)
Date / Approx. Time of Accident:	July 29, 2020 / 6:06 a.m. MST ⁴
Incident Description:	railroad derailment / bridge collapse / fire
NRC ⁵ Report No.:	1283108, as updated
Track Reference Location (approximate):	Milepost 914.1 on the Phoenix Subdivision

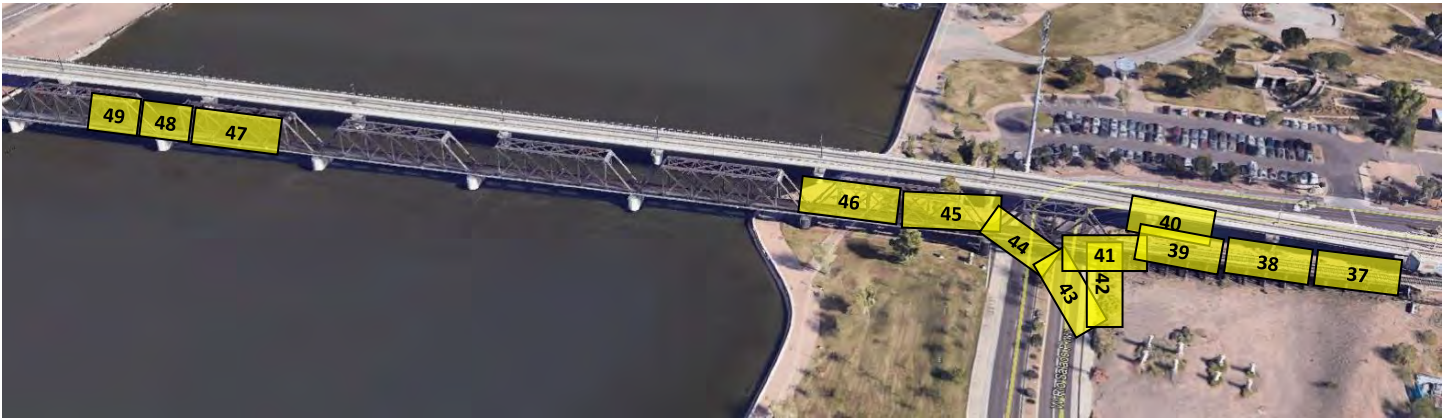
Approximate Layout of Train Cars, Post-Incident

(Based upon scene photographs and Union Pacific Consist, as received by Tempe Police Department on 07/29/20 at 0632 hours, with knowledge that Union Pacific orders their train car sequence from the rear)
