NATIONAL TRANSPORTATION SAFETY BOARD
Office of Railroad, Pipeline, and Hazardous Materials Investigations
Washington, D.C. 20594

Group Chairman's Supplemental Factual Report^{1, 2}

– Emergency Preparedness / Emergency Response³ –

NTSB Accident Number:	RRD20LR005
Location (accident reference):	Tempe, Arizona (AZ)
Date / Approx. Time of Accident:	July 29, 2020 / 6:06 a.m. MST ⁵
Incident Description:	railroad derailment / bridge collapse / fire

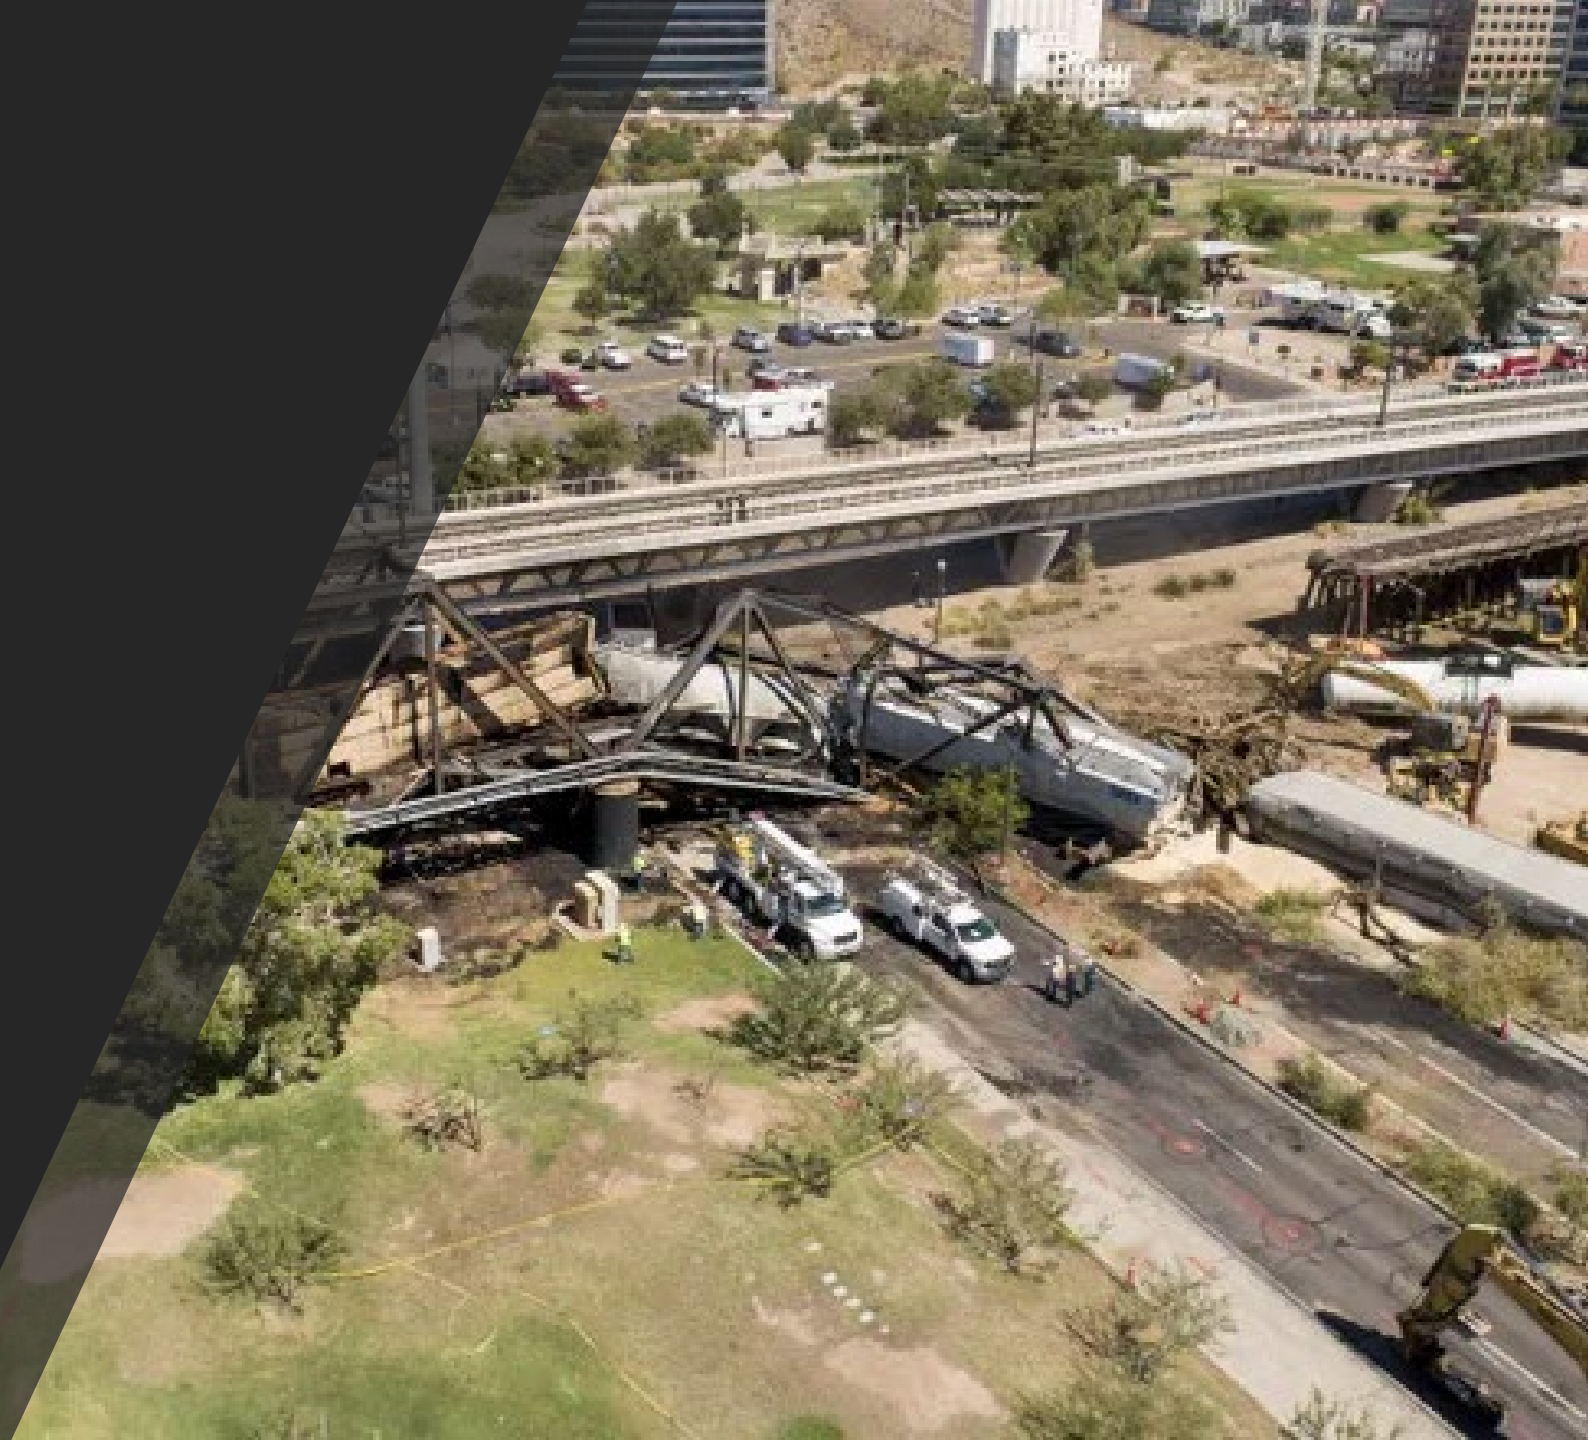
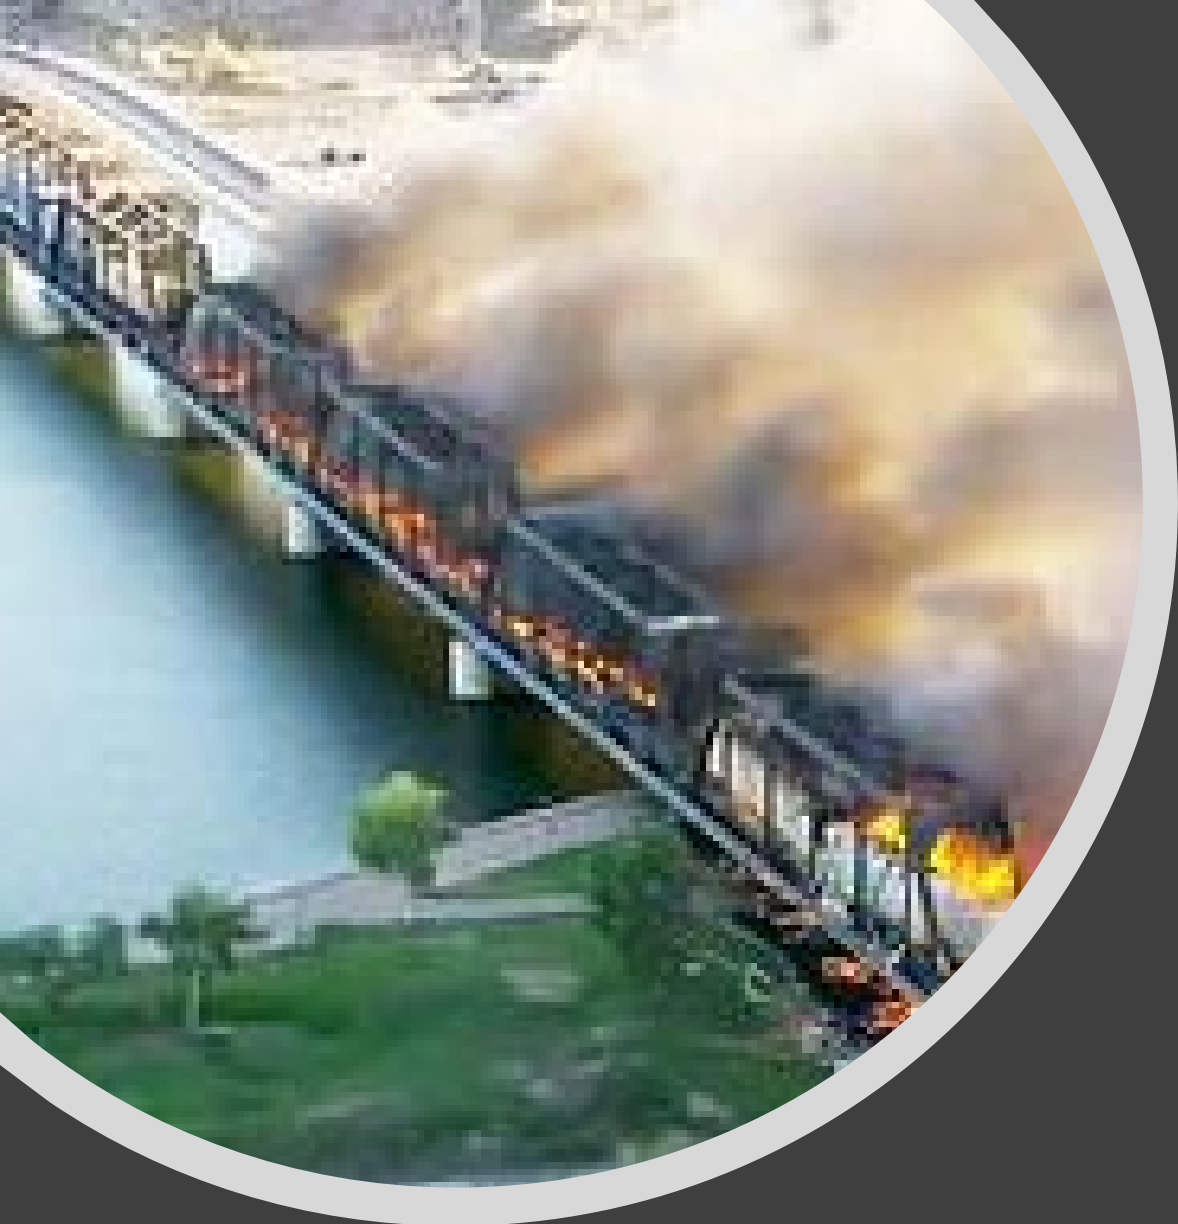
- Hazards come on all shapes and sizes and can be a person, animal, object or situation.
- Along the alignment, operators will come into contact with various forms of hazards and must be prepared to react properly.
- An example would be the recent derailment of a Union Pacific train. As the freight line runs parallel to the alignment, operators must take into consideration the hazards associated with it.
