Railroad Investigation Report: RIR-22/09

Union Pacific Railroad Derailment with Bridge Strike and Fire

Tempe, Arizona
July 29, 2020

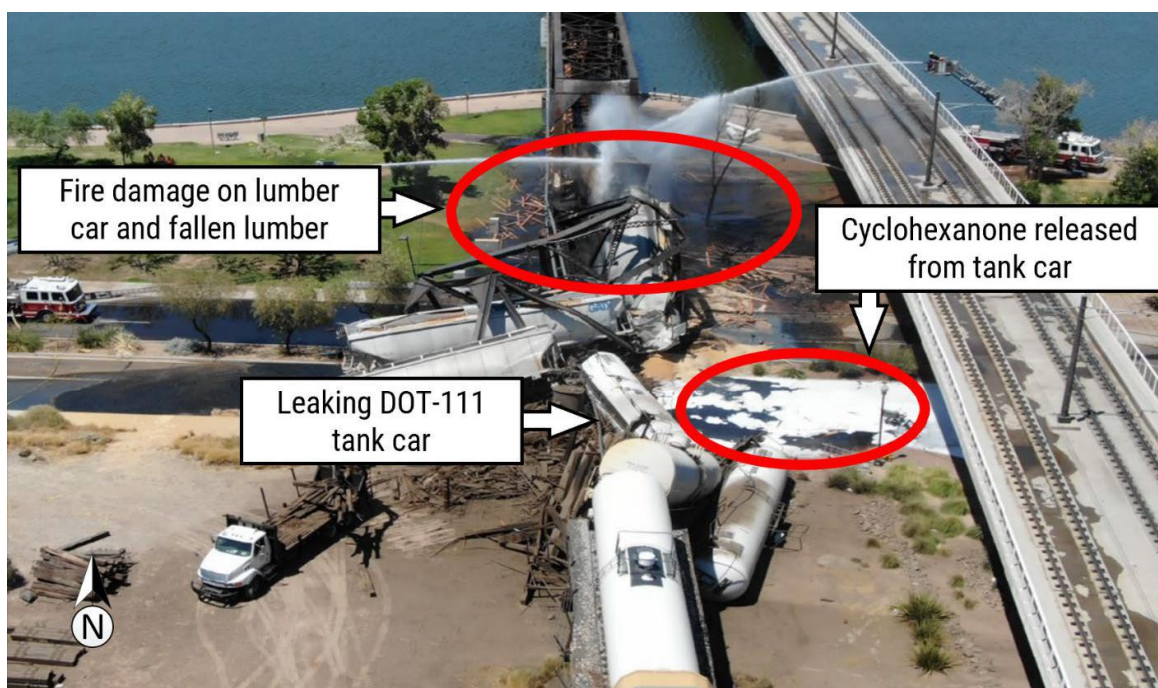
Figure 1. Aerial view of the derailment scene. (Photo courtesy of Union Pacific Railroad.)

NTSB investigators reviewed surveillance camera images from a southbound Valley Metro train crossing an adjacent bridge at the time of the derailment. These images showed a spark burst from an MTUPX-29 railcar striking a critical member of the bridge's first steel span on its east side.⁷ After the initial strike, the top chord of the bridge buckled and the steel span collapsed. The failure spread up-track from the initial failure point, collapsing part of the wooden trestle. Subsequent images of the south end of the bridge showed derailed railcars colliding with each other and falling into the void opened by the bridge collapse. A single tank car, GATX 90208, began leaking cyclohexanone.

A review of surveillance images showed that, during the derailment, railcars moved laterally (east) until one struck the first steel span. The strike compromised a critical member, leading to the bridge's partial collapse. Although the track over the steel spans featured an IGR, the track over the trestle portion of the bridge did not. The derailment occurred on this unprotected stretch of track just south of the steel structure. As a result, derailed railcars were able to move laterally until they encountered the bridge itself.

When UP rebuilt the Tempe Town Lake Bridge, it included IGR flare portions extending at least 50 feet north and south of the structures that require protection. The

new IGR configuration aligns with UP's engineering standards as discussed above. These flare portions are designed to keep derailed equipment in-line with the track, preventing contact with critical members even when a derailment occurs south or north of the steel spans themselves.

After rebuilding the bridge, Union Pacific installed a flare portion of IGR at both ends of bridge in accordance with their engineering standards to mitigate derailments by keeping derailed equipment in-line with the track. If kept in-line, equipment is less likely to strike the bridge structure and cause damage or a collapse.

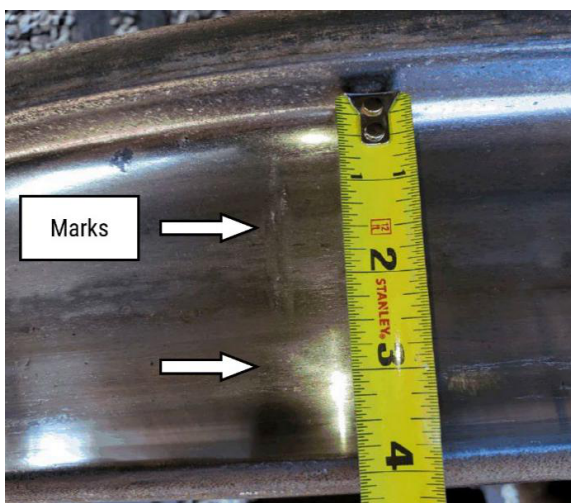
Railcars 49-60 (counting backward from the head of the train) derailed. While inspecting the derailed railcars, investigators discovered that railcars 48 and 49 had marks on their wheels consistent with having traversed a broken or damaged rail head.⁸ (See figure 2.) Railcar 48 had a mark on the trailing axle and railcar 49 had marks on the leading two axles; the marks were on three consecutive axles across two railcars. The marks were all on the east wheels. Investigators found no other marks of this kind on the train's other wheels.

Figure 2. Marks from railcar 49. (Photo courtesy of the Federal Railroad Administration.)

The first physical evidence of abnormal operation is a mark on the rearmost east-side wheel of railcar 48, which indicates that it traversed a broken rail end. The lack of marks on wheels up-train of railcar 48 indicates that the first 47 cars traversed the rails normally, without encountering any rail breaks.

Marks on the first two east-side wheels of railcar 49 show that they too rolled over the broken rail end. Subsequent wheels did not exhibit similar marks, indicating that the train had derailed far enough that wheels were no longer traversing the broken rail end.

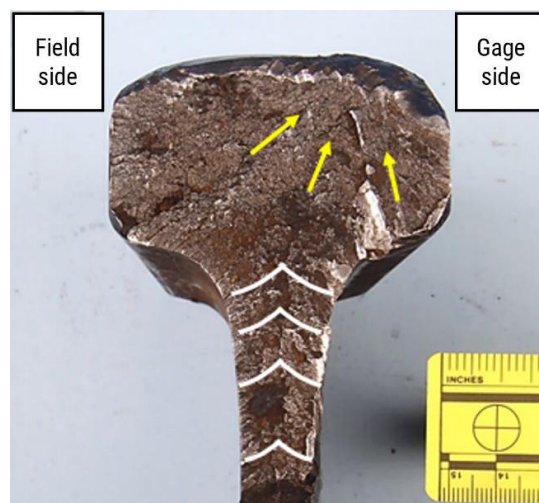
In reconstructing the damaged rails, investigators found rail-end batter on a rail segment from the eastern rail about 30 feet south of the first steel span, where the track was supported by a ballast deck over a wooden trestle.⁹ (See figure 3.) The segment exhibited departing-end batter, and no other recovered segments exhibited rail batter of any kind. The NTSB's metallurgical analysis of the rail segment found no signs of rail fatigue or defects, but examination of the fracture face revealed a chevron pattern (shown in white in the figure) and micro features (marked with yellow arrows) consistent with overstress.¹⁰

Figure 3. The fracture face of a recovered rail segment.

Rail reconstruction identified a single segment of rail, about 30 feet from the bridge's first steel span, that showed rail-end batter, a type of damage inflicted by wheels traversing a broken rail end. Given the wheel marks and the single rail segment exhibiting rail-end batter, physical evidence places the initial point of derailment at this broken rail. Forty-seven railcars traversed the rail normally before it broke under the 48th. The final two east-side wheels of railcar 49 (and all the wheels of 11 subsequent cars) derailed far enough that they were no longer traversing the broken rail end, as shown by their lack of marks.

Metallurgical analysis of the rail near the derailment point did not identify any signs of fatigue or flaws. The fracture pattern is consistent with overstress, suggesting that the rail broke due to forces applied immediately before the derailment.
