Pressure Testing of SPBP Welded Repair Design

Final Report

Prepared for Amplify Energy Corp.

100335-RP02-Rev0-111521

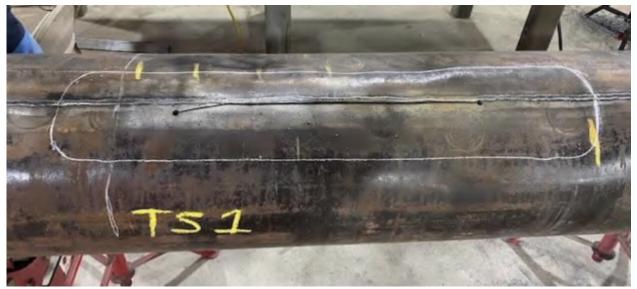
The construction drawings for the temporary repair considered in the full-scale testing program are included in Appendix A. ADV understands that a comparable repair configuration will be fabricated for use on the actual SPBP leaking defect. The temporary repair consisted of several circumferential welds connecting end caps to a short nominal 10-inch diameter pipe section. All welds passed NDE (radiographic and magnetic particle testing) as documented in in Appendix B. The temporary repair also included two, 2-inch threadolets and bull plugs that could be used to provide venting during underwater welding. The 10-inch vessel was then cut longitudinally to form a standoff temporary repair and welded over a simulated through-wall defect fabricated onto the deformed pipe using a ¾ inch single sided fillet weld, per the drawings included in Appendix A. In addition to the temporary repair, holes will be drilled at the termination of each end of the crack (i.e., drill stops), as shown in Figure 2-1 on the test vessel. These drill stops are installed to mitigate crack propagation.

Figure 2-1: Photograph of test vessel with installed crack and drill stops.

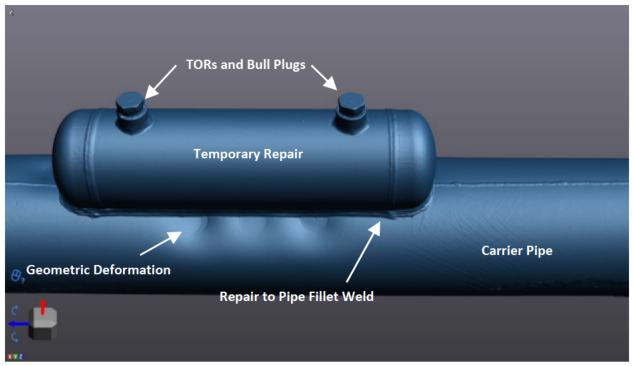
Figure 3-2: 3D rendering showing relationship between temporary repair and geometric deformation on the received pipe sample.

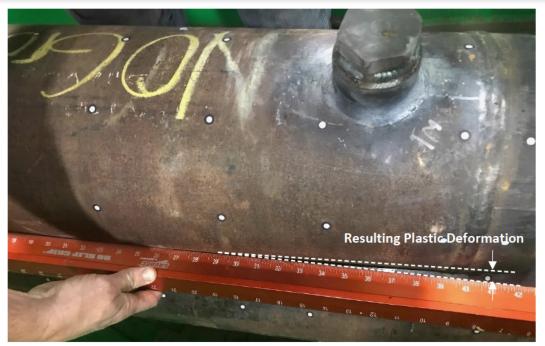
After seal welding the TOR/Bull plugs, the cyclic test program was restarted. Cyclic testing was repeated as shown in Figure 4-2, and then the pressure was increased to 1,440 psig. This pressure was held overnight resulting in a 17.9 hour hold as shown in Figure 4-3. Upon completion of this hold, ADV increased the pressure to find the maximum pressure containing capacity of the temporary repair. At 1,619 psig the pressure within the sample started to decrease. Upon inspection, it was discovered that the temporary repair had begun to experience plastic deformation without an identified leak as shown in Figure 4-4 and further quantified in Section 5.0, Post-Test 3D Scan. Therefore, ADV stopped the testing program. The most significant conclusion from this test was that the test vessel successfully contained pressure for 17.9 hours at 1,440 psig providing confidence in the welded temporary repair's ability to contain pressure and mitigate product leakage.

Figure 4-4: Photograph showing resulting plastic deformation of the temporary repair.

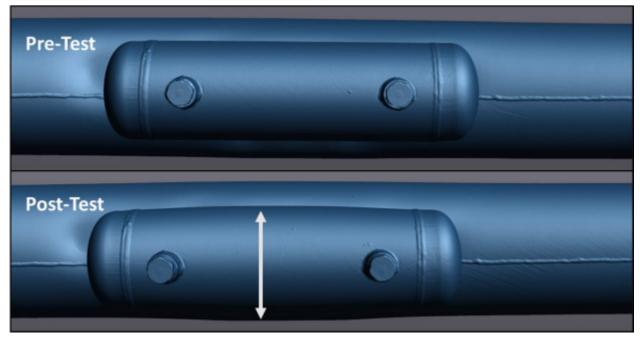
After completion of the full-scale test, ADV scanned the vessel using a Creaform HandyScan 307 with reflective positioning targets applied to the outside surface. A 3D rendering of the test vessel is shown in Figure 5-1. The 3D scan captured the change in the temporary repair diameter as shown in Figure 5-2. To better quantify the change in shape, ADV prepared a virtual cross section through the pipe/repair assembly, shown as green lines in Figure 5-3. The pre- and post-test diameter of the temporary repair at nine (9) locations were tabulated and presented in Figure 5-4. A maximum change in diameter of 0.96 inch between the pre- and post-test measurements was calculated.

Figure 5-2: 3D rendering of temporary repair showing change in shape (white arrow).

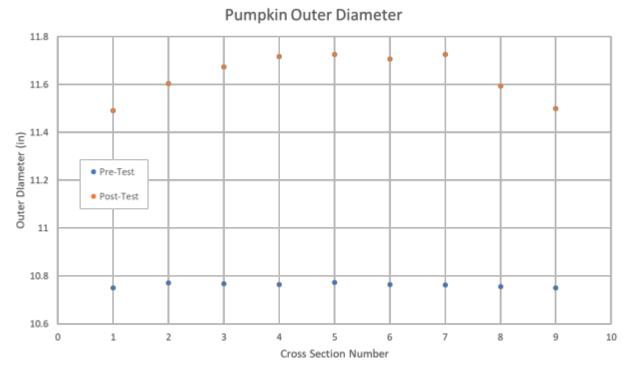
Figure 5-4: Plot comparing outer diameter of temporary repair, pre- and post-test.
