TESLA INSPECTION FACTUAL REPORT

HWY18FH011

**NATIONAL TRANSPORTATION SAFETY BOARD
OFFICE OF HIGHWAY SAFETY
WASHINGTON, D.C.**

Location: Southbound US Highway 101 (US-101) south of North Shoreline Boulevard at the exit ramp transition to State Route 85 (SR-85), milepost 43.38, Mountain View, Santa Clara County, California

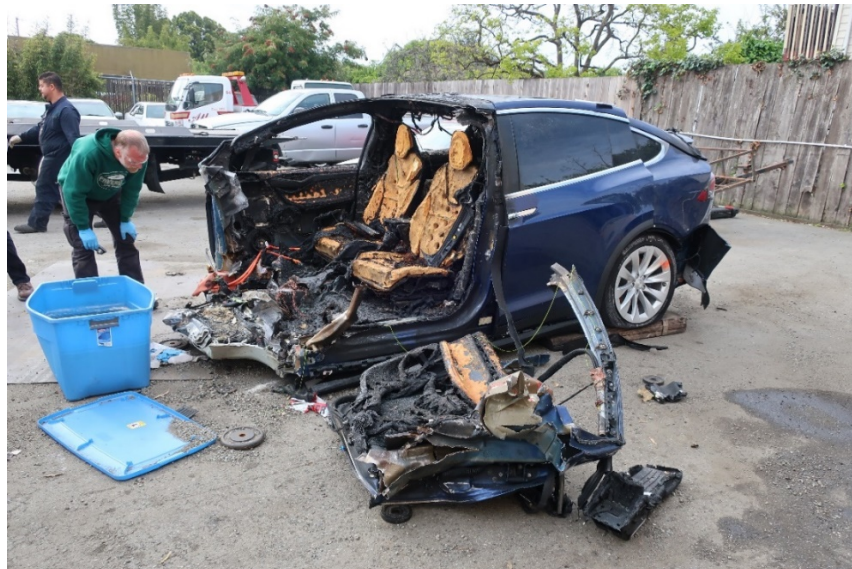
The 2017 Tesla Model X had Vehicle Identification Number (VIN) 5YJXCAE28HFXXXXXX.² The Tesla struck an attenuating barrier at the highway off ramp, separating the car forward of the passenger compartment, damaging the primary battery, which ignited and caused a vehicle fire. The vehicle structure had been split in pieces during the crash, to the extent that nothing from ahead of the front door pillars was present for examination. This included the 12 VDC battery, front drive motor, body parts, and complete front suspension. The front left (driver) door was laying loosely on the ground next to the vehicle and a bucket (tub) of water containing loose battery debris was found at the front of the vehicle, as shown in Figures 1 and 2.

Figure 1. Overall view of vehicle, as found at tow yard. Blue bucket has been pulled forward from contact with the vehicle.

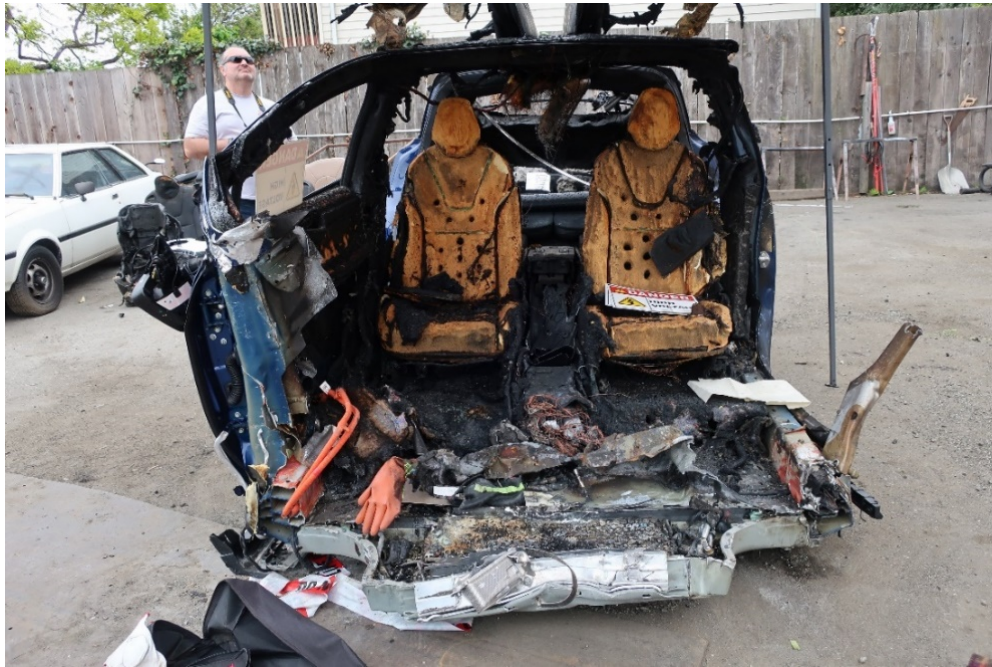
Figure 2. Frontal view of the vehicle, showing crush to front of battery casing at bottom.

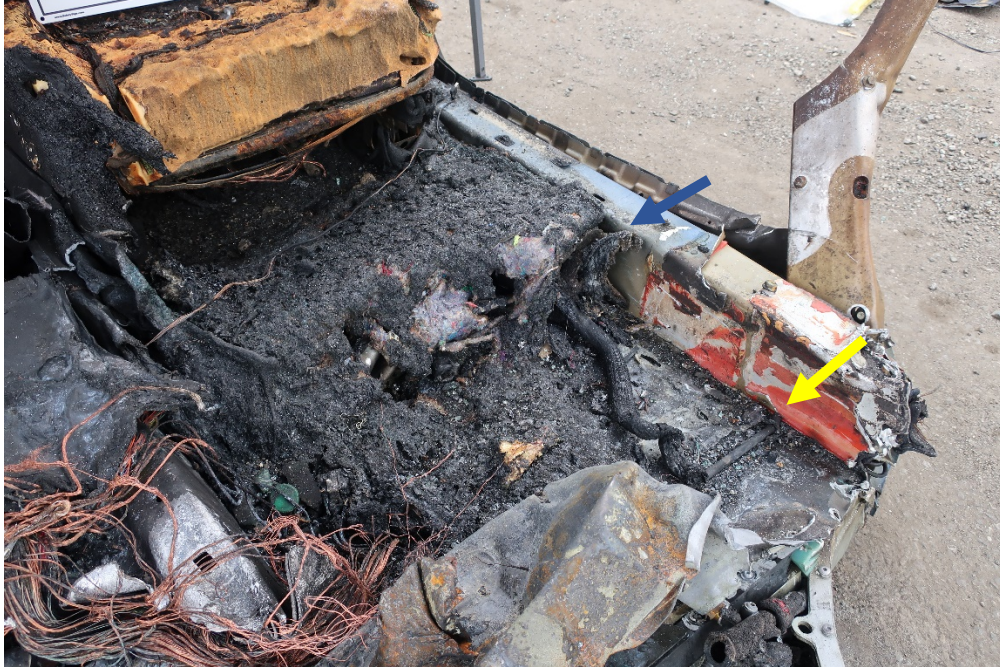
A thick closed-cell foam egg-crate layer beneath the carpet pad raised the interior floor above the bottom of the aluminum vehicle body. The egg-crate had melted back about two inches farther on the driver side than the passenger side. In the passenger footwell was an additional triangular portion melted away from the front right corner with a slightly smoother and blacker different appearance.

Figure 7. Fire damaged wiring in lower left. The driver seat is at top left of driver footwell. The lower yellow arrow shows the remaining forward edge of the vapor barrier. The step-like appearance at the upper blue arrow is the edge of the egg crate foam beneath the carpet.

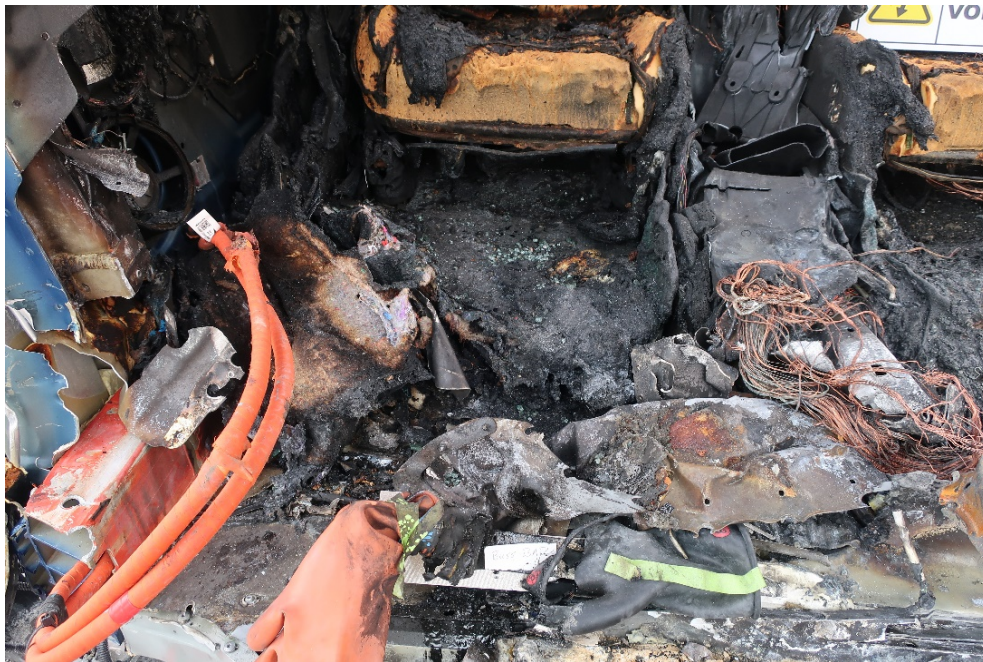
Figure 8. Passenger footwell with passenger seat at top.

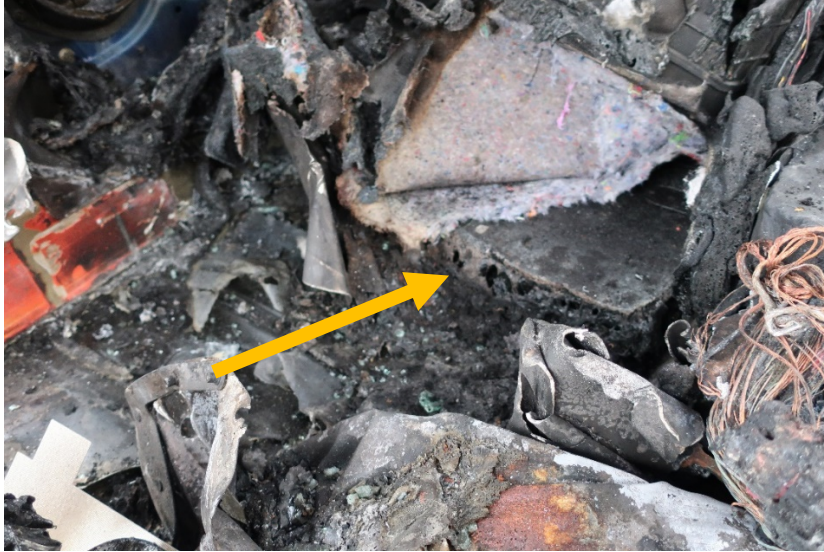
Figure 9. Cut back carpet and pad in driver footwell, lifted from the egg crate foam, which is referenced by the arrow.

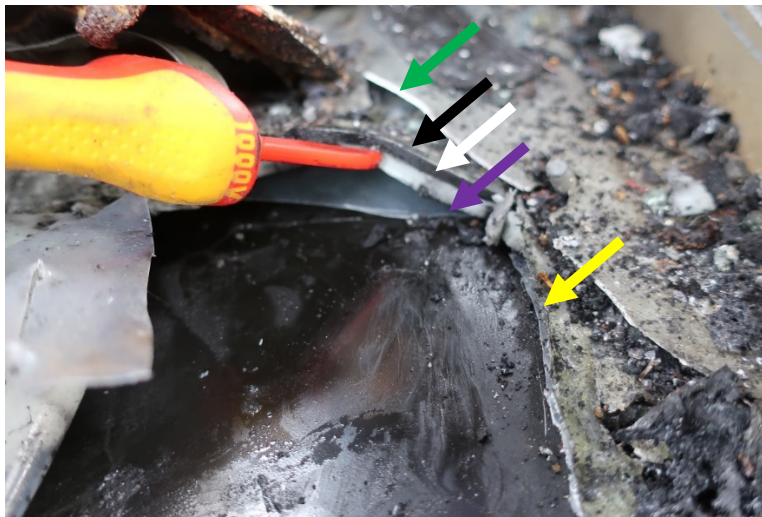
A layer of rubber-like black layer existed between the bottom of the vehicle body and a clear sheet of plastic vapor barrier which covered the battery. While an air gap of less than a centimeter existed between the battery and bottom of the vehicle, it was filled with compressible materials. This hindered water from flowing along the top surface of the battery. The layers found are shown in Figure 10. The plastic sheet was found melted to about the mid-distance between the front and rear of modules 13 and 14.

Figure 10. Layering of materials prevents ability of cooling water to flow in space between the vehicle body and steel top of battery. Green points to edge of aluminum vehicle floor pan, black to rubber-like material, white to compressible material, purple to vapor barrier, yellow to the steel top of the battery case.

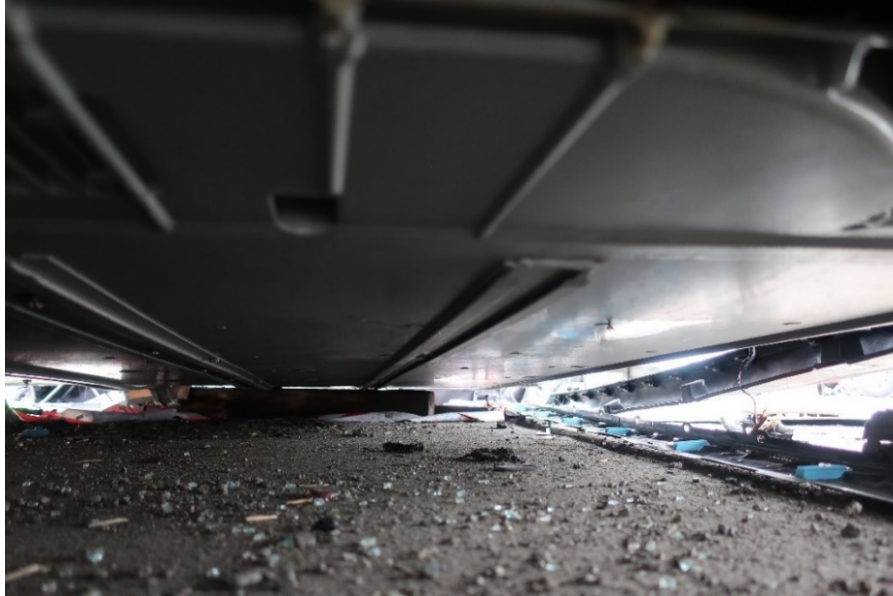
The 400 VDC 100 kWh battery was found with the front edge crushed aft and up. Due to concerns of potential re-ignition of the battery from excessive movement of the vehicle, an unobstructed view of complete underside was not possible. Although the rear tires were resting on three layers of wood, which raised the rear end about 5.25 inches, the air suspension had deflated to leave a minimal gap between the bottom of the battery and the ground. The area of the battery case visible (bottom surface aft of modules 13 and 14), was smooth and unbuckled, aft of modules 13 and 14, as shown in Figure 12.

Figure 12 . Smooth bottom surface of battery and limited amount of clearance to ground. Note that wood elevates the front and rear of the vehicle. The discharge port is located to the left of this photo.

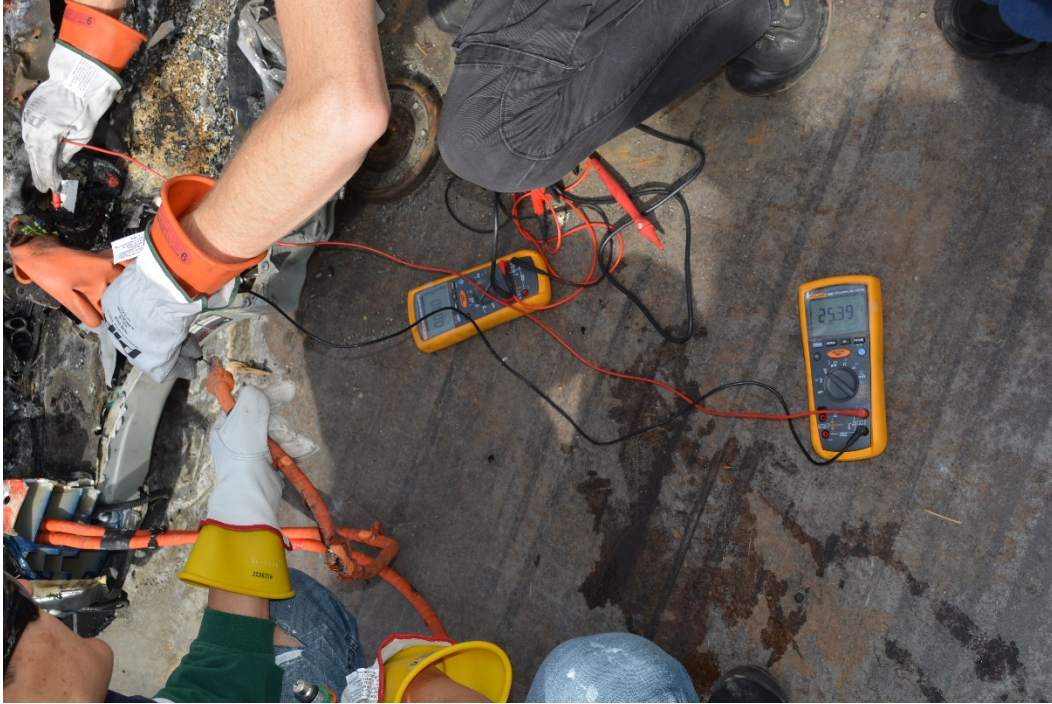
Electrical potential of 25.39 VDC was initially found from an exposed bus bar which hung roughly above the right end of module 15 to the aluminum battery case, see Figure 16. The bus bar was connected to module 14 on the left and was referred to as the “14 positive bar.”

Figure 16. Multimeter display of voltage on the 14 positive bus bar.

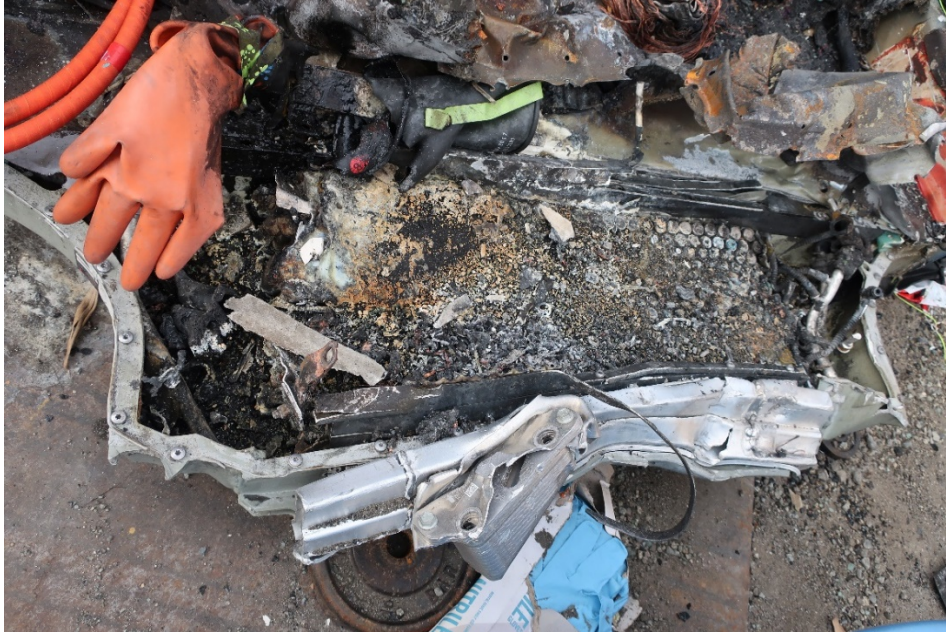
Because power was found, the vehicle battery was relatively intact, and it had already begun to burn twice, the group did not move the vehicle and took care not to reposition, stress, or place weight on the damaged battery. The group also occasionally examined the exposed features of the battery with thermal imaging cameras to assure that a new discharge event had not initiated as work progressed. The 14 positive bus bar material was too thick to cut with available tools (in order to reduce risk of HV exposure). An insulating rubber glove was put back on and a mica box was taped over the area after the inspection was completed, as shown in Figure 17.

Figure 17. View of front of the 400 VDC 100 kWh battery, as found, looking down and aft. The black and red rubber gloves are on the 14 positive bus bar. The exposed cells are the tops of module 15 and the buckle through the middle of module 15 is visible.

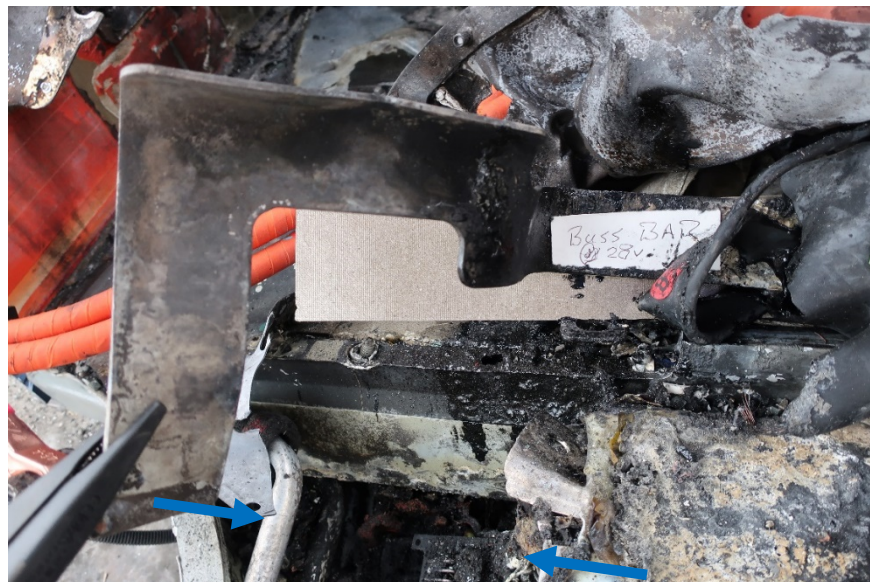
An indication of a fluid level was observed from black residue evident in module 15 and on the wall between modules 13 and 15, as shown in Figure 18. (The residue was typical of deposits burning above fluid.) This was consistent with firefighter descriptions of aiming water stream into open and burning area.

Figure 18. This captioned tag is on the 14 positive bus bar. The added blue arrows point to a fluid level, typical of burning above a fluid depth.

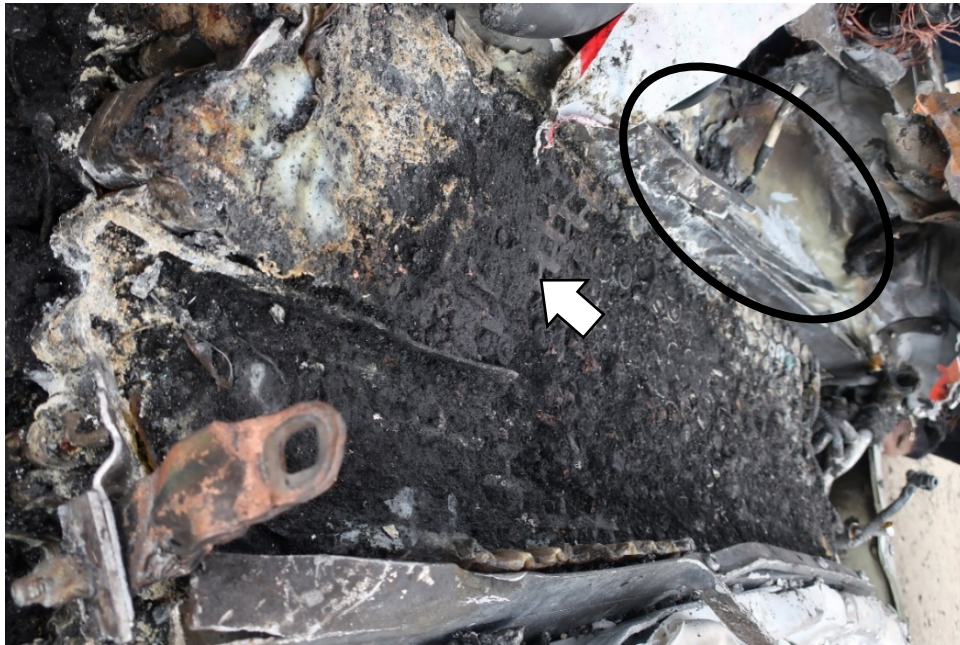
While module 16 was essentially missing and only remained as fragments in the water bucket, the exposed top of module 15 was largely intact, with the tops of module 15 cells visible, some displaced upward. Many of the module 15 cells had fire damage and evidence of open tops. The copper materials at the top of module 15 had fused and the plastic features of both modules 15 and 16 had largely been consumed. The module 15 BMB was in place with blackened and fire-damaged features. Figure 19 shows a view of Module 15.

Figure 19. Top of module 15 after cleaning off debris from the fire. The forward edge is along the bottom of the photo. The arrow points to the edge of the top plastic tray. The oval indicates the partially open cover at the front of module 14. At the lower left is the module 15/16 bus bar.

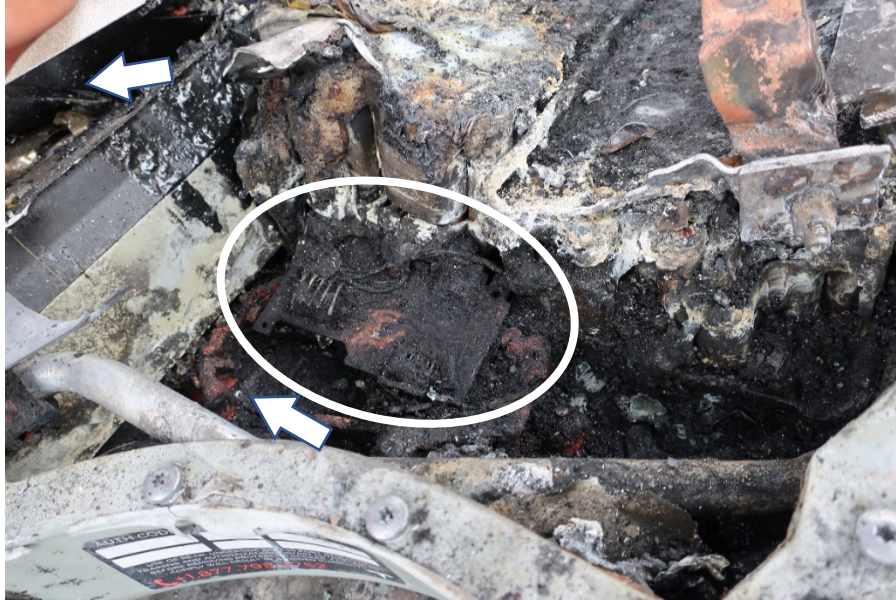
The aft displacement of the battery case cover from module 16 had exposed areas of modules 13 and 14. A gap also existed below the bolted wall which separated modules 13 and 14 from modules 15 and 16, as shown in Figure 20.

Figure 20. Oval around module 15 BMB. Base plastic of the pyrotechnic fuse remained beneath the BMB. The arrows point from the area of modules 15/16 to module 13 and partially covers a fragment of the pyrotechnic fuse.

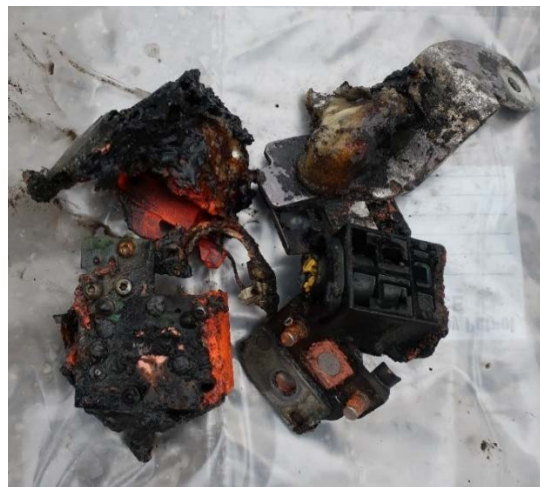
The majority of the pyrotechnic battery fuse which had been in module 15 was found in the bucket of water. Electrically, the fuse was found in the open configuration. The body of the fuse had fractured into multiple parts which were held together by the internal metal features, such as wiring. The contrast between burned surfaces and clean fracture surfaces indicated that the fuse had fractured after an initial intense fire exposure, as shown in Figure 21.

Figure 21. Pyrotechnic fuse.

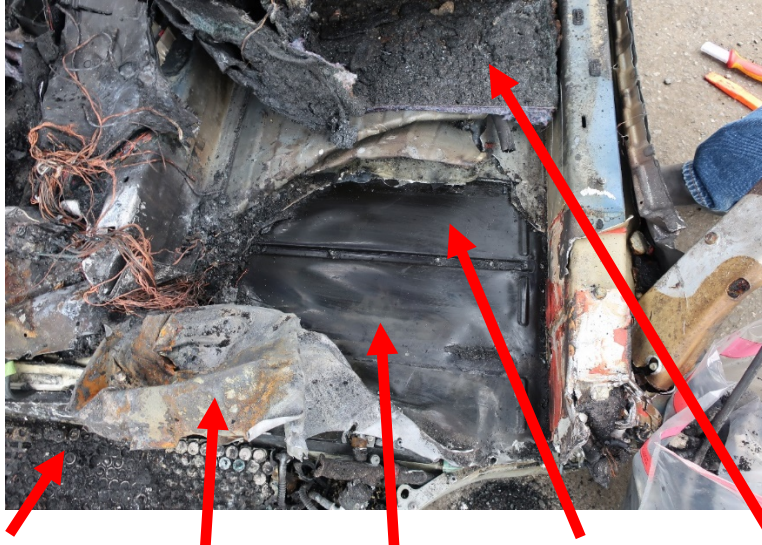
The general battery had buckled laterally through the aft portions of modules 13 and 14 and 12, with the battery forward of that slanted slightly upward, as shown in Figure 22. The steel top of module 16 was folded back along with a portion of the aluminum vehicle floor. This prevented removal of the battery.

Figure 22. View of the top of the driver footwell, looking aft after cleaning off the fire debris. The buckle in the top surface of the modules 12 and 14 is visible. The aluminum driver footwell floor is accordion-folded aft.

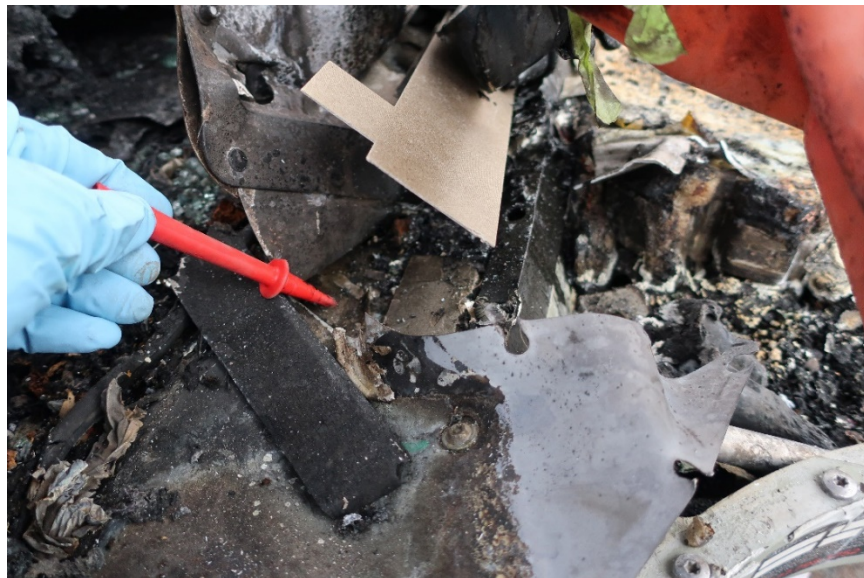
After cleaning away the fire debris, the mica insulator in module 13 was found fragmented and broken. The steel top of the case could be flexed by hand, so the mica was not disturbed in order to minimize potential contact between the steel and conductive materials beneath the mica, as shown in Figure 23. Module 14 also had exposed mica which appeared to be less damaged, but the same precaution was taken to avoid flexing the steel downward where it might contact exposed conductors.

Figure 23. Top of module 13 after cleaning away fire debris, pointing at broken mica on plastic tray. The mica and plastic were able to be moved to see the cell

tops. The rectangular material above the pointer was added to isolate the powered bus bar.

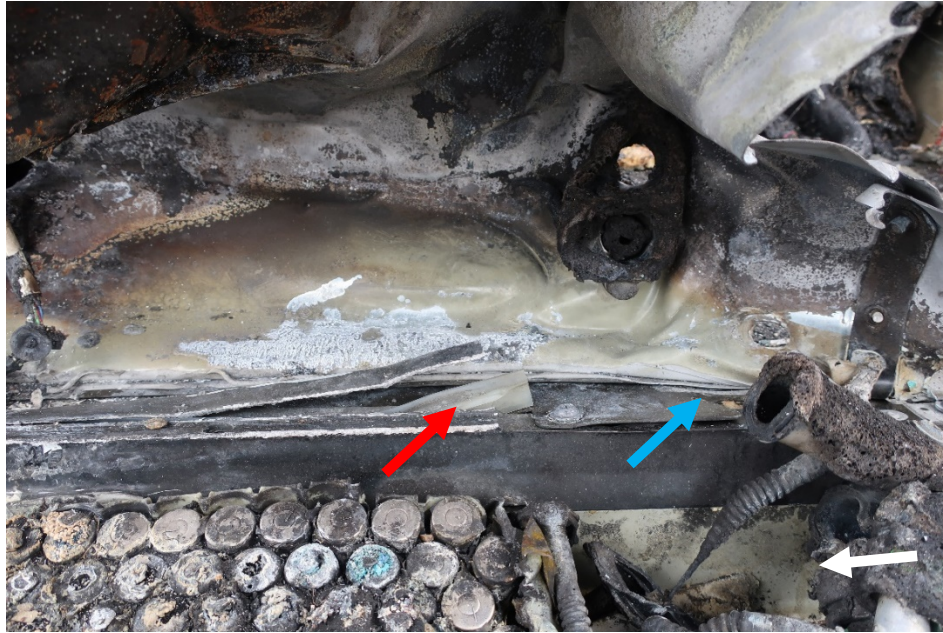
The exposed top of module 14 had features not containing residue of venting cells or thermal exposure, which included a length of silicone-like translucent material, adhesive exposed by the peeling top of the module, and other exposed plastics, as shown in Figure 24.

Figure 24. Looking aft into the top of module 14 from 15/16. Left red arrow points at unburned silicone-like material on aft side of wall between modules. Right blue arrow points to unburned adhesive. A flood level mark is at approximately half the 18650 cell heights as was visible near the BMB and is pointed to by the lower white arrow.

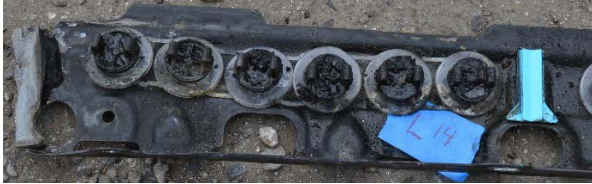
Examining the left set of modules, the features for four (2, 4, 6, 14) of the seven sets of umbrella poppets appeared to retain their translucent normal appearance and no evidence of heat. Module 8 had five clean umbrellas and one separate which was coated with black sticky residue. The poppets for modules 10 and 12 were coated with sticky black residue. Black residue and standing water were found in the baffles beneath the corresponding umbrella poppets.

Figure 25. Module 14 poppets and baffle. Note that 25.39 had been measured on the 14 positive bus bar

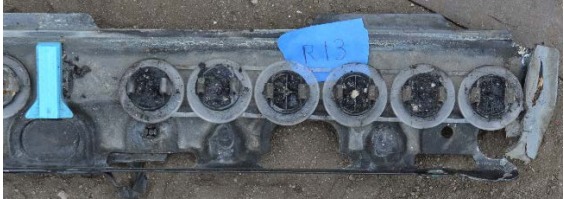
Examining the right set of modules, five sets (1, 3, 5, 7, 9) of poppets were clear of black residue. The module 13 set had black residue which had a washed appearance. All but one of the module 11 set were clear of black residue but had a similar grey muddy deposit similar to that seen in the BMS auxiliary module. The wetness in the baffle trays dried during the day of examination.

Figure 26. Module 13 poppets and baffle.

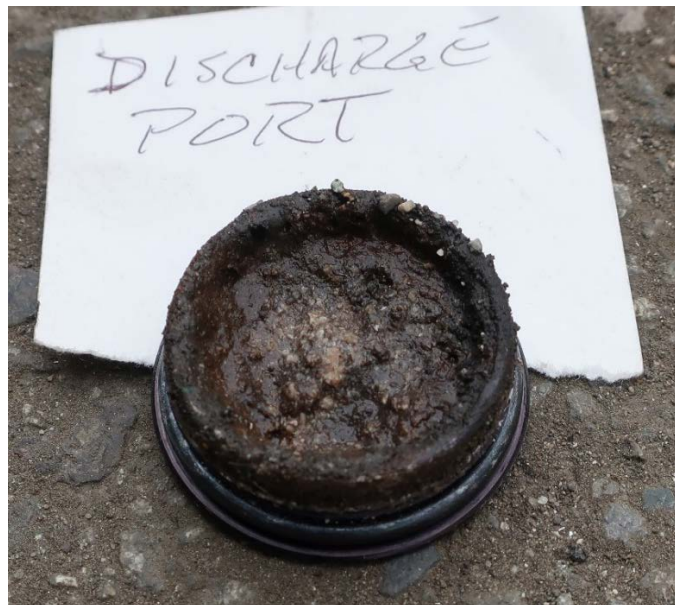
The plug contained a thick layer of residue which dried to a muddy paste, as shown in Figure 39. The group discussed that while the modules were essentially isolated from each other, the isolation was not water-tight. Water entering the front of the battery was able to find paths to reach the rear auxiliary/BMS compartment of the battery.

Figure 39. Muddy material drying out in the discharge port cover.

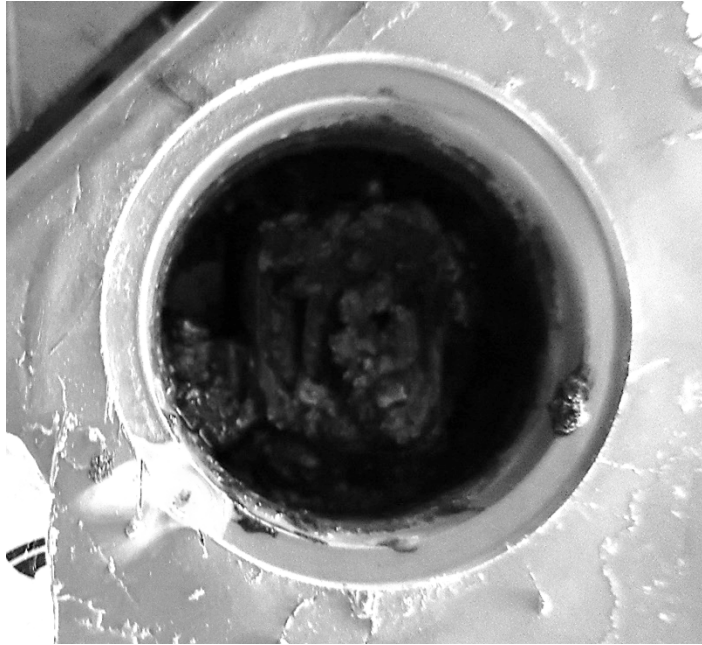
Because the bottom of the car was so close to the ground, the electrical connector within the port could only be seen by taking photographs and examining the images. The images showed that the electrical connector was also filled with the muddy residue, which was cleaned as much as possible in the limited access, as shown in Figure 40. Once the discharger was attached by a cable, the electrical connection was not sufficiently clean for the discharger to function.

Figure 40. Muddy material in the discharge port beneath vehicle. The bright area at the lower left of the hole is water draining. For best visibility of electrical connection in the black confines, the image is shown in black and white after modifying the sharpness and brightness.

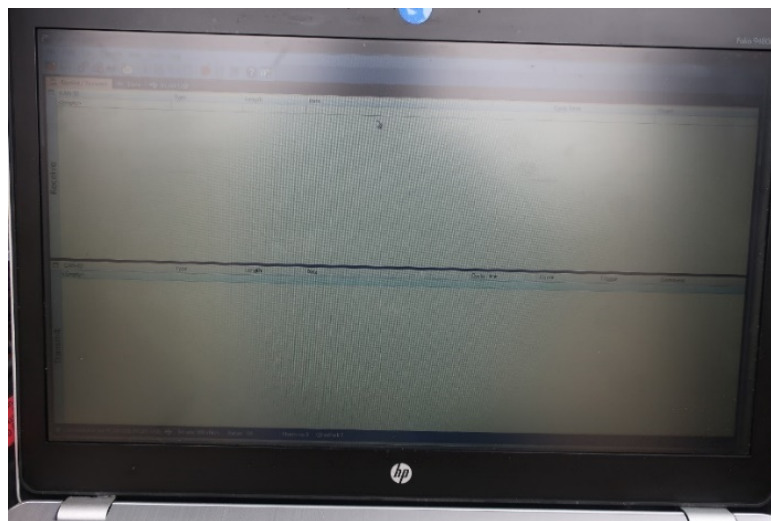
The rear seat was removed from the vehicle by cutting the supporting legs. The carpet and padding under the seat were pulled from the aft surface to expose a small rubber plug and wire harness. After referring to a wiring diagram, the wires of the harness were cut and connectors were attached to the wires as shown in Figure 41. A small battery was used to place power on the bus. The attempt to communicate with the BMS in the wet auxiliary compartment of the vehicle battery was unsuccessful as shown in Figure 42.

Figure 42. Screen of laptop, shows lack of response on battery communication bus
