**TESTING OF PRESSURE RELIEF
VALVE "RV1919"**

**OFFICE OF PIPELINE &
HAZARDOUS MATERIALS SAFETY
NATIONAL TRANSPORTATION
SAFETY BOARD
Washington, DC**

STRESS ENGINEERING SERVICES, INC.
Houston, Texas

Subject: Report Entitled "Testing of Relief Valve 1919"

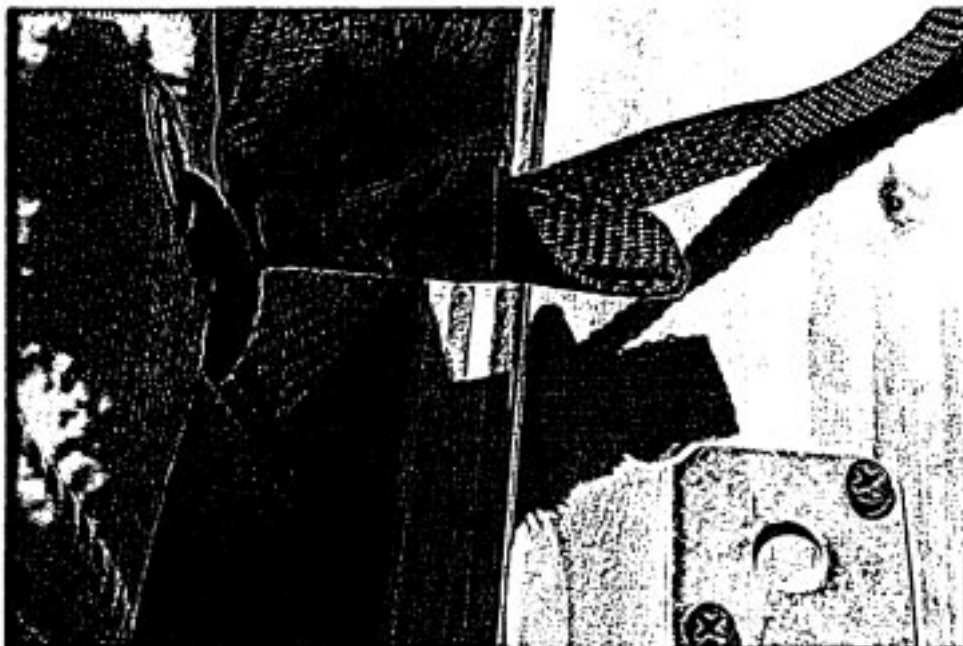
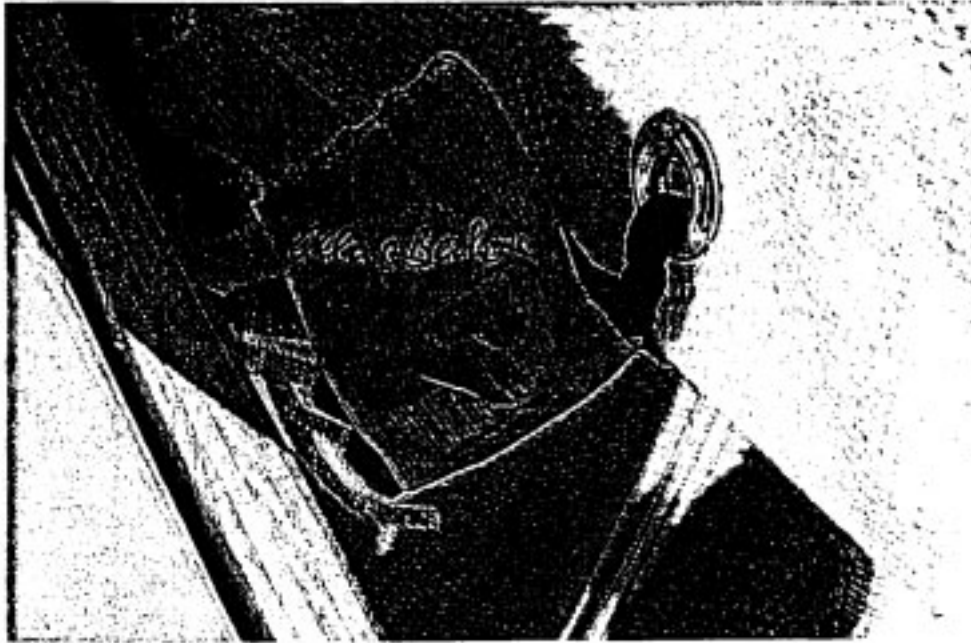
Figure 2.3 Signed Tags on Sealed Crate

Figure 2.4 Signed Tags on Sealed Crate

The steel bands on the crate were added by **SES** when **the** crate was received. Figures 2.3 and **2.4** show the tags that were signed by Allan Beshore, of the NTSB, when the valve was crated by the NTSB. The **tags** were secure and intact.

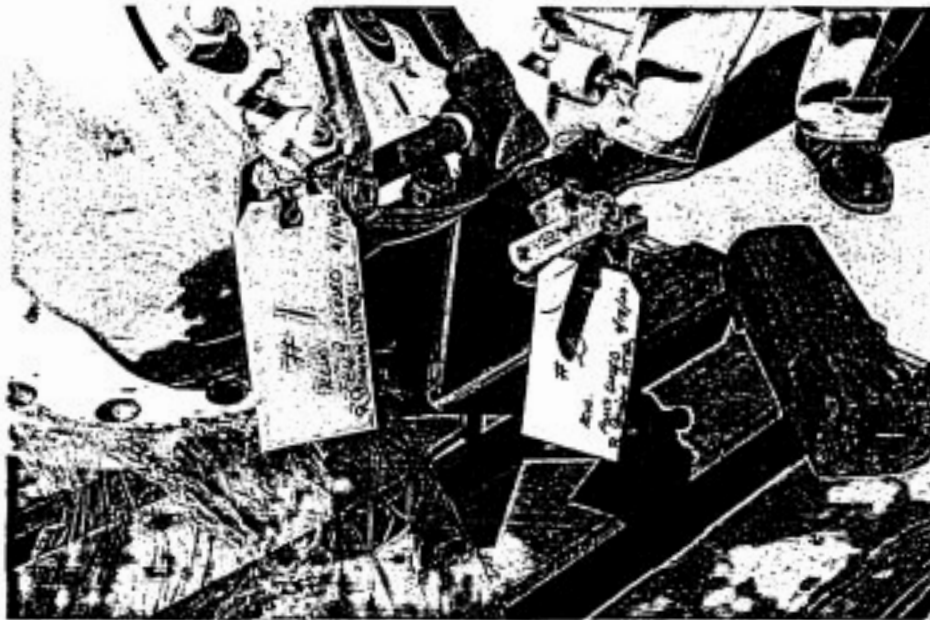
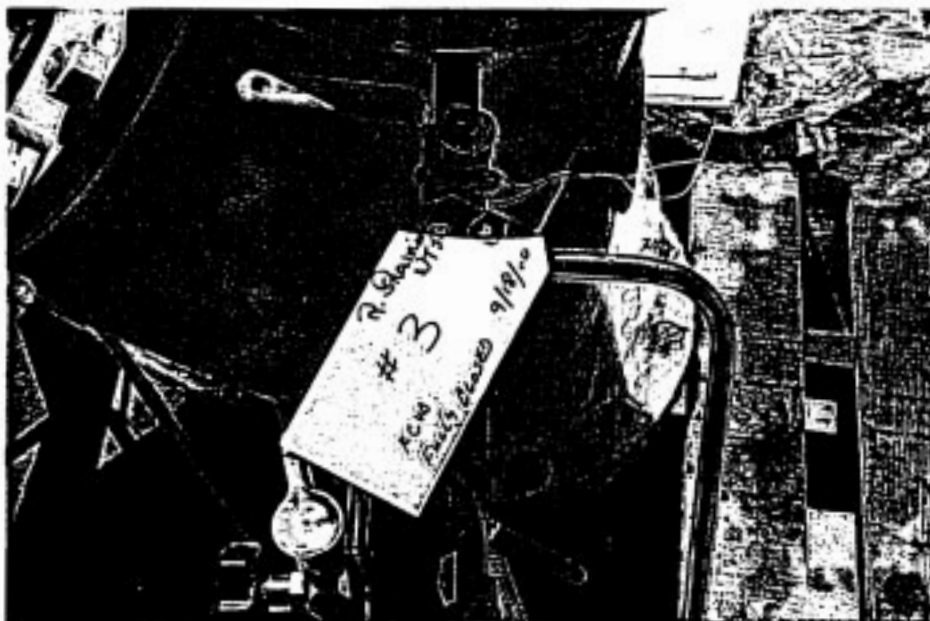
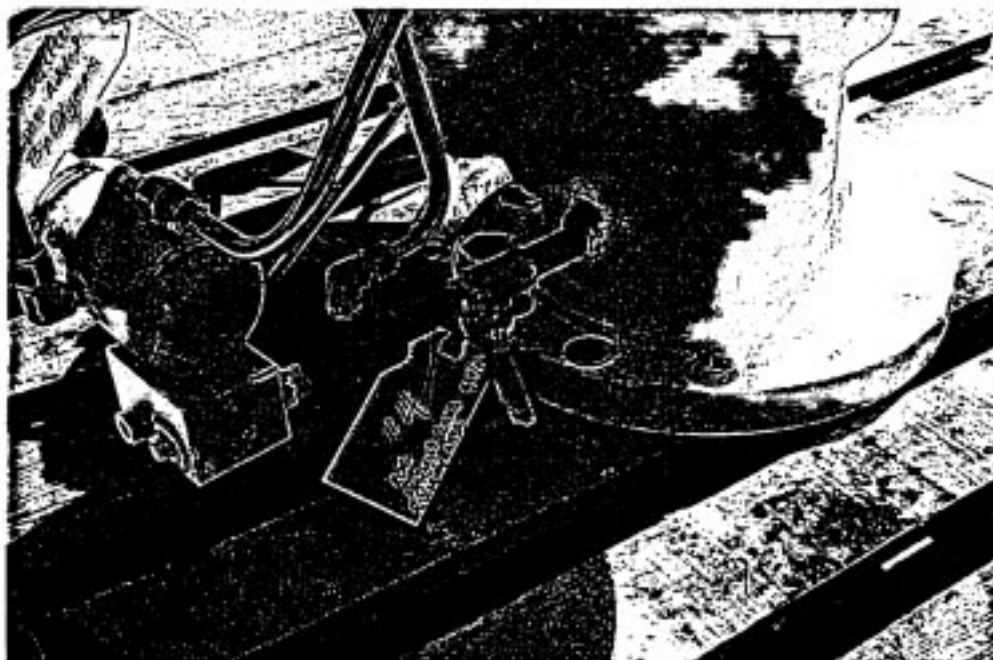
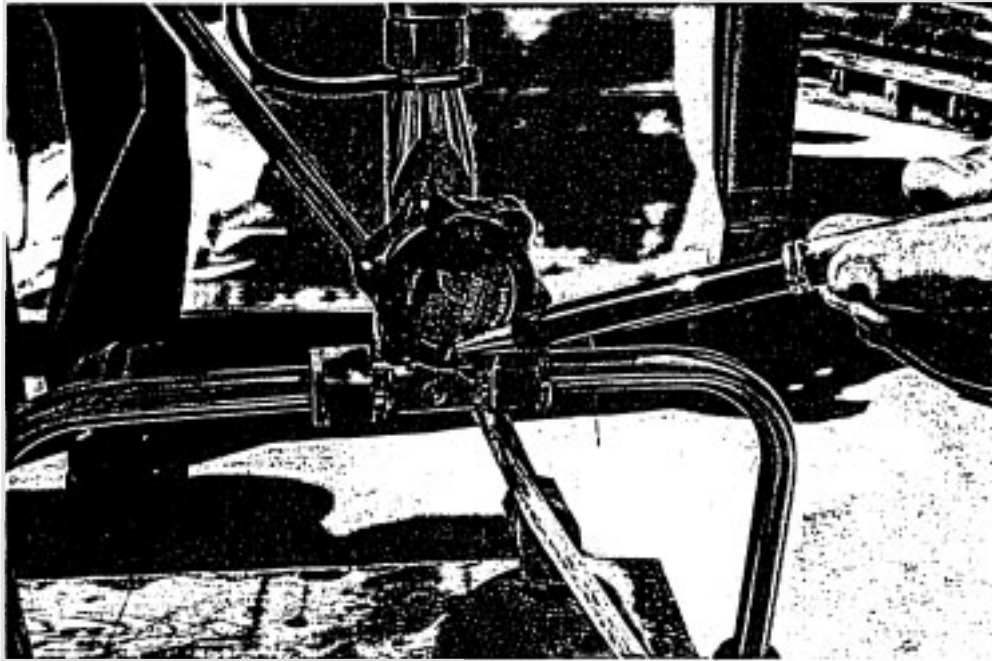
Five manual valves were **installed** in the pilot sensing lines. The Fisher-Rosemount representatives stated that these manual valves were not standard equipment. Four of the valves appeared to be **ball** valves with handles. The **fifth** valve **was** located on a tee in one of the lines and had a knob that could be turned to open or close the valve. The four ball valves were tagged **and** numbered **1 through 4**. Valves 1, **2**, and 3 were **fully** closed. Valve **4** was located in the sensing line between the inlet side of the relief valve and the housing containing the needle valve and strainer assembly. Valve **4** was not fully closed. Photographs of the manual valves which show the orientations and locations of the manual valves **are** shown in Figures 2.7 through 2.10.

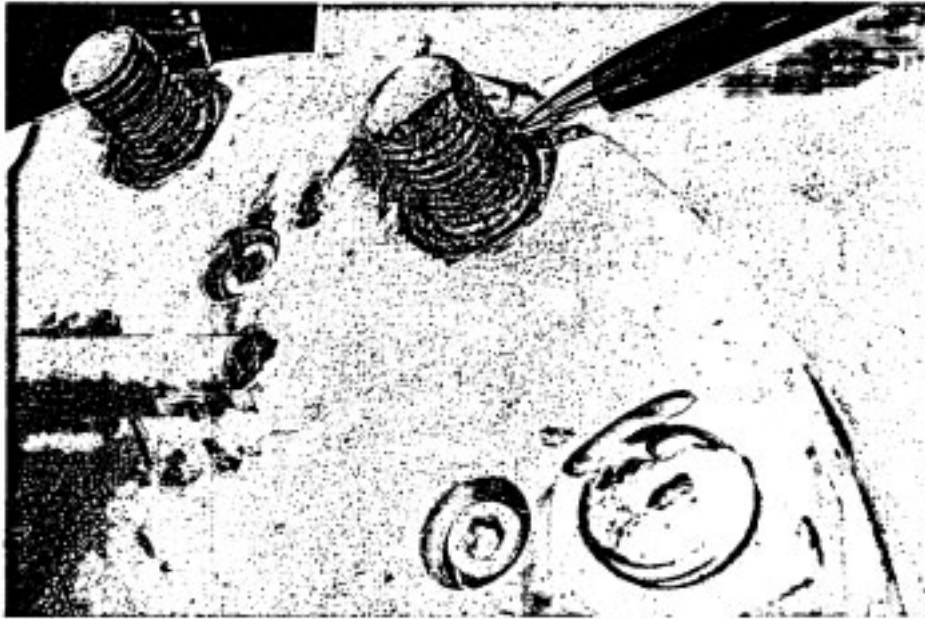
The final item of note in relation to the visual examination of the valve is that two nuts were missing from the cylinder head. SES understands that these nuts were in place before the valve was removed from the line. Figure 2.11 shows the studs where the nuts were missing. In addition to the nuts being missing, one of the studs had significant thread damage. The damaged stud is the one with the pen pointing to it in Figure 2.11.

Figure 2.11 Missing Nuts and Damaged Stud

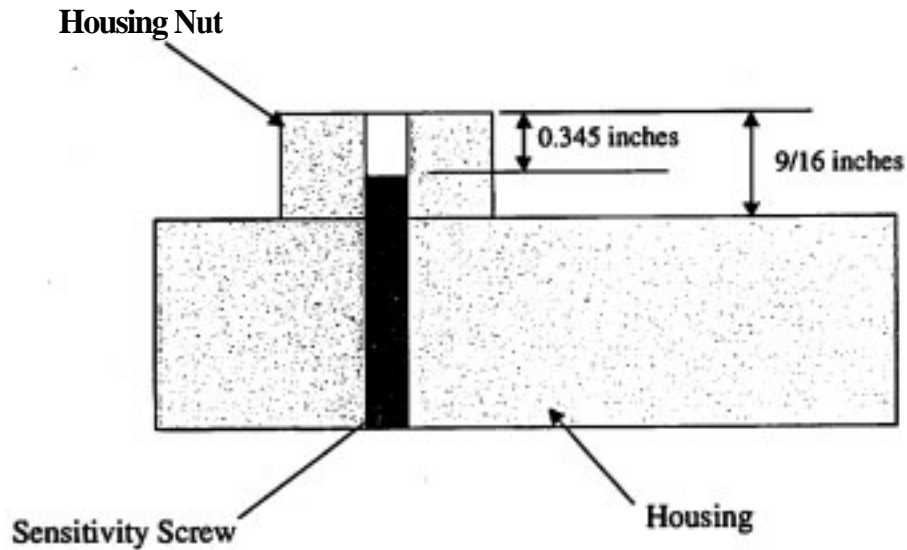
The sensitivity screw was also examined. **This** sensitivity screw controls a needle valve. The position of the needle affects the closing speed of the relief valve. Measurements were taken to record the position of the sensitivity screw. The top of the screw was **0.345** inches below the top of the housing nut. The height of the housing nut was **9/16** inch. A sketch illustrating these dimensions is included in Figure **2.14**. The housing which contains the sensitivity screw is **rectangular** in shape and contains **a** strainer in addition to the needle valve. The pilot valve mounts to a port in **this** housing. In **Figure 2.9**, the housing **can** be seen adjacent to the pilot valve.

Figure 2.14 Measurements of Sensitivity Screw Location

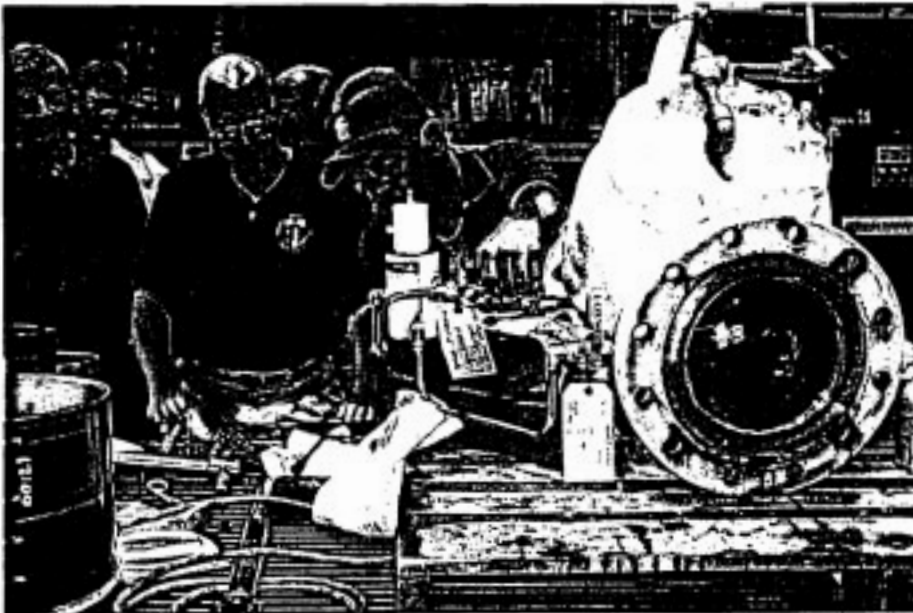
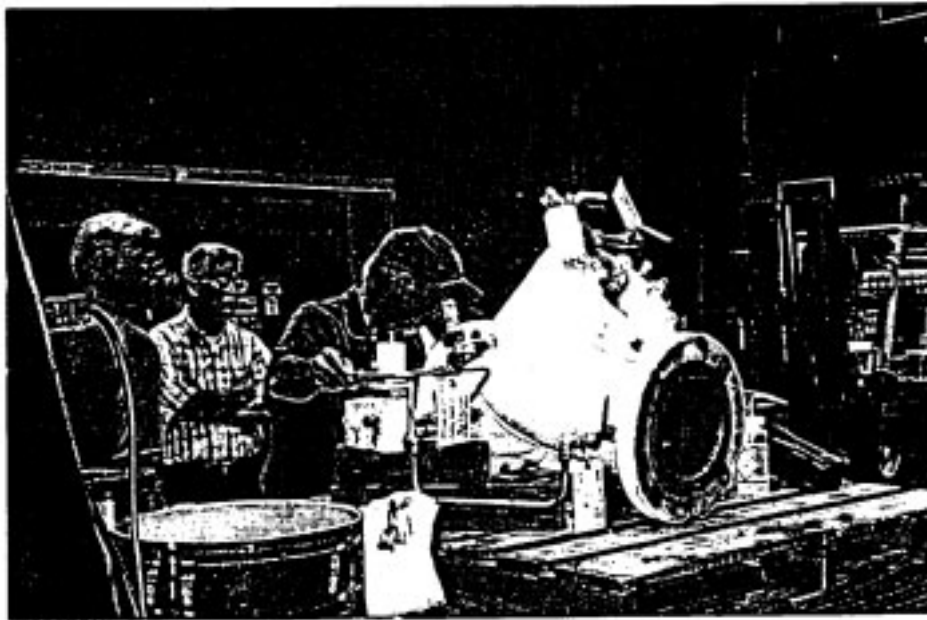
All of the lines and components were examined with the optical probe. There were no debris or blockages found. All of the lines and the strainer were clean. During the examination, a significant amount of gasoline, approximately 5 quarts, was drained from the cylinder head. Figure 2.15 shows the gasoline being drained ~~from~~ the cylinder head. Figure 2.16 shows the gasoline that was drained. The gasoline was discolored, but appeared ~~free~~ of debris. Figures 2.17 through 2.19 show the optical probe inspection.

There ~~was~~ nothing found during the radiographic, visual, or optical probe inspection that would indicate that the valve would not operate.

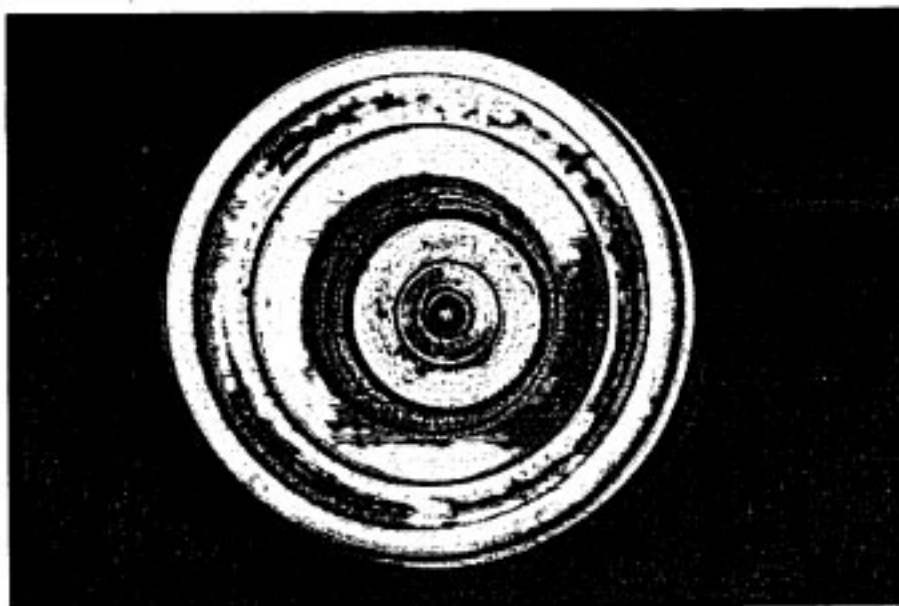
The next step in the disassembly process was to remove and inspect the spring cover. There **was** no apparent damage to the O-ring in the spring cover. The O-ring was brown in color and had no cuts or tears. The O-ring groove was clean. There **was** no visible damage to the inside of the cover. However, there was a sticky residue on the piston seating surface of the inside cover.

Figure 4.8 Inside Cover of Pilot Valve

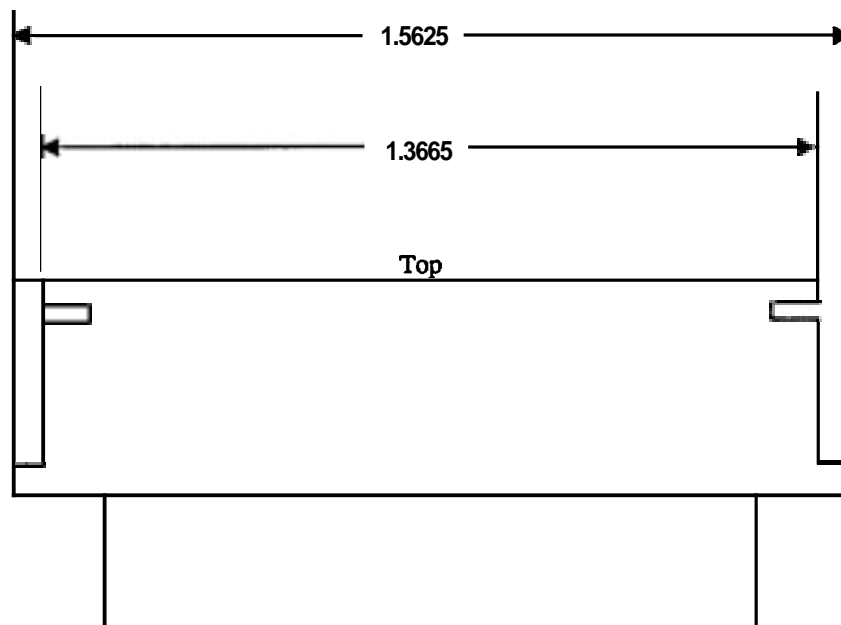
Figure 5.2 Dimensions of Piston from HP Exemplar Pilot Valve

It was noted that the dimension taken at the top of the piston, 1.3665 inches, does not match the 1 13/64 inch dimension in the available literature (i.e., the pilot spring selection table).
