## Air Safety Investigations Aircraft Incident/Accident Technical Report

<b>Aircraft Incident/ Accident Information</b>	Year: 1959	Make: Cessna	Model: 175
	Serial number: 55884		Registration: N7584M
Location: Reserve, NM		Date: 10-15-21	Time: 1100 MDT
<b>Aircraft Owner</b>		<b>Aircraft Operator</b>	
Harry A. Pecotte [REDACTED] Silver City, NM 88061-6646		Same as Aircraft Owner	
<b>Report Information</b>			
Senior Air Safety Investigator: Peter J. Basile		Report #: ASI-21-CW-T	Report date: 01-03-22

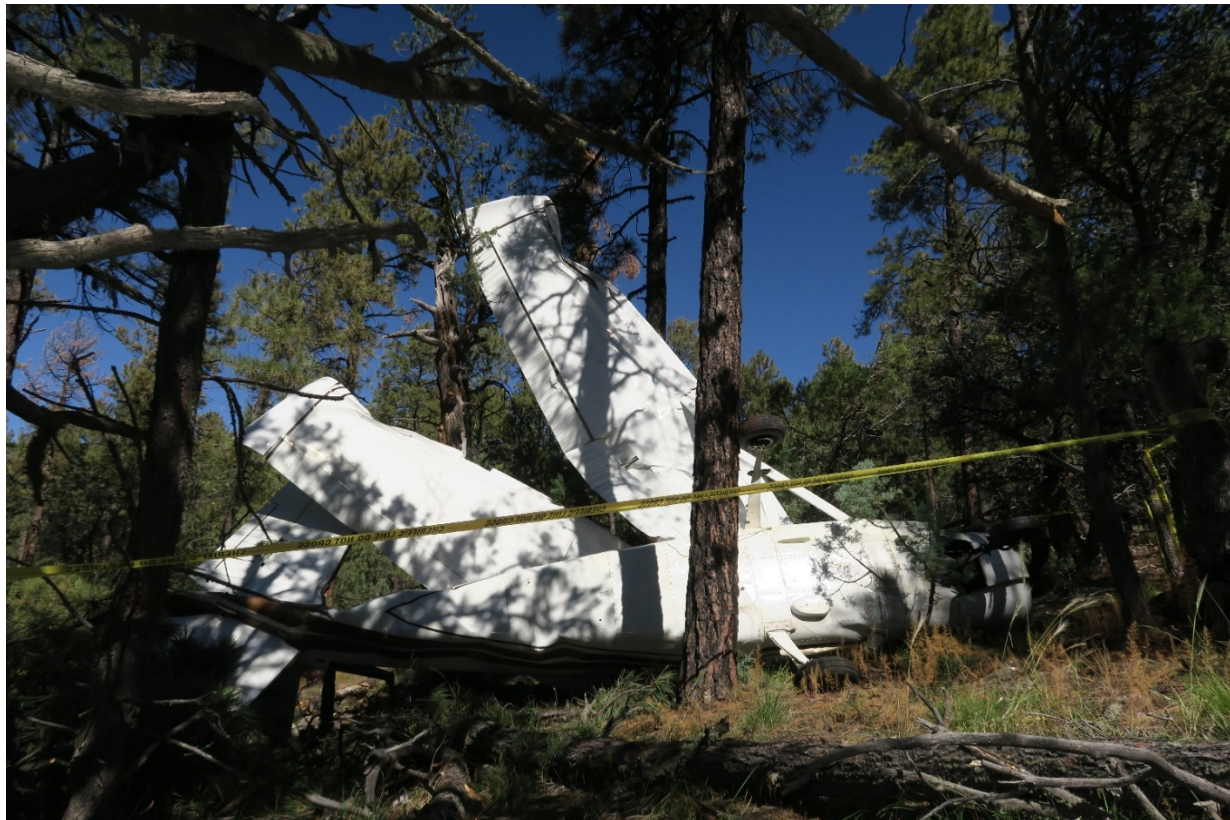
On-site, ASI-21-CW-012

The wreckage path from the initial tree strike to the fuselage was about 100' long on an approximately 090° heading. The leading edge of the left and right wing sustained tree impact damage. The aircraft came to rest on the left side of the fuselage with the partially separated left wing bent backwards and sticking up in the air. The fuselage sustained minimal fragmentation and appeared to impact the trees and terrain at a slow airspeed.

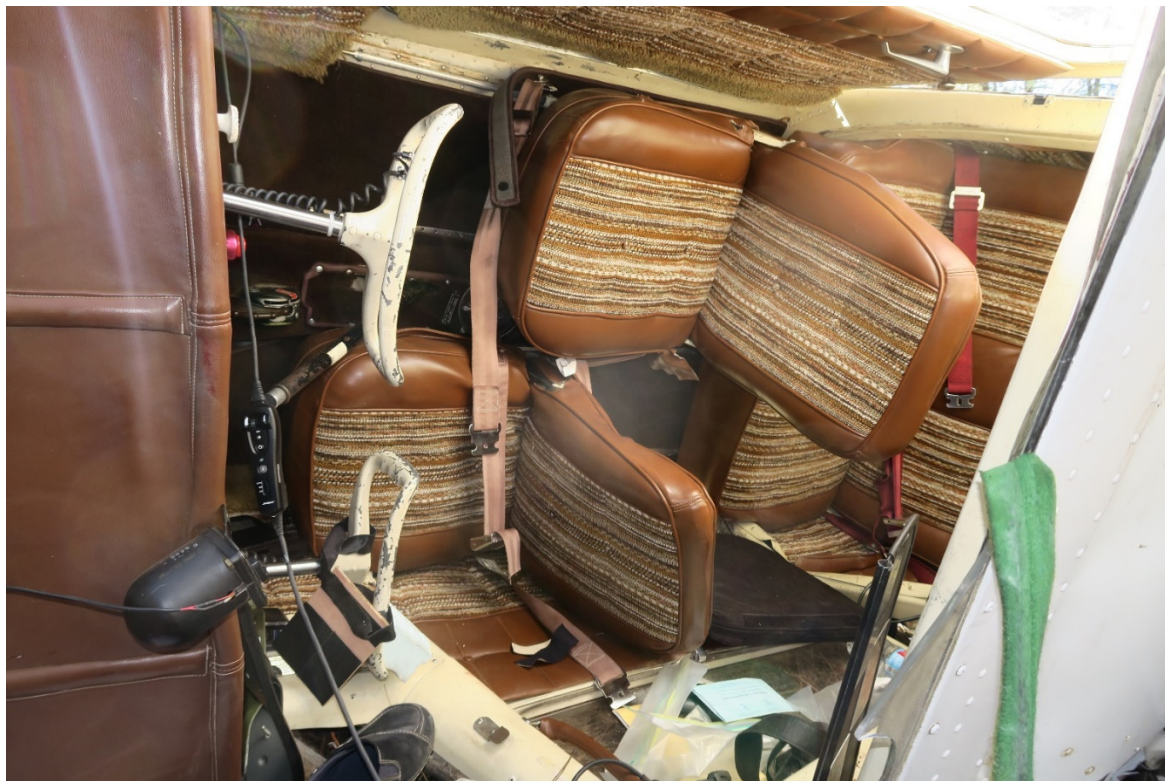
On-site, ASI-21-CW-026

The seats remained attached to the floor assembly. Passenger seating positions were undetermined. The aircraft was equipped with lap belts; all lap belts were found unbuckled.
