## Air Safety Investigations Aircraft Incident/Accident Technical Report

Aircraft Incident/ Accident Information	Year: 1975	Make: Cessna	Model: 414
	Serial number: 414-0603		Registration: N1996G
Location: Monongahela, PA		Date: 06-19-22	Time: 1304 EDT
Aircraft Owner		Aircraft Operator	
Caiolinn Chelsea Ertel [REDACTED] Spokane Valley, WA 99037-8543		Same as Aircraft Owner	
Report Information			
Senior Air Safety Investigator: Ernest C. Hall		Report #: ASI-22-BN-T	Report date: 09-06-22

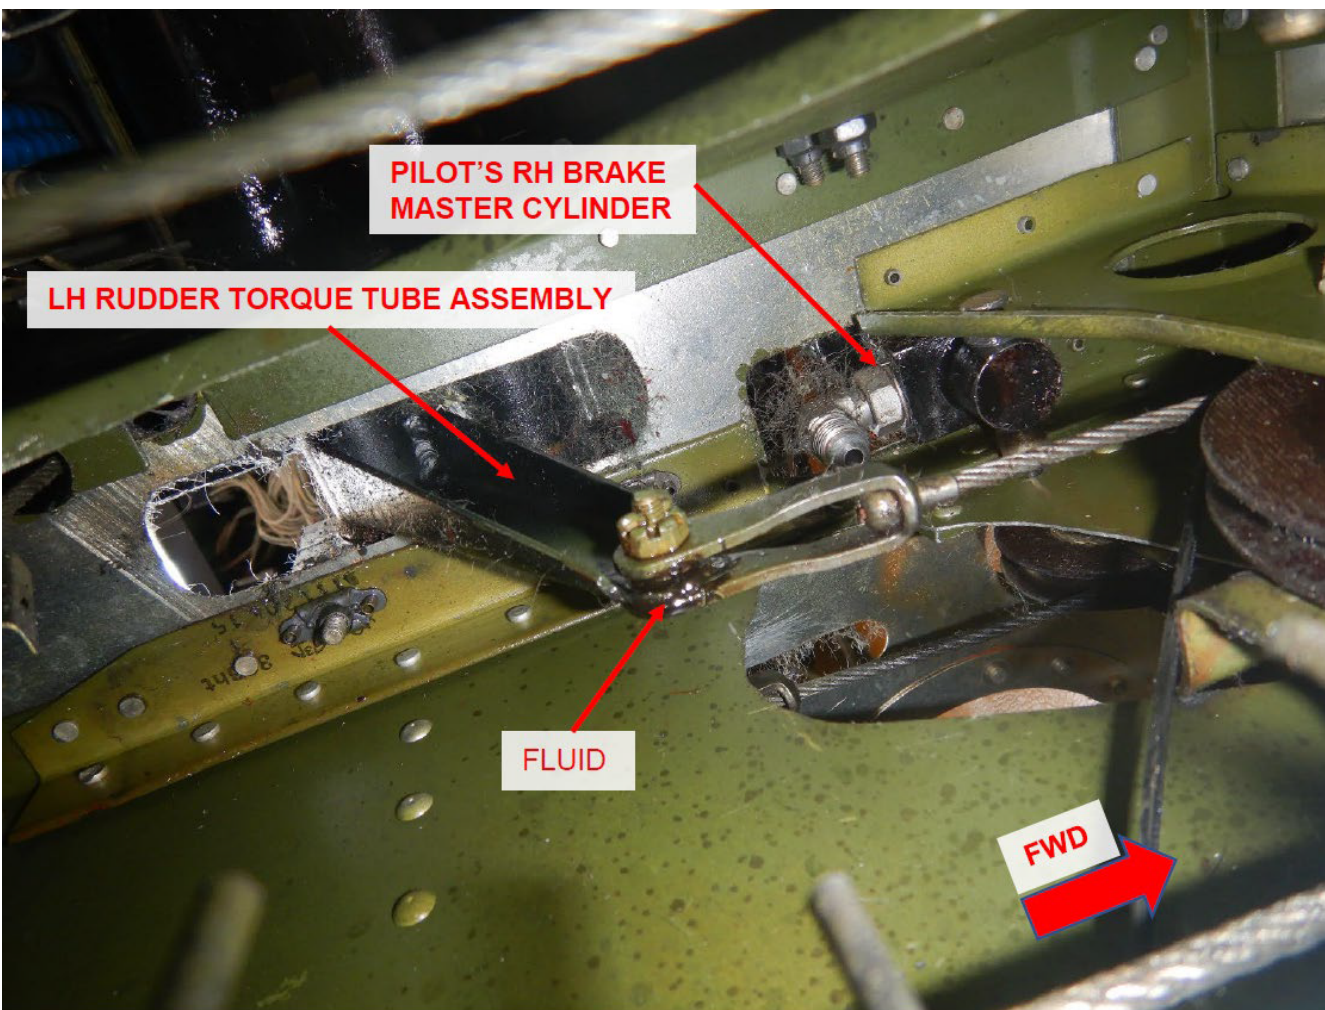
The pilot's side, cockpit floorboard carpet and panels were removed to access below the floorboard to examine the brake hoses and fittings. After removing the exterior access panel on the bottom of the aircraft just aft of the nose landing gear bay, hydraulic (brake) fluid was observed in the area. One of the connections between the pilot's right brake master cylinder and the connecting brake hose was found loose.

Textron Aviation - ASI-BN-019 – Looking Up Through Exterior Access Panel

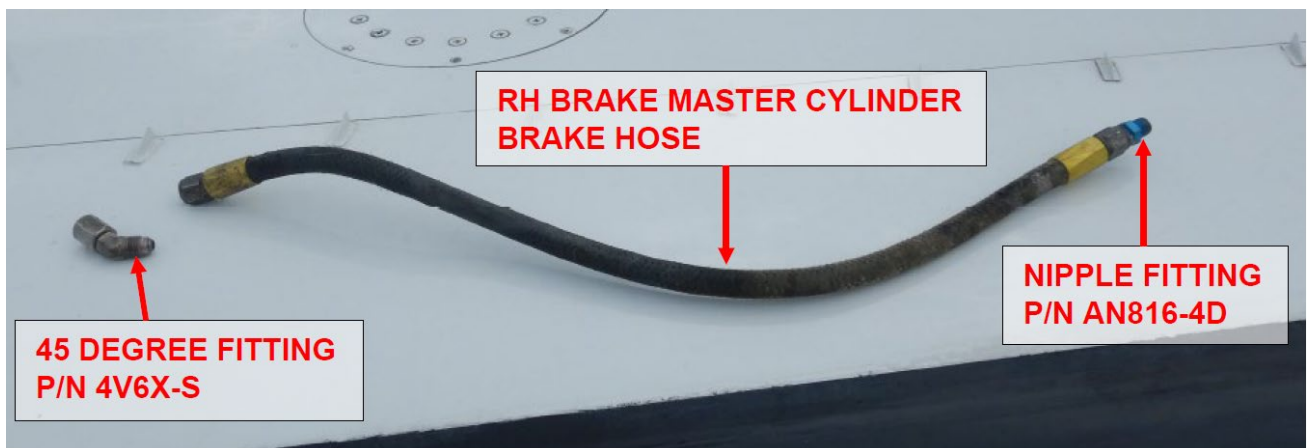
Cropped – Textron Aviation – ASI-22-BN-021

Each connection was checked for tightness by hand. Each part number listed are per the applicable aircraft model IPC. The pilot's RH brake master cylinder 90° fitting, part number 4C5BX-5, was found to be tightly secured to the cylinder. The 45° fitting, part number 4V6X-S, that attaches to the 90° fitting was found loose. The brake hose, part number S1167-4-0202, that attaches to the 45° fitting, part number 4V6X-S, was found to be tight. The other end of the brake hose that attaches to the parking park valve assembly, part number C165007-0201, was found to be tight.

The brake hose found installed was a different part number, 111417-4S0520, than what is called out in the applicable aircraft model IPC. According to S1167 specification, it indicates: "Hose shall conform to MIL-H-8794. Approved sources & hose designation: Aeroquip, Type 303 & Stratoflex, Type 111." The installed hose assembly appeared to be similar standard MIL and AN style spec fitting hose assembly. Review of the aircraft logbook, two brake hose's part number 111417-4S0520, LH & RH, were installed on 10-15-12.
