## Air Safety Investigations Aircraft Incident/Accident Technical Report

Aircraft Incident/ Accident Information	Year: 1984	Make: Beechcraft	Model: A36
	Serial number: E-2203		Registration: N100JB
Location: Colusa, CA		Date: 01-07-19	Time: 1050 PST
Aircraft Owner		Aircraft Operator	
Chalk Hill Consulting Group LLC [REDACTED]		Jeffrey Thomas Webber [REDACTED]	
Report Information			
Air Safety Investigator: Jennifer D. Barclay		Report #: ASI-19-AE-T	Report date: 07-08-19

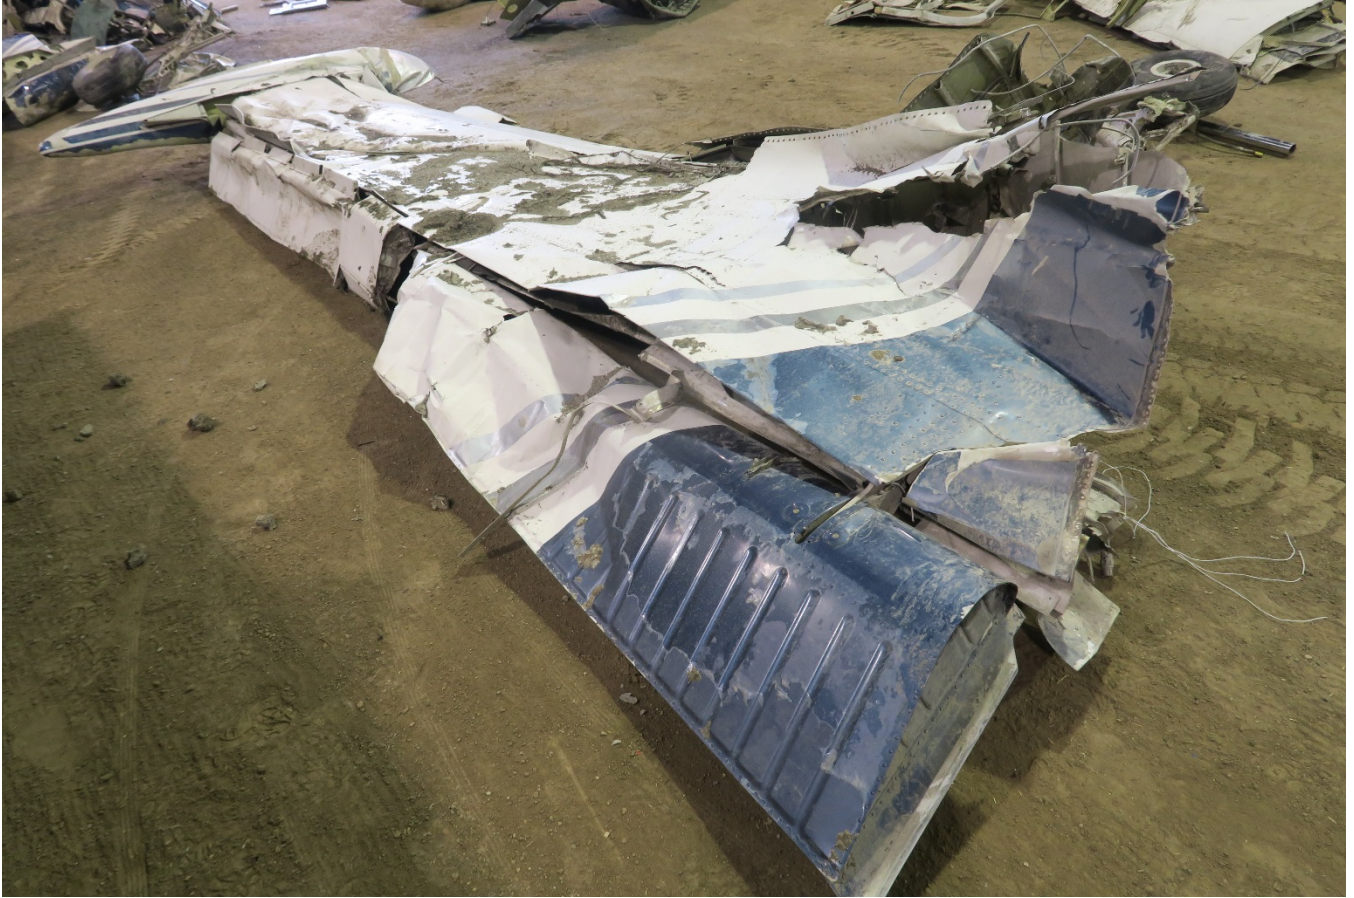
Left wing, ASI-19-AE-038

The aircraft impacted a water irrigation pond in a right wing and nose low attitude. The aircraft was highly fragmented. The vertical stabilizer was not observed. The left and right horizontal stabilizers exhibited leading edge crush damage. The right horizontal stabilizer exhibited inboard skin tearing to the spar. The fuselage was separated at the aft wing spar and just aft of the baggage compartment. The right side of the fuselage was not observed. The left wing sustained minimal leading edge damage to the outboard portion of the wing. The inboard 3' of the left wing was substantially damaged forward of the flap. Most of the right wing was not recovered; the inboard skin with gear leg and gear door attached and a substantially damaged tip tank were observed.

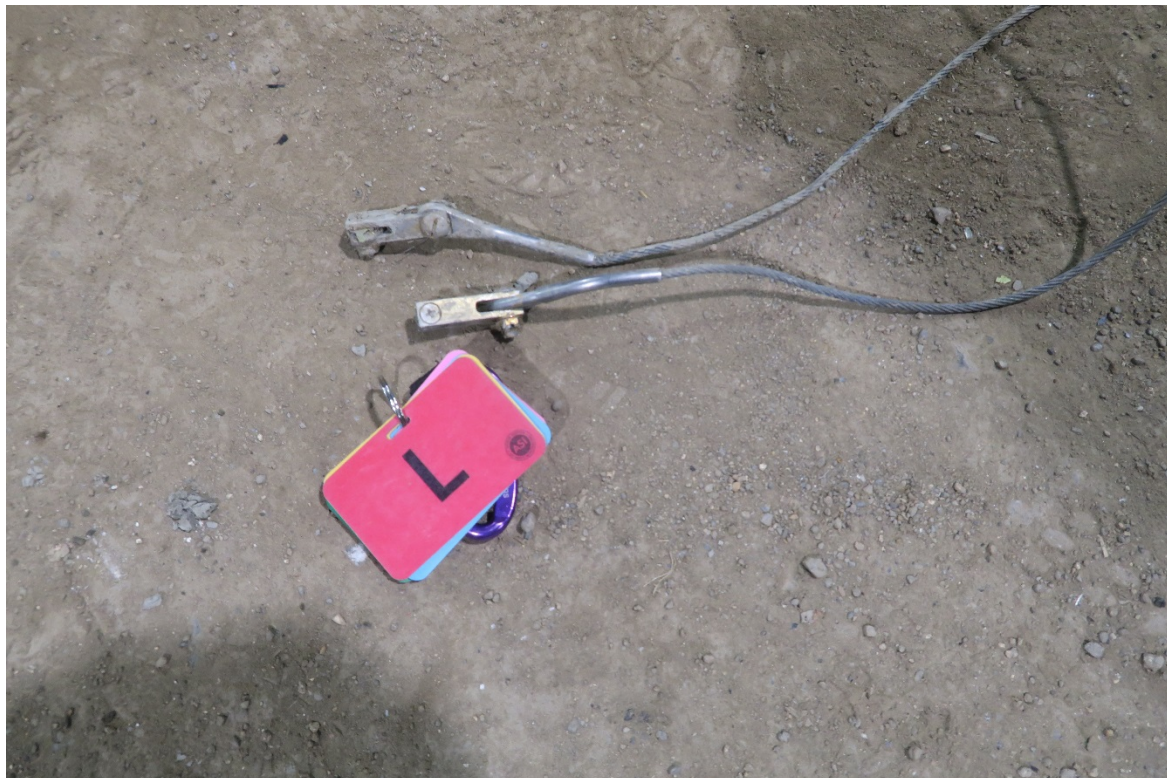
Left aileron cables, ASI-19-AE-066

Partial flight control cable continuity was established due to fragmentation of the wreckage. The rudder cables were attached to the rudder plate and were cut during recovery just aft of the baggage compartment. The elevator cables remained attached to the fractured bellcrank. Aileron cables were observed pulled from the wings and not attached to the fractured bellcranks. Aileron and elevator trim tab measurements were unreliable. The trim tab cables separated in tensile overload. The left flap and aileron remained attached to the left wing. The left flap actuator remained attached to the fuselage, its position indicated the flaps were retracted. The right flap actuator was not observed. Most of the right wing was not recovered.
