March 5, 2019

[REDACTED] ominium
Fort Lauderdale, FL [REDACTED]

RE: Tower Documentation of Paint Transfers and Damage Caused by the Plane Collision

This report is to document the findings of the visual inspection of the east building wall that the plane impacted. This inspection was performed by swing stage on March 2, 2019 by the Project Engineer for the amenity deck and tower structural restoration and architectural projects.

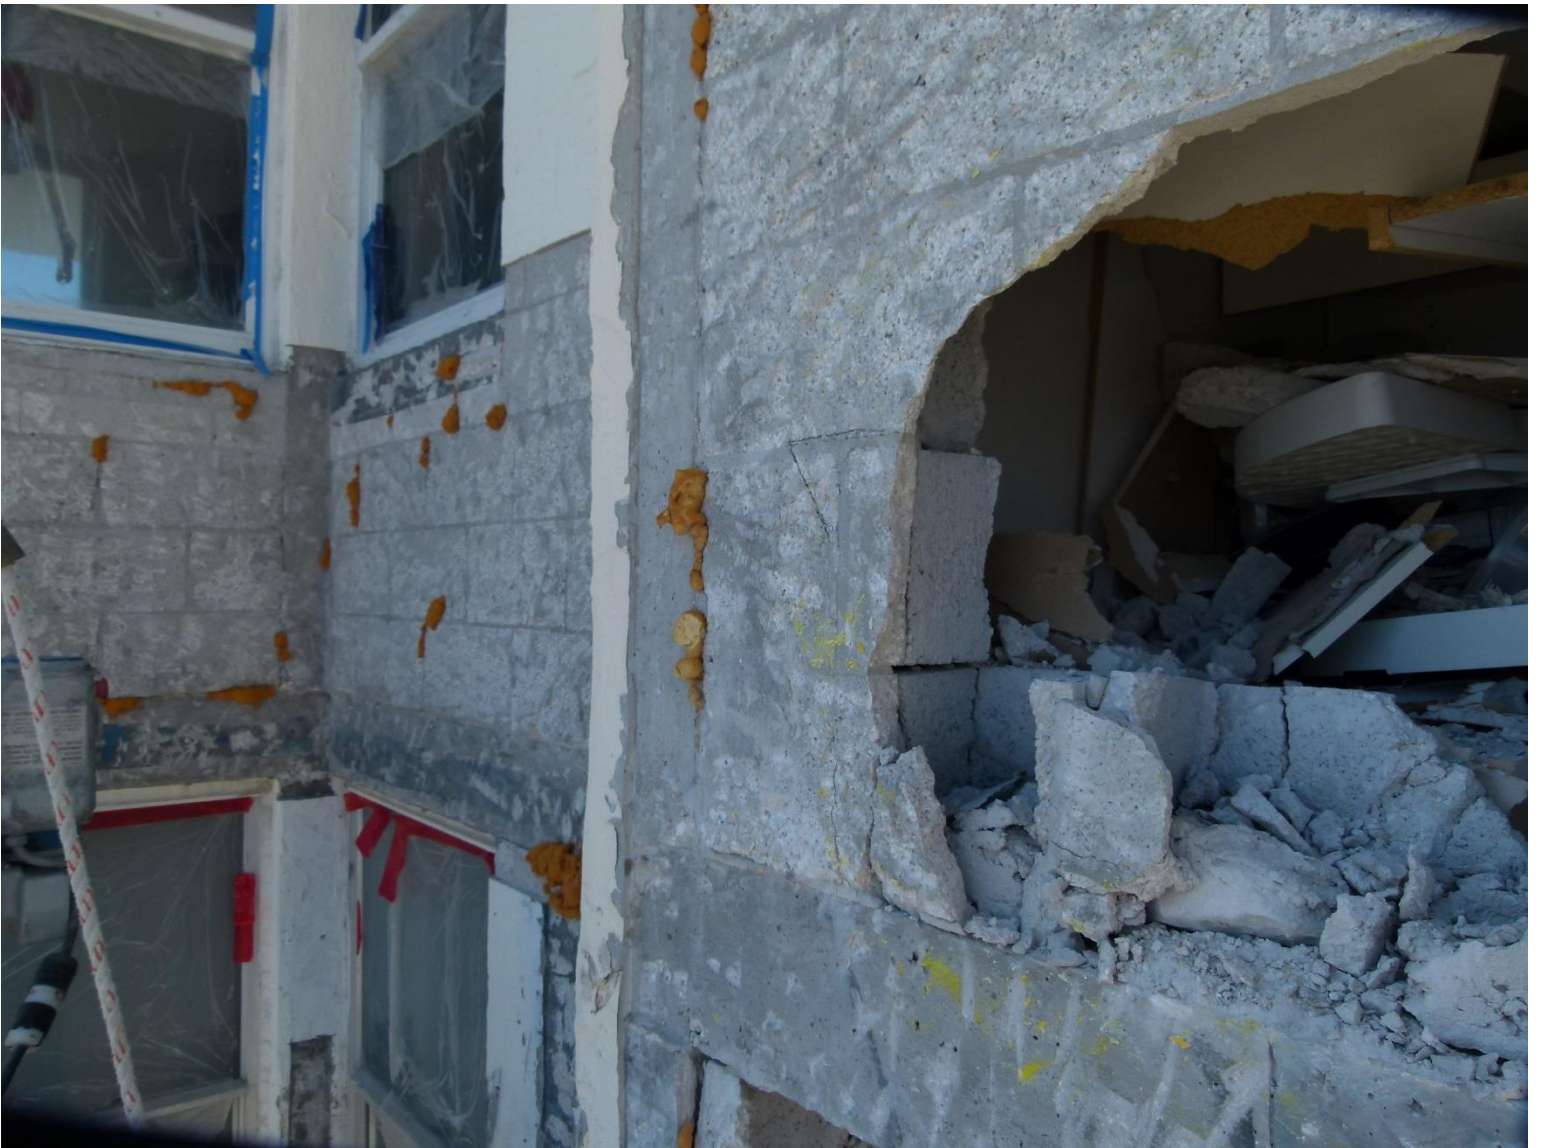
- Apartment 19G: no evidence of paint transfer or impact damage observed on building walls.
- Apartment 19F: no evidence of paint transfer or impact damage observed on building walls.
- Apartment 18G: no evidence of paint transfer or impact damage observed on building walls.
- Apartment 18F: no evidence of paint transfer or impact damage observed on building walls.
- Apartment 17G:
 - Above kitchen window header:
 - No evidence of paint transfer or impact damage observed on building walls.
 - Window level (between kitchen window header and kitchen window sill):
 - No evidence of paint transfer or impact damage observed on building walls.
 - Below/adjacent to kitchen window sill:
 - Approximately a 45" x 24-1/2" opening in CMU wall caused from impact of plane. Opening is approximately 18" from south exterior wall edge. Refer to attached Figure 1.

Figure 1: Opening in 17G showing damage and paint transfer markings.

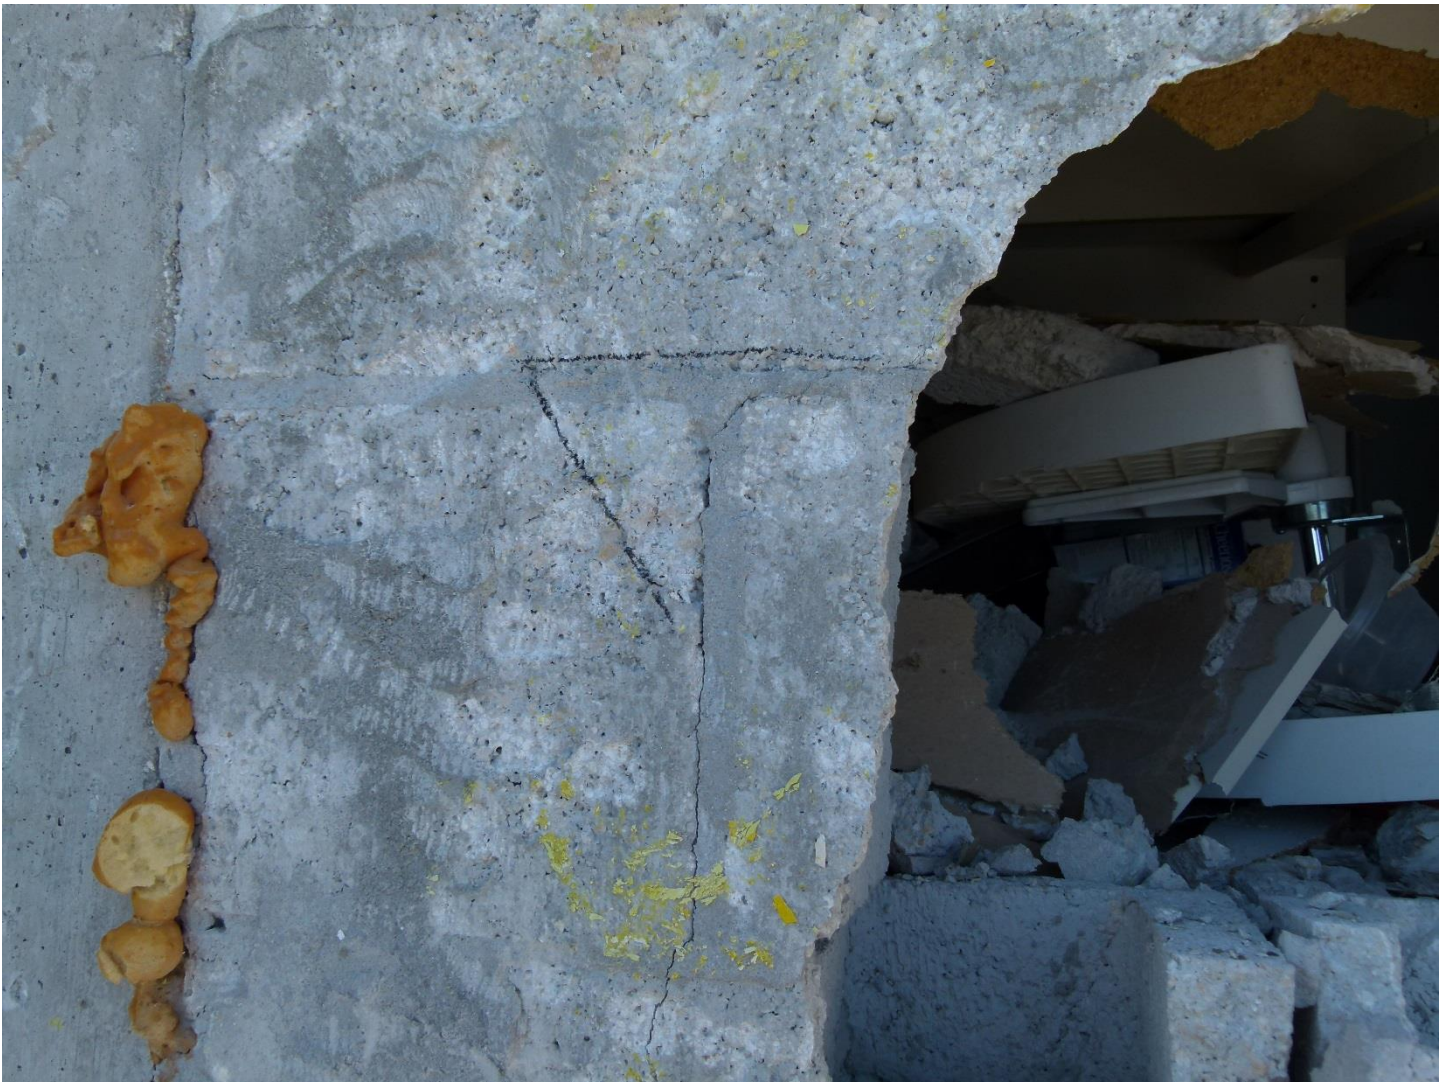
- Paint transfer from plane was observed all around opening. Paint transfer opening is angled downward at an approximate 60° angle. Refer to attached Figures 2 and 3.

Figure 2: Angle drawn to paint transfer adjacent to 17G opening.

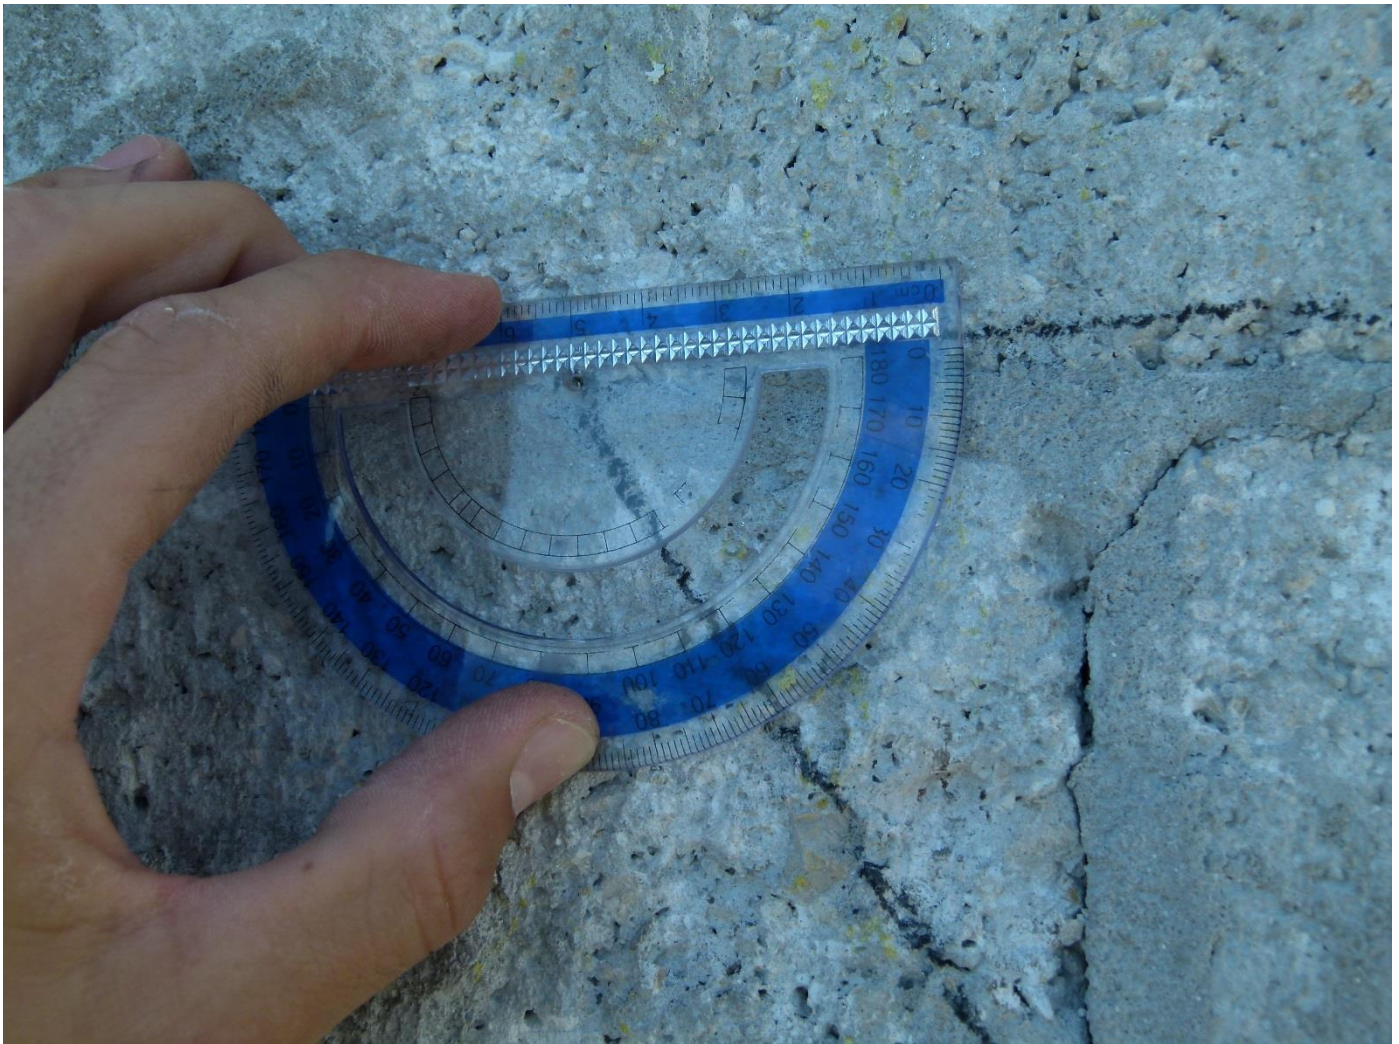
Figure 3: Approx. measurement of angle drawn to paint transfer of 17G opening.

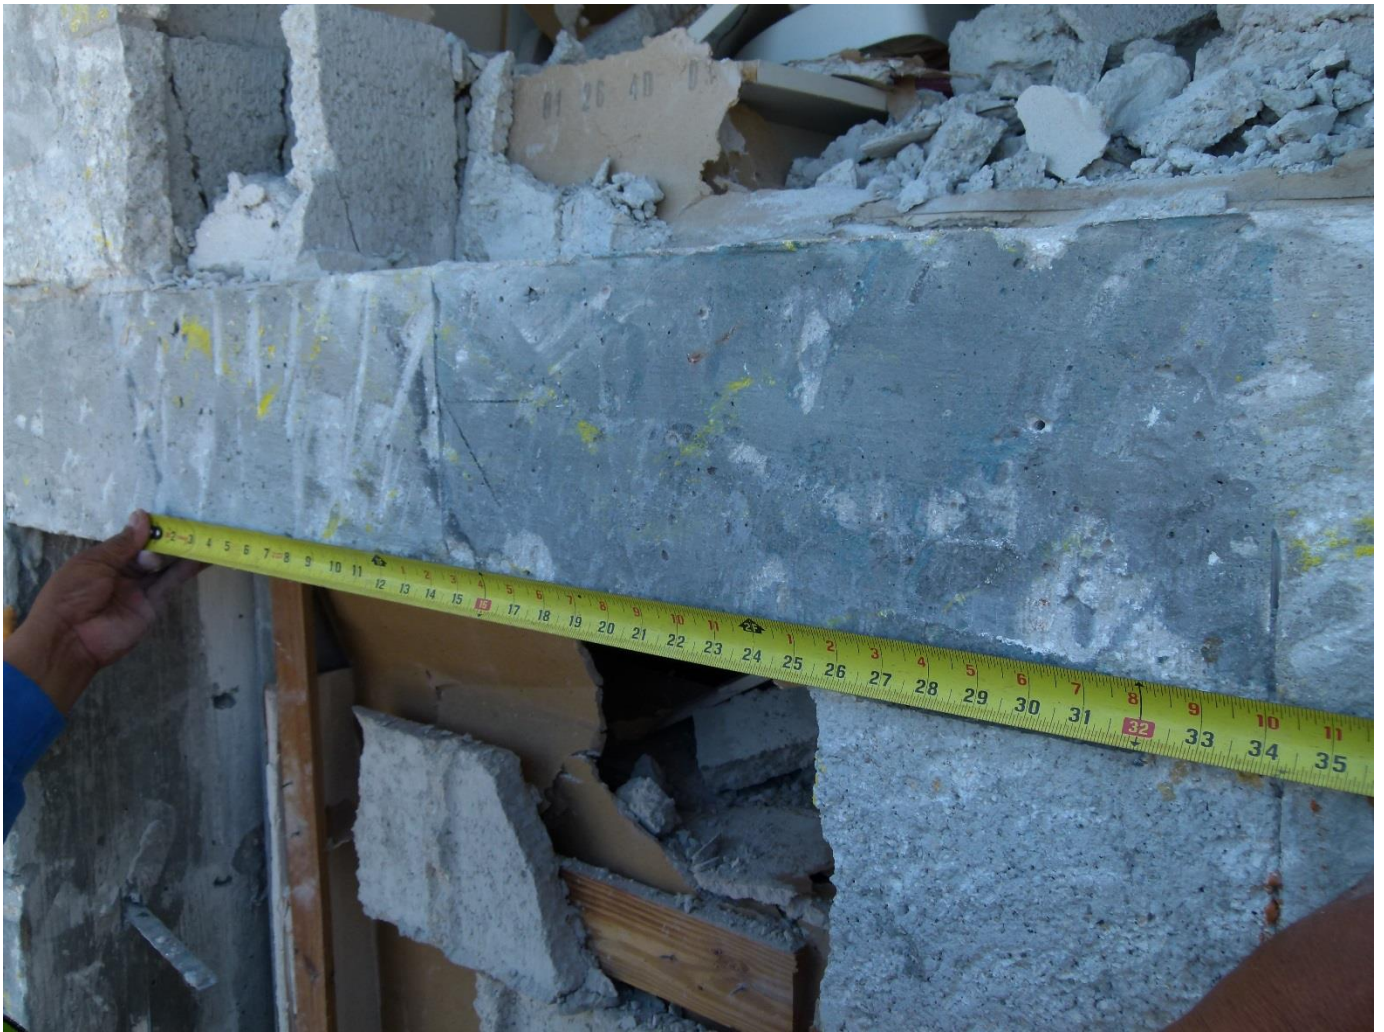
- Slab edge between 17G and 16G:
 - Vertical striations in concrete, not typical in undamaged concrete, were observed. Refer to attached Figure 4.
- Apartment 16G:

Figure 4: Vertical striations in concrete slab between 16G and 17 G.

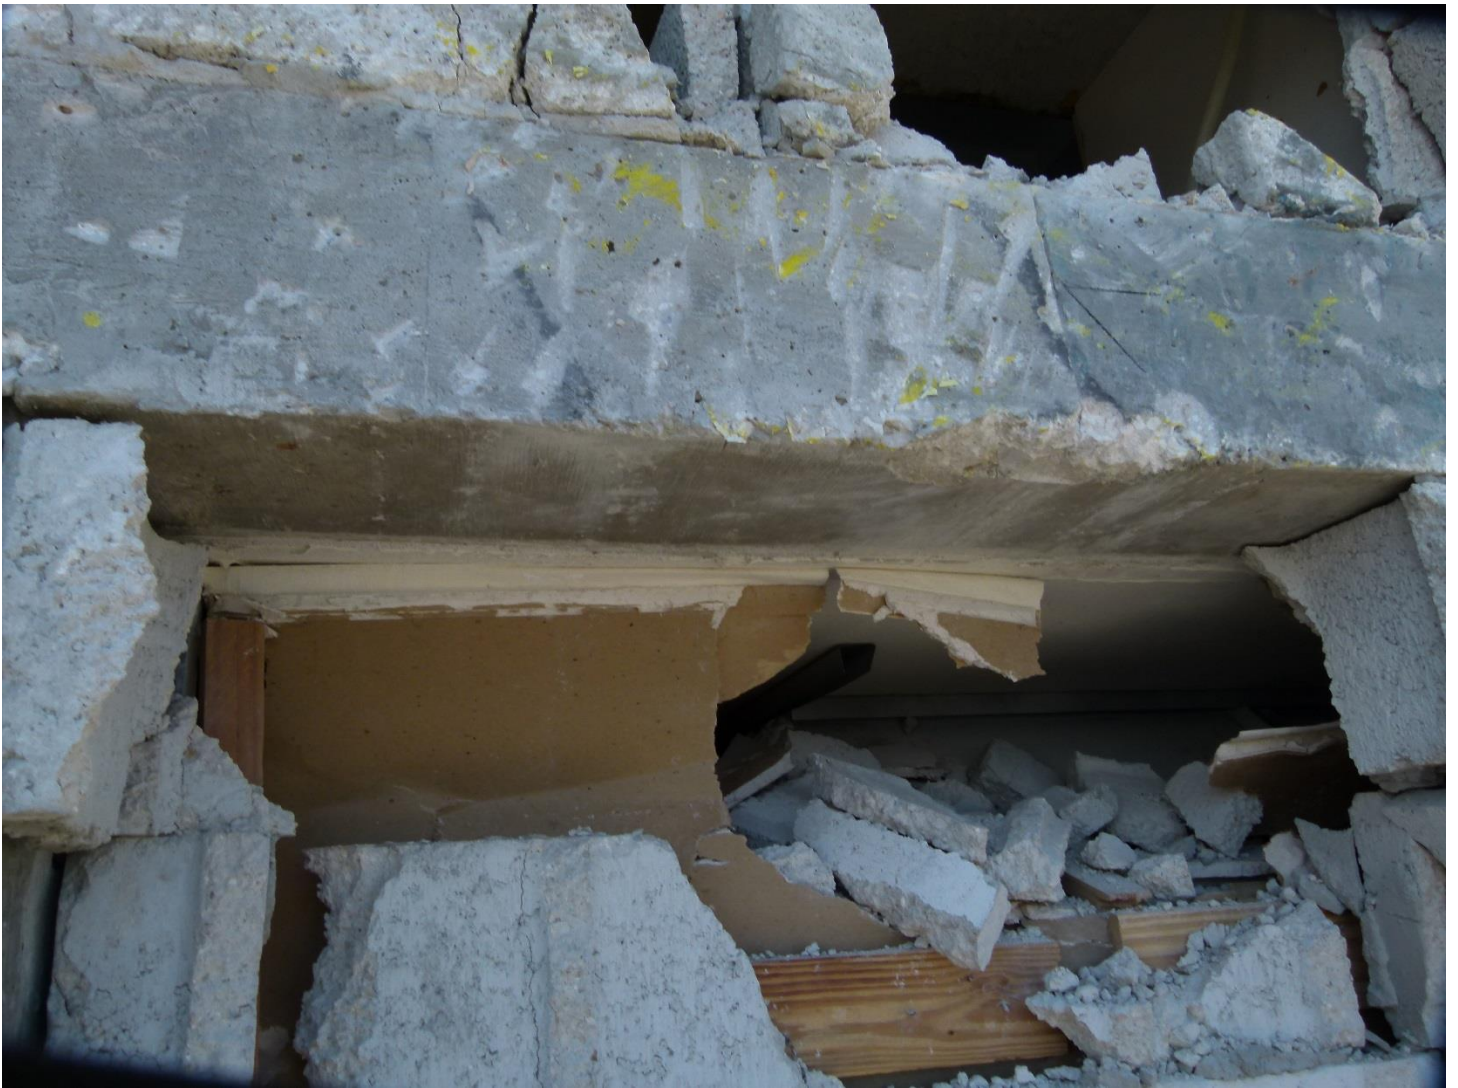
- Above kitchen window header:
 - Paint transfer from plane was observed all around opening. Paint transfer across opening is angled downward at an approximate 50° angle. Refer to attached Figure 5.

Figure 5: Angle drawn to paint transfer adjacent to 16G opening.

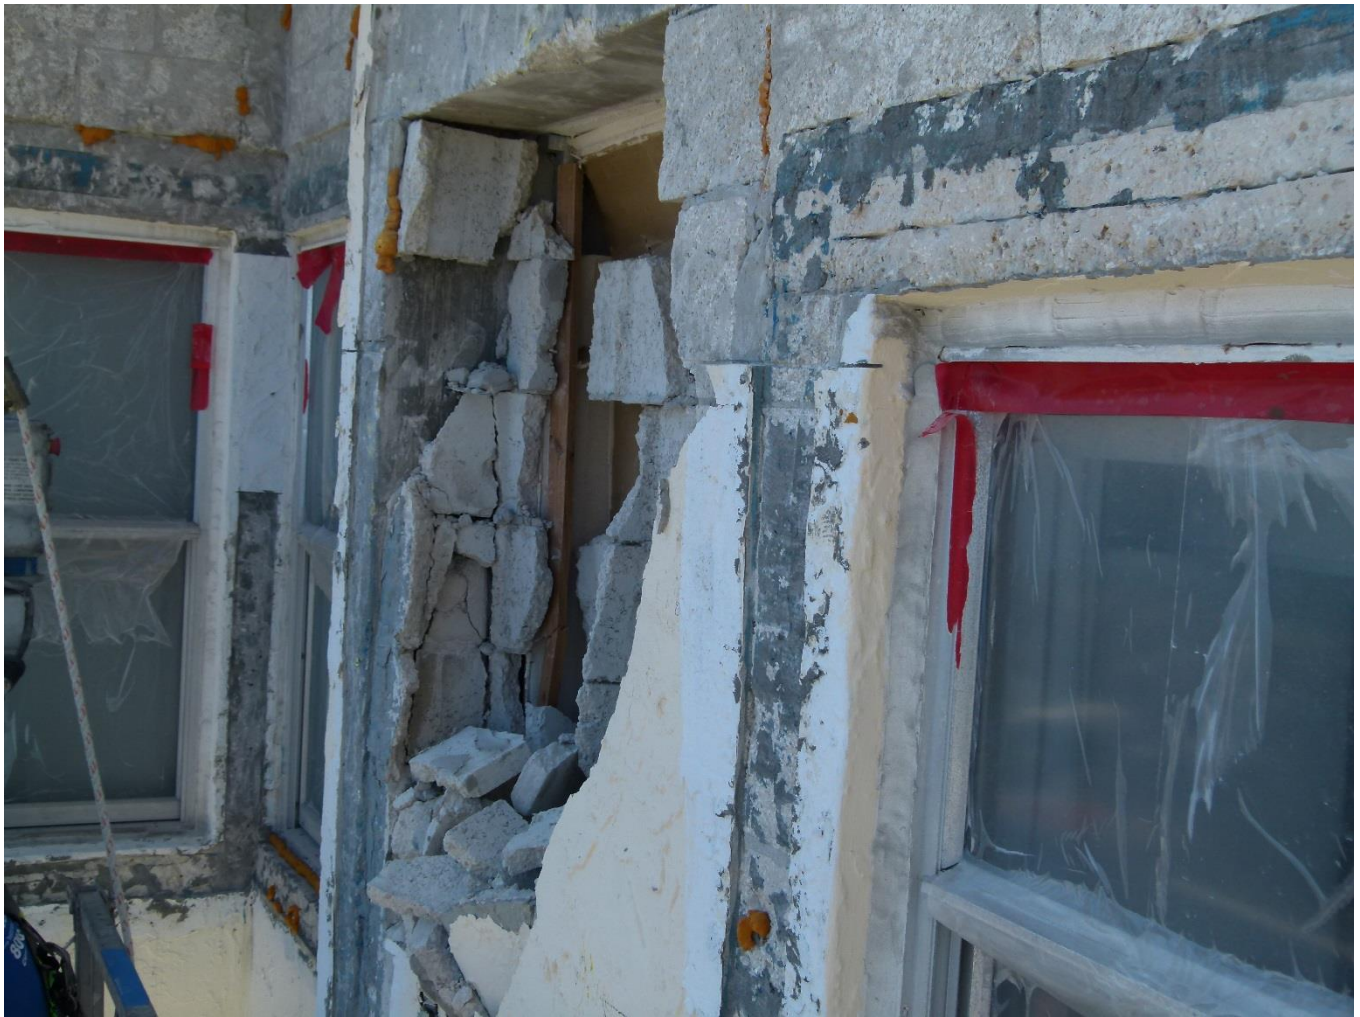
Figure 6: Opening in 16G showing damage and paint transfer markings.

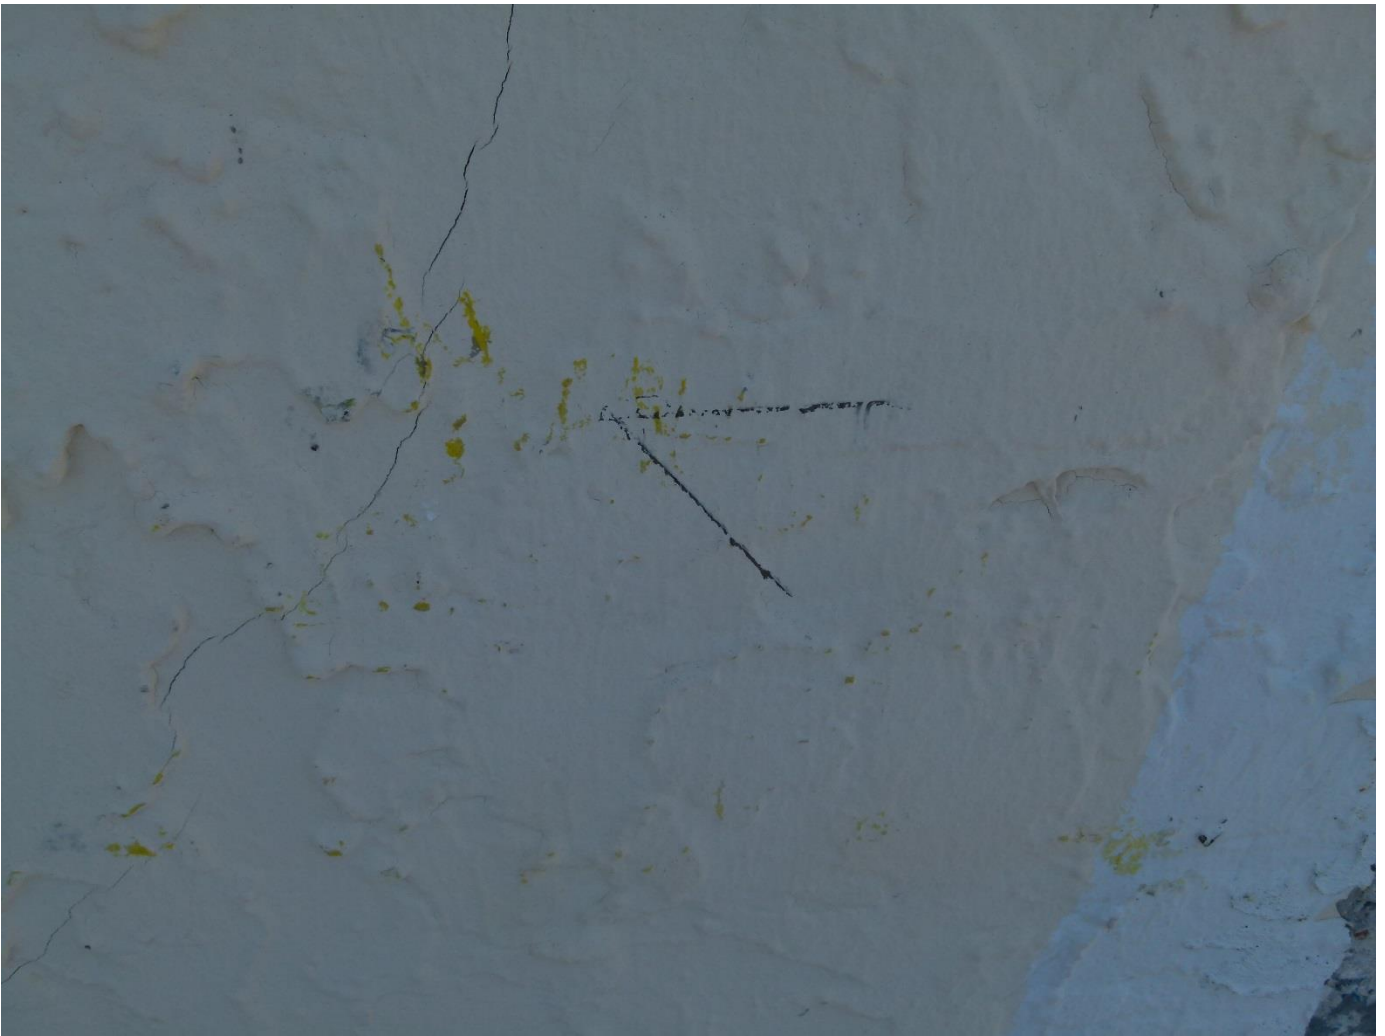
- Approximately a 51” x 42” opening in CMU wall caused from impact of plane. Refer to attached Figure 7.
 - Window level (between kitchen window header and kitchen window sill):

- Paint transfer from plane was observed all around opening. Paint transfer across opening is angled downward at an approximate 50° angle. Refer to attached Figure 7.

Figure 7: Angle drawn to paint transfer adjacent to 16G opening and window.

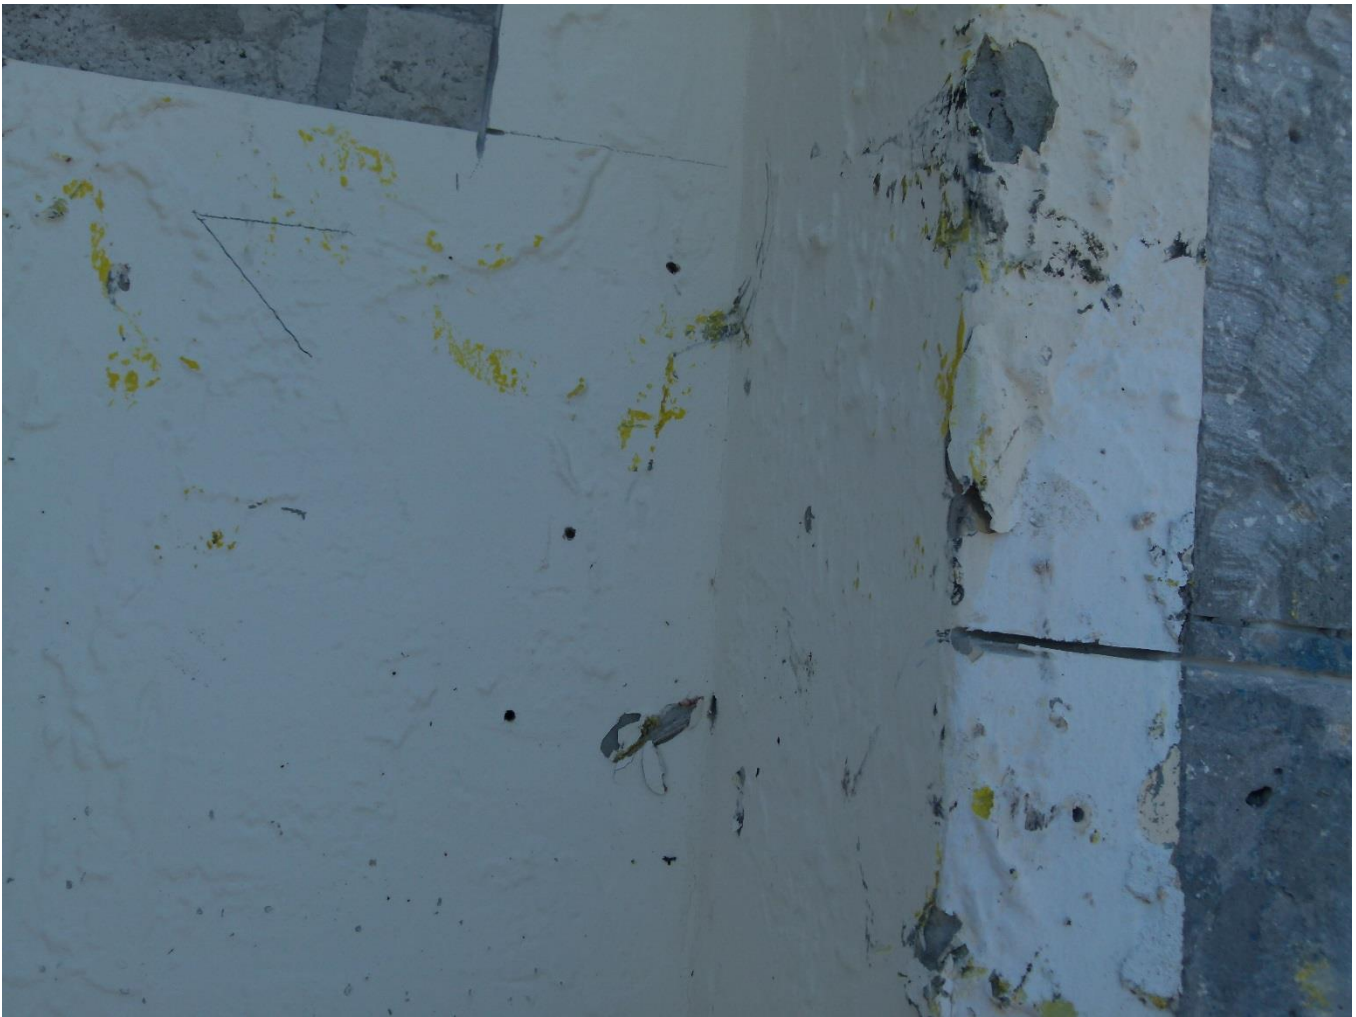
- Stucco striations and paint transfer was observed on south window stack wall of 16G (adjacent to opening) angled downward at an approximate 50° angle. Refer to attached Figure 8.

Figure 8: Stucco striations and paint transfer observed on south window stack wall of 16G (adjacent to opening) angled downward with approx. drawn angle.

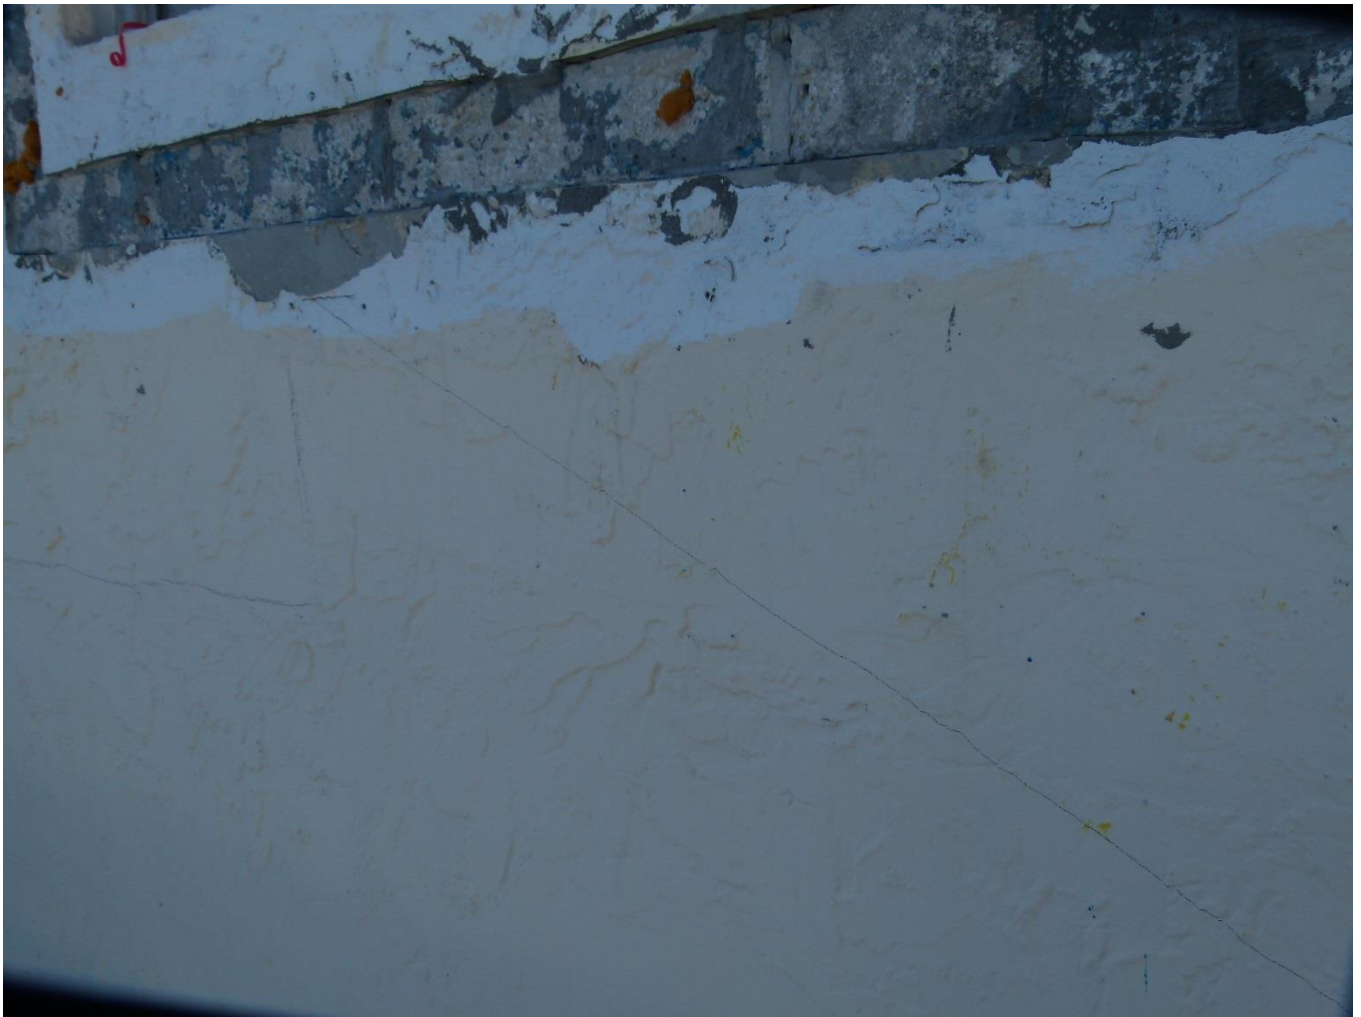
- Paint transfer was observed below and to the right of the kitchen window of 16G (adjacent to opening) angled downward towards unit 15F kitchen window at an approximate 25° angle and approximately 12’ in length. Refer to attached Figure 9.

Figure 9: Paint transfer observed below and to the right of the window of 16G (adjacent to opening) angled downward towards unit 15F window with approx. angle drawn.

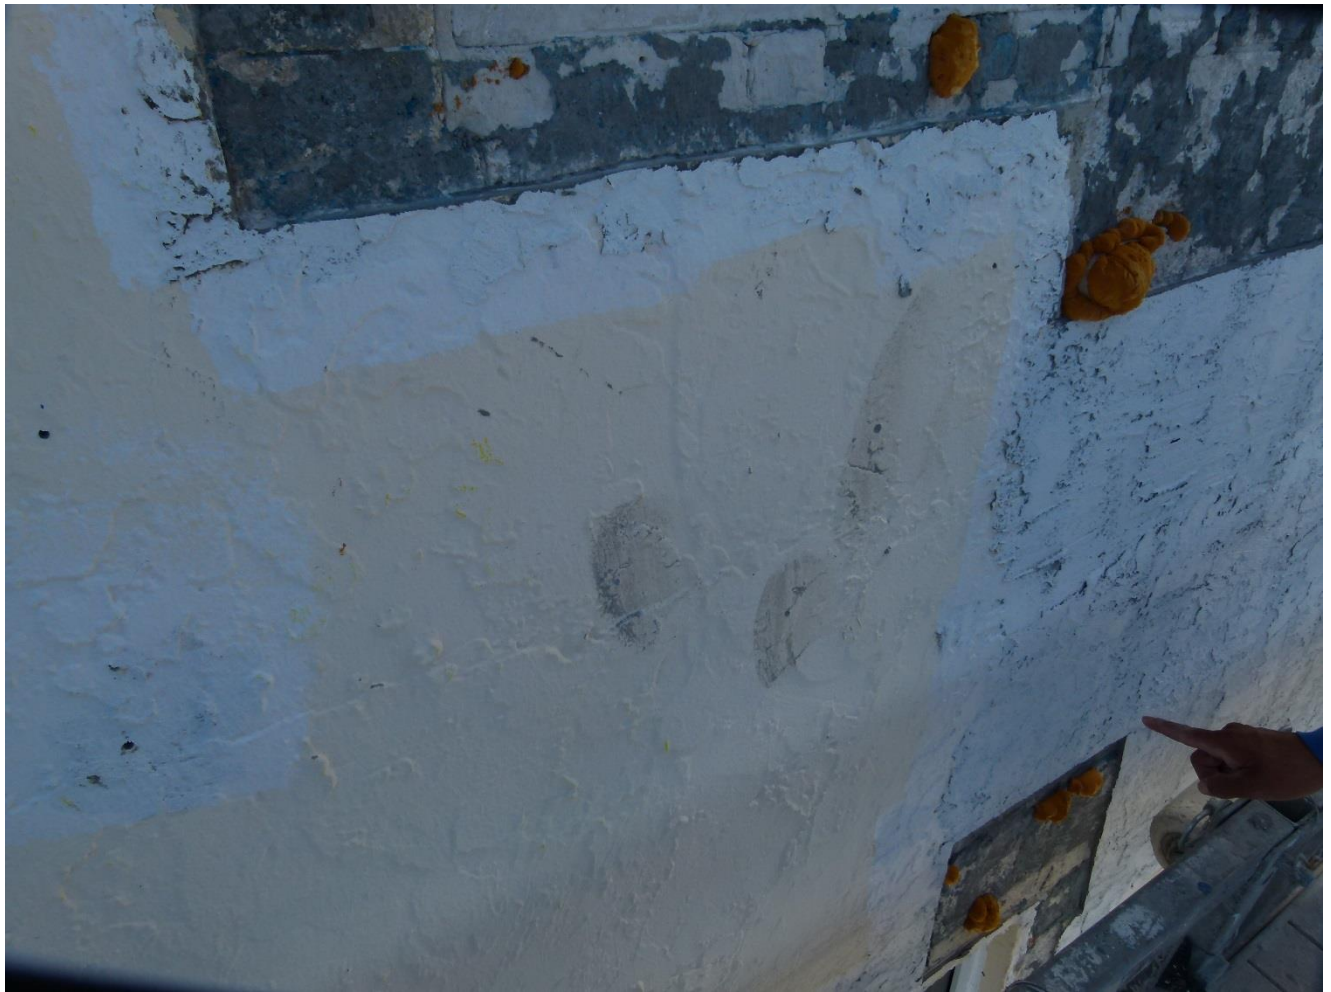
- Unit 16F:
 - Paint transfer observed at unit 16F kitchen window, continuing downward on wall between units 15G and 15F. Refer to attached Figure 10.

Figure 10: Paint transfer observed at unit 16F window, continuing downward on wall between units 15G and 15F

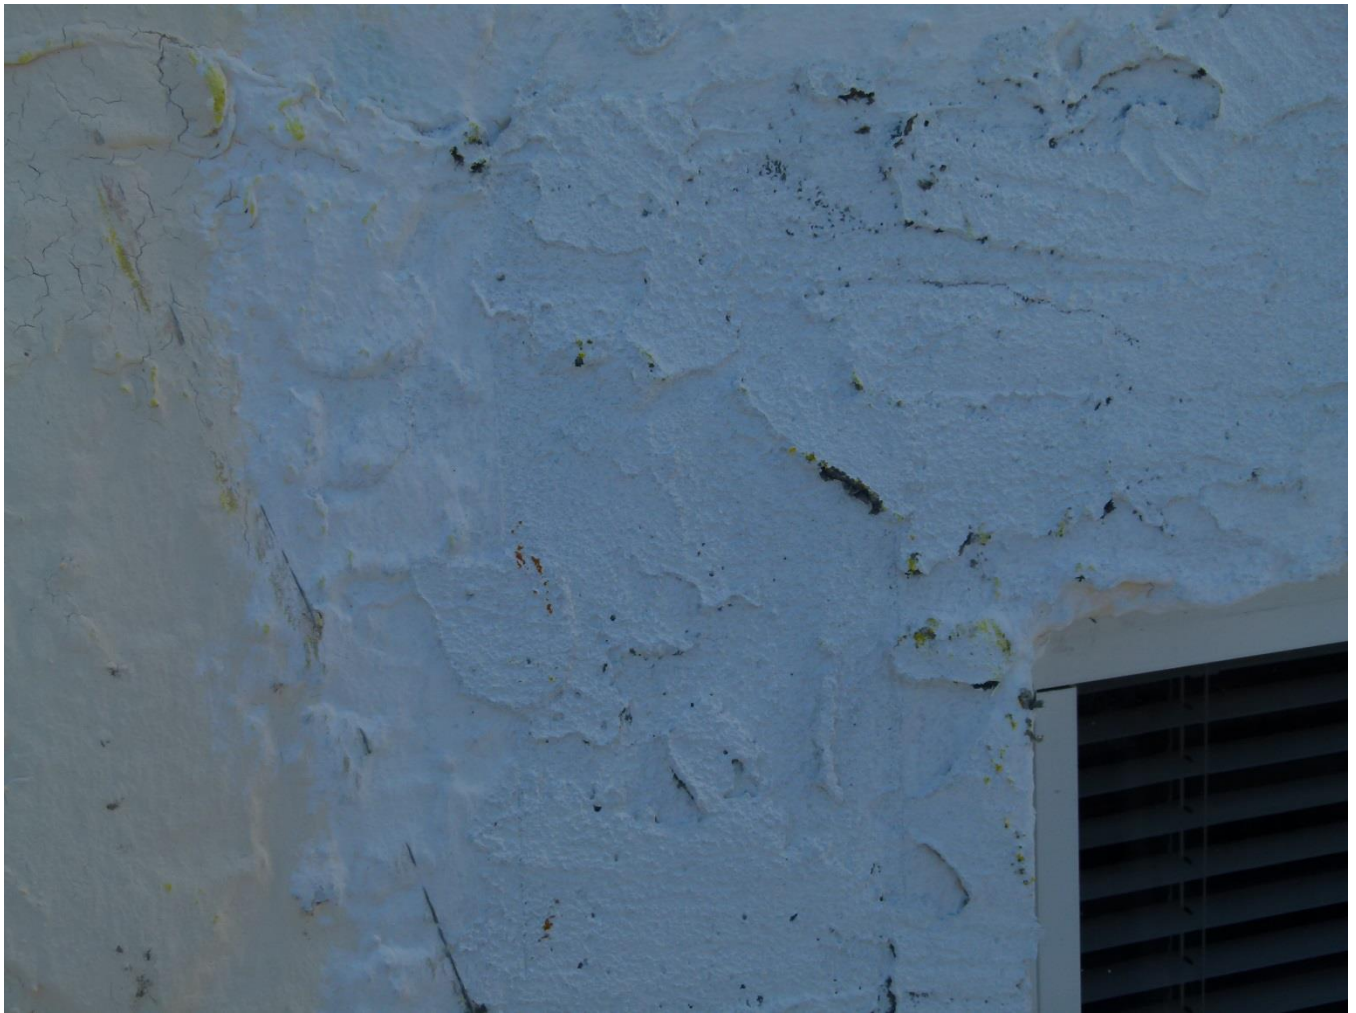
Figure 11: Paint transfer observed at 15G continuing downward along wall edge.

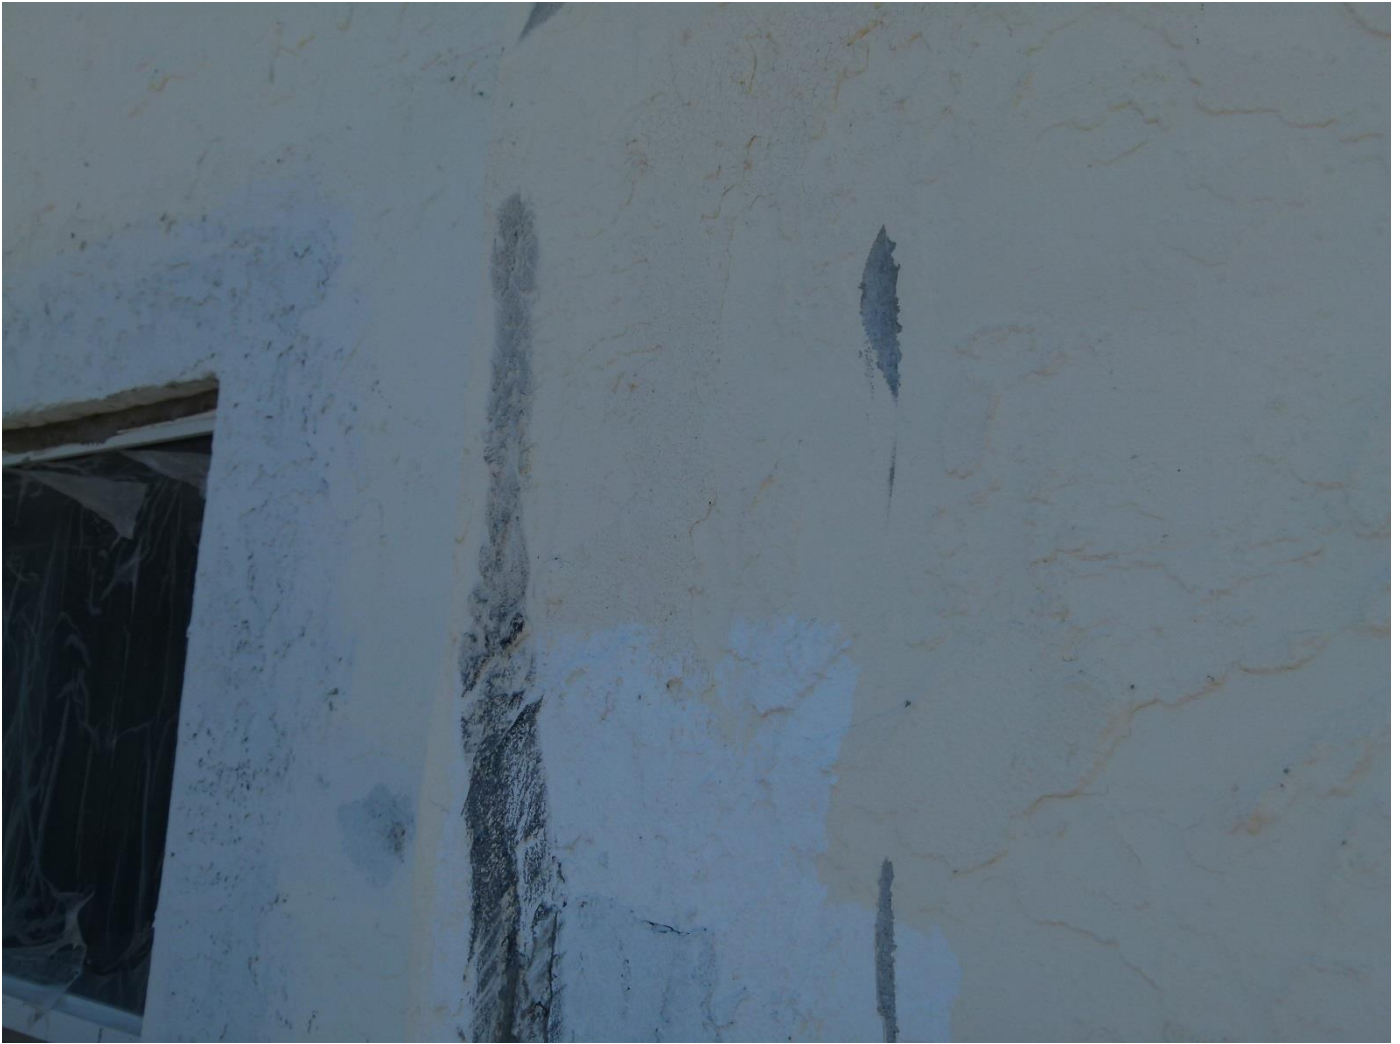
- Unit 15G:
 - Paint transfer observed at 15G continuing downward along wall edge. Refer to attached Figure 11.
- Unit 9G:
 - Paint transfer observed at unit 9G continuing downward along wall edge. Refer to attached Figure 12.
- No additional damages or paint transfers were observed below unit 9G.

Figure 12: Paint transfer observed at unit 9G continuing downward along wall edge.
