1 National Transportation Safety Board

RRD23FR013

**TRACK**

Group Chair's Factual Report

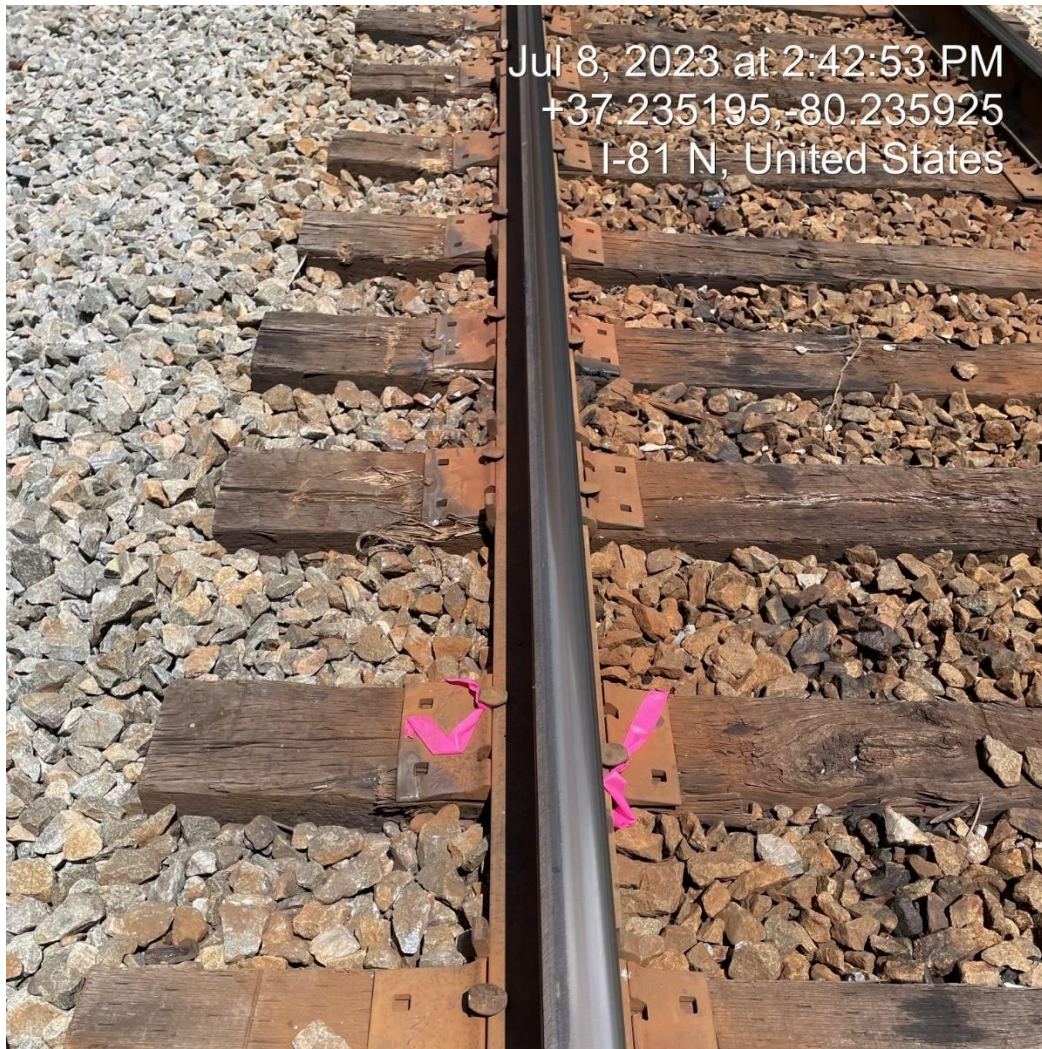
The point of derailment (POD) was determined to be located at M.P. 263.6. FRA identified the wheel marks on the north rail where the first wheel left the rail. NTSB investigators arrived on scene after the clean up and clearing operation had started. NTSB and NS personell verified the previously identified POD.

Figure 1. Photo of the point of derailment site. (source: NTSB)
