1 National Transportation Safety Board

RRD24MR002

TRACK AND ENGINEERING FACTUAL REPORT

Group Chair's Factual Report

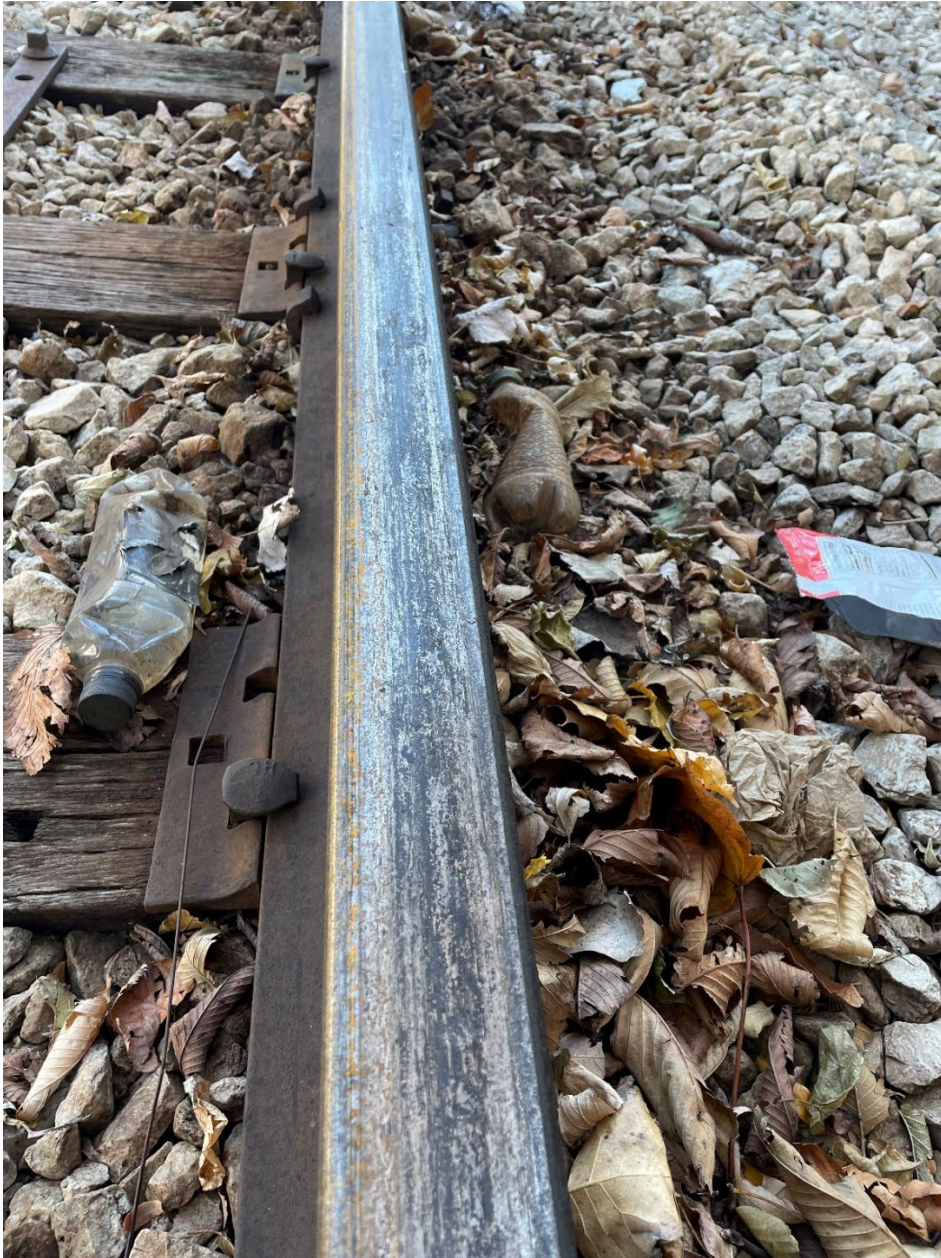
18 During the field investigation, NTSB noted that a black substance was on top of
19 the rails. The substance was found to exist in various locations on this segment of
20 track and at the location of the collision. Samples of this unknown black substance
21 were collected for analysis. These samples were sent to NTSB's materials laboratory in

1 Washington D.C. for testing and identification. The area also had high amounts of
2 fallen leaves on the track and identifiable leaf matter on the rails.

7
8 The combination of spectral patterns and similarities to several natural amino-
9 carbohydrates and other materials, the unknown material was most likely plant
10 material. Plant or leaf material consists of a combination of carbon, nitrogen,
11 carbohydrates, organic acids, mineral substances, and water. Molecular bonds for
12 these materials were all present within the unknown spectrum. The presence of the
13 elemental carbon in the sample indicates that the material had sustained some type
14 of thermal exposures carbonizing the material.

Figure 3: Photo of black substance found on top of the rail. (Source: NTSB)

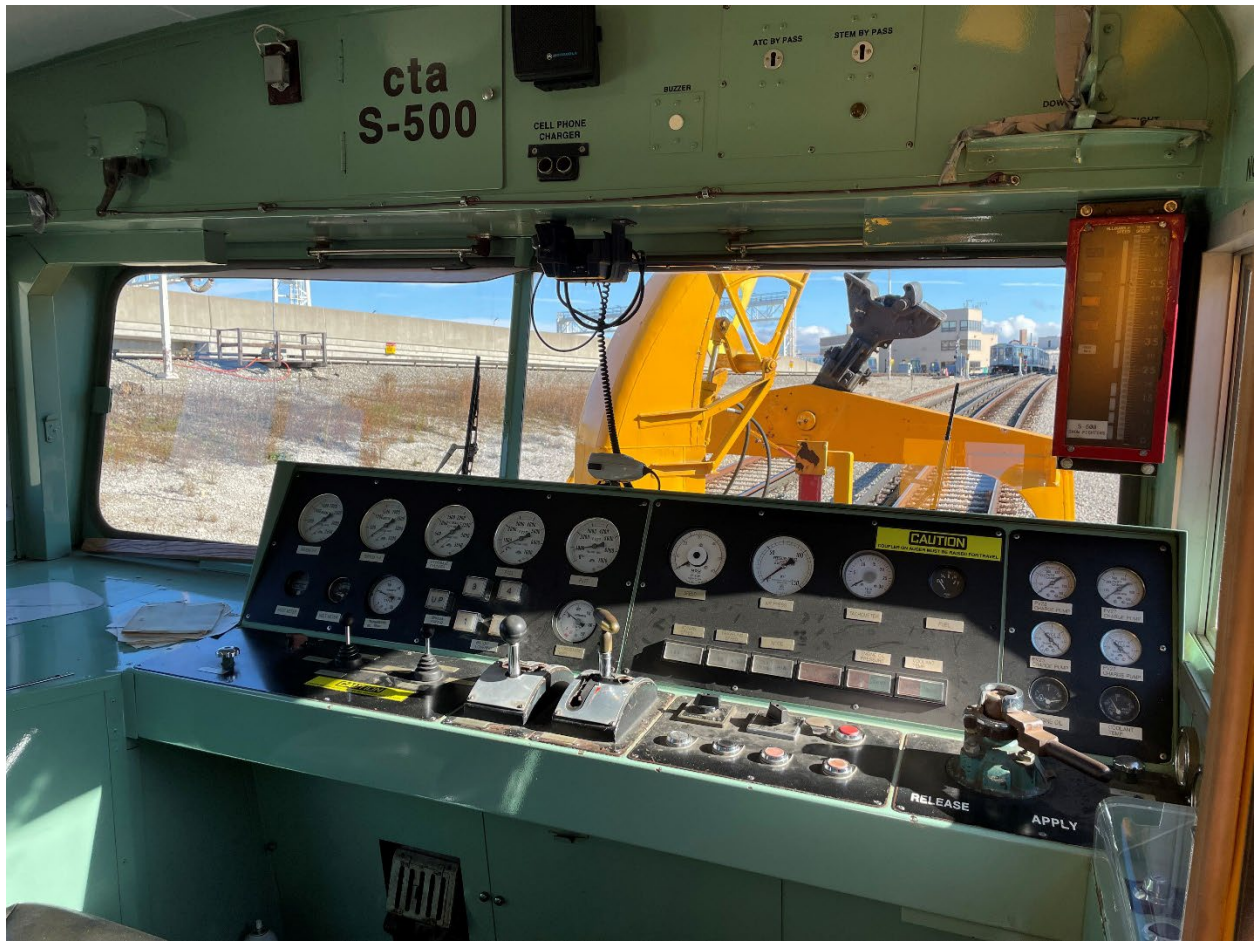
Figure 3: Photo of inside south cab of S-500. (Source: NTSB)
