**NATIONAL TRANSPORTATION SAFETY BOARD**

**Track Factual Report**

**RRD18FR009**

**Collision between BNSF Intermodal Freight Train and BNSF CWR Work Train**

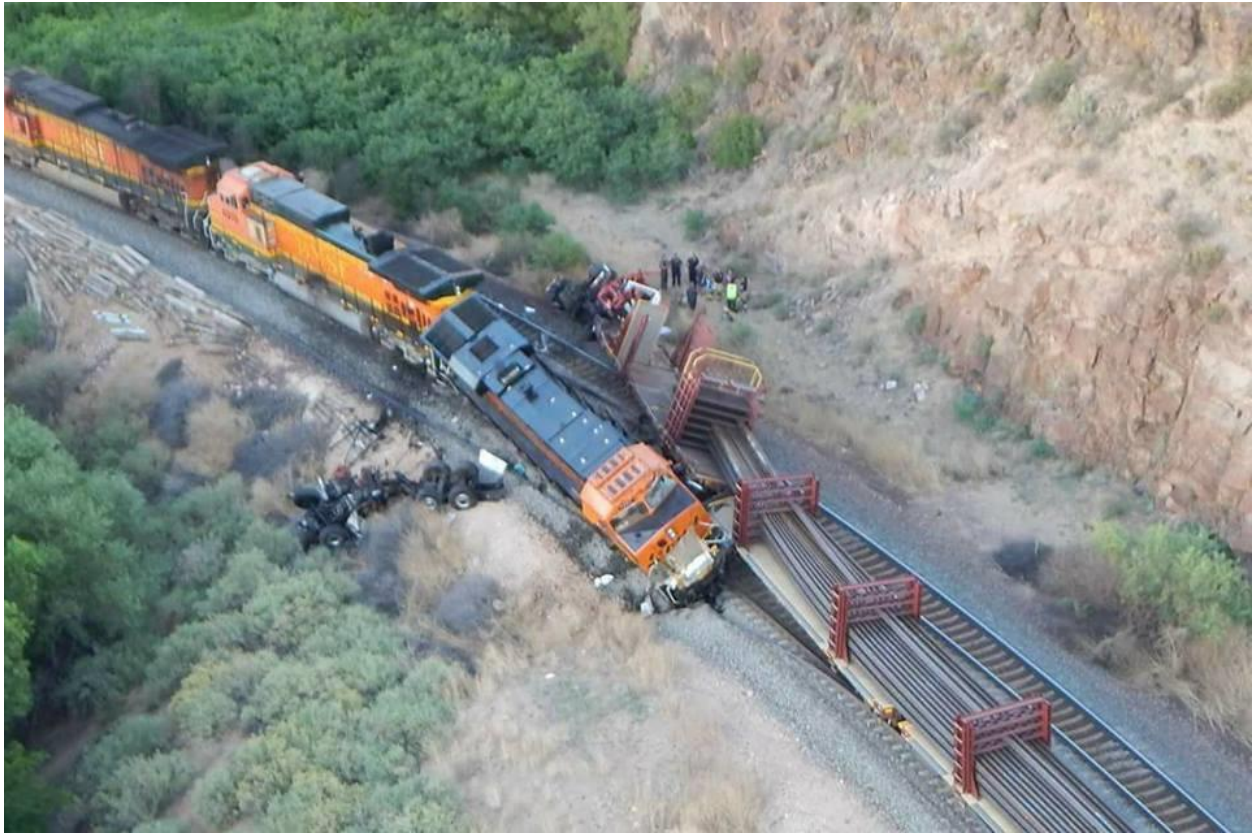
Figure 1. Drone aerial photo of the accident collision. Picture courtesy of BNSF.

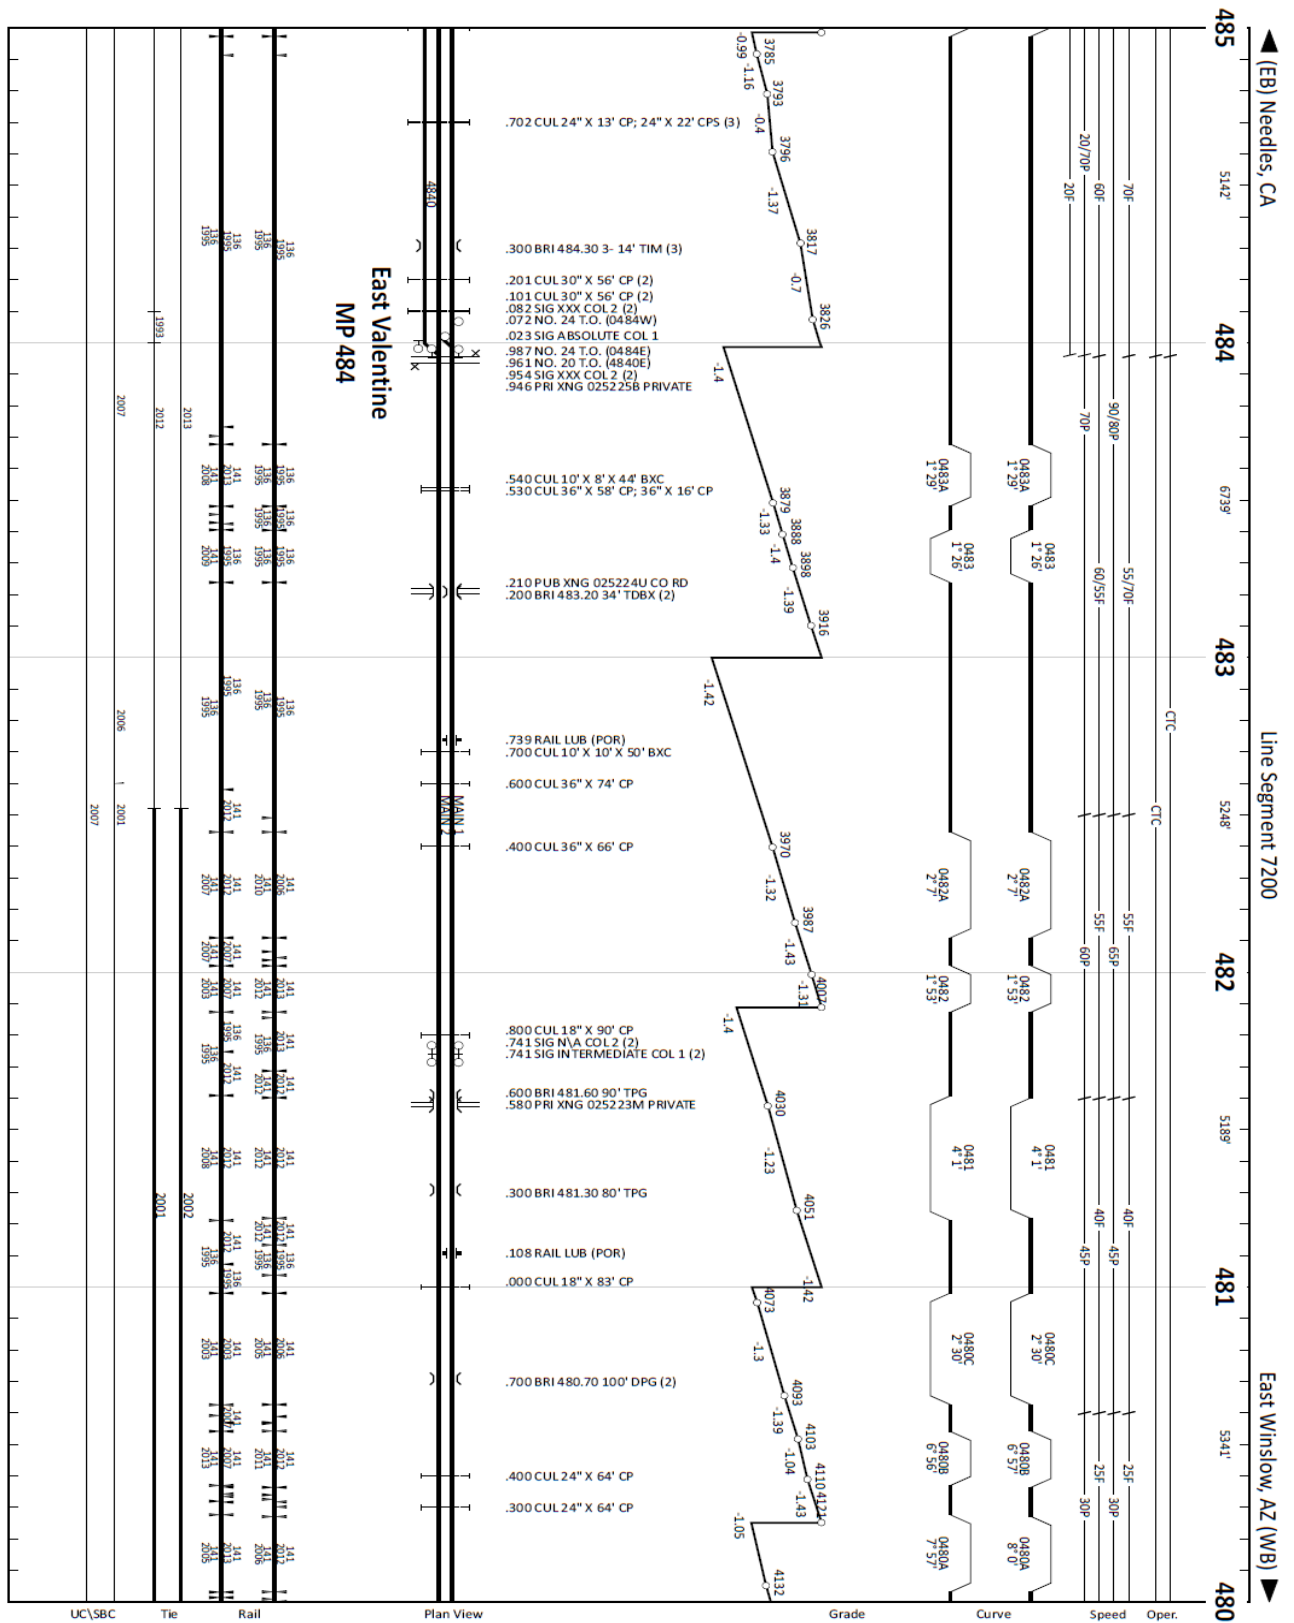
Figure 7. BNSF engineering track map showing track layout and civil design of collision area.

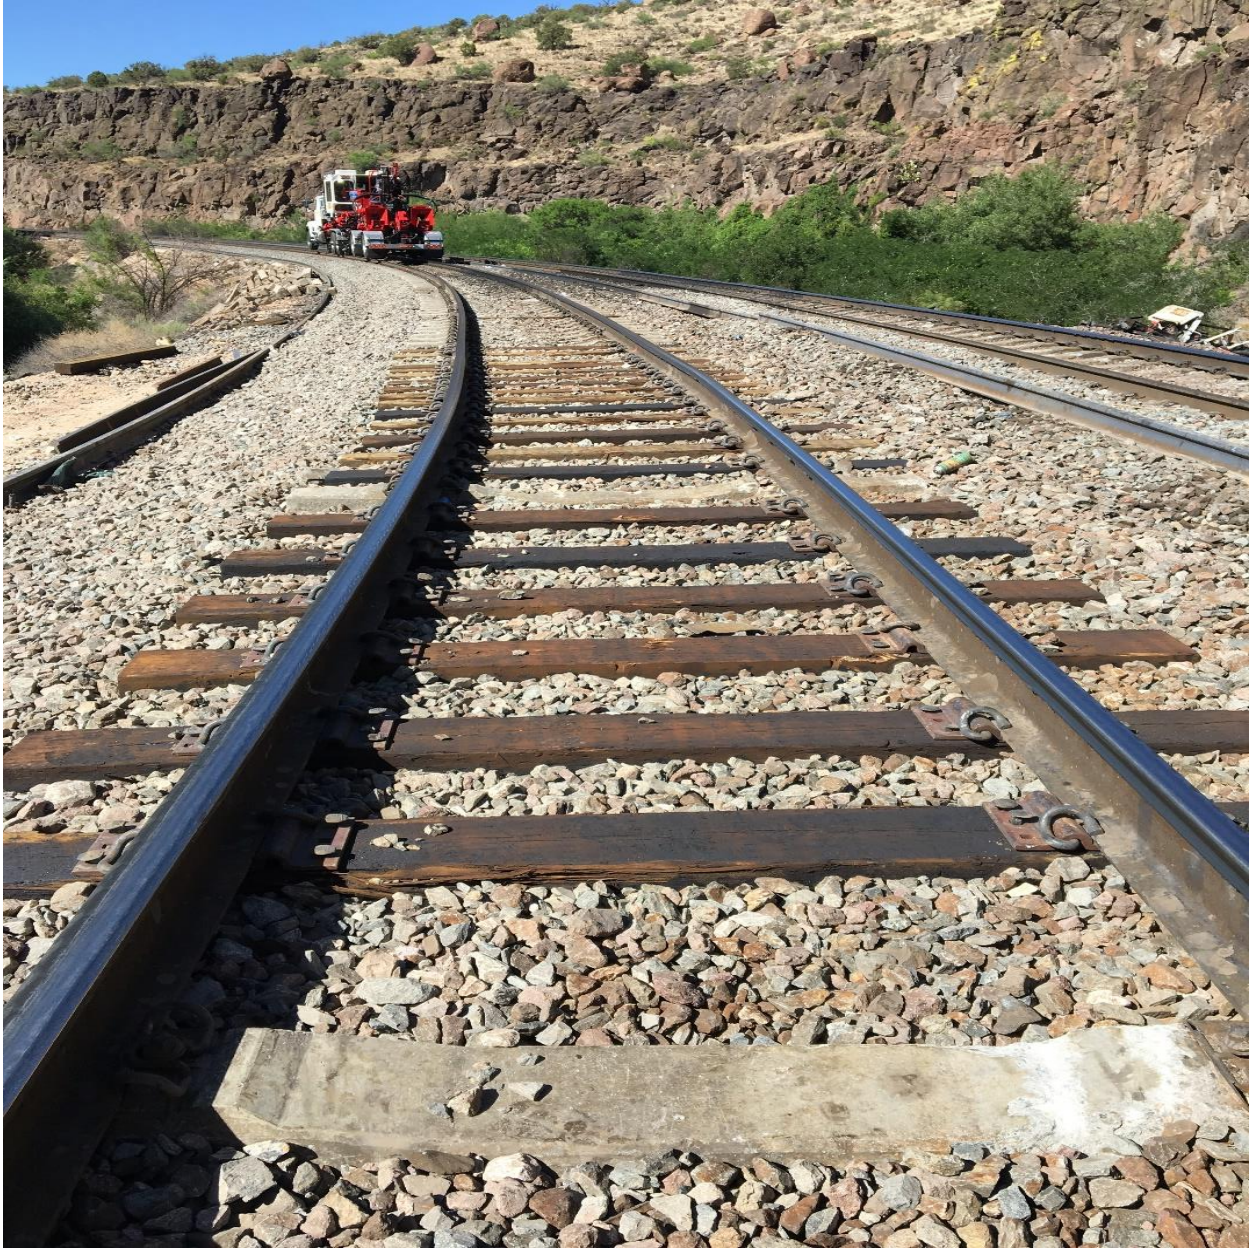
- Twenty concrete ties and about forty feet of track in the full body of curve #480A was damaged during the collision. Temporary repairs were made by BNSF maintenance-of-way employees by installing twenty standard timber crossties measuring 9- inches by 7- inches by eight foot 6 inches long (9"x7"x 8'6"). These temporary track repairs were made before the arrival of investigator to the collision site (see figure 8).
- A 1- inch rail alignment deviation (rail was bent) existed on the high-rail in curve #480 from the forces of where the two trains collided/ point-of-collision (POC).

Figure 8. Picture looking eastward into curve #480A or collision site with an exemplar RUM.

As of June 19, 2018, all temporary track repairs have been permanently made to include the completion of a forty-foot concrete tie track panel, the replacement and welding of eighty feet of rail on the high-side of curve #480 and track surfacing on both main tracks to eliminate the track geometry deviations created by the train collision, subsequent derailment and re-railing/clean-up efforts. BNSF engineering personnel conveyed that the post-accident damage and repairs were estimated at \$31,650. This figure includes the costs of the temporary track repairs and includes the final cost repairs for the installation of one forty-foot concrete tie panel, the replacement and welding of eighty feet of running rail, track tamping/surfacing on both main tracks and other replacement track materials.
