NATIONAL TRANSPORTATION SAFETY BOARD
Investigative Hearing

Norfolk Southern Railway general merchandise freight train 32N
derailment with subsequent hazardous material release and fires,
in East Palestine, Ohio, on February 3, 2023

Track Factual Report

RRD23MR005

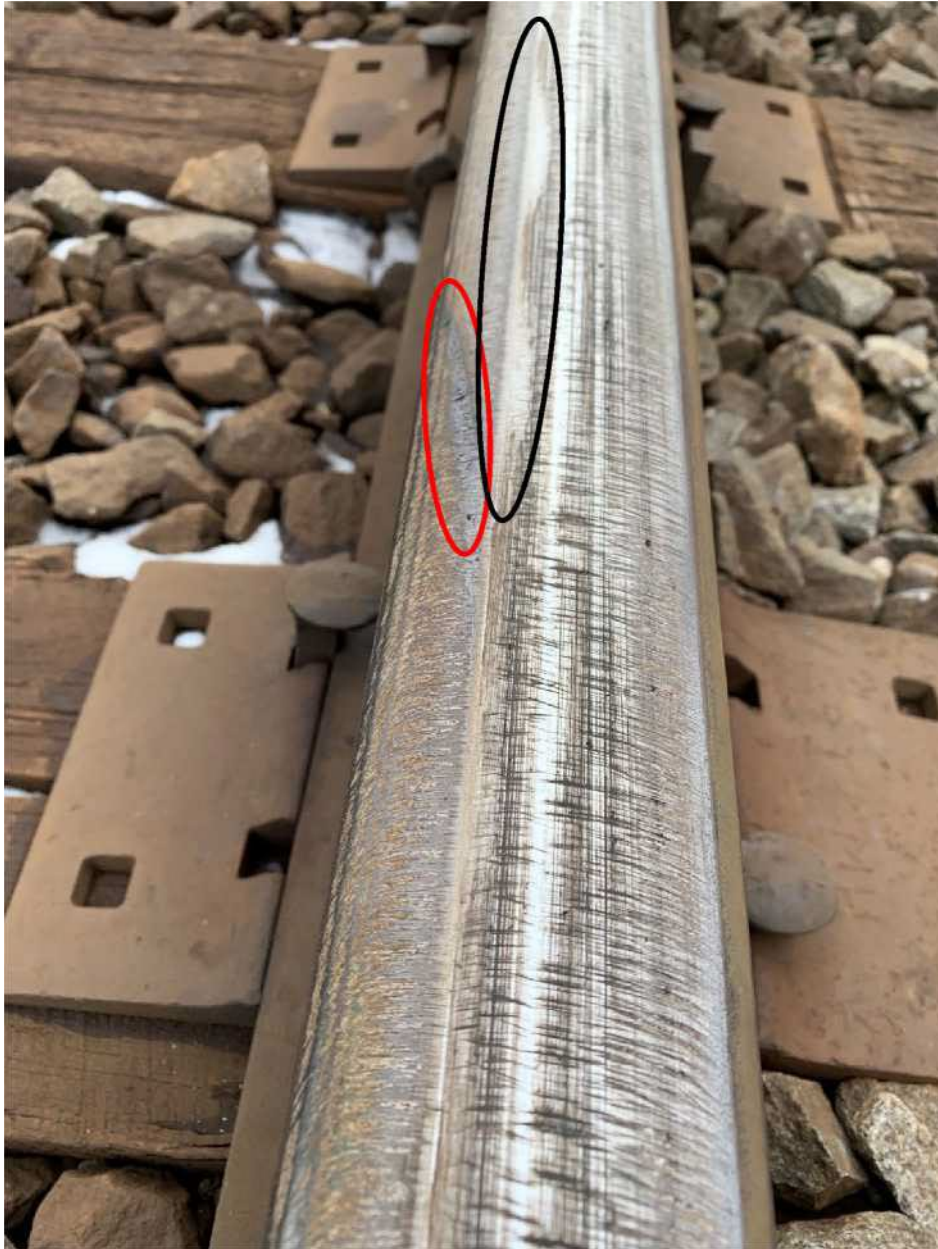
Investigators noted and photographed witness scrape markings located along the top railhead portion of the south running rail at milepost PC 49.5³. The derailment scrape markings start from the gauge corner region of the rail, and extends about 3” in the direction of the gauge face corner of the rail.⁴

Oscillation (wavy) scrape markings were also observed along the top railhead portion of the south rail starting at the point of derailment. These oscillation markings extend eastward along the top portion of the south railhead about 1,464’.⁵ Additional indications of derailment were noted along the south field side crosstie ends from where the truck frame and other components were striking the crosstie ends.

⁴ Indicated by the red circle in figure 1

⁵ Indicated by the black circle in figure 1

Figure 1- Point of derailment at MP PC 49.5

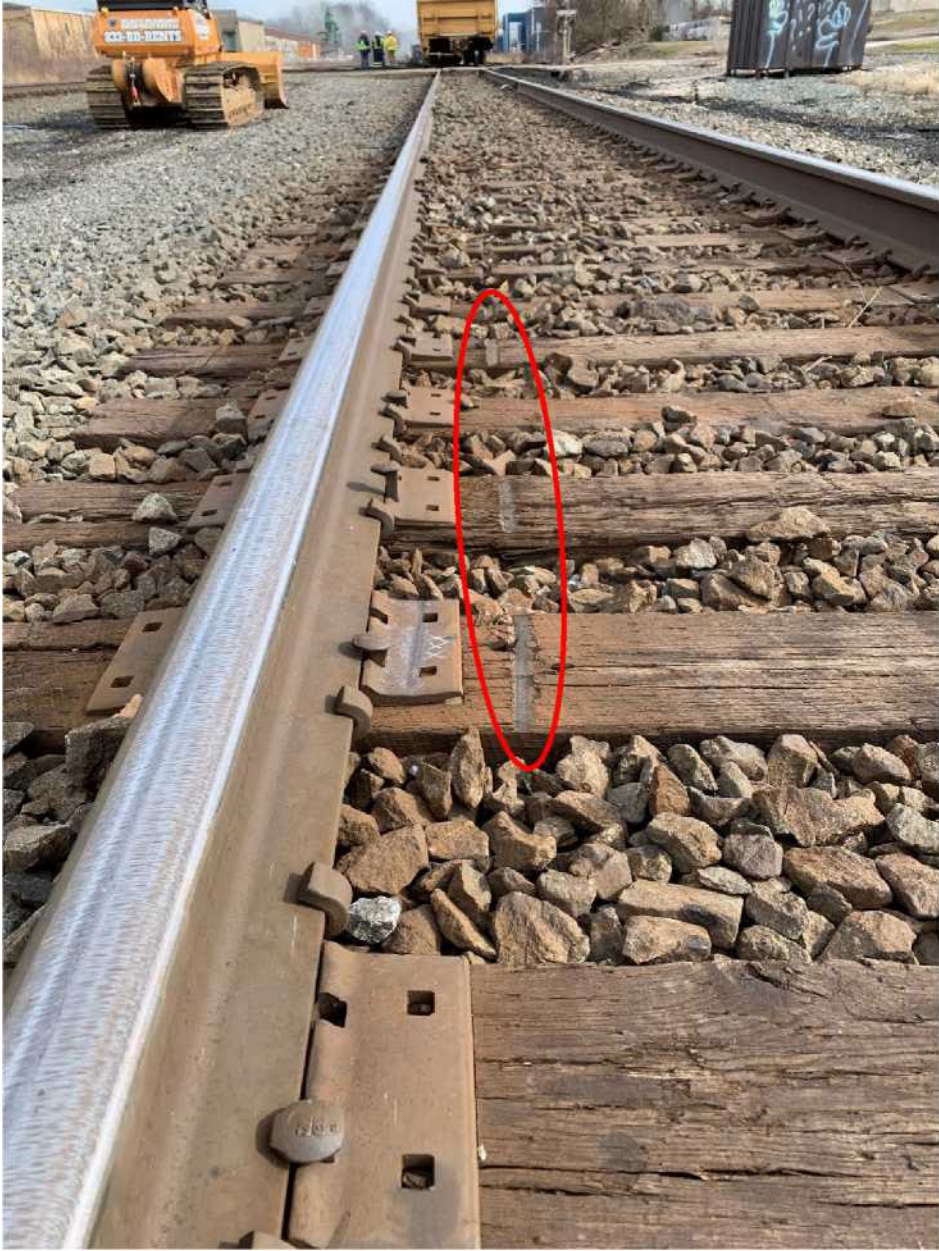
Additional wheel flange derailment markings were observed in the gauge of the track starting about 120 feet west of Pleasant Drive Railroad Crossing at milepost PC 49.2. These derailment markings were observed to the inside gauge portion of the track and run parallel with the north running rail and extend eastward to where the north derailed wheel strikes the Pleasant Drive Railroad Crossing.⁶

⁶ Indicated by the red circle in figure 2

Figure 2- Wheel flange derailment markings at milepost PC 49.32

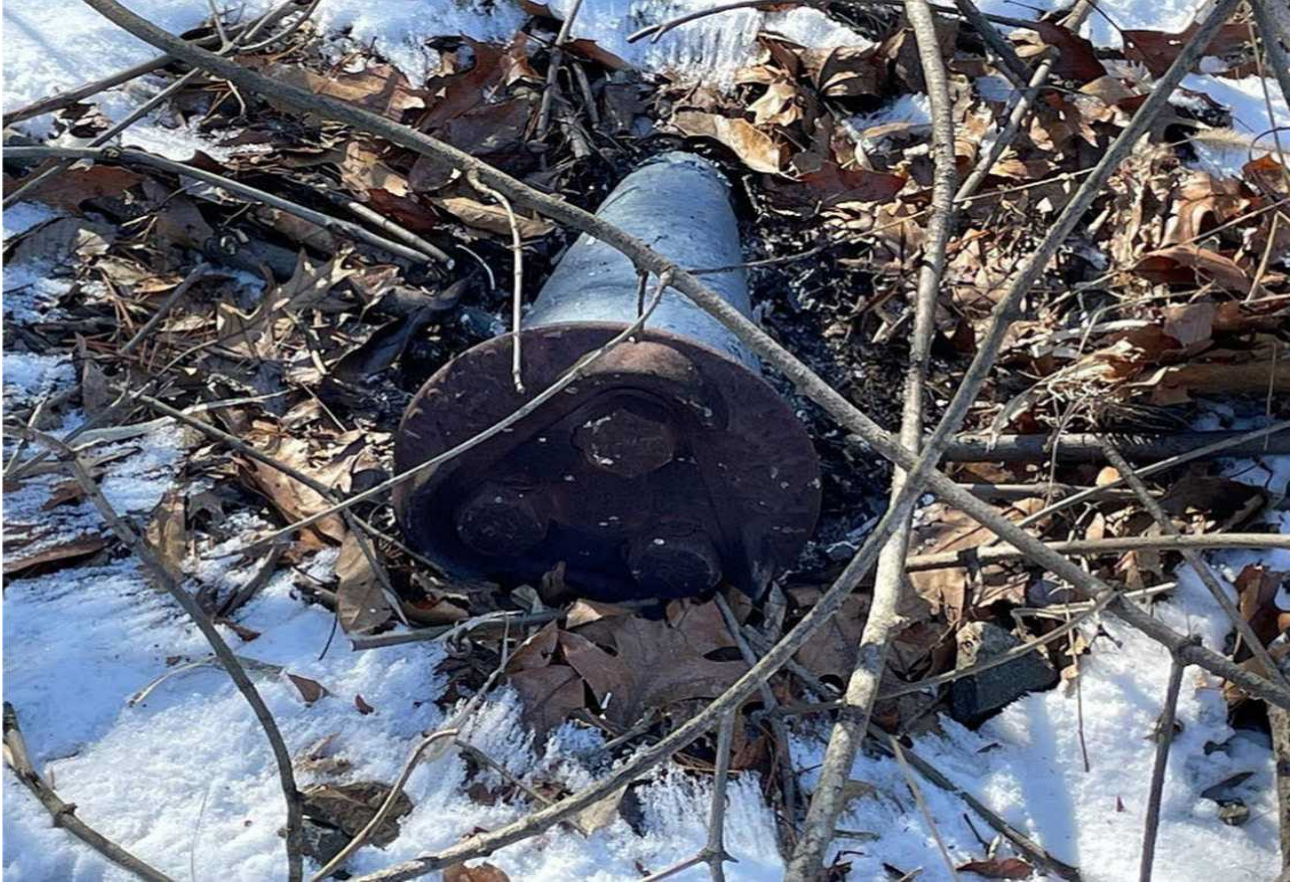
Investigators observed the first indications of derailment where the south wheel bearing, part of the axle, and other truck components departed from the railcar that came in contact with the top portion of the south rail. The departed wheel bearing was found by investigators some 106’ away from the point of derailment (POD), laying in a small, wooded area about 16’ away from the field side of the south running rail.

Figure 3- Final resting location of the burnt off journal.
