# NATIONAL TRANSPORTATION SAFETY BOARD

## TRACK FACTUAL REPORT

**RRD19FR007**

### **Derailment of Denatured Ethanol Unit Train with Subsequent Fire**

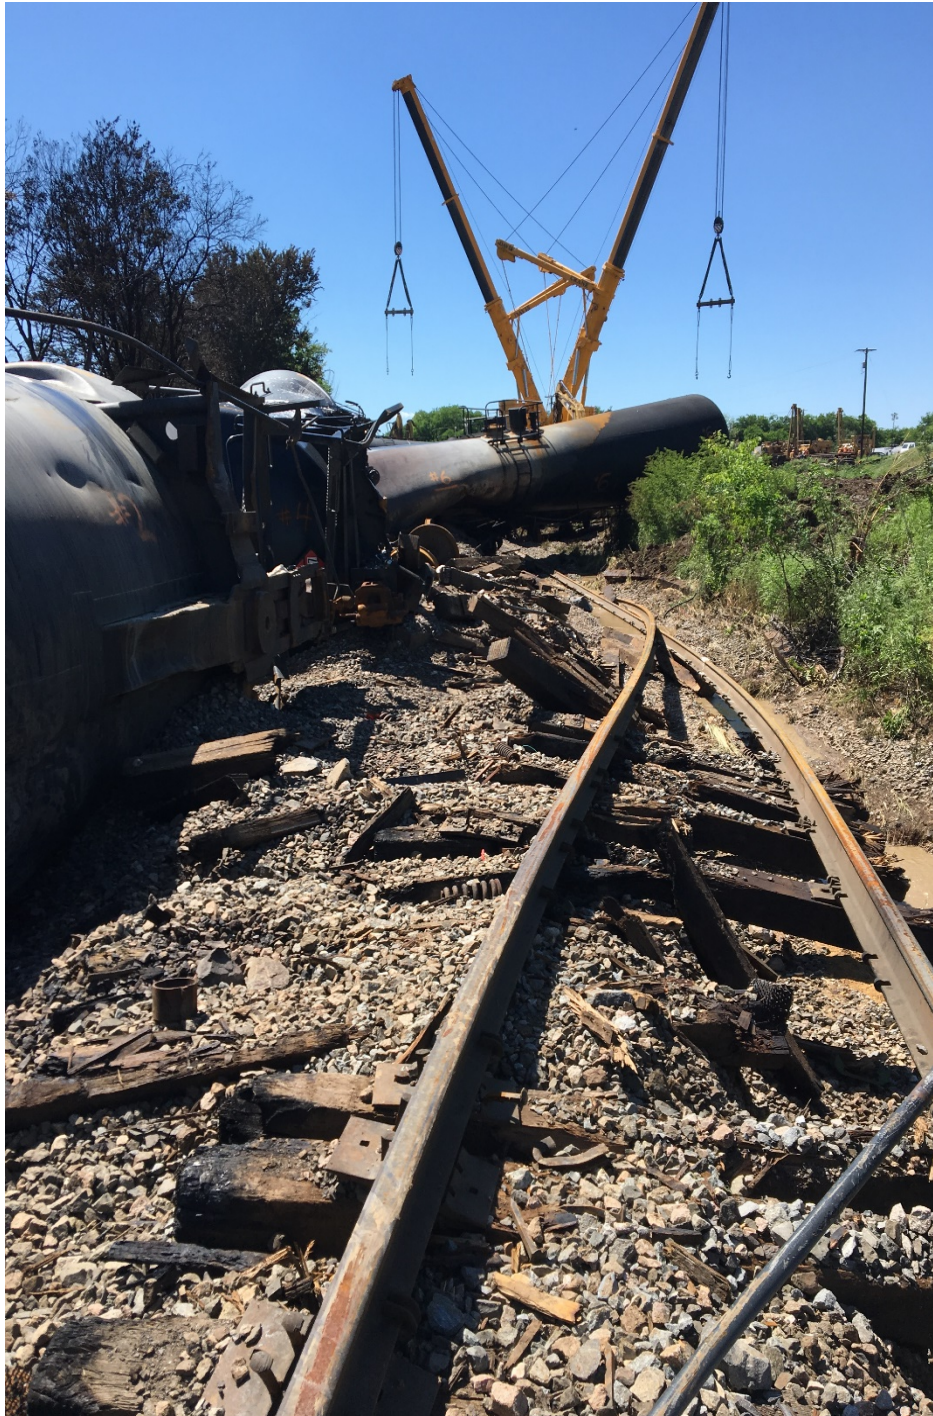
Figure 1- photo shows the destroyed track infrastructure and derailed/damaged tank cars with re-rail cranes working in the background. Picture is taken looking north in the area of the point of derailment at milepost 48.8.

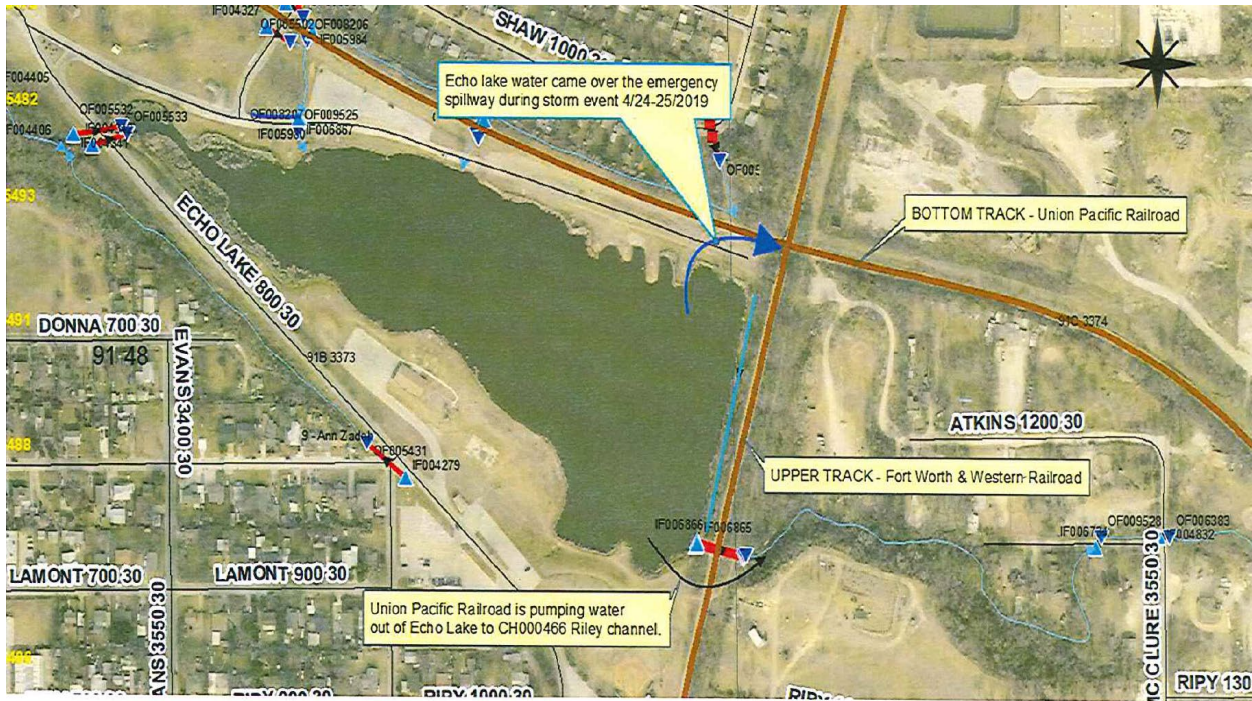
Prior to the accident, the City of Fort Worth and surrounding jurisdictions received large amounts of rainfall over several days, which caused Echo Lake to overflow onto the railroad property on April 16, 2019 and April 24, 2019. The water level was still high with water still overflowing onto the railroad's property when investigators arrived on scene. Investigators noted that from milepost 49.03 (overhead railroad bridge) to about four hundred feet north, the west ballast shoulder was washed away exposing the west tie ends, with standing water in the gauge of the track. Investigators noted that large amounts of water was flowing down the west side of the track structure, where the lake's water was actively overflowing onto the railroad property. Investigators determined that about 670 feet of the tracks west shoulder (right side of track in direction of train travel) was washed out at this location. Investigators also noted large piles of ballast covering both rails sporadically throughout the inspected portion of track. (see figures 2 & 3)

Figure 2- graphic of an overhead map showing Echo Lake and the Midlothian Subdivision track and surrounding properties. Blue arrow from Echo Lake indicates where water overcame the railroad property.

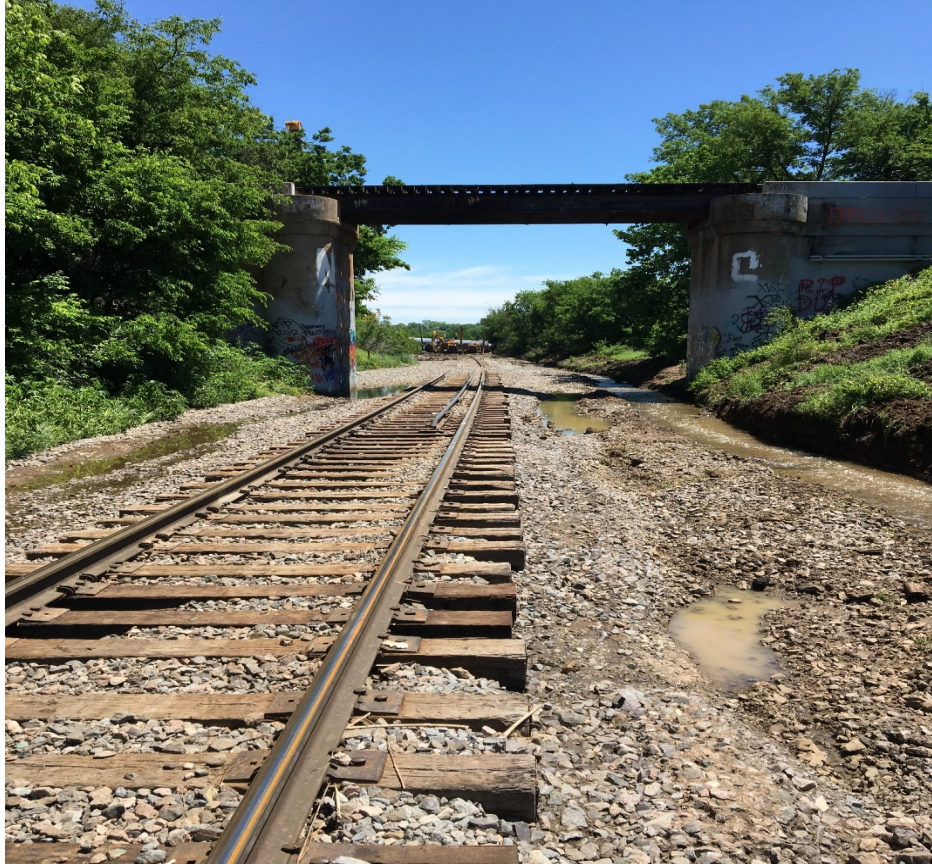
Figure 3- Post flooding and accident photo taken of the railroad track looking south towards the derailment location with active water flowing to the right (railroad west) and washed out shoulder and crib ballast. Note in the foreground where the ballast was washed up and over the railroad track.

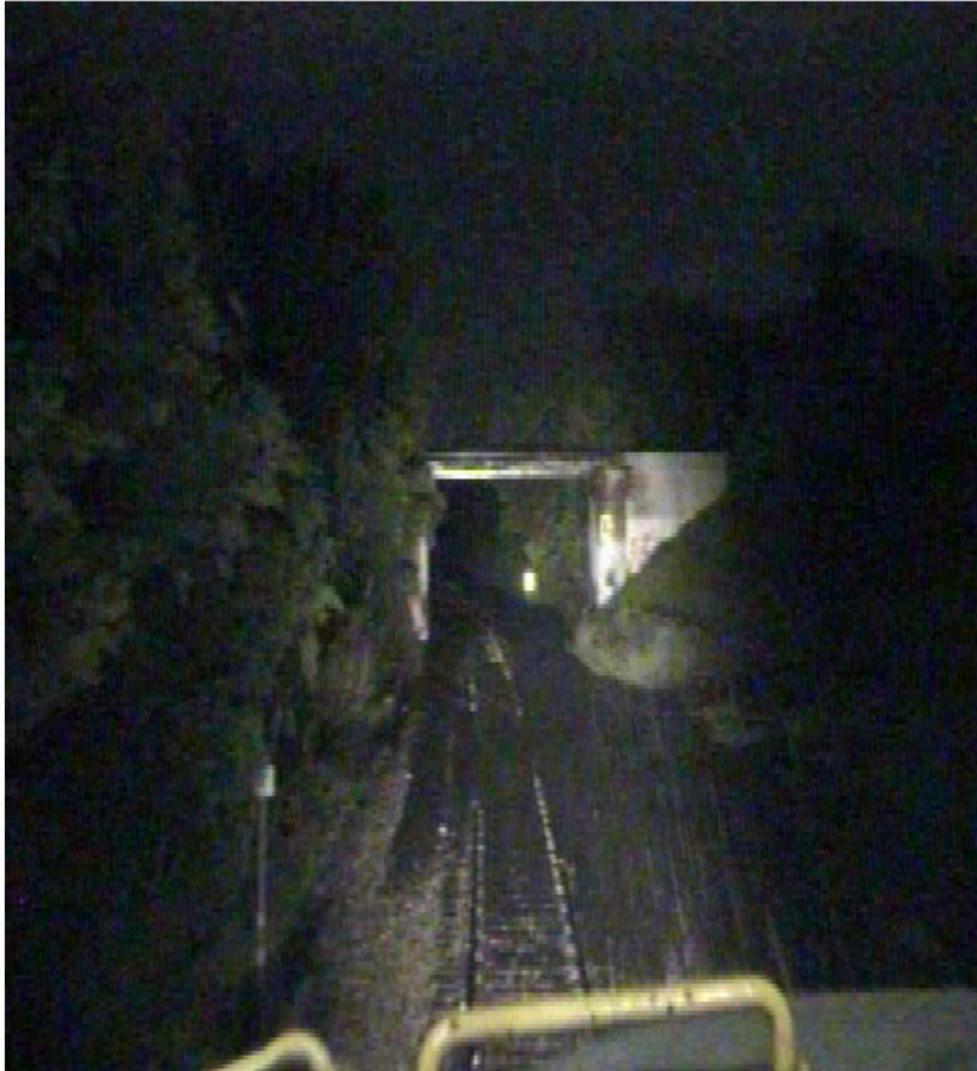
Figure 4- Forward facing video from UP locomotive 2677

[Alt. text: Photo is from a screen shot taken from the forward-facing video. The photo shows a flooded track in front of the train.]

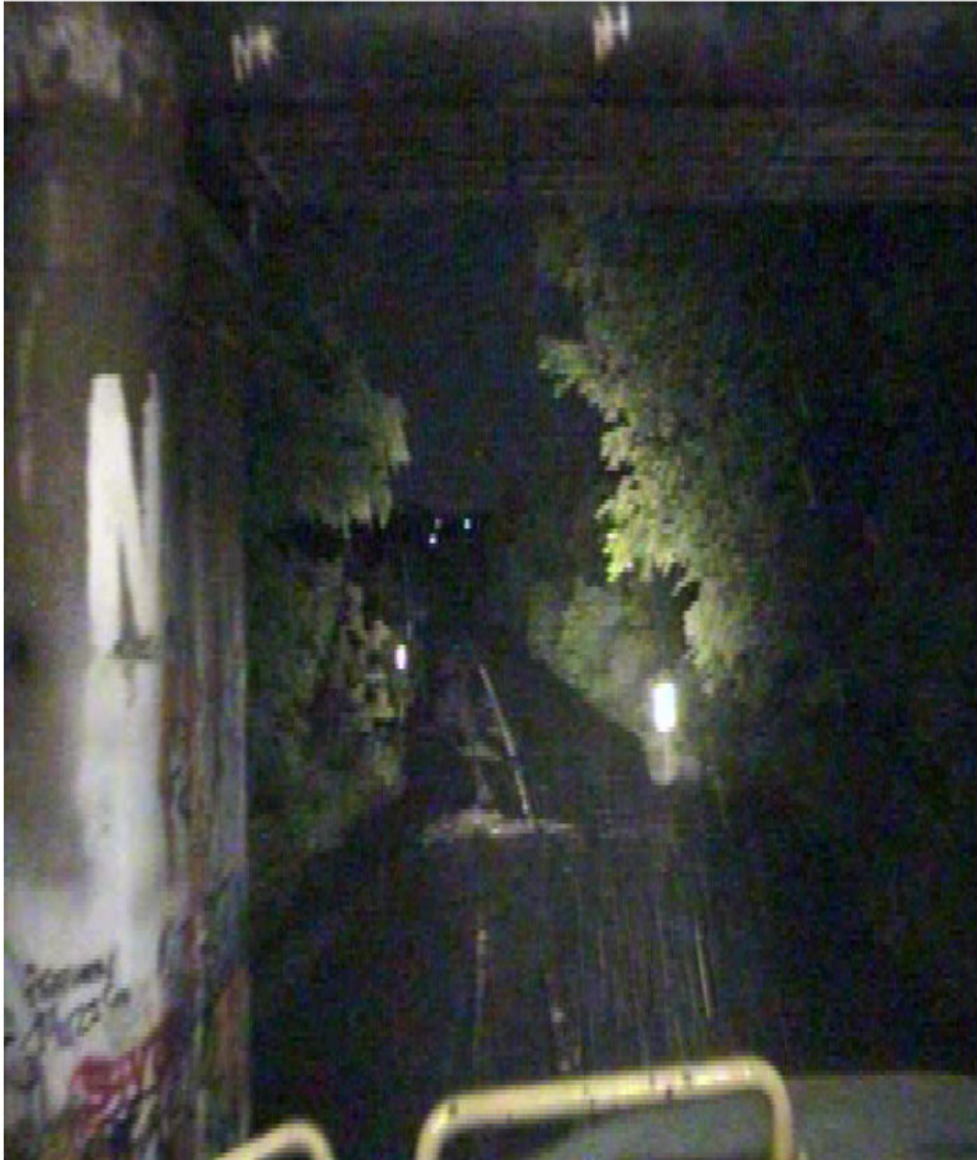
Figure 5- Forward facing video from UP locomotive 2677

[Alt. text: Photo is from a screen shot taken from the forward-facing video. The photo shows a flooded track in front of the train.]

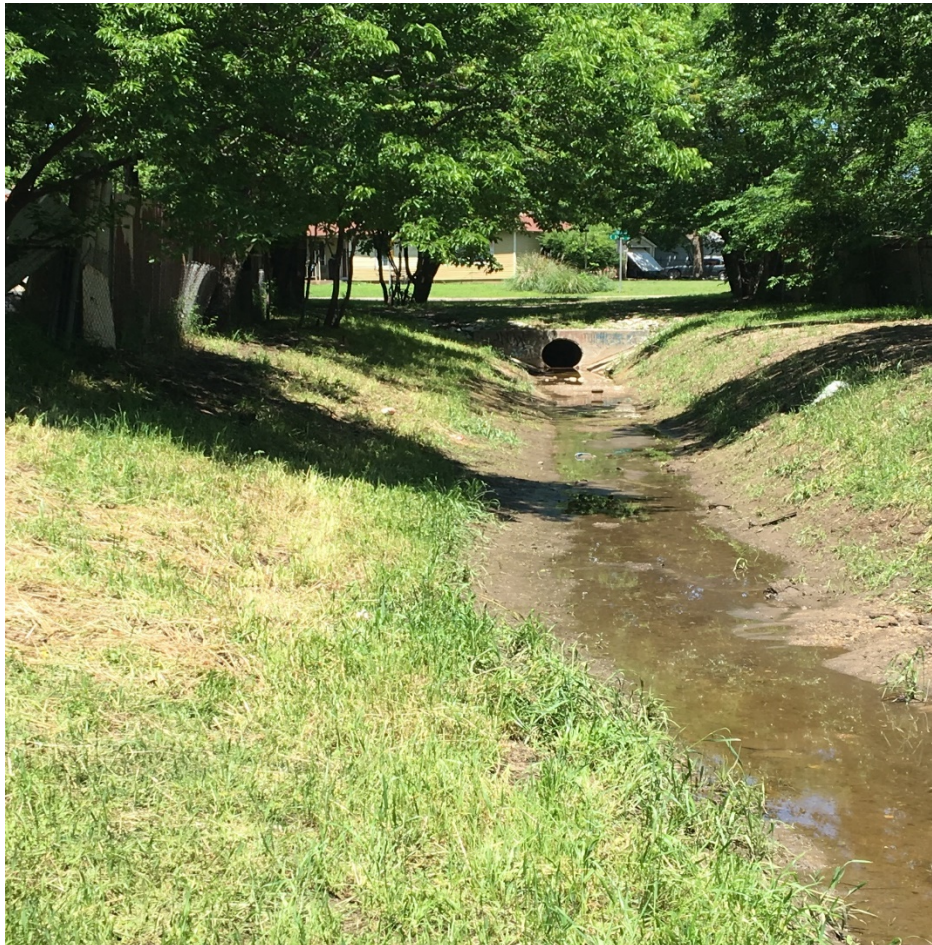
On the east side of the track there is a street drainage culvert that is located about 100 feet north of the overhead bridge at Todd and East Shaw Street, where water runoff drains onto the railroad property and pools under the overhead bridge. Investigators noted active water flow from the street drainage culvert and vegetation that laid over in a south direction for about two hundred feet indicating that at one time large volumes of water was actively flowing in a southward direction from the street culvert onto the railroad property. (see figures 6, 7 & 8)

Figure 6- photo show a street drainage culvert located on the left side (railroad east) of the railroad with active water flowing onto the railroad property.

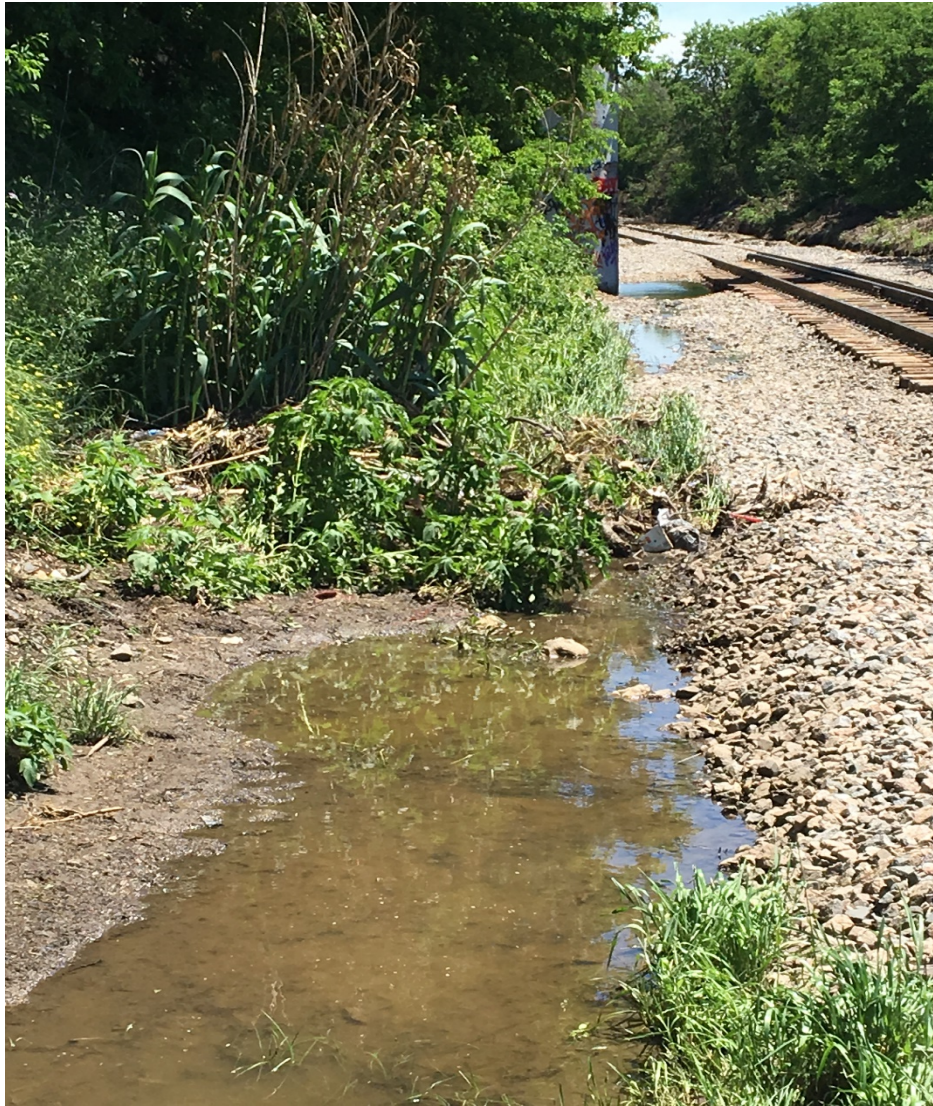
Figure 7- Photo taken from the left side (railroad east) of the track and looking south. Photo shows a standing pool of water from storm water run-off from the street drainage culvert, with tall vegetation laying over in a southward direction indication water flow direction. Note of east bridge abutment wall of the Fort Worth and Western Railroad overhead bridge.

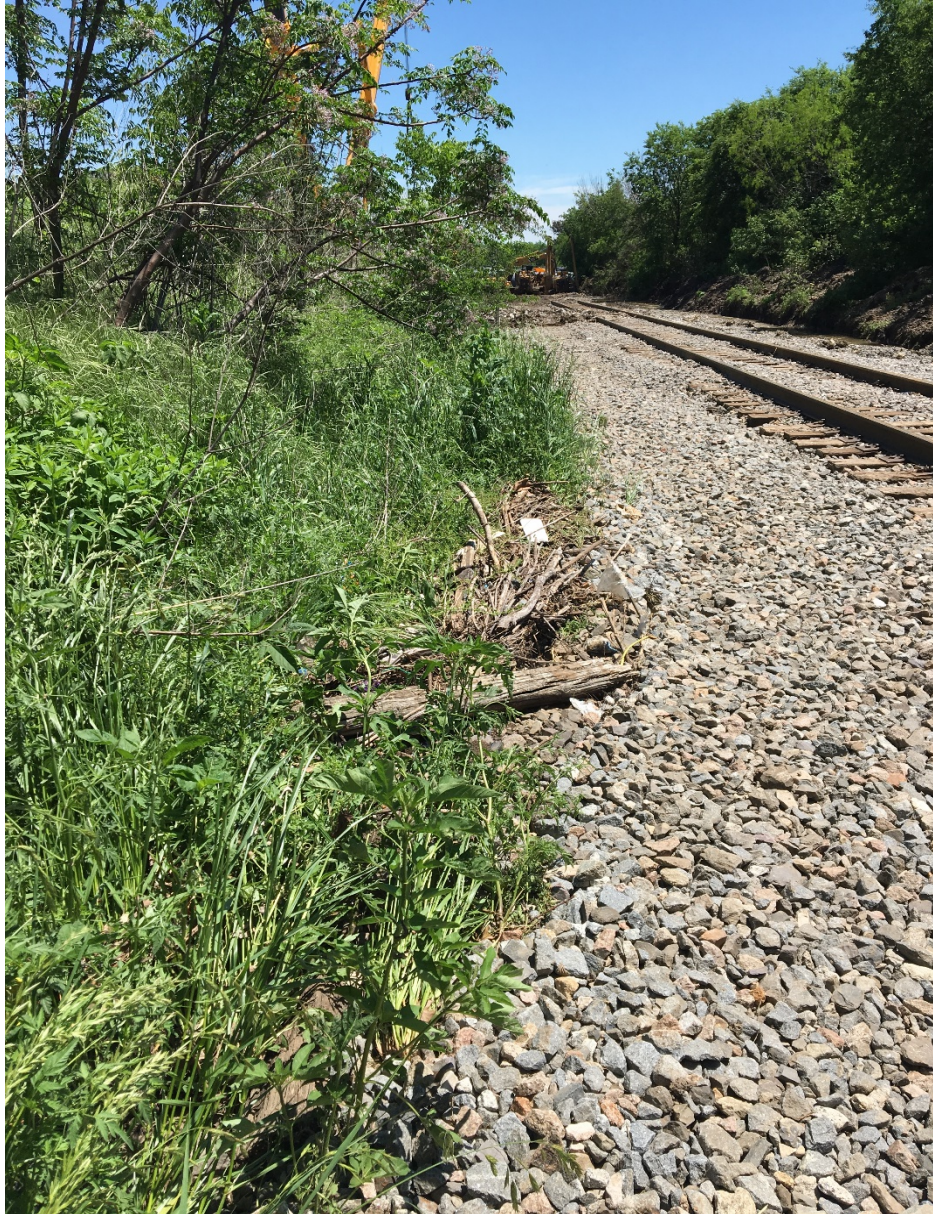
Figure 8- photo was taken while standing on the left side (railroad east) of the track and looking south. Picture shows vegetation laying over in a southward direction with debris piled up from the flow of storm water.

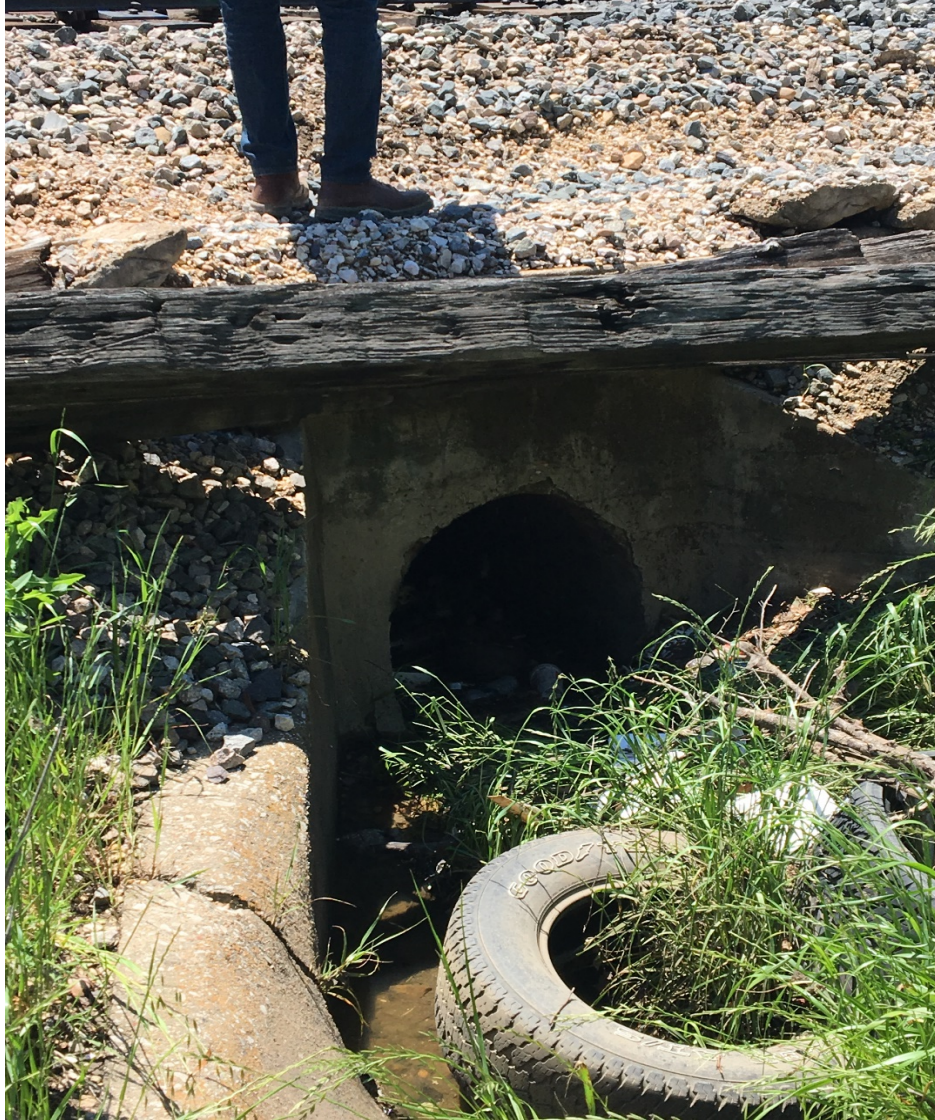
At milepost 49.33, there is a railroad crossing at Shamblee Drive that has two street culvert drains located north and south of the road crossing that run parallel to the track structure on the east side and under Shamblee Drive. The street culvert drains are in place to direct the water flow into the single culvert drain that runs directly under that track structure, south of the road crossing. Water from these culvert drains empty storm water runoff into Echo Lake. Investigators noted that large amounts of trash, weeds, timber and debris was clogging all three street drains and stopping the flow of water, allowing the water to rise and flow onto the track structure. Investigators also noted that tall vegetation located about twenty feet away from the culvert drains was laid over in a south direction indicating that at one time a large volume of water was flowing in a north to south direction, adjacent to the east side of the railroad property. Investigators noted fouled ballast on the east and west shoulders with moist soil directly south of the road crossing. (see figures 9, 10 & 11)

Figure 9- photo show a street drainage culvert that runs under the track and directs storm water run-off towards Echo Lake. Photo shows the drainage swell clogged and littered with trash, vegetation and debris.

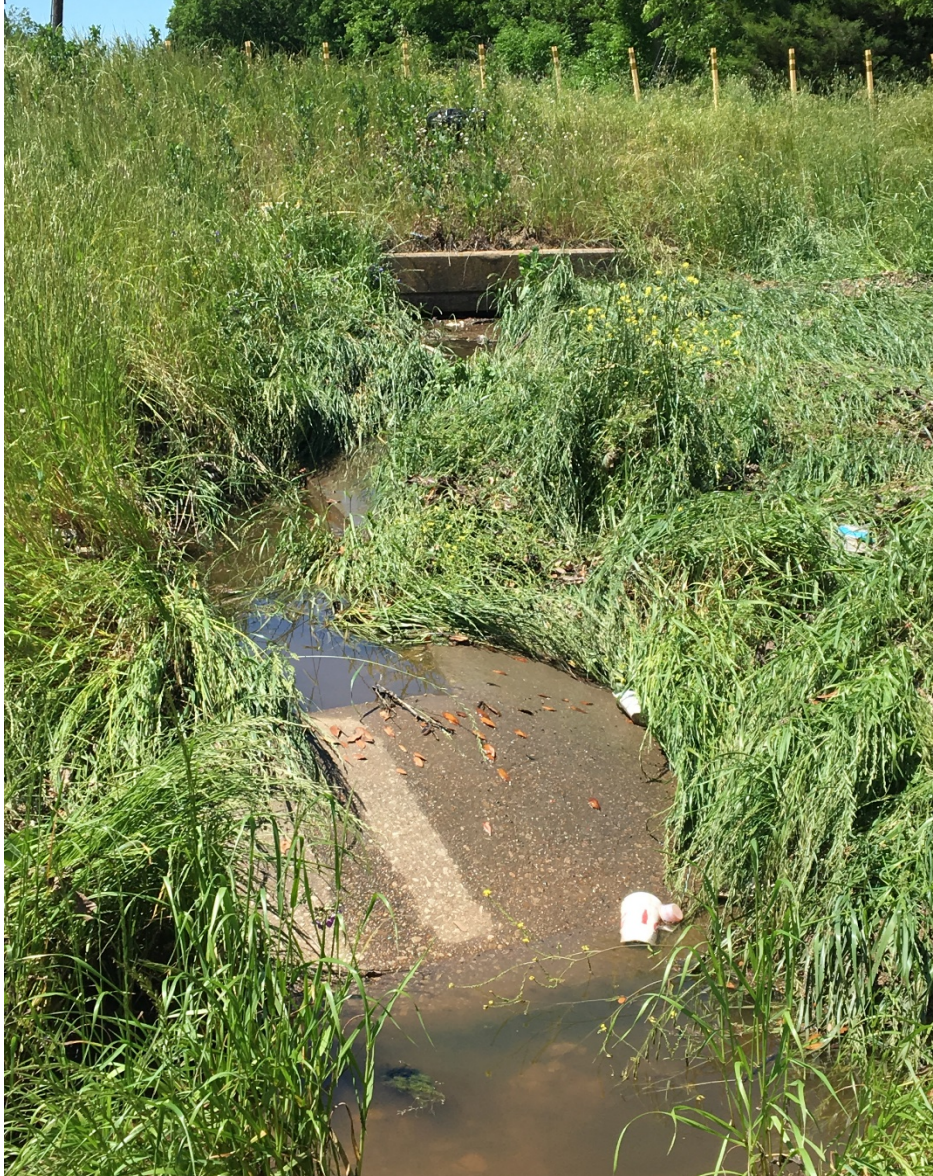
Figure 10- photo shows the Shamblee Drive street drainage culvert with standing non-flowing water due to vegetation clogging the waterway.

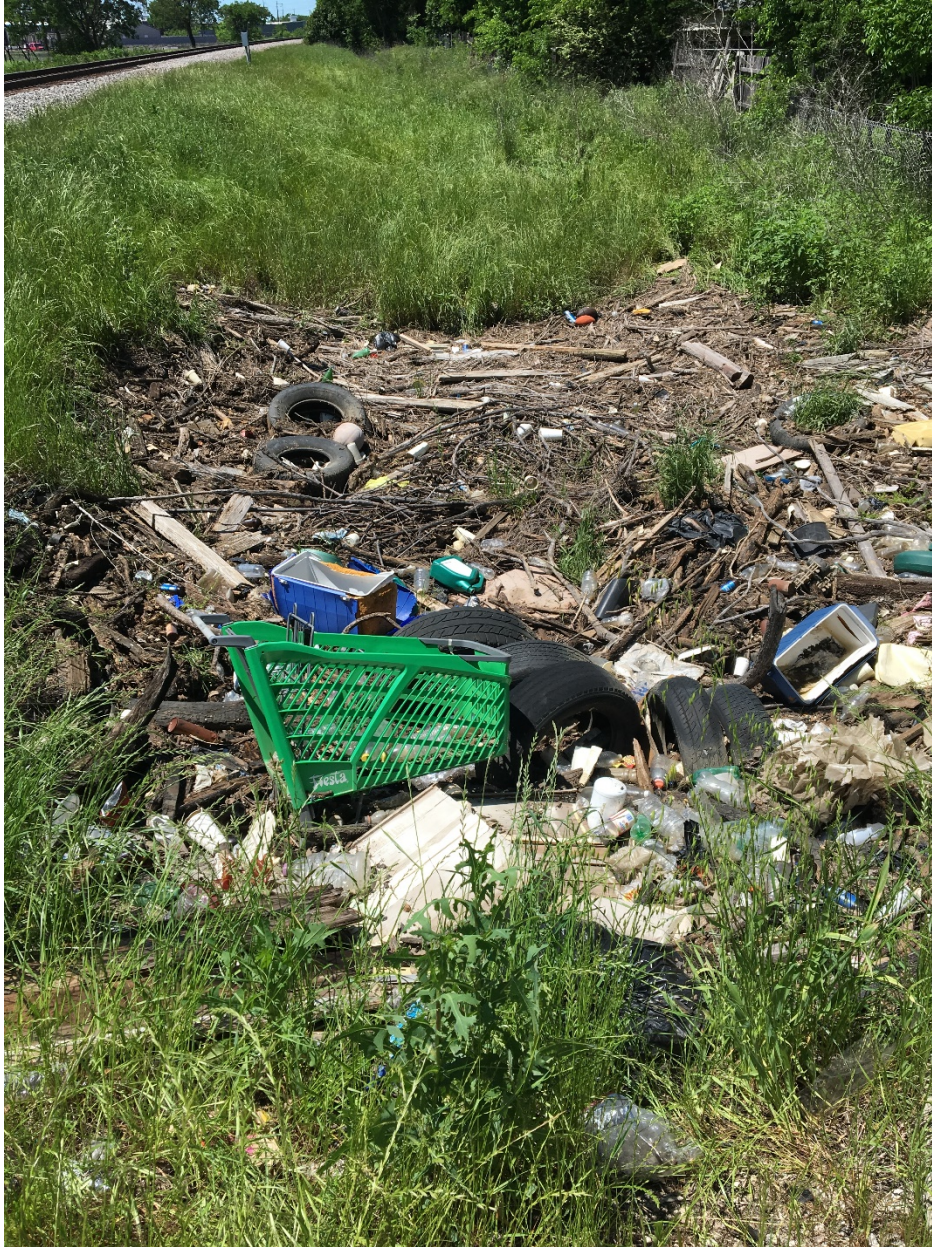
Figure 11- Photo is taken standing to the right side (railroad east) of the track and looking north. Photo shows a totally clogged drainage waterway with large amounts of trash, dirt and debris.
