NATIONAL TRANSPORTATION SAFETY BOARD

RRD19FR004

SEPTA Roadway Worker Fatality

TRACK & ENGINEERING FACTUAL REPORT

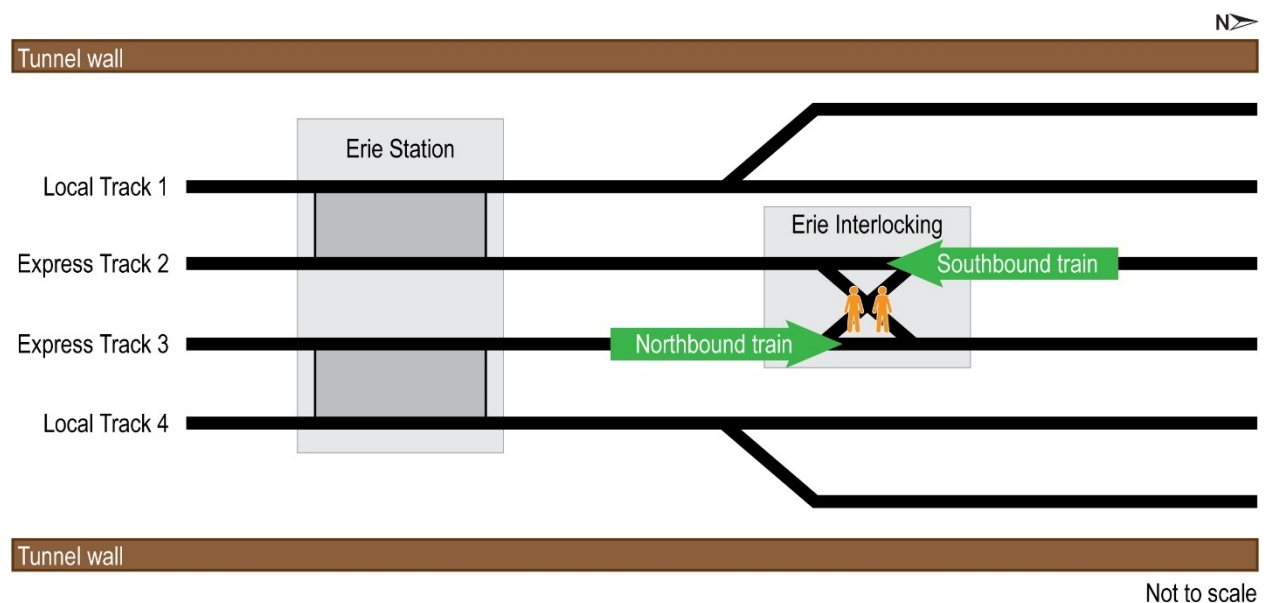
Figure 2- graphic shows the accident site layout of the tracks, Erie Station and Erie Interlocking.

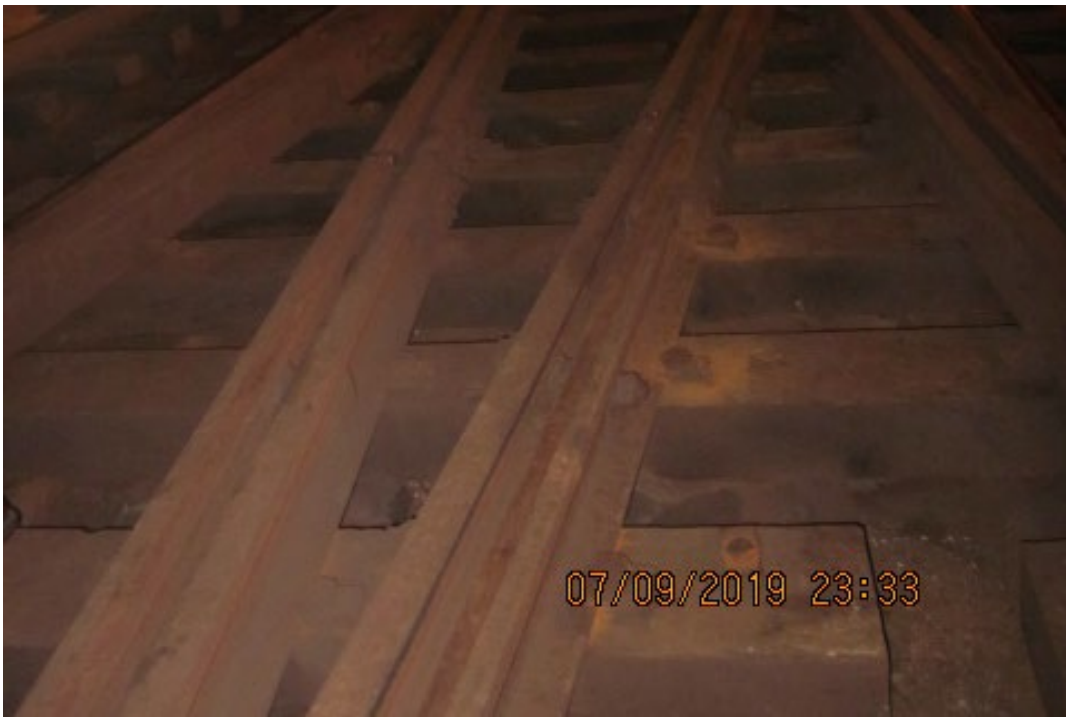
Figure 3 shows Local track 1 at Erie interlocking and the Type B track construction.

[Alt. text: This photo shows a series of rail connections and crossties that make up the construction of Erie Interlocking. The photo shows the walking and tripping hazards created by the non-standard crosstie measurements and deep voids below and between the crossties.]
