# **NATIONAL TRANSPORTATION SAFETY BOARD**

**RRD22LR003**

**Contractor Roadway Worker Fatality**

**TRACK & ENGINEERING FACTUAL REPORT**

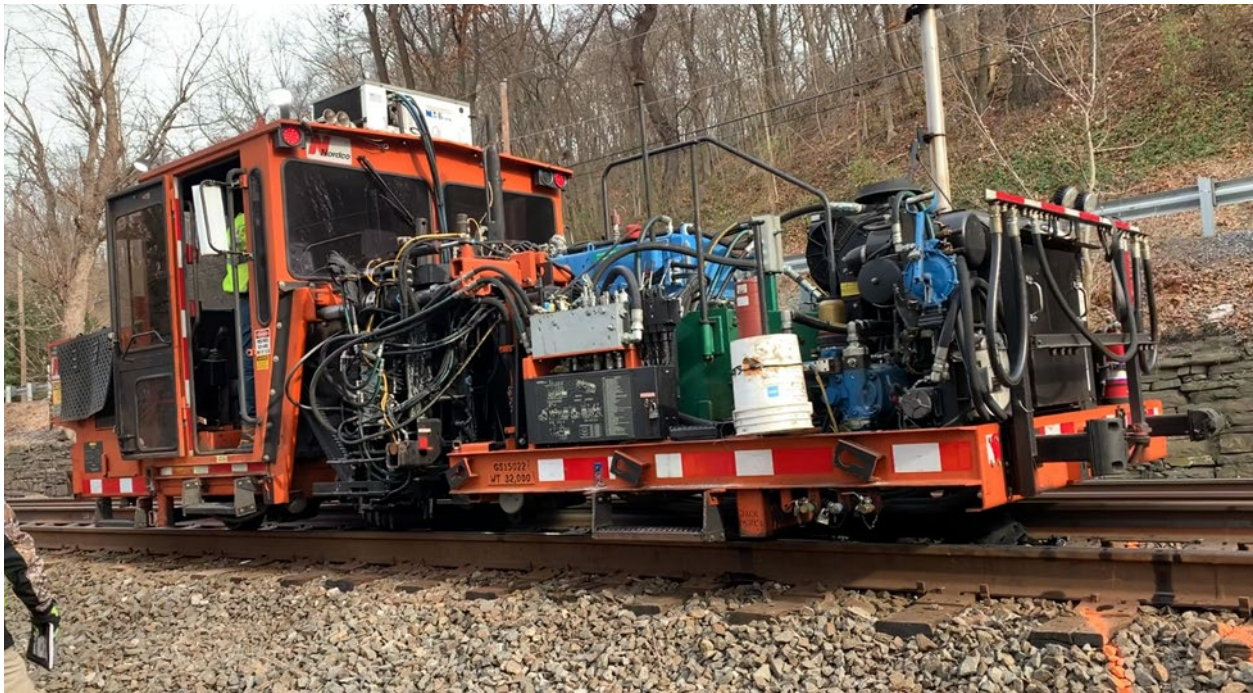
*Figure 1- Photo of the accident spiking machine (Spiker No. 2)*

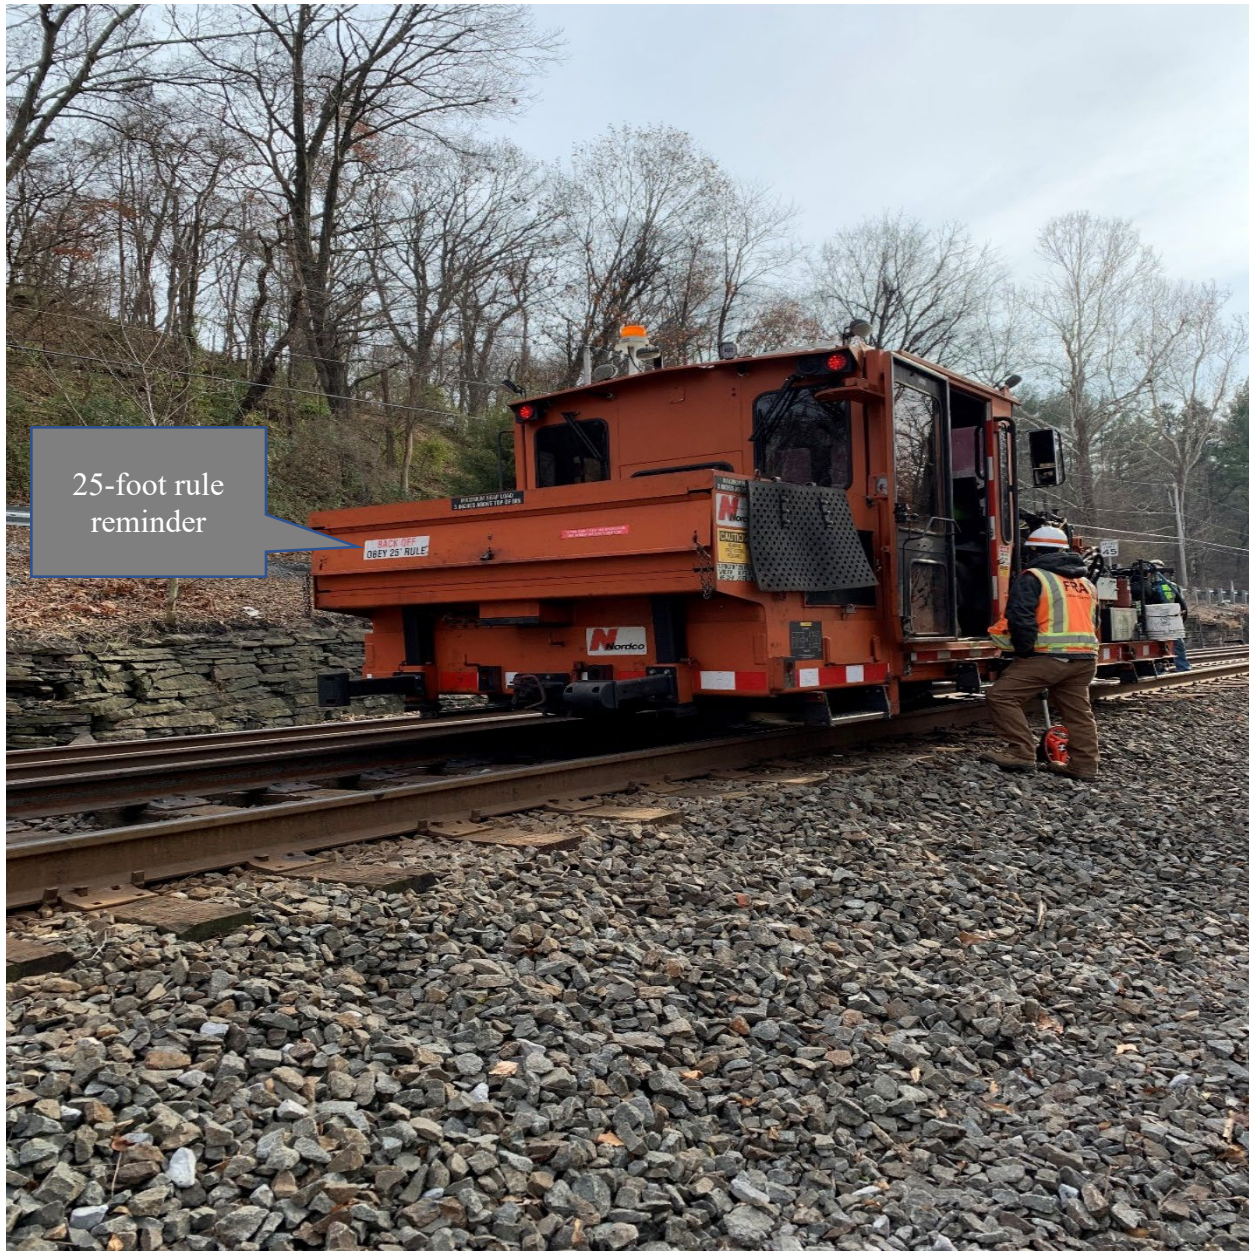
Figure 2- Photo of the rear of spiker No. 2

- Rear of spiker No. 2 to group determined point-of-contact with roadway worker = 29'11"
- Body drug to final resting location = 34'10"
- Body at final resting location under spiker No. 2 = 65'9"
- Rear of spiker No. 2 to front of spiker No. 3 = 126'6"
- Spiker No. 3 operator seat to point-of-contact = 114'10"
- Front of spiker No. 2 to lead spiker No 1 = 34'11"
- Clearance under spiker No. 2 = 17"
