NATIONAL TRANSPORTATION SAFETY BOARD

Amtrak Train No. 7 Derailment

Joplin, Montana

Track and Engineering Group Chairman Factual Report

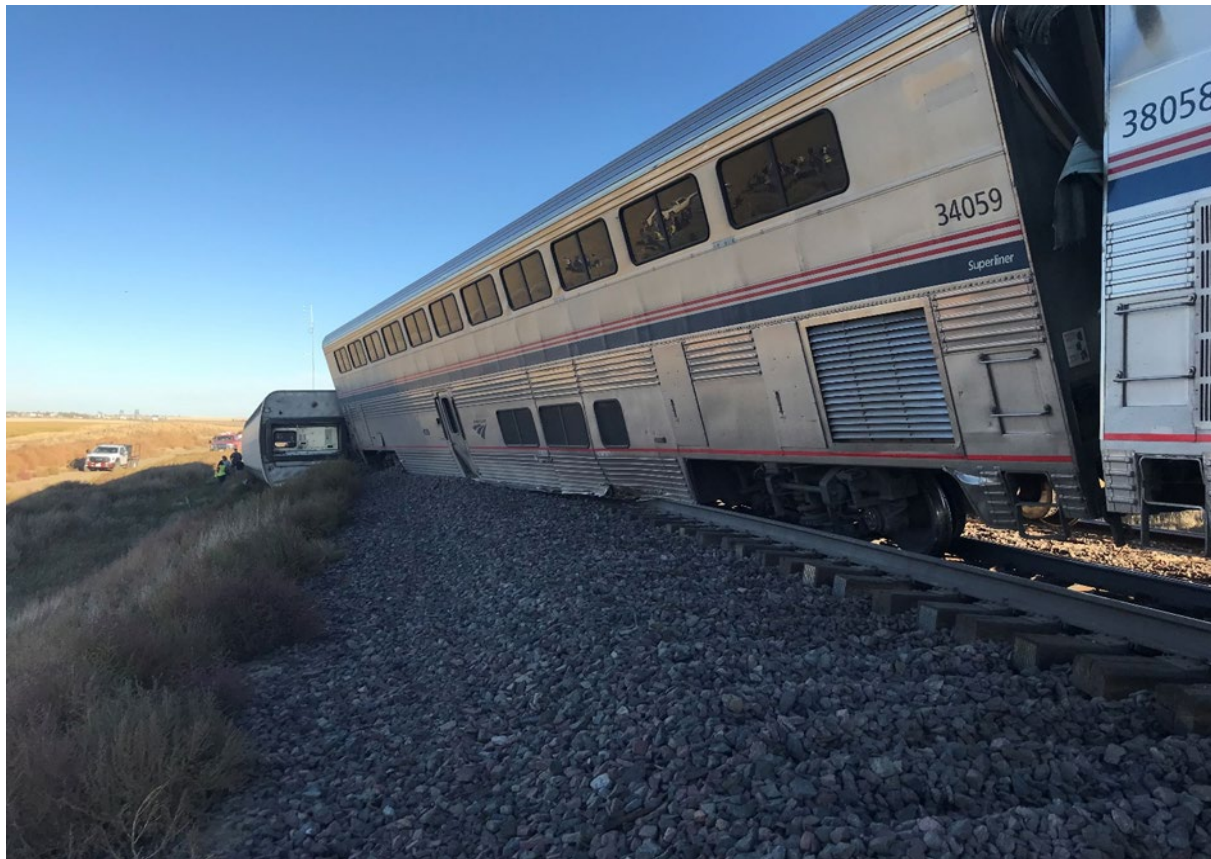
Figure 1- Derailed Amtrak railcars

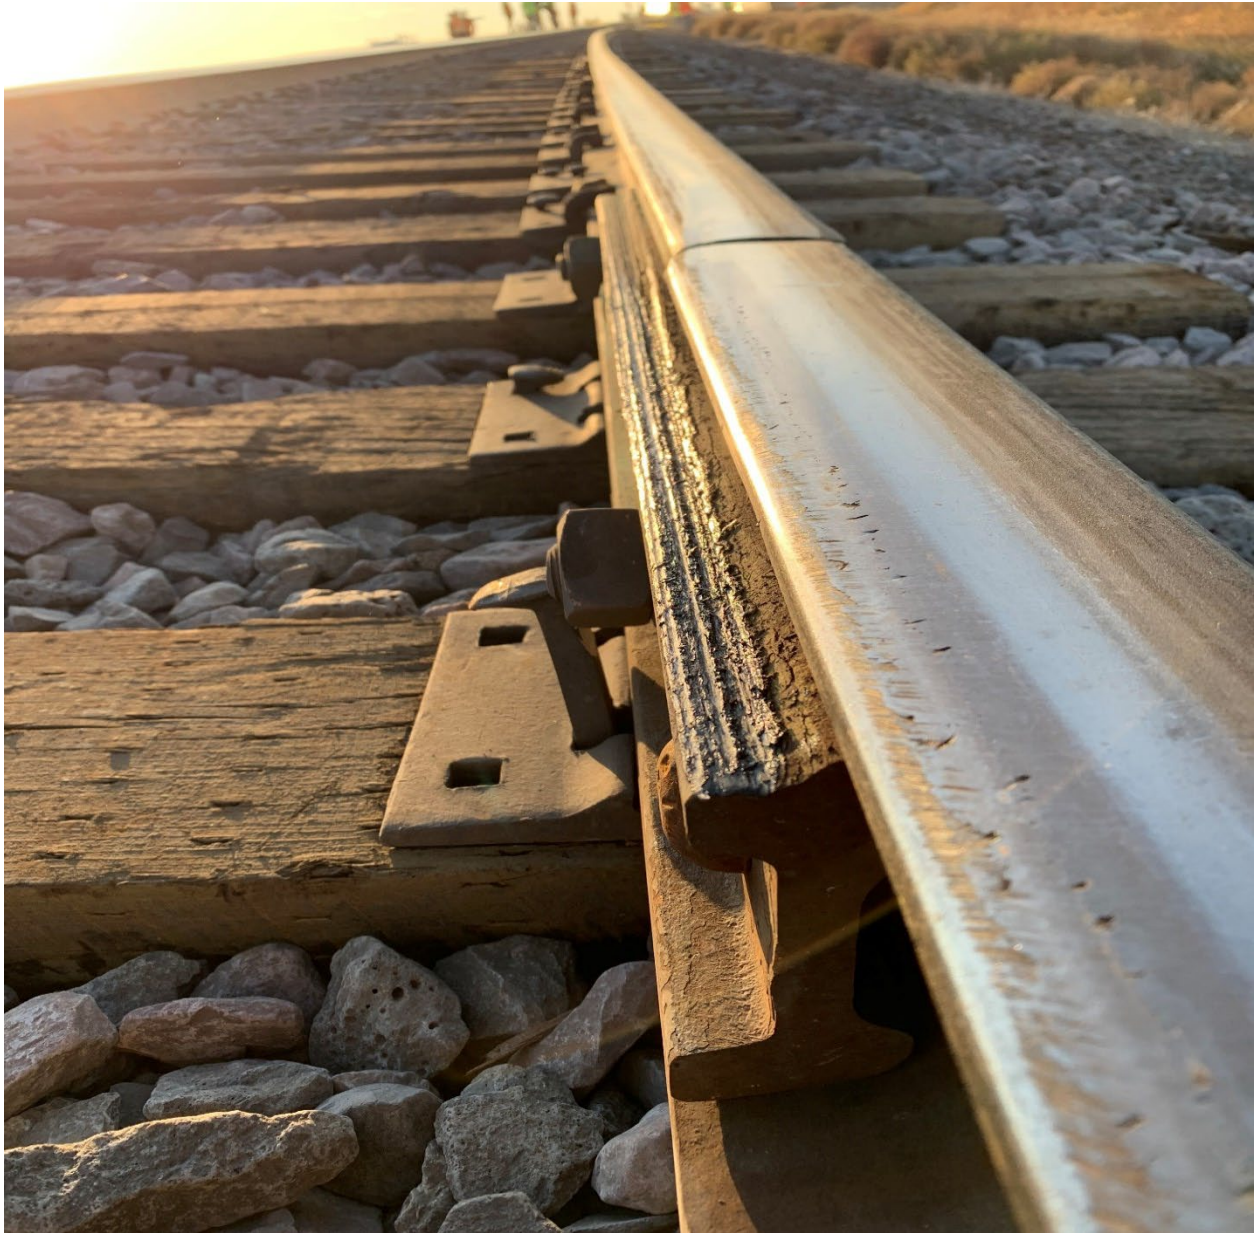
Investigators noted a low-side plug rail with two bolted suspended rail joints that measured 19'6" long between milepost 1014.554 and milepost 1014.550. The 19'6" plug rail consisted of a 132-pound—RE—CC—USS—Illinois—manufactured in January 1982. The bolted plug rail was secured to the existing low-side running rail with standard six-hole joint bars measuring 36" long. Each plug rail joint was drilled for in-track welding, and had four--6.5" standard bolts, nuts and locking washers securing the joint bars. Investigators noted that the east suspended plug rail joint

had evidence of train wheel flange contact at the top surface of the gauge side joint bar (see figure 2).

Figure 2- East low/north plug rail joint showing indication of wheel flange contact

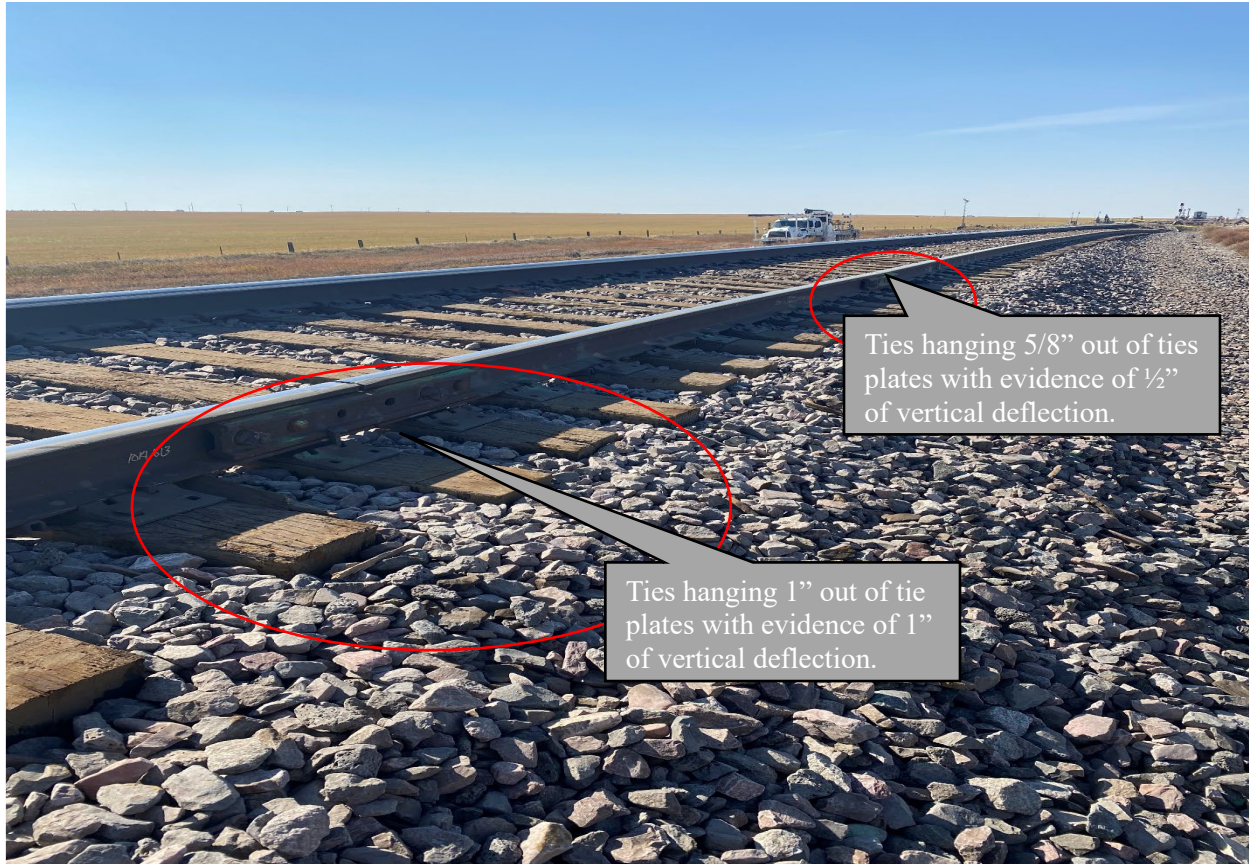
As found by investigators during postaccident track inspections, investigators noted that the east low-side suspended plug rail joint was hanging out of the crosstie plates about 1- inch, with evidence of an additional 1- inch of underloading vertical deflection (movement up and down) measured on the sides of the crossties.⁴ Investigators also noted during postaccident track inspections that the west low-side suspended plug rail joint was also hanging out of the crosstie plates about 5/8" (.625 inches), with an additional 1/2" (.50 inches) of vertical deflection measured on the sides of the crossties. (See figure 3)

Figure 3- "As found" by investigators- non-supporting ties under suspended plug rail joint

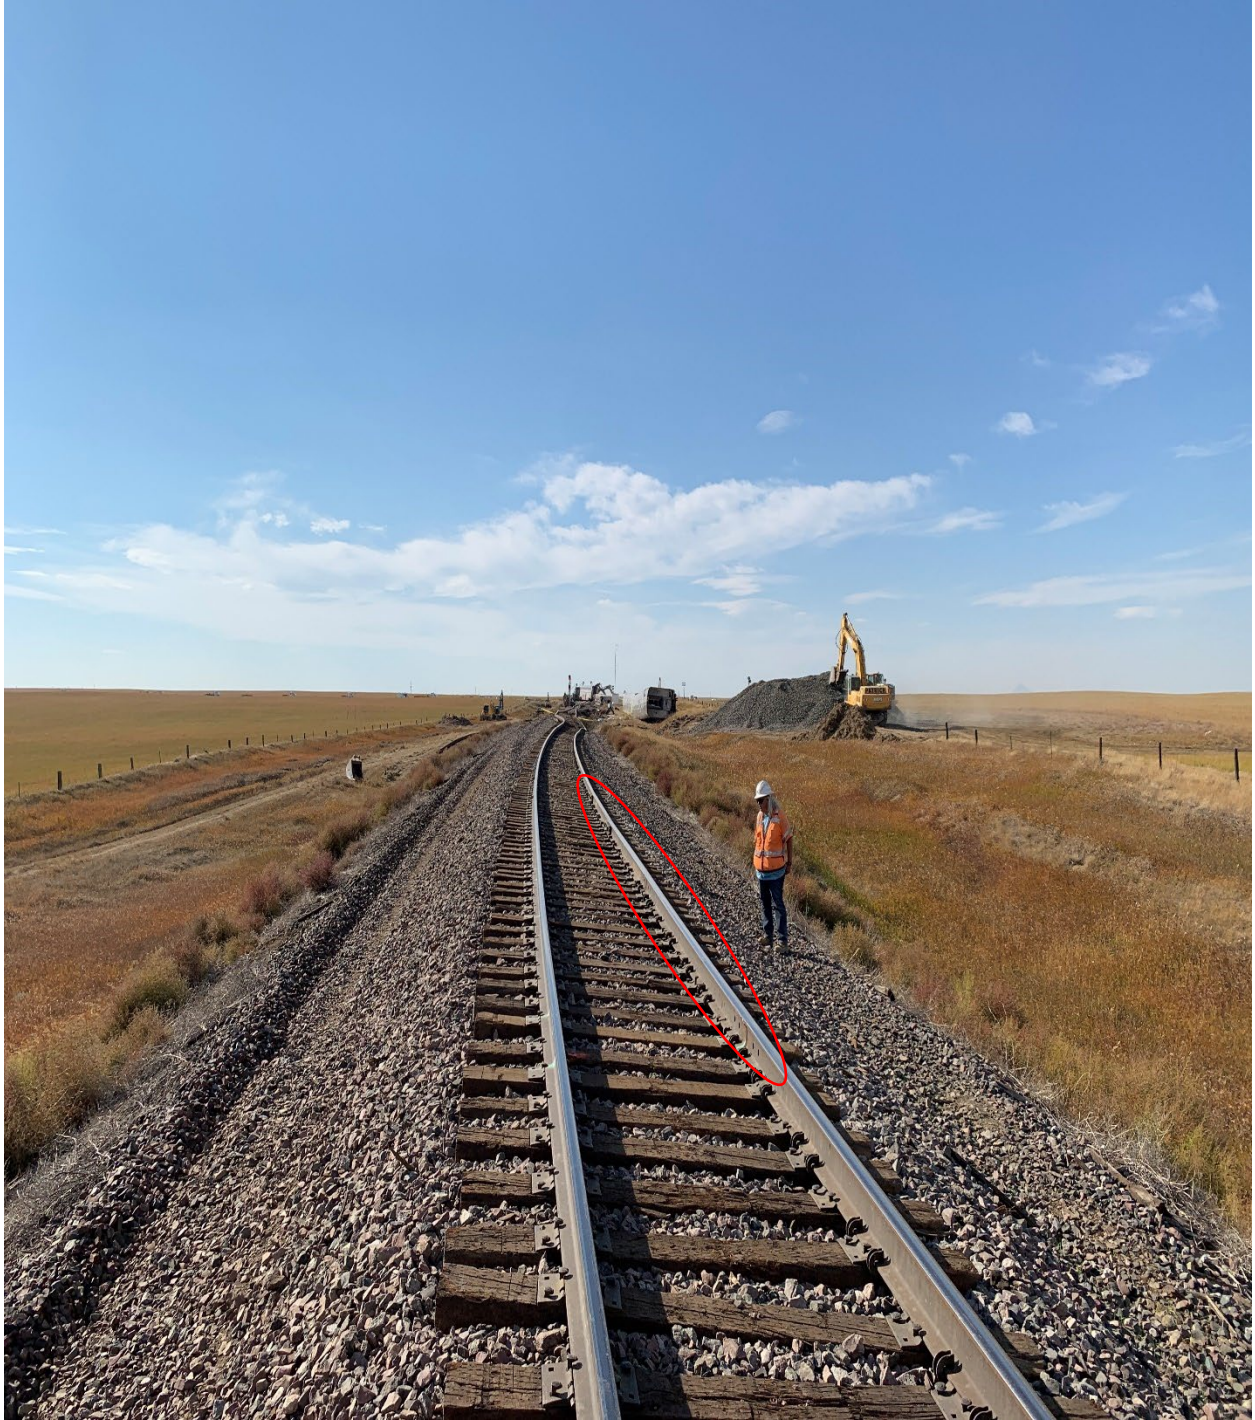
extends another 19'6" east and ends at a field weld located at milepost 1014.543. (See figure 3)
 The two existing field welded plug rails consisted of 132-pound—RE—CC—USS—Illinois, manufactured in April 1983. According to the web of rail markings near the two field welds, the two field welds were completed on February 4, 2020, with rail gap---1.25"—pulled—2.25" and adjusted 400 feet when the field welds were completed.

Figure 3- Photo of the in-track 19'6" bolted plug rail and two in-track welded 19'6" plug rails

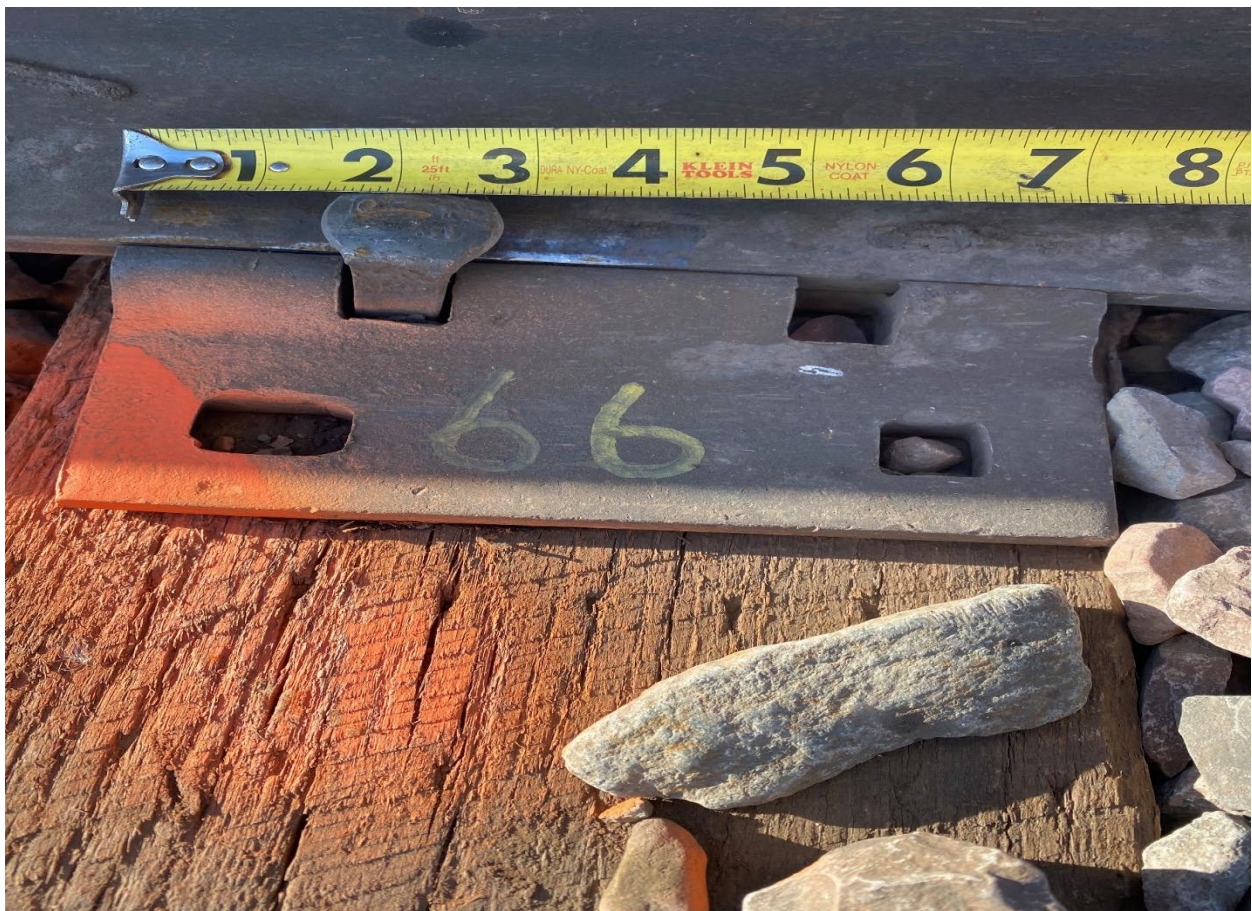
filled between three-quarters to seven-eighths full. Investigators noted no fouled or dirty ballast on both ballast shoulders and crib ballast sections. From about milepost 1014.56 to milepost 1014.60, which includes the area of the point of derailment, the ballast section had been disturbed as a result from the postaccident derailed equipment, whereas the track had been shifted downhill (north direction) between six and eight feet.

Figure 4- Photo showing longitudinal rail movement through spike.

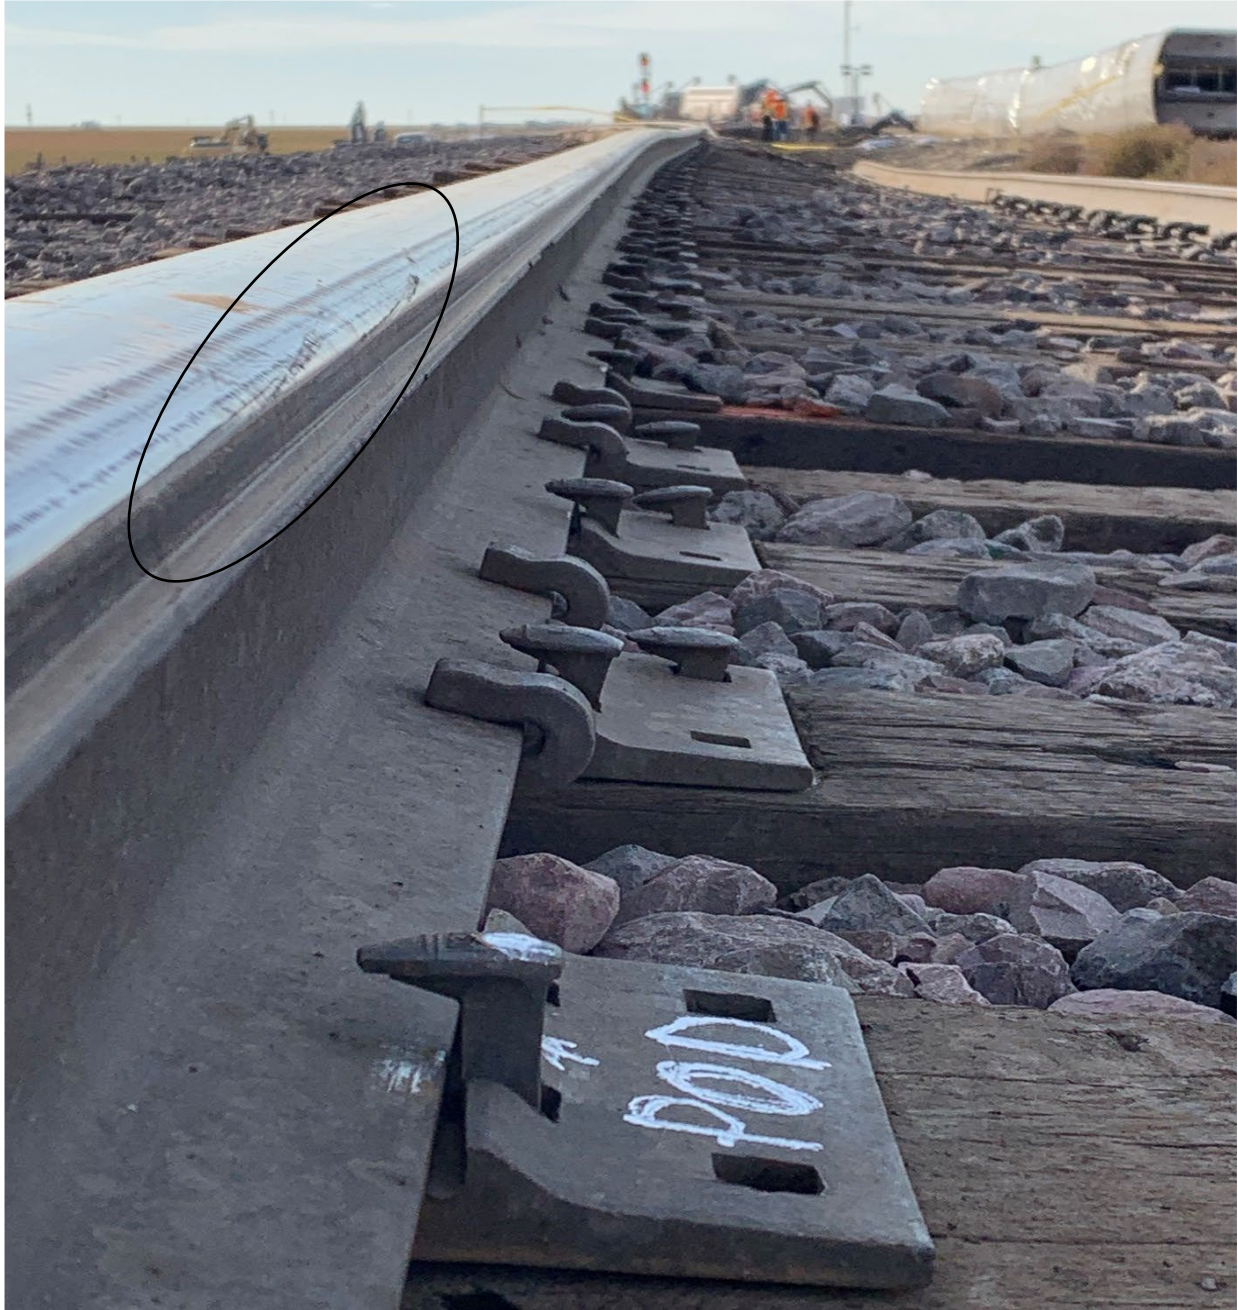
The point of derailment (POD) was measured and confirmed by the investigative track group to be at milepost 1014.57, located along the high-rail in curve No. 1014. Investigators measured the POD to be about 883 feet east of the point-of-switch at CP East Buelow. Representatives from BNSF measured (wheeled-off) the POD to be approximately 2,943 feet west of milepost 1014.00, placing the POD at milepost 1014.5740.

Figure 3- Point of Derailment looking west. High rail or south rail showing wheel departure marks

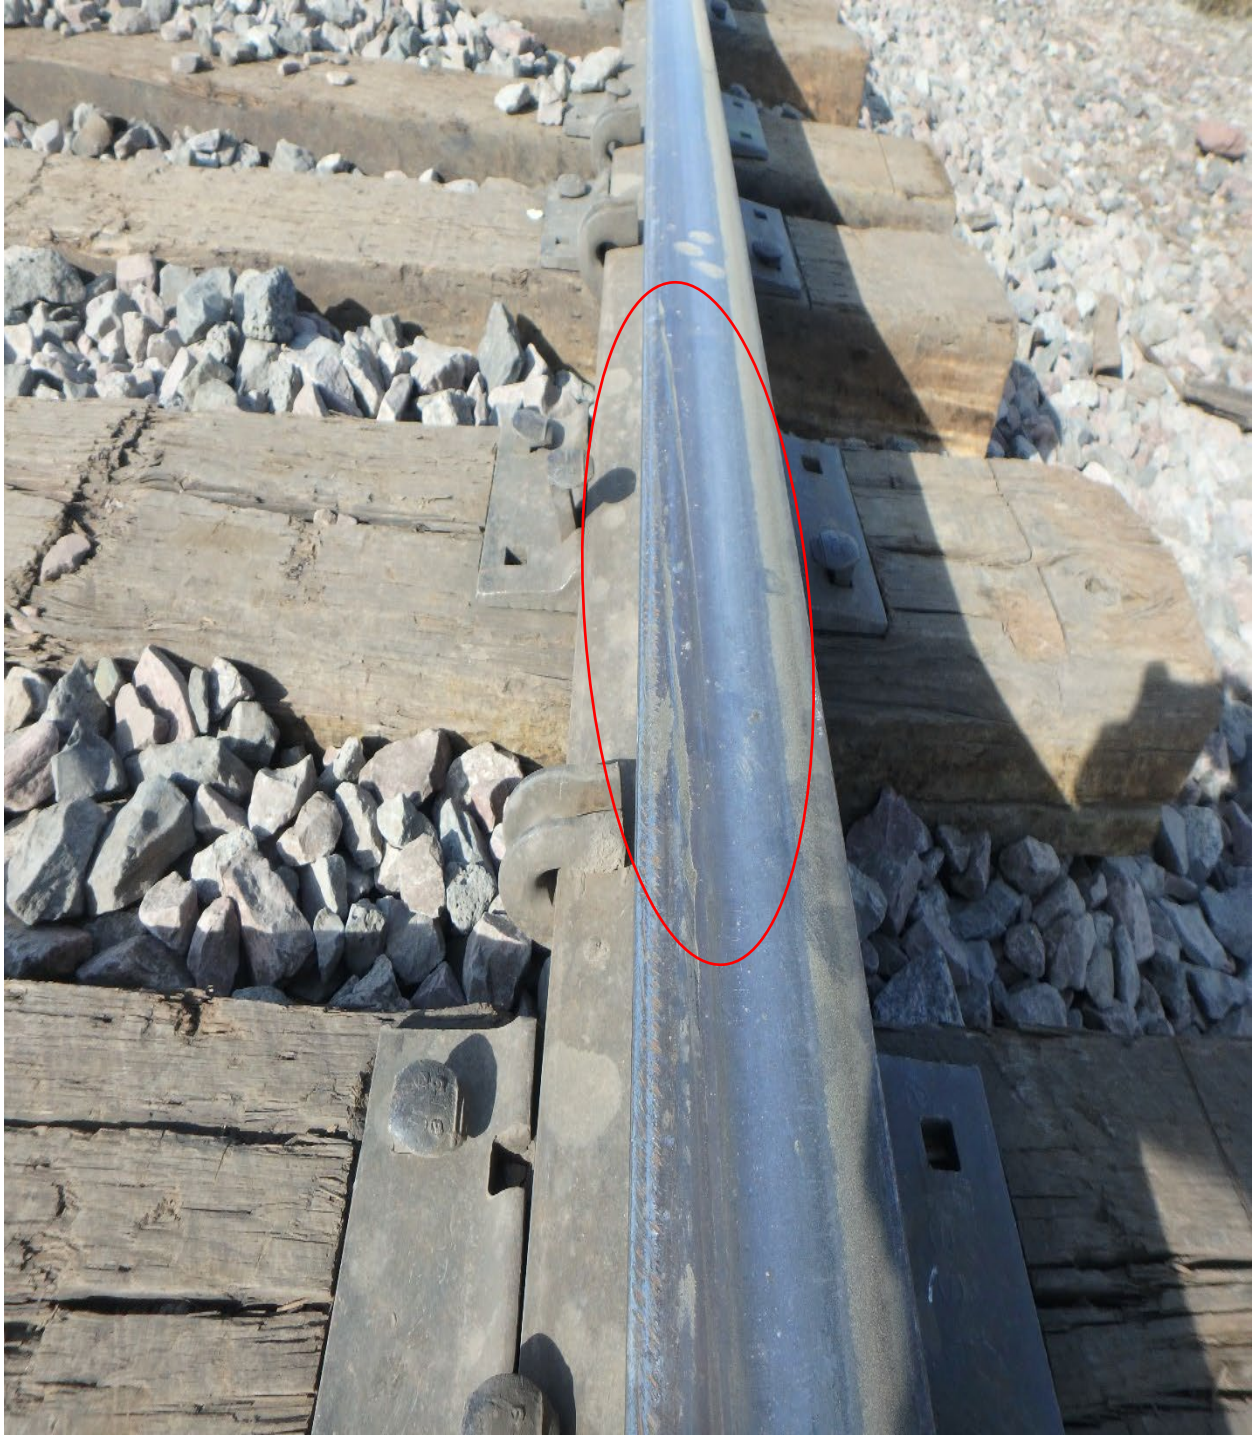
Figure 4- low side rail show wheel departure marks

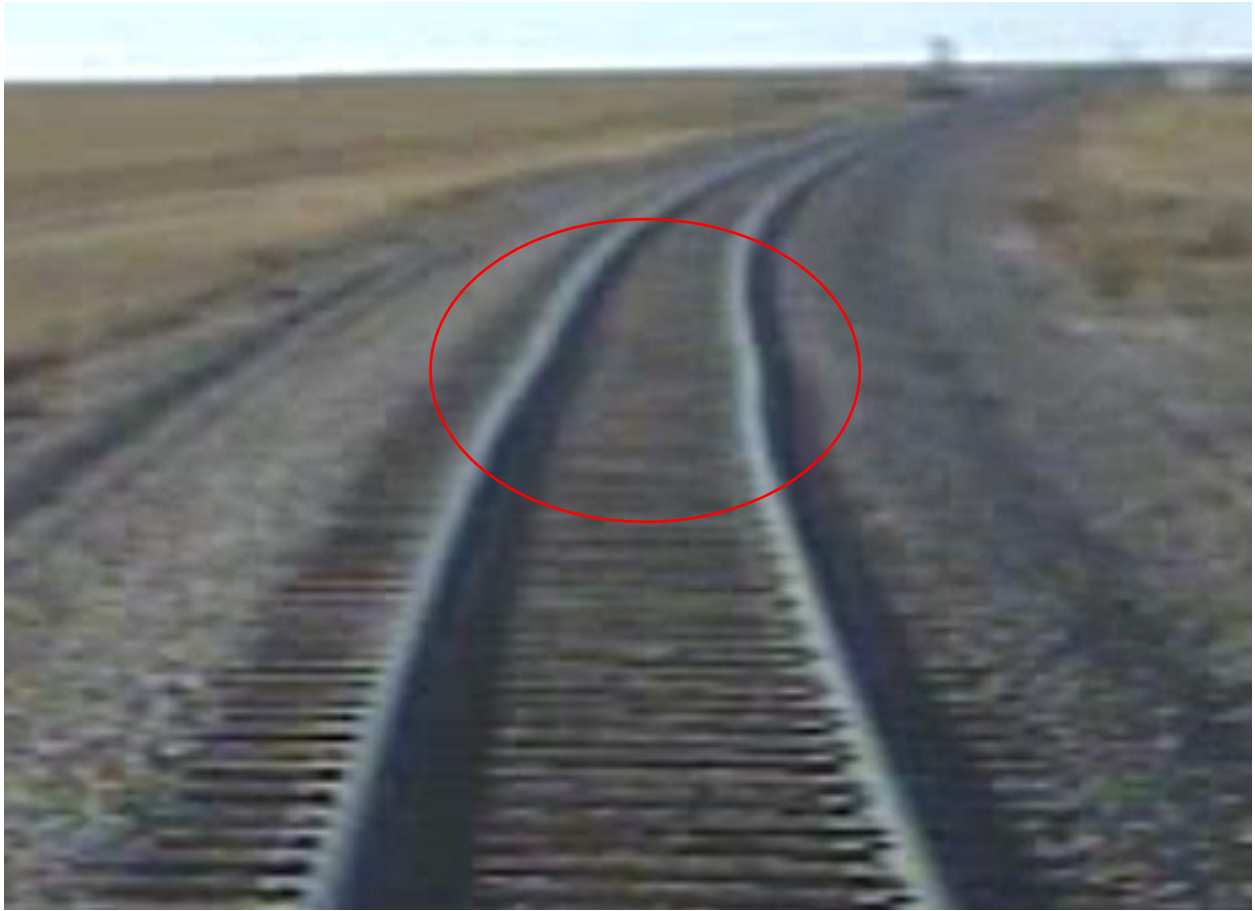
Figure 5- Head-end of Amtrak train No. 7 showing misaligned track
