**TRACK AND ENGINEERING GROUP CHAIRMAN
FACTUAL REPORT**

RRD19FR011

**Head-on Collision between Two Sacramento Regional Transit District (SRTD)
Passenger Trains**

Sacramento, CA

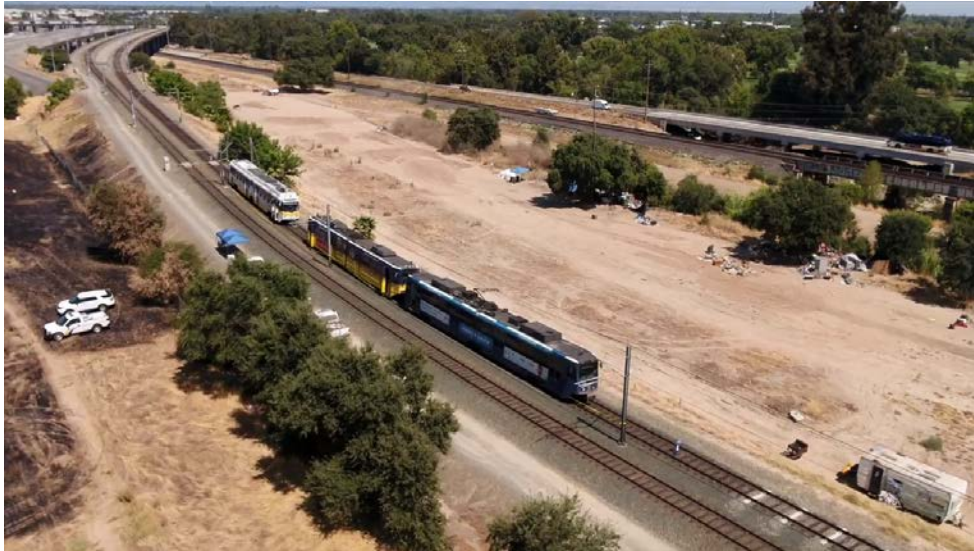
Figure 1. Aerial photo of the point of collision site. (source: local news photo)

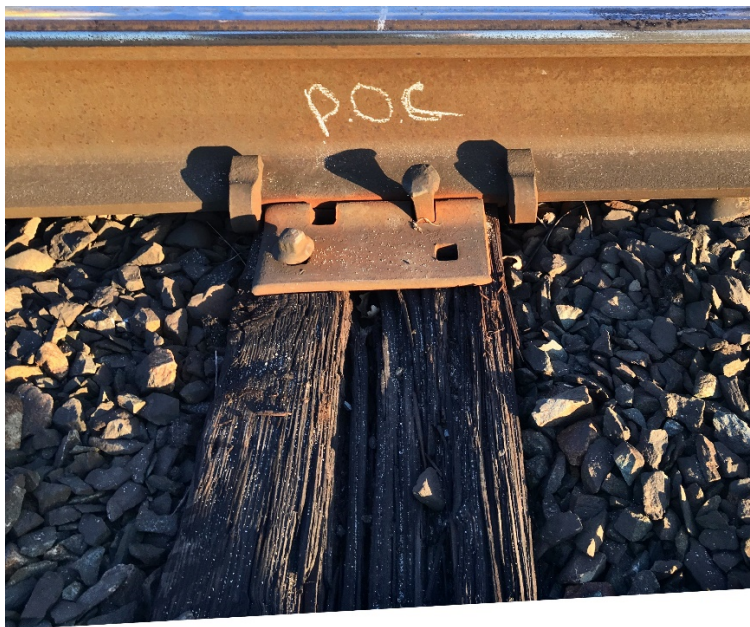
Investigators identified the point-of-collision (POC) as a location about 150 feet south of intermediate signal N672 on the outbound main track. Investigators observed mechanical debris dropped in-between the rails where the equipment first collided. North of the POC, investigators observed wooden crosstie damage between the rails from a knuckle and draw bar of train 103 that dropped to track level after the collision (POC).

Figure 2, View of POC.

SRTD engineering personnel estimated the total track structural damages at \$2,500. This figure includes costs for the installation of crossties, associated ballast and track materials. No equipment derailed in this incident; however, the collision caused the knuckle and drawbar assembly to drop and those parts of train 103 caused damage to the track structure.

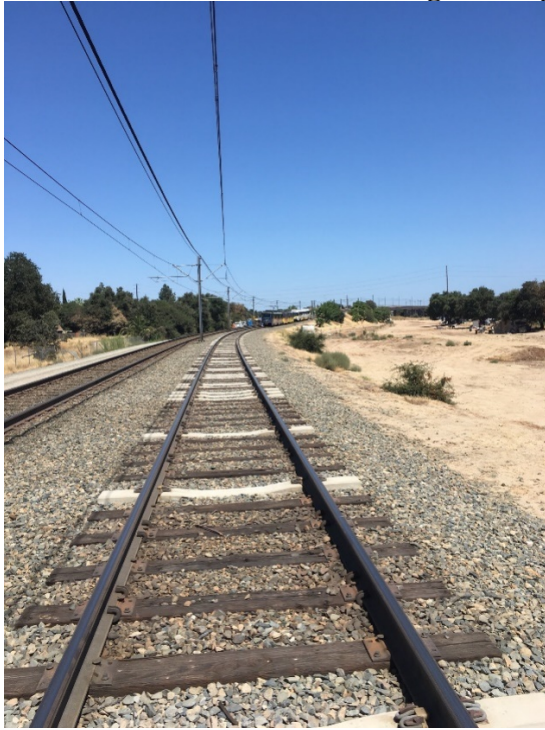
Investigators measured the degree of curvature along with superelevation and determined that the curve's maximum operating speed was allowable for 57 mph (using FRA's Vmax formula: curvature of 3 degrees and 15 minutes; superelevation of 4 1/2 inches in the full body). The curve is currently authorized for 55 mph. This is the last segment of track that each train traversed prior to the POC.

Figure 3. Looking in the direction of the travel for train 103 as the train traversed a curve into the POC area. (daylight view)

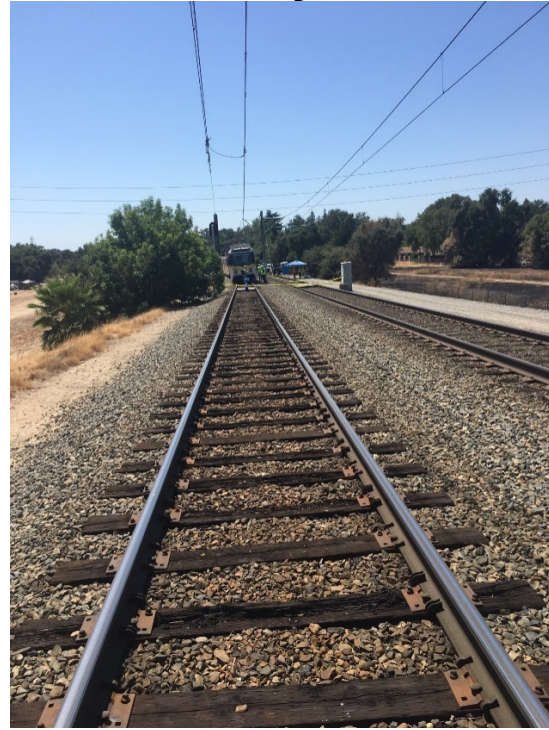
Figure 4. Looking in the direction of travel of the maintenance train. Resting position after collision south of signal N672. (See Mechanical Group Chairman Factual Report for more detail--daylight view)

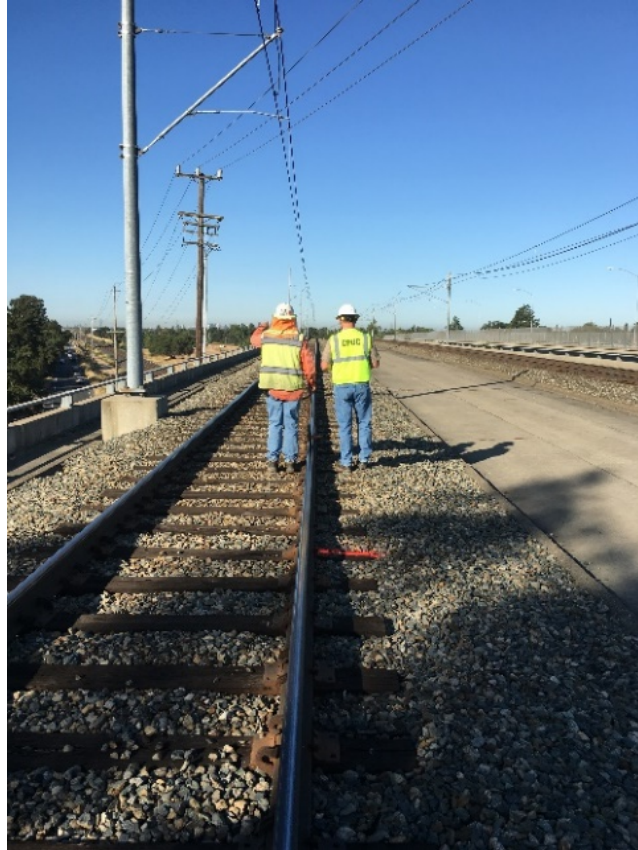
- 2,331' from POC, this is where the MT could not be seen by the revenue train.
- 1,972' from POC, this is where the revenue train could see the MT.
- 650' from POC, the MT could tell that the revenue train was on the same track.

- 45' from POC, this is where the RT can see that the MT is on the same track.
- 506' from POC, this is where the MT can first see the RT.
- 725' from POC, this is where RT can first see the intermediate signal display (signal N672).

Figure 5. *Investigators measuring the distance from landmarks post sight distance tests.*
