**TRACK & ENGINEERING /
SIGNAL & TRAIN CONTROL
FACTUAL REPORT**

RRD22LR001

**Washington Metropolitan Transit Authority Passenger Train
Derailment**

**Arlington, VA
October 12, 2021**

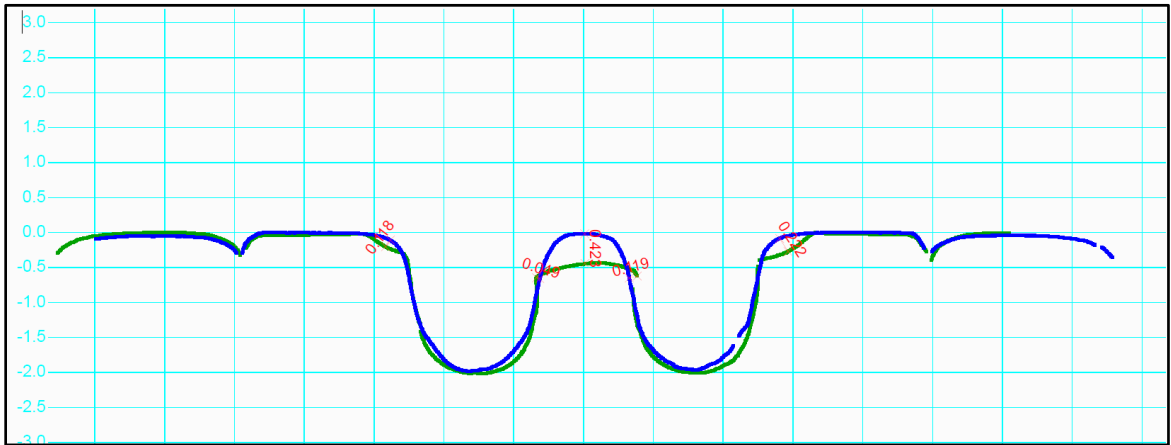
On October 13, 2021, investigators identified the final point of derailment in the frog of the turnout at chain-marker 146 + 70, about 166 feet south of the Rosslyn station. The team identified flange marks in the turnout at the frog of the switch in the C05 switch. Corresponding flanges marks from departing wheels were found on track components in the area. The frog in the C05 switch had distinguished wear on the tread portion of the insert. Investigators measured 7/16" tread wear on the point portion of the frog at about 11" back from the point.

Figure 1. Laser scan representation from the C05 turnout frog. Image shows worn profile in green with the new frog profile in blue.

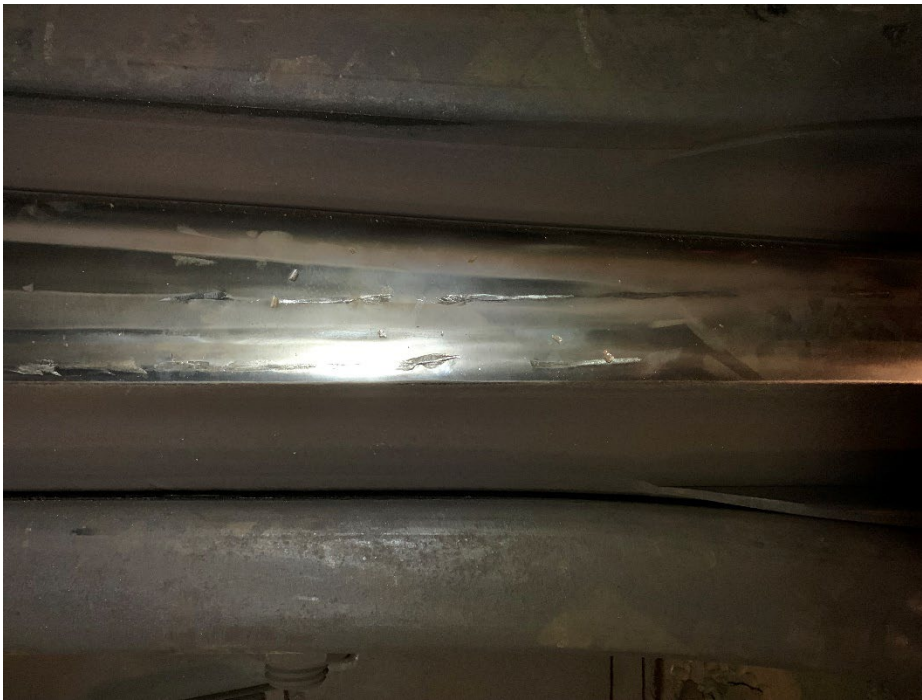
Figure 3. Wheel flange marks noted on the tread portion of the frog point at the C05 switch.

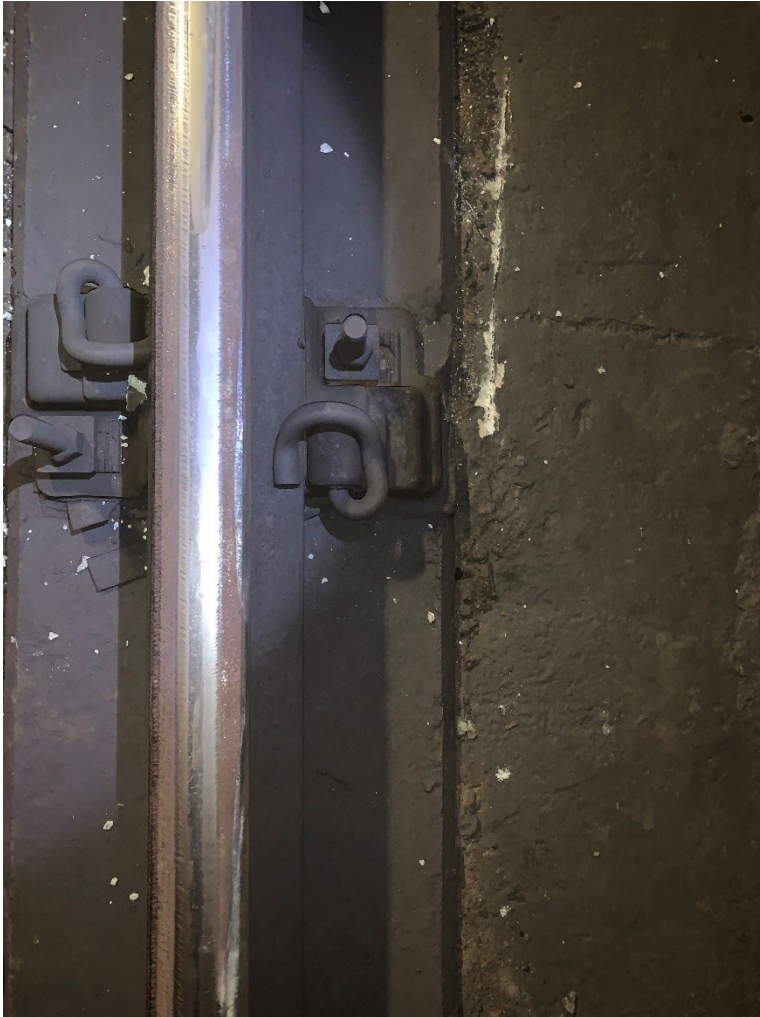
Figure 2. Corresponding wheel flange marks noted south of the frog on the concrete invert/tunnel floor near the C05 switch.

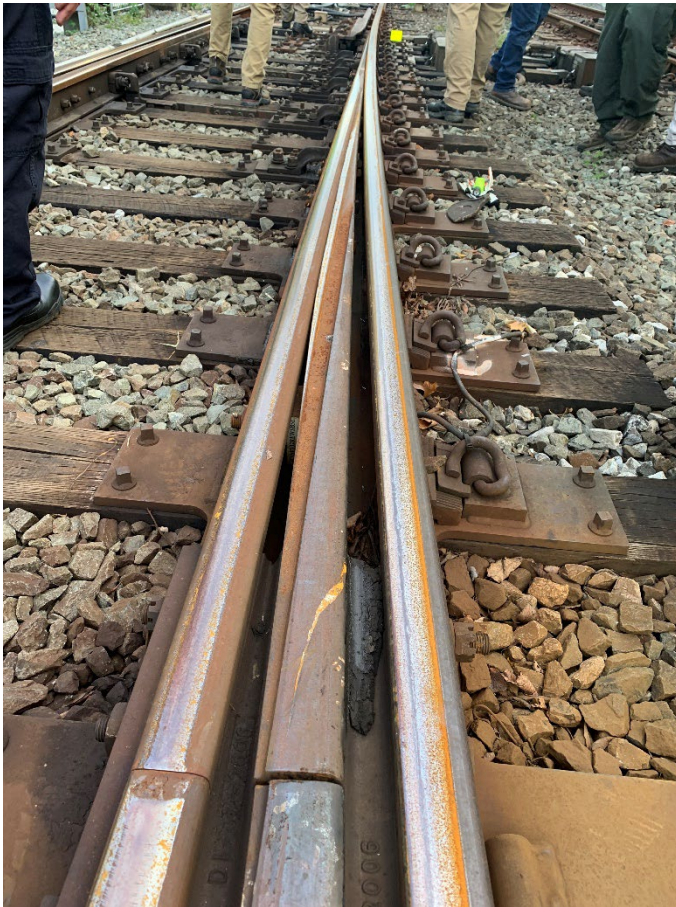
WMATA employees discovered evidence of a prior derailment on track No.1 in the crossover north of the AC station. This damage was noted the 1A and 3A switches. Investigators noted evidence derailed wheels striking two heel blocks, breaking bolts, scaring ties, and damaging Automatic Train Control (ATC) equipment as they were ground running. Broken sections of brake discs were

Figure 3. Wheel flange mark seen coming across the switch point near the heel of the switch in the 1A switch in the Arlington Cemetery station area.

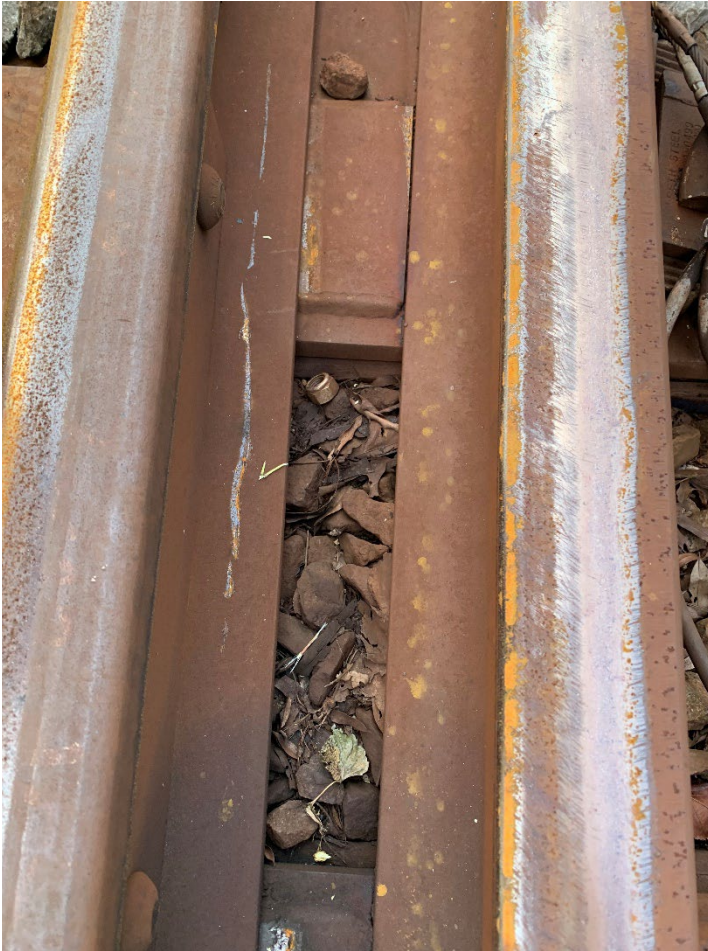
Figure 4. Corresponding wheel flange departure marks near the heel of the switch in the 1A switch in the Arlington Cemetery station area.

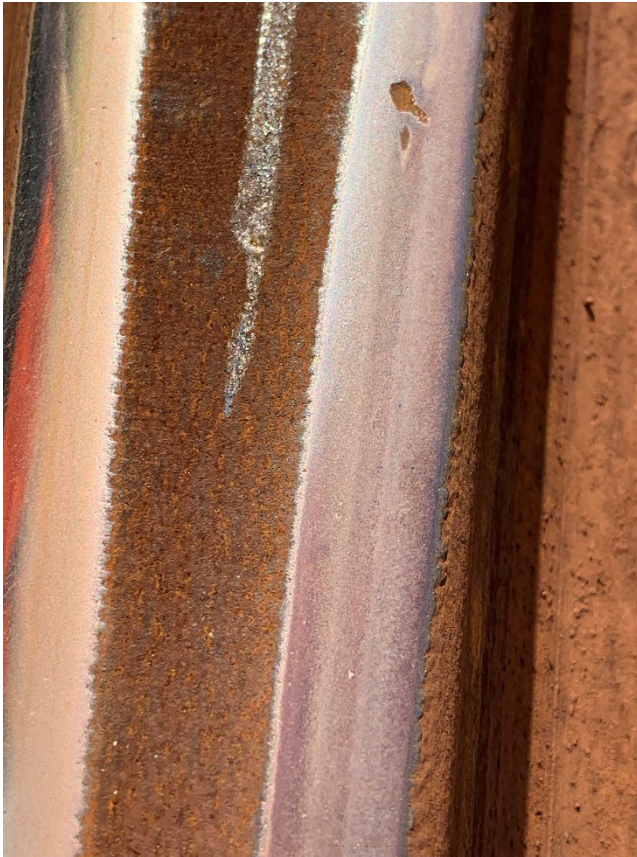
On October 14th, investigators traveled to Largo Town Center (LTC), here investigators confirmed that the train had previously derailed and railed at the LTC station; the LTC station and AC station locations are about 15 track miles apart. In G05, Largo, there was evidence of derailling/rerailing over switch 1B and 3B. Wheel marks on the ground seemed to indicate a bouncing of the wheel set. Grout pads were broken in large chunks, ATC equipment was also damaged

Figure 5. Wheel flange marks noted on the tread portion of the frog point at the G05 switch.

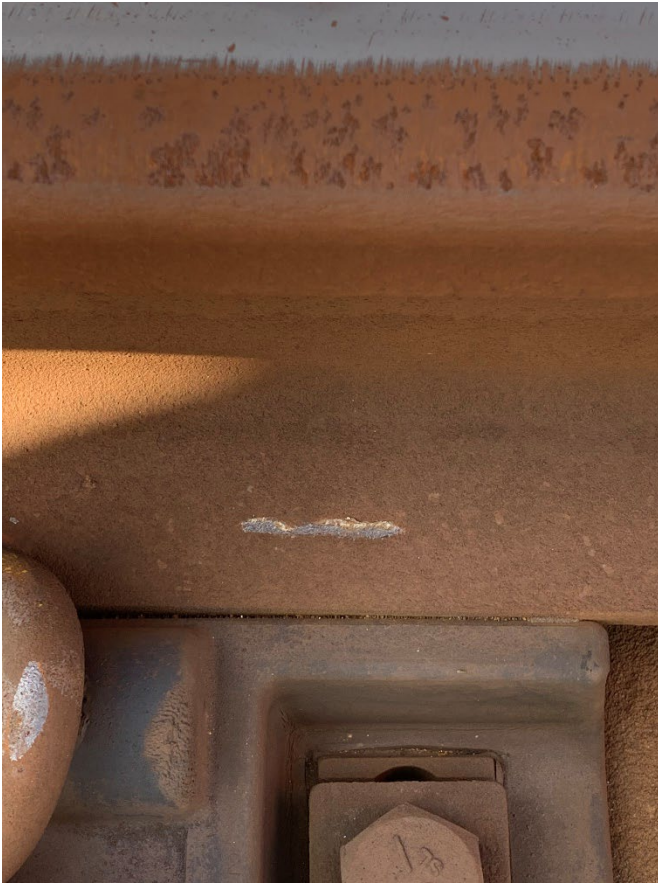
Figure 6. Corresponding wheel flange marks noted on the rail base in the G05 turnout.
