# Car Damage Report

3-12-15  
DGT-004  
Rev 4

Date of Derailment 1-8-77

Location BNSF Oklahoma TX  
Pinard 1987

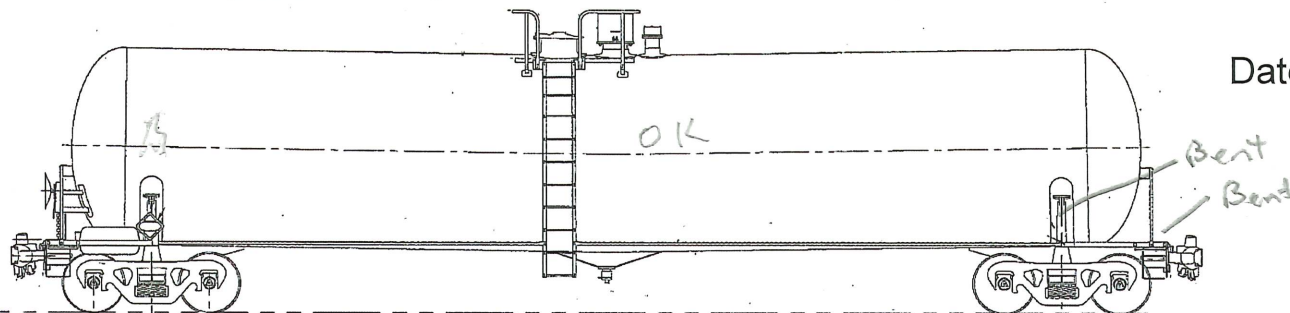
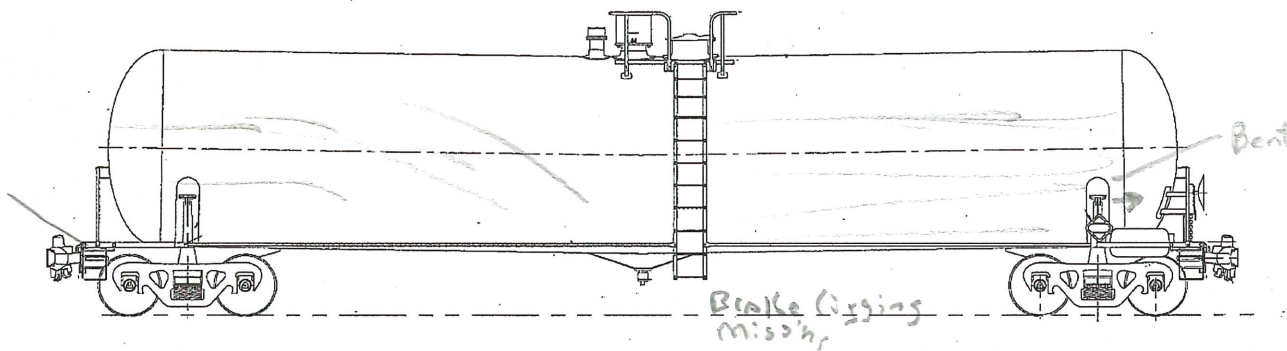
Car Number T1LX731779

Top fittings MW OK MH OK  
 Bottom Outlet Leg Sheared Handle DT Bent ok  
 Breach- Thermal Tear No Mech Tear No  
 Draft Sill A OK B OK A Coupler Sheared  
 Head Shield A OK B OK  
 PRD Functioned- Yes No  
 SK:d OK

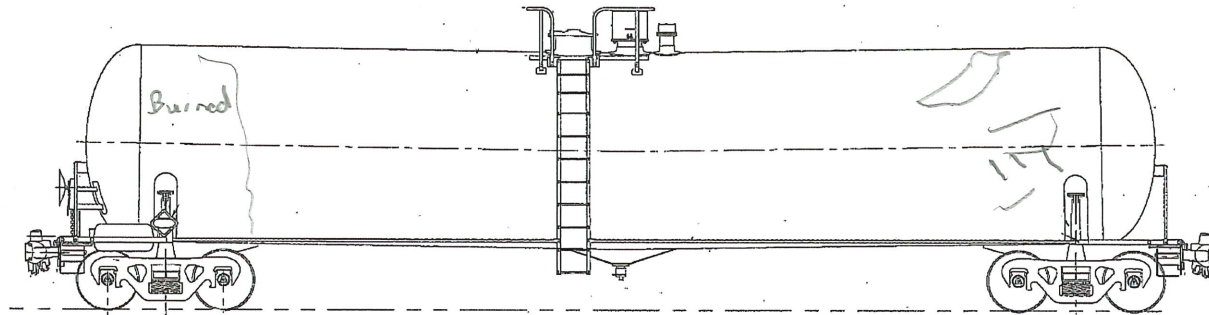
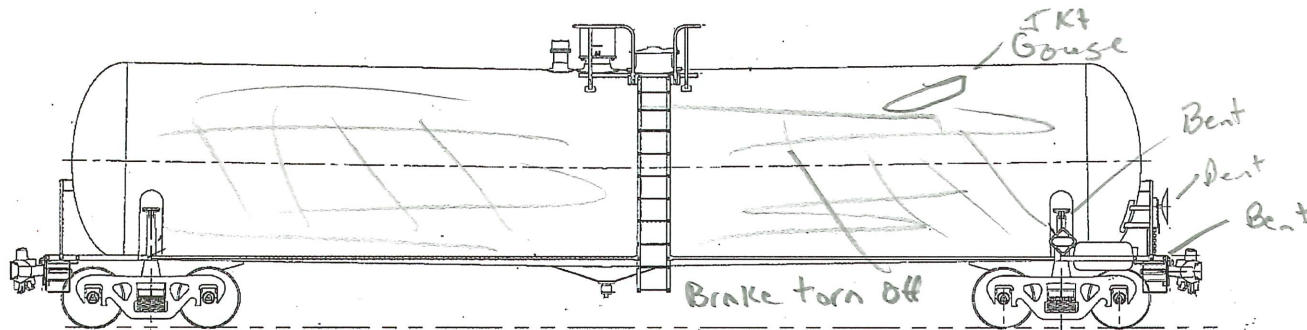
Car Number T1LX 73169Z

Top fittings MW OK MH OK  
 Bottom Outlet Leg Sheared Handle DT Bent  
 Breach- Thermal Tear No Mech Tear No  
 Draft Sill A OK B Twisted Left  
 Head Shield A OK B OK  
 PRD Functioned- Yes No  
 Skid OK

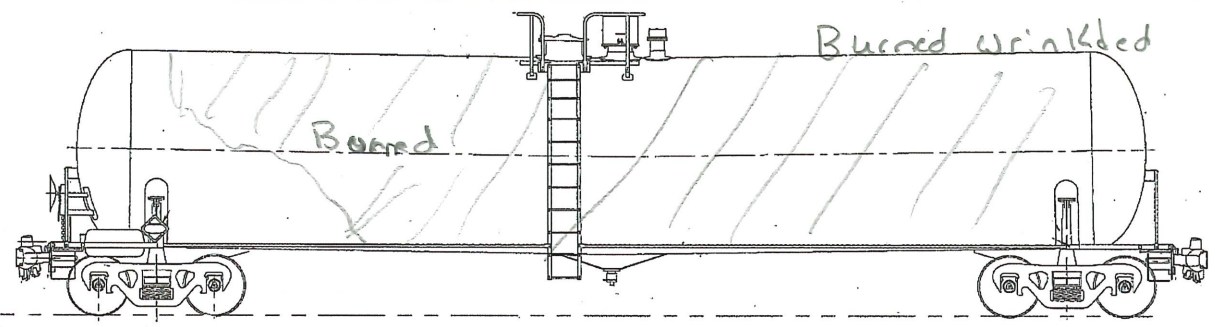
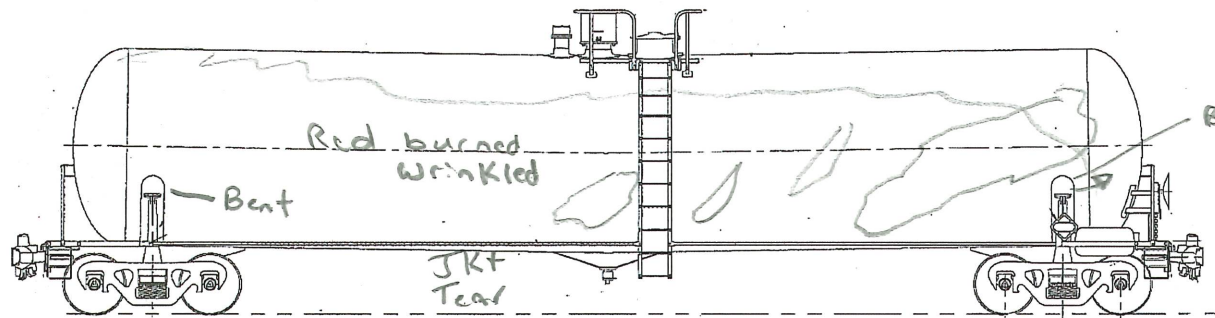
Car Number T1LX731698

Top fittings MW OK MH OK  
 Bottom Outlet Leg Sheared Handle DT Torn off  
 Breach- Thermal Tear No Mech Tear No  
 Draft Sill A Twisted B OK  
 Head Shield A OK B OK  
 PRD Functioned- Yes No  
 SKid OK

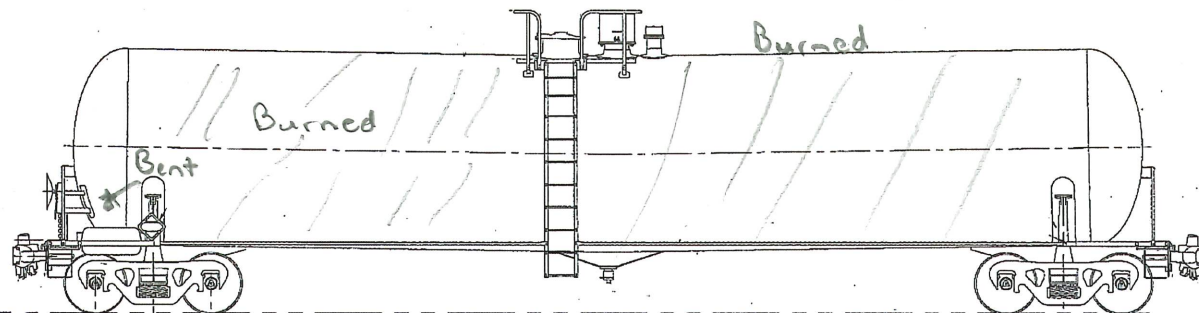
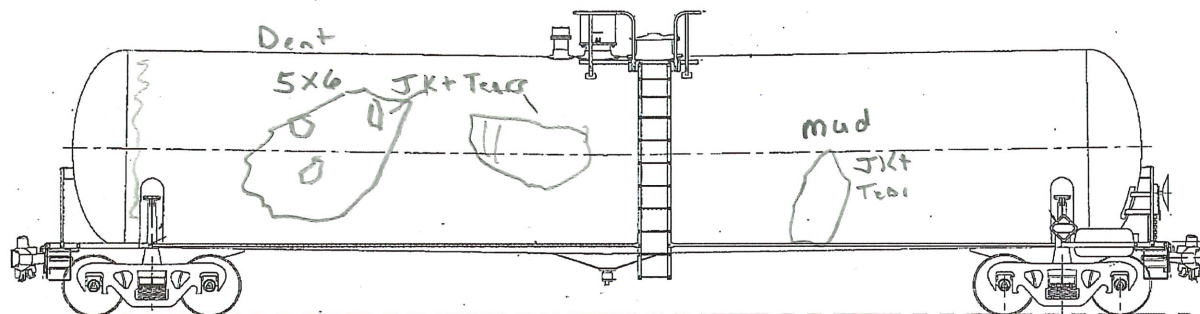
Car Number TILX 731775

Top fittings MW OK MH OK  
 Bottom Outlet Leg Sheared Handle DT OK  
 Breach- Thermal Tear No Mech Tear No  
 Draft Sill A OK B Twisted torn  
 Head Shield A OK B OK  
 PRD Functioned- Yes No  
 Skid OK

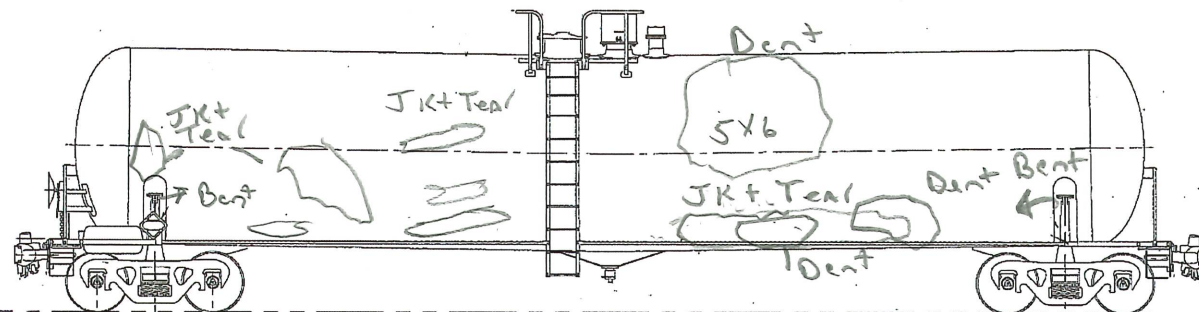
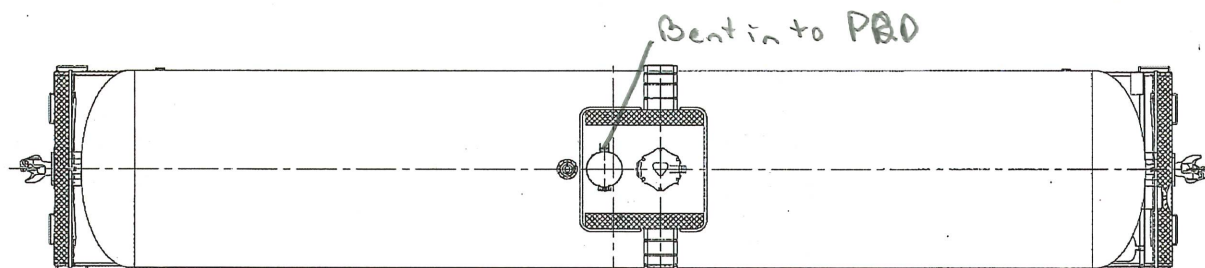
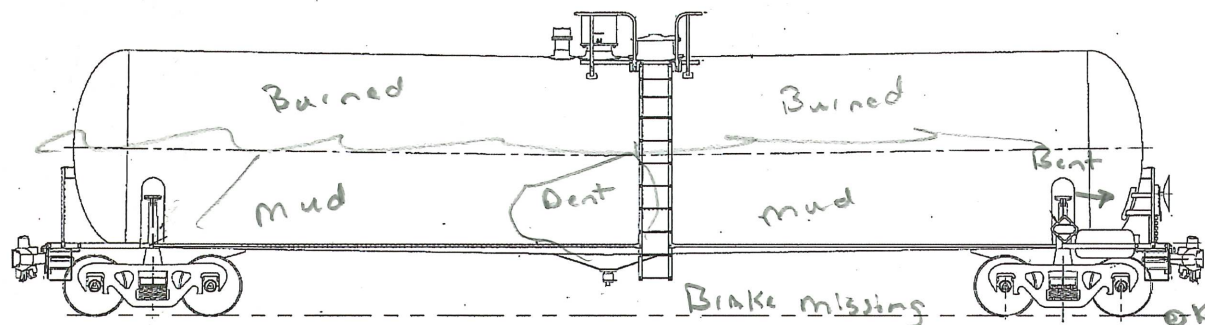
Car Number TILX 731721

Top fittings MW <sup>2 Eye bolts bent over</sup> MH Bent  
 Bottom Outlet Leg Sheared Handle DT Torn off  
 Breach- Thermal Tear No Mech Tear No  
 Draft Sill A Bent torn B Twisted  
 Head Shield A OK B OK  
 PRD Functioned- Yes No  
 Skid Damaged Stem bent

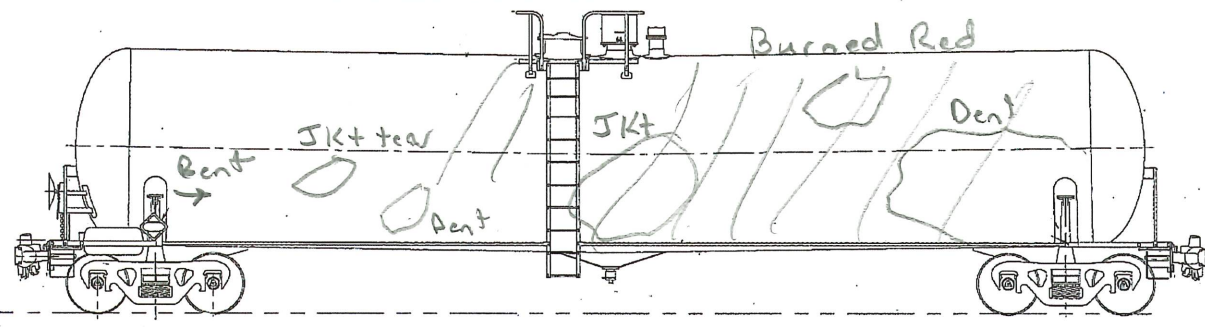
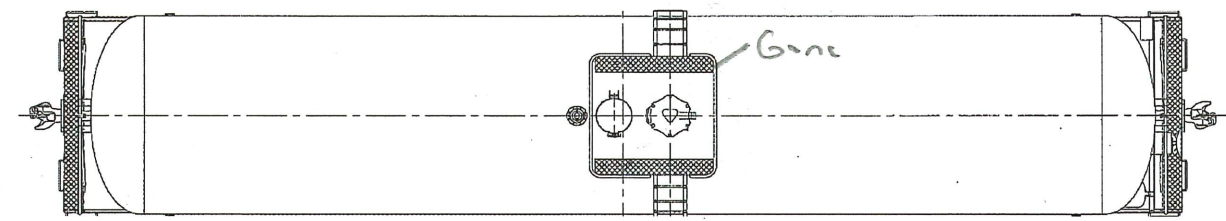
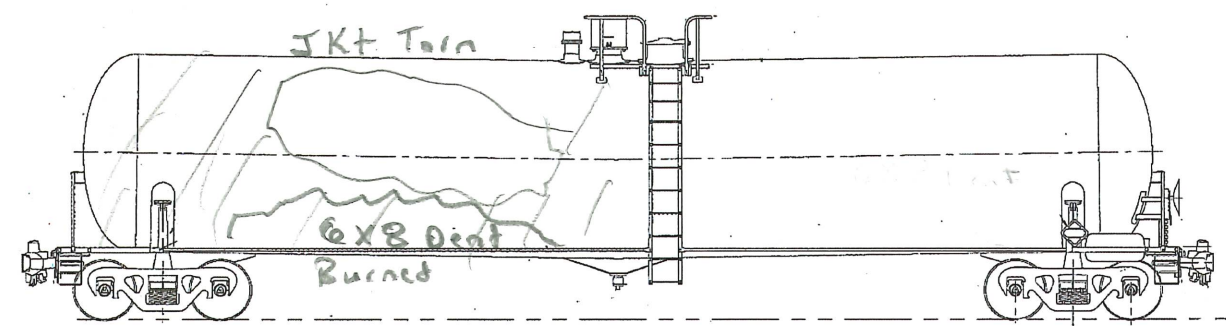
Car Number CRDX300110

Top fittings MW OK MH Bent OK  
 Bottom Outlet Leg OK Handle DT OK bent  
 Breach- Thermal Tear No Mech Tear No  
 Draft Sill A Bent torn B OK  
 Head Shield A Dents B Dent  
 PRD Functioned- Yes No  
 SKid OK

1/4  
 Hold A End Sill Remove head shield

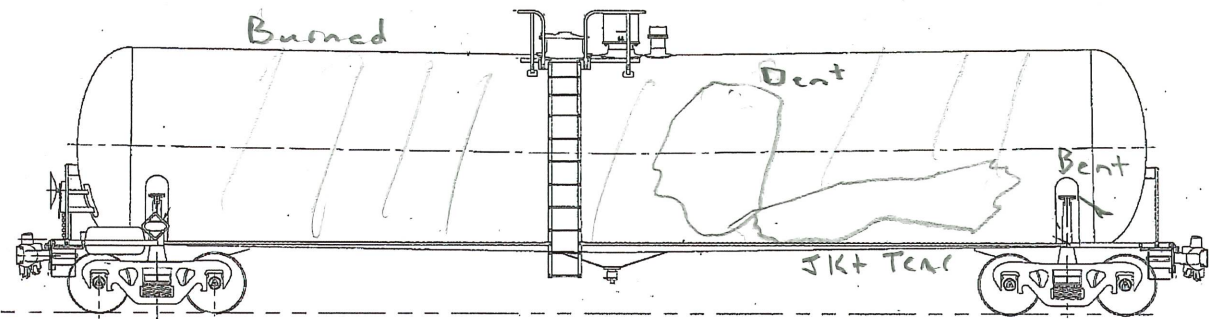
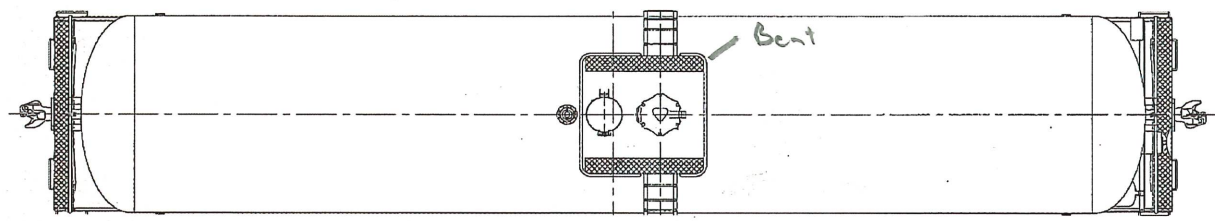
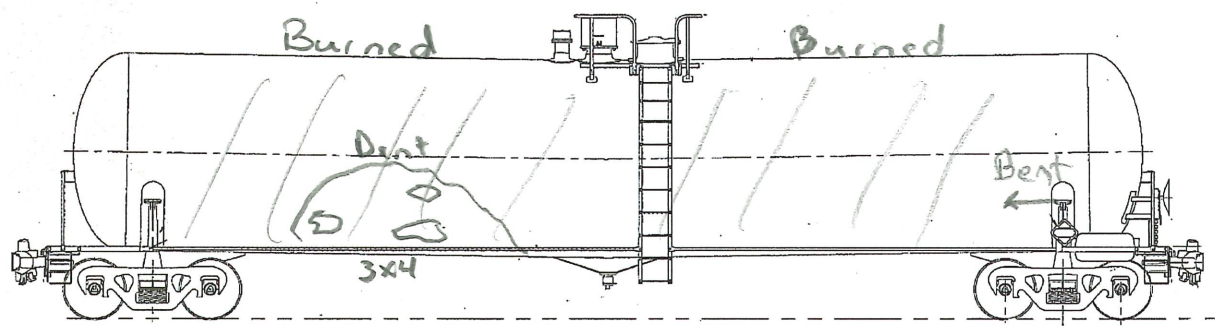
Car Number CRDX 300070

Top fittings MW OK MH OK  
Bottom Outlet Leg Sheared Handle DT bent  
Breach- Thermal Tear No Mech Tear No  
Draft Sill A Bent B Bent Coupler torn off  
Head Shield A Dent B OK  
PRD Functioned- (Yes) No  
SKid bent BDU hit

Hold A End remove head shield

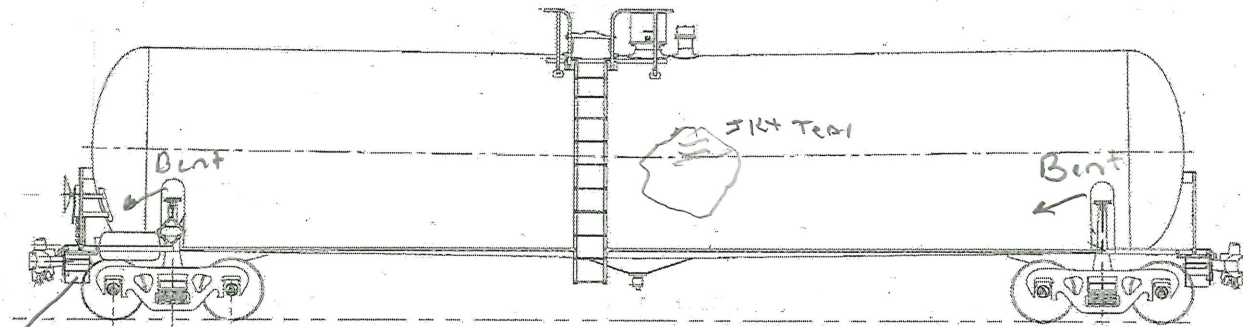
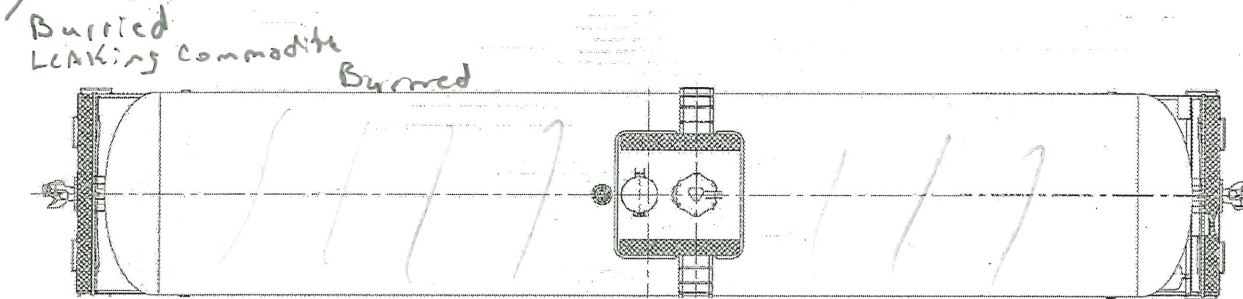
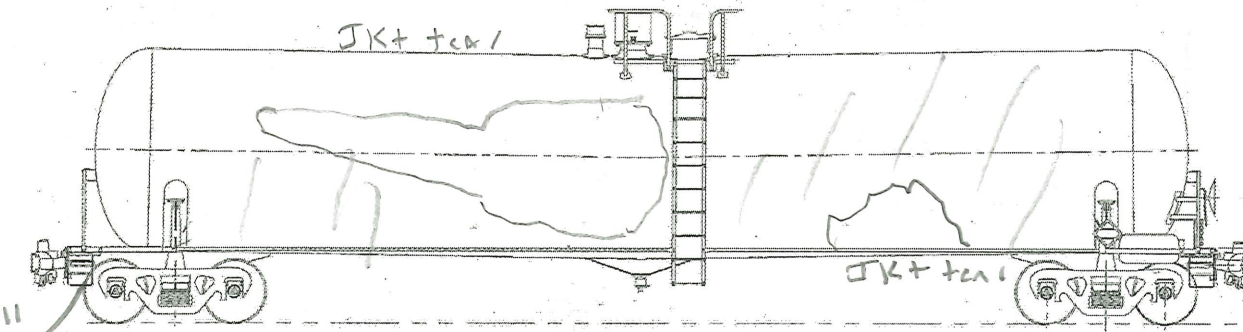
Car Number TILX 731462

Stub Sill  
Torn off  
@ HB  
inspect  
Empty  
Hold

Top fittings MW OK MH Egg Shape  
Bottom Outlet Leg Sheared Handle DT torn off  
Breach- Thermal Tear No Mech Tear No  
Draft Sill A torn off B Dent  
Head Shield A OK B OK  
PRD Functioned- Yes (No)  
SICID OK

Housing & Valves Sheared off

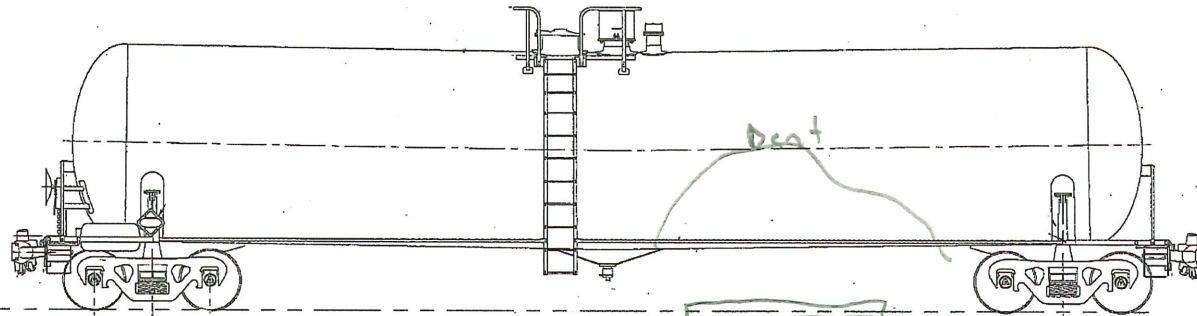
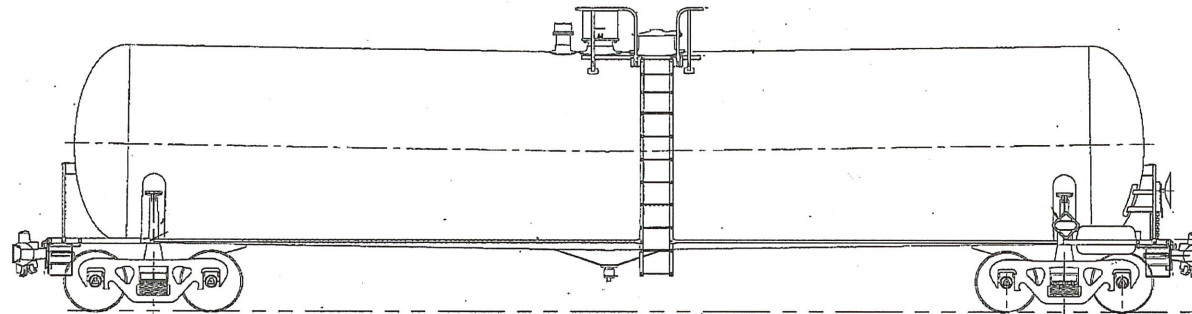
Car Number TILX731426

Breach- Thermal Tear No Mech Tear 2x2

Bent  
CR side

Hold inspect center shell hole - Roll / remove Dirt

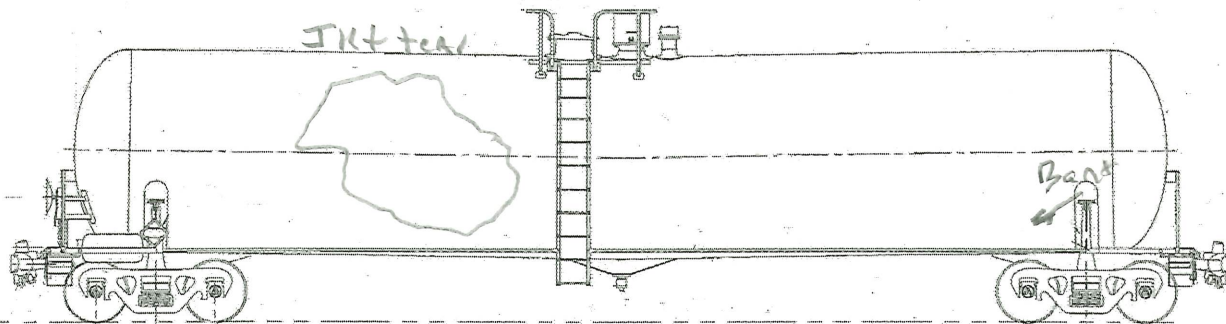
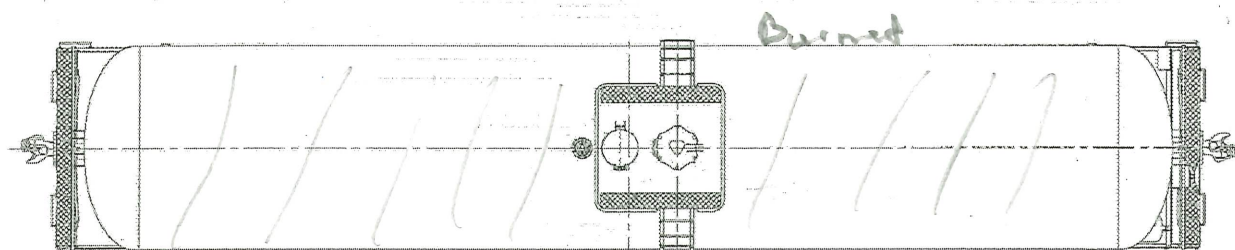
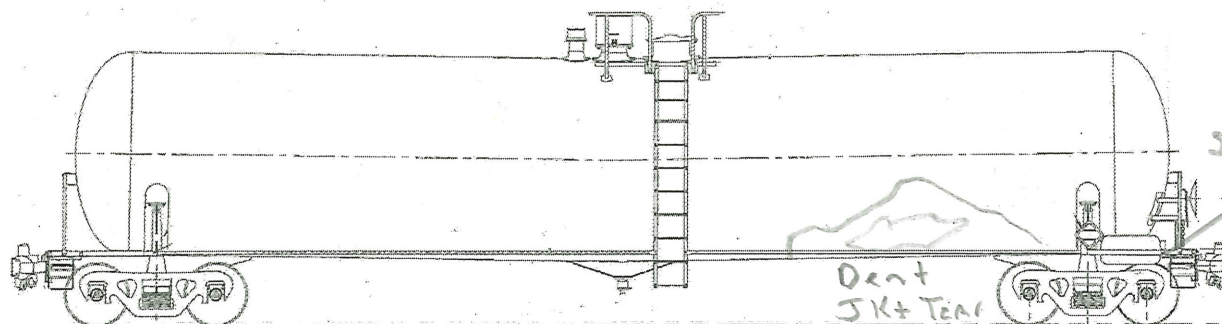
Car Number TILX 731748 Wreck index Number 10 Consist 51

Top fittings MW Leaking MH OK  
Bottom Outlet Leg Sheared Handle DT torn off  
Breach- Thermal Tear No Mech Tear No  
Draft Sill A torn off B HB crack to pad torn off  
Head Shield A Dent B Dent 6x6  
PRD Functioned- Yes No  
SKid Bent  
1 Eye bolt Sheared

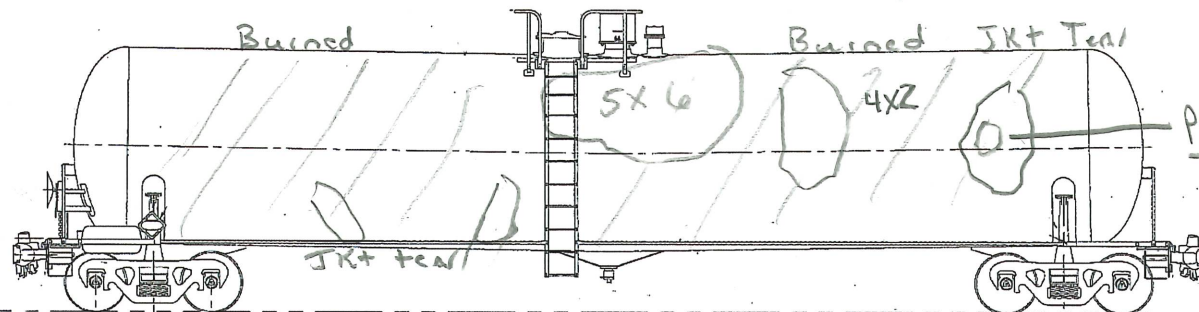
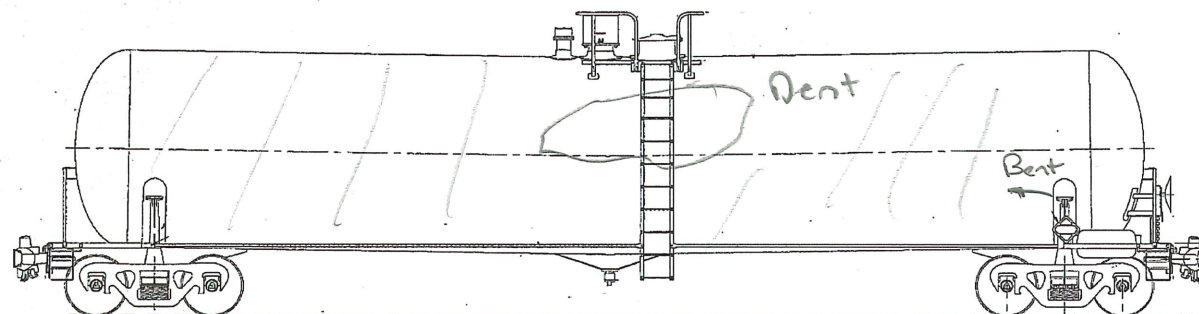
Car Number TILX 731754

Top fittings MW OK MH OK  
 Bottom Outlet Legs sheared Handle DT torn off  
 Breach- Thermal Tear No Mech Tear AR Shell Breach  
 Draft Sill A Bent B Bent  
 Head Shield A Dents B OK  
 PRD Functioned- Yes  No  
 Skid bent Lock fouling skid

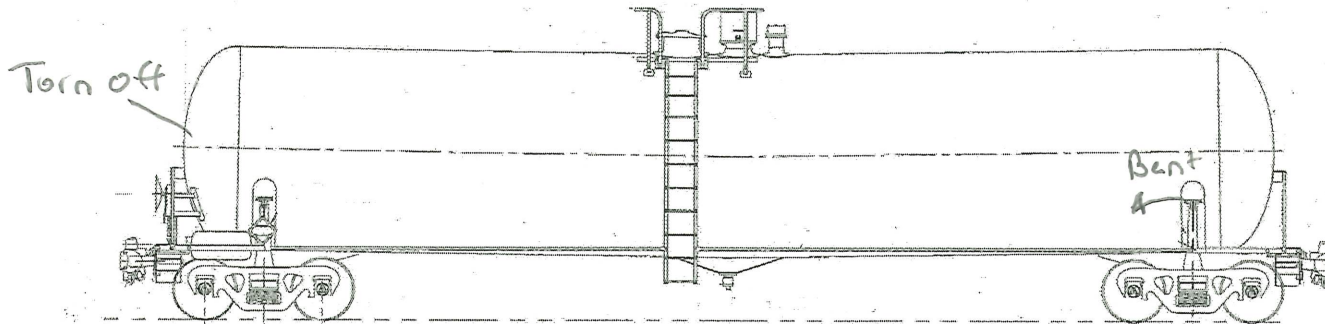
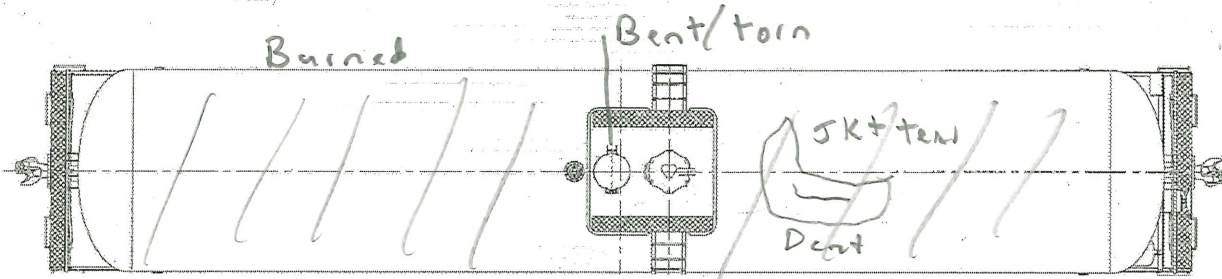
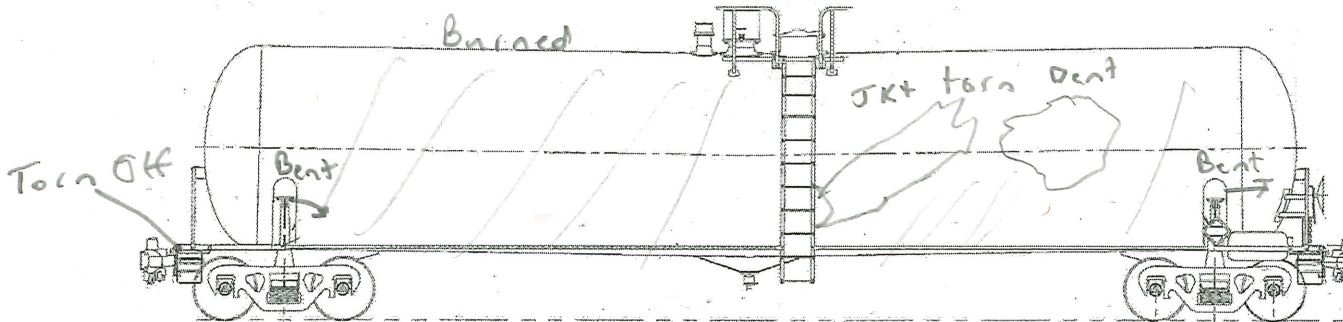
Car Number TILX731717

Top fittings MW OK MH Bent  
 Bottom Outlet Leg sheared Handle DT bent  
 Breach- Thermal Tear No Mech Tear No  
 Draft Sill A OK left sheared B torn off  
 Head Shield A Dent B Torn off  
 PRD Functioned- Yes No  
 Skid OK

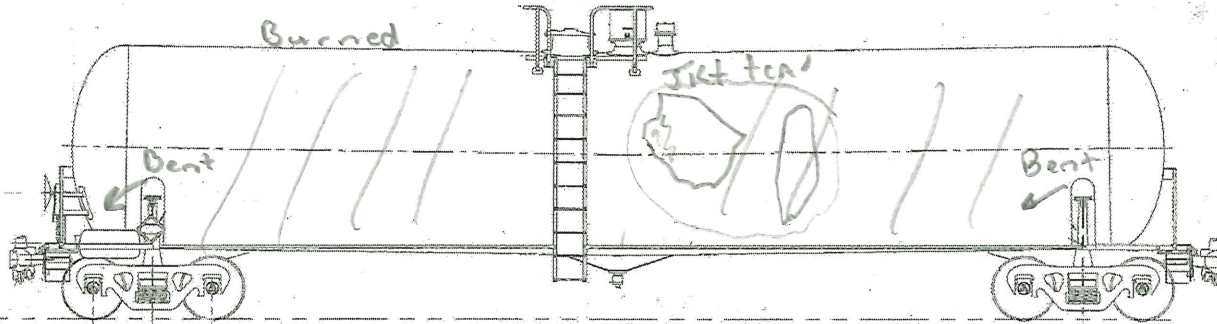
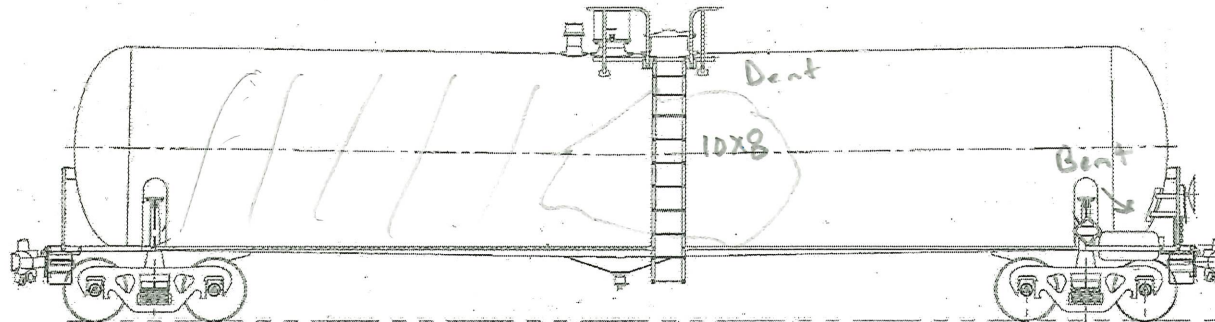
Car Number TILX 731726

Top fittings MW OK MH OK  
 Bottom Outlet Leg ? Handle DT ?  
 Breach- Thermal Tear No Mech Tear No  
 Draft Sill A OK B Bent  
 Head Shield A Dent B Dent  
 PRD Functioned- Yes No  
 Skid buried ?

Hold  
Roll  
B stub HB  
SKid

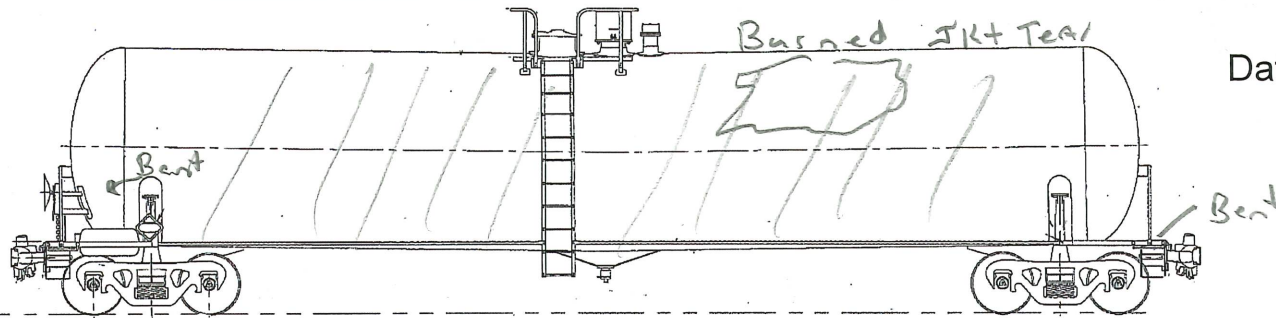
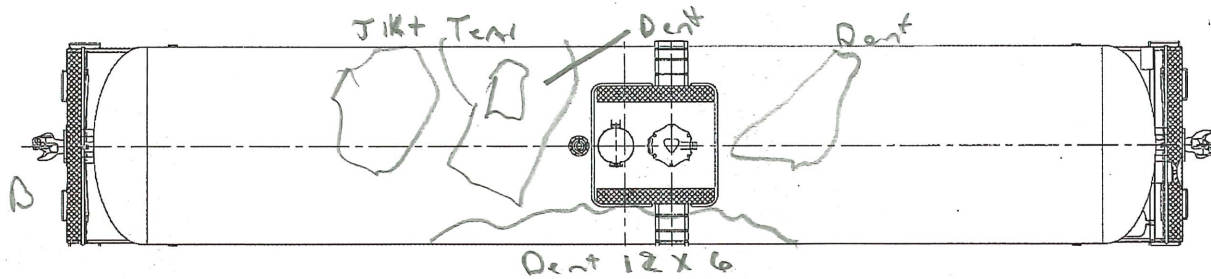
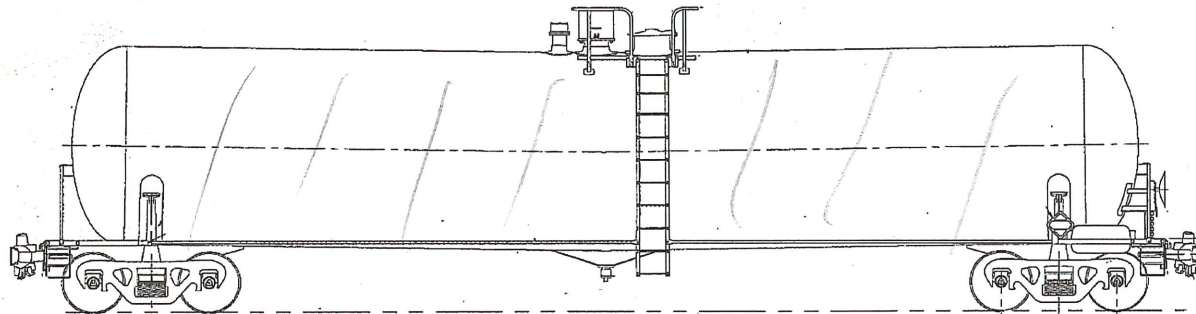
Car Number CRDX 3000 59

Builder Trinity  
 Built Date 11-26-15  
 DOT 1175100W  
 File# T15038  
 Loss of Commodity (Yes) / No  
 Valves -Leaked / Sheared  
BOV Dripping

Top fittings MW OK MH OK  
 Bottom Outlet Leg OK Handle DT Bent  
 Breach- Thermal Tear No Mech Tear No  
 Draft Sill A Bent Cplc Shear B OK  
 Head Shield A Dent B OK  
 PRD Functioned- (Yes) No  
SKid OK

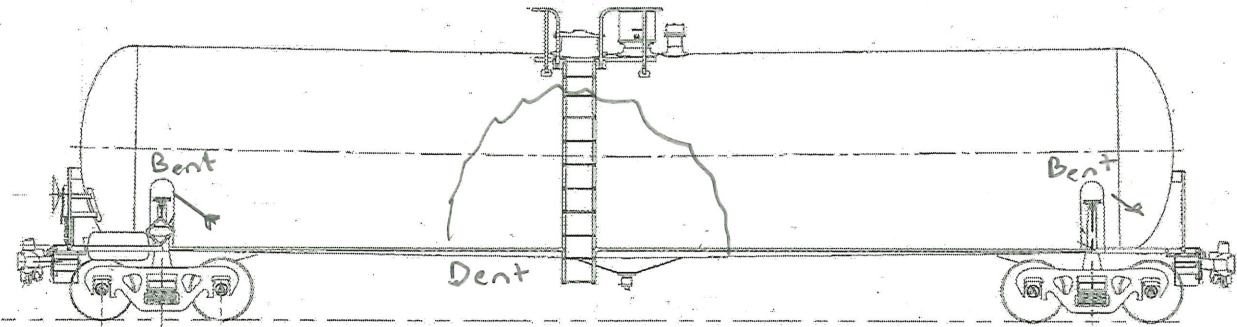
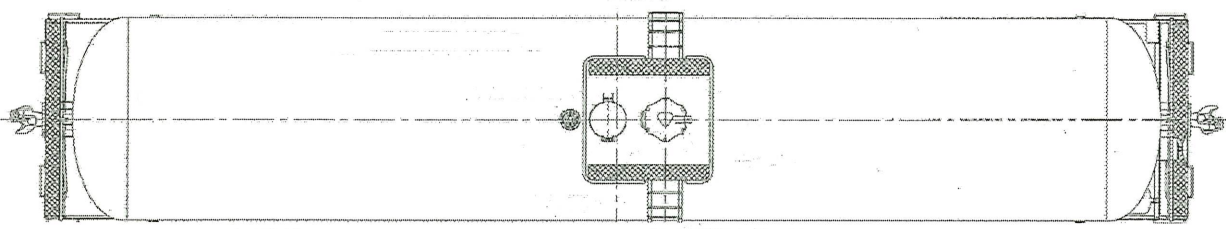
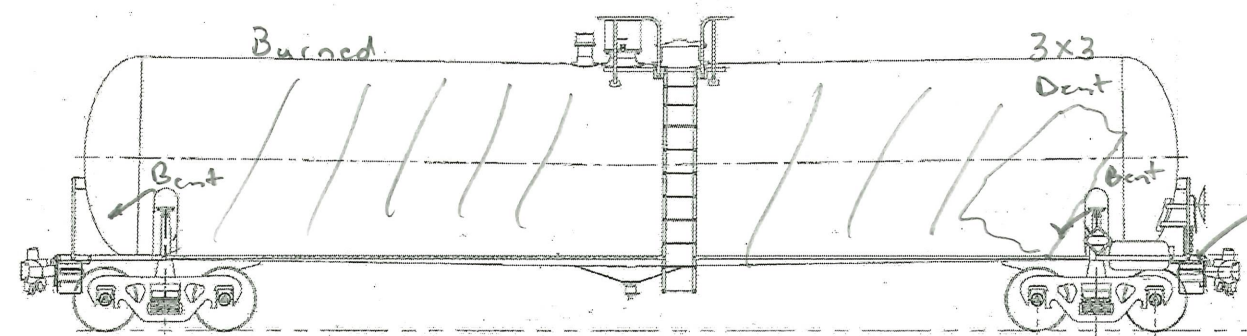
Top fittings MW OK MH OK Dent  
 Bottom Outlet Leg 3 Buried Handle DT Bent  
 Breach- Thermal Tear No Mech Tear No  
 Draft Sill A Bent B Twisted  
 Head Shield A OK B Dent  
 PRD Functioned- Yes No  
 Skid buried

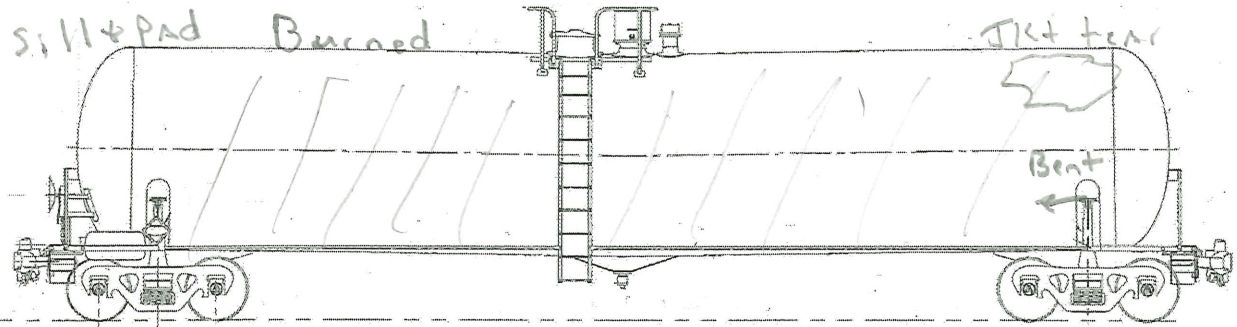
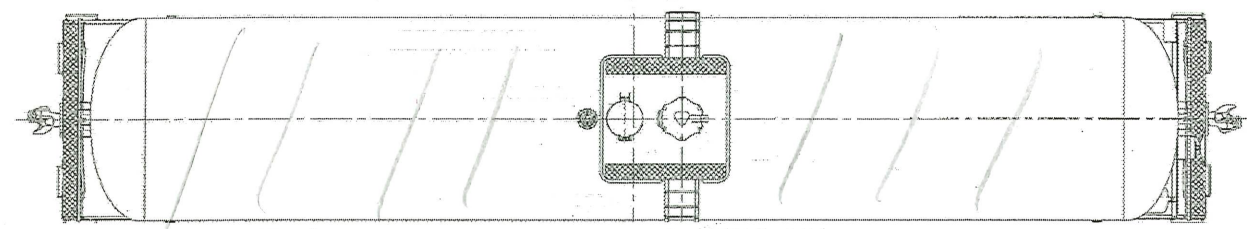
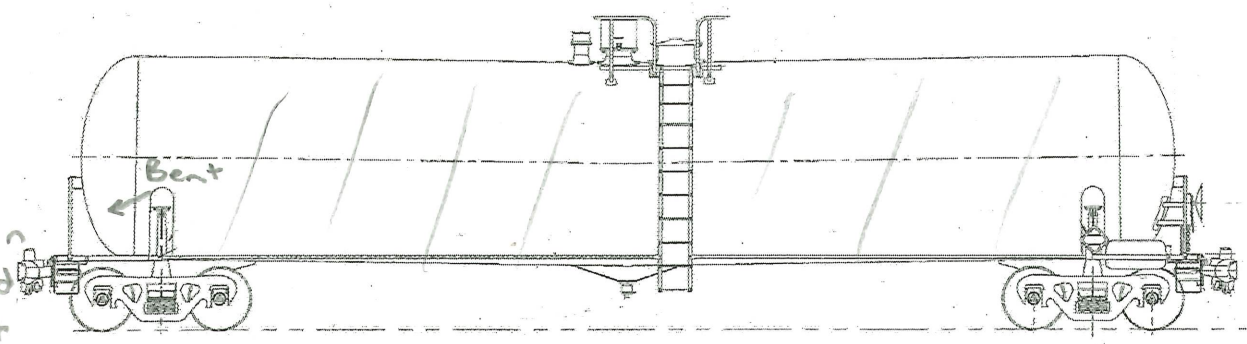
Hold  
HB torn  
from pad  
Top of  
cut out  
torn tank shell  
A+top

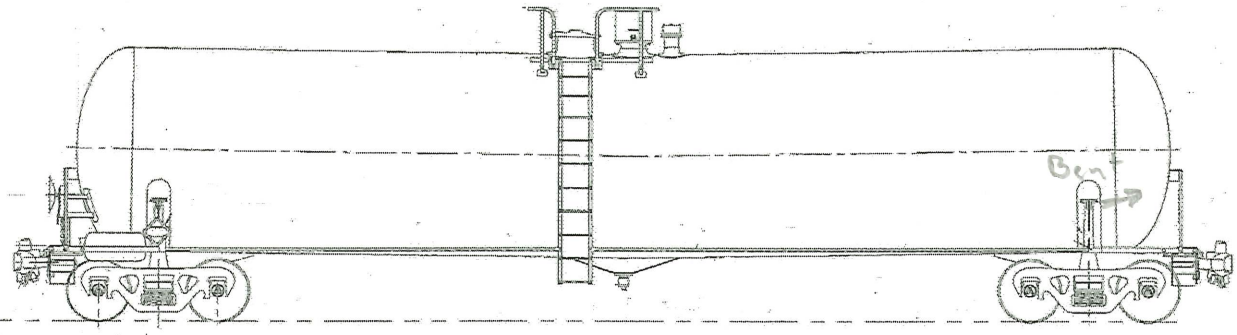
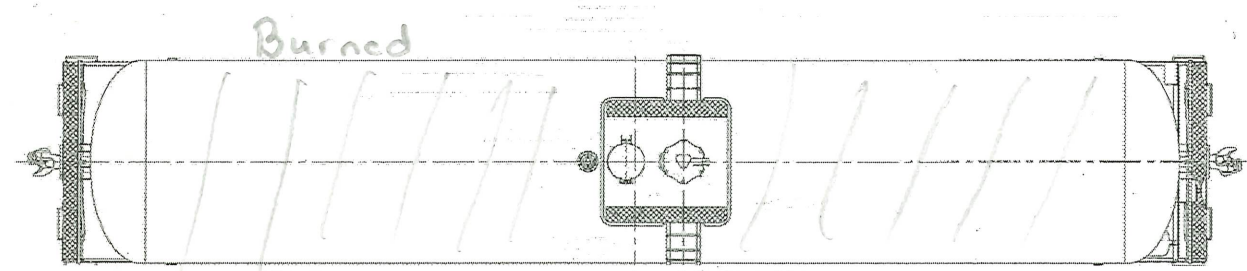
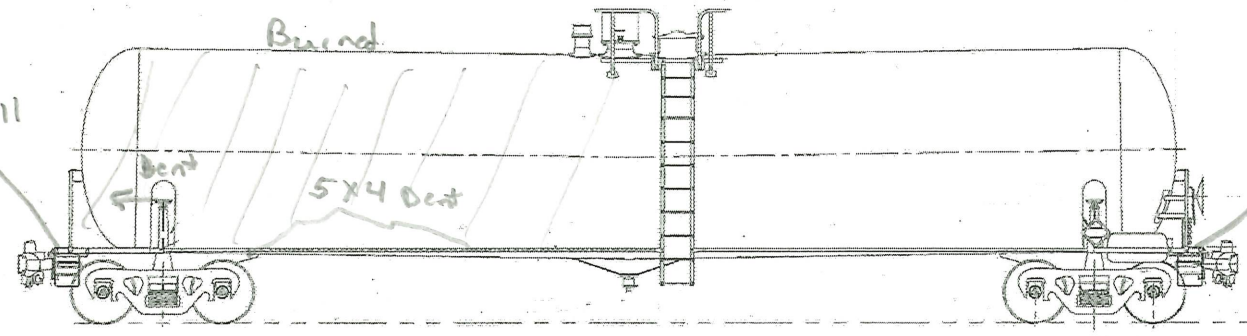
Top fittings MW OK MH OK  
Bottom Outlet Leg Sheared Handle DT OK  
Breach- Thermal Tear No Mech Tear No  
Draft Sill A torn off @ HB B OK Cplr Sheared off  
Head Shield A OK B OK  
PRD Functioned- Yes No  
SKD OK

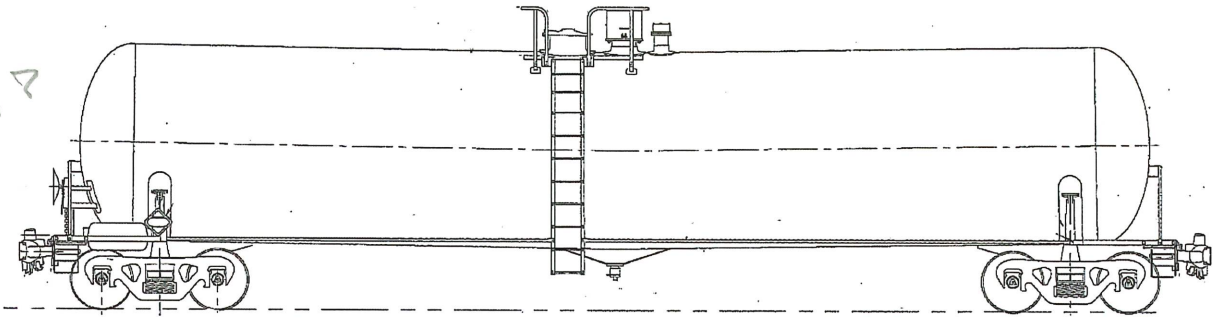
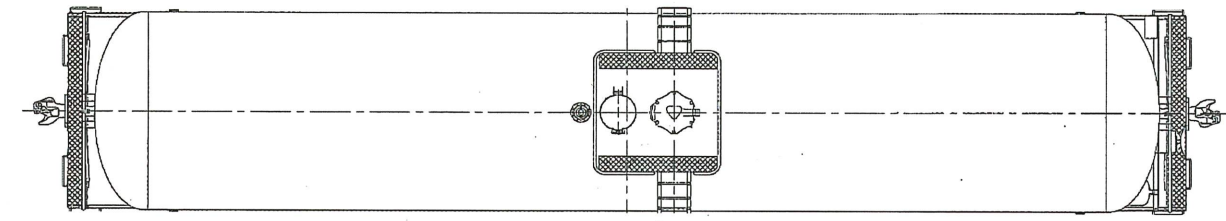
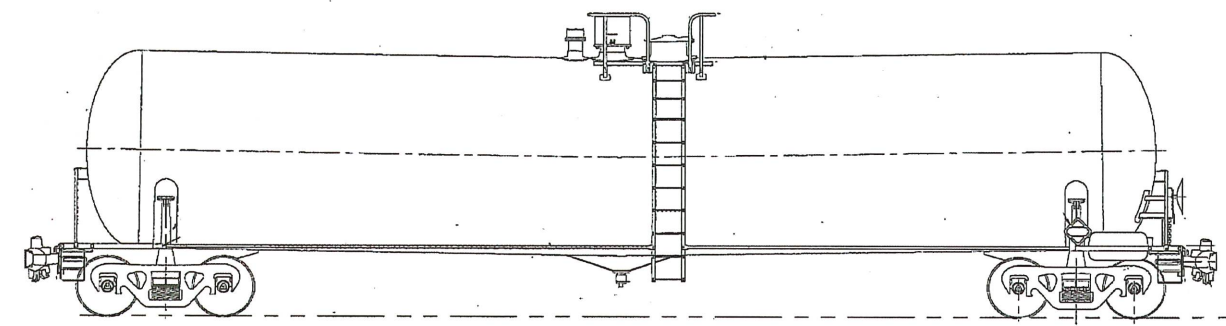
Location DKlaunion Tx mm  
Head Pad 10-12  
SARS 10-12  
Cut out 5mm  
Inband  
10-12 outband

Turn off  
AT Head  
brace

Sill bent to AL  
Side  
Stub Sill torn  
off @ HB  
Head Pad has  
2" crack AR  
Cut out

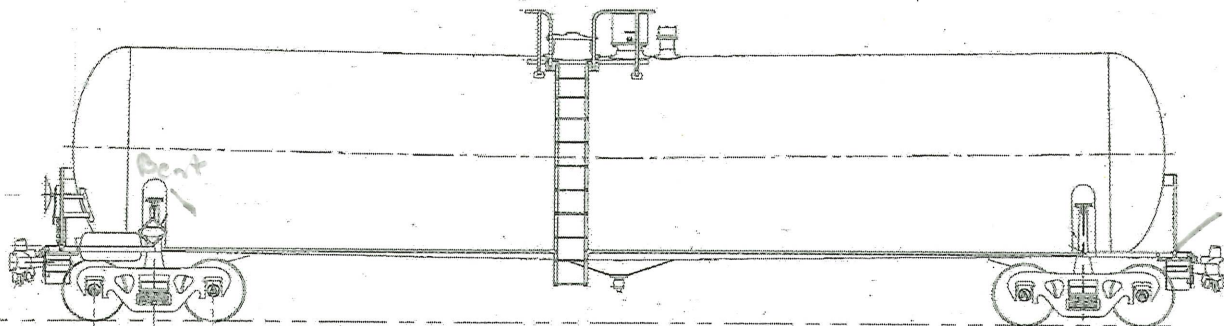
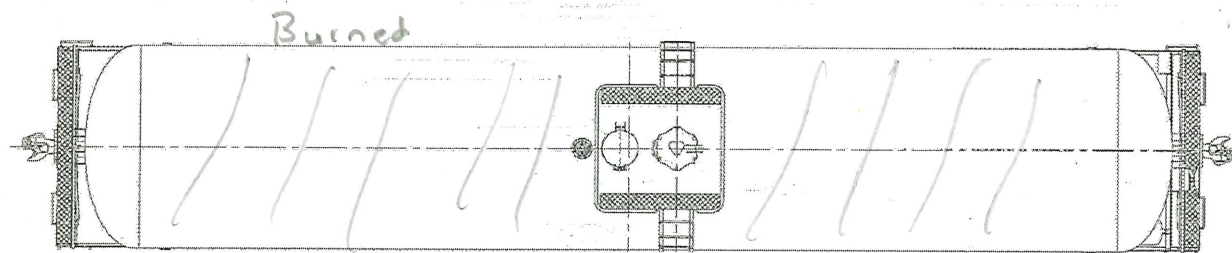
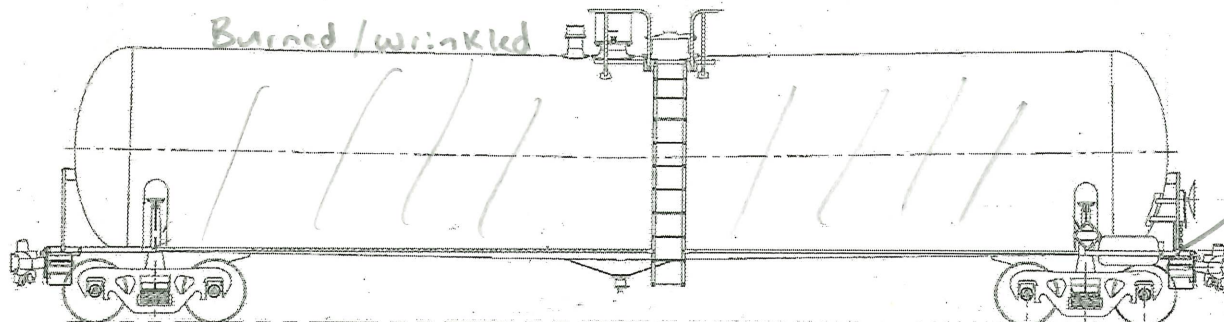
Top fittings MW OK MH OK  
 Bottom Outlet Leg OK Handle DT OK  
 Breach- Thermal Tear No Mech Tear No  
 Draft Sill A twisted B OK Coll Sheared  
 Head Shield A OK B Dent  
 PRD Functioned- Yes No  
 Skid OK

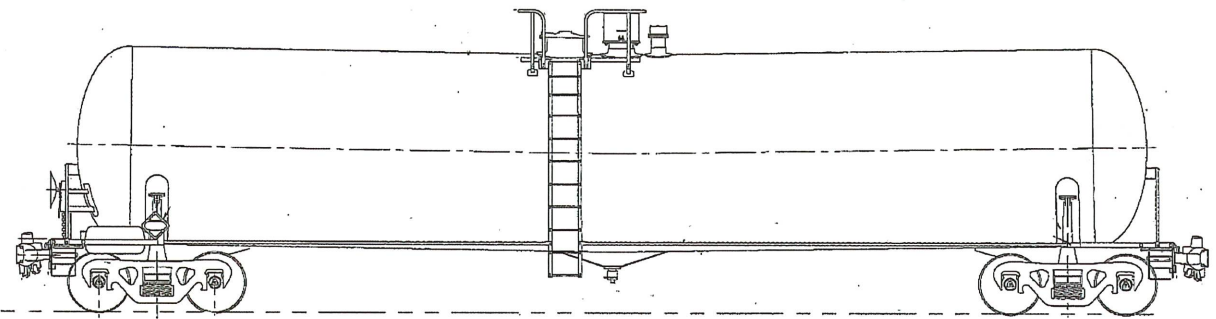
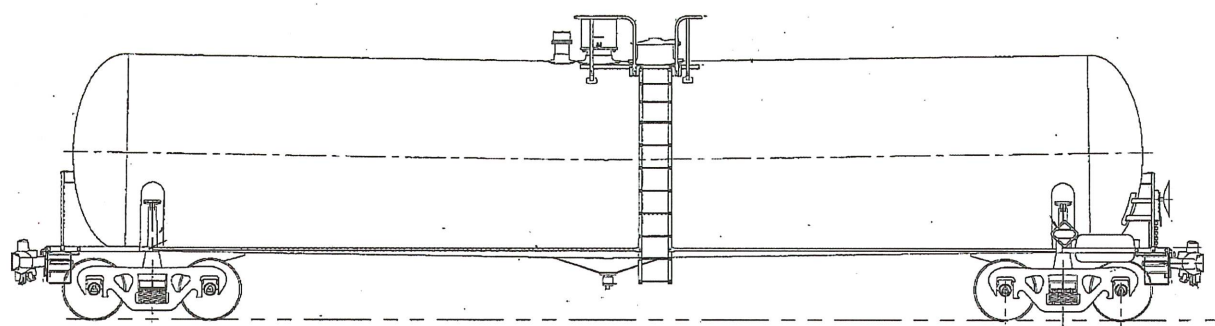
A End head  
Sill twisted  
to right side

No CRACK

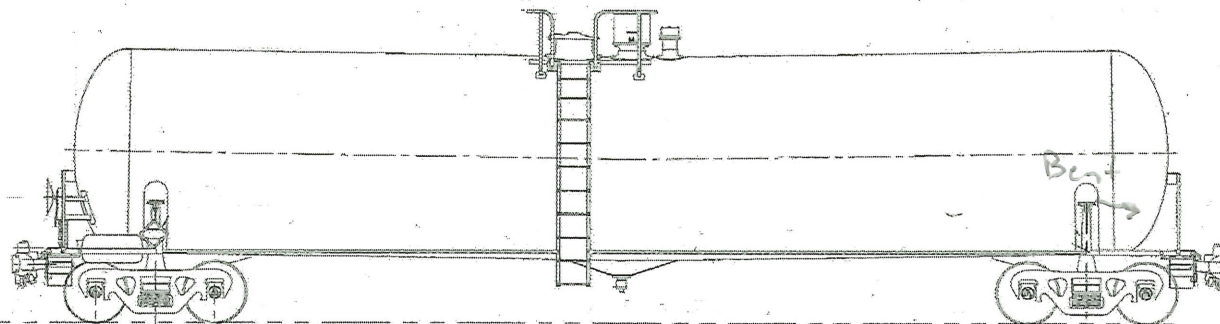
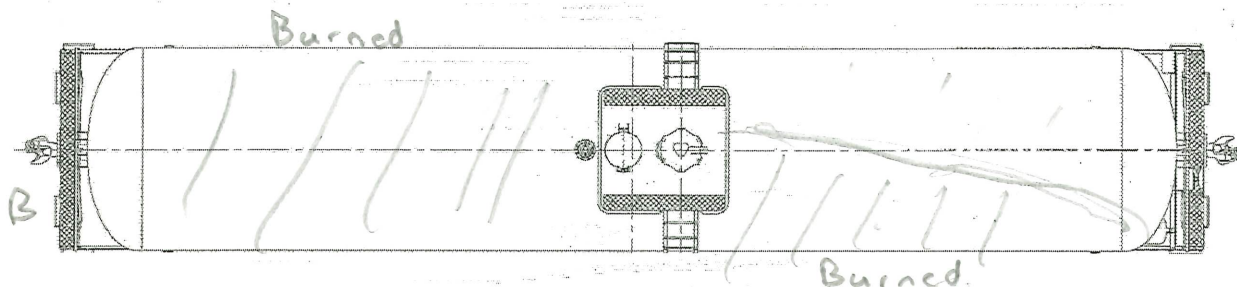
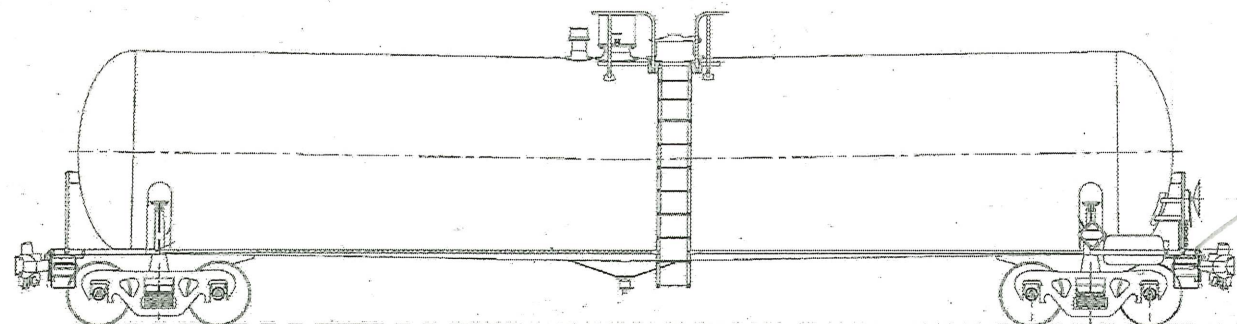
Top fittings MW OK MH OK  
Bottom Outlet Leg OK Handle DT Bent  
Breach- Thermal Tear No Mech Tear Yes Head + shield  
Draft Sill A Bent torn B Bent  
Head Shield A OK B Punctured  
PRD Functioned- Yes No  
SKid OK

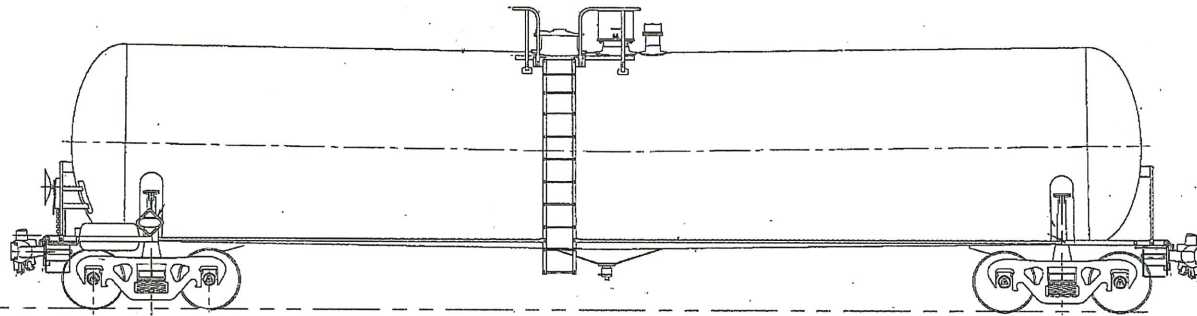
Crack in  
4 1/2" weld  
OK

2) (1)NTSB (1)Trin  
3X3 Coupons  
Removed  
for testing  
A  
End

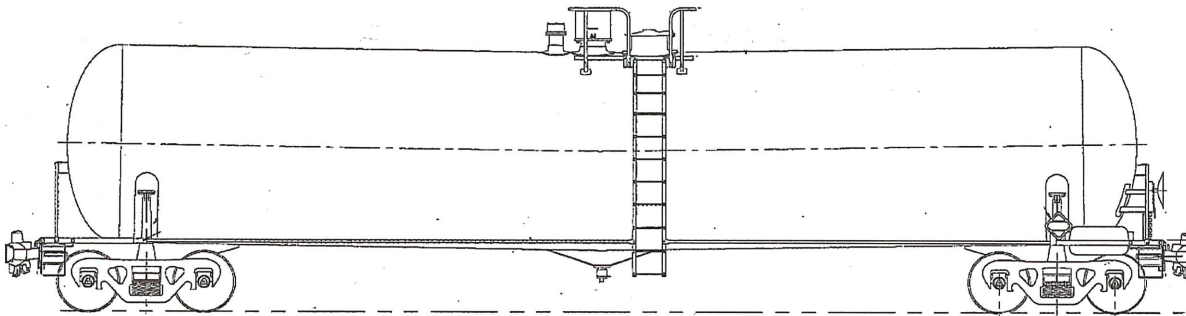
B head  
Dent 36" x 39"  
Puncture 6"  
16" from bottom
