# Car Damage Report

3-12-15  
DGT-004  
Rev 4

Date of Derailment 1-8-77

Location BNSF Oklahoma TX  
Pinard 1987

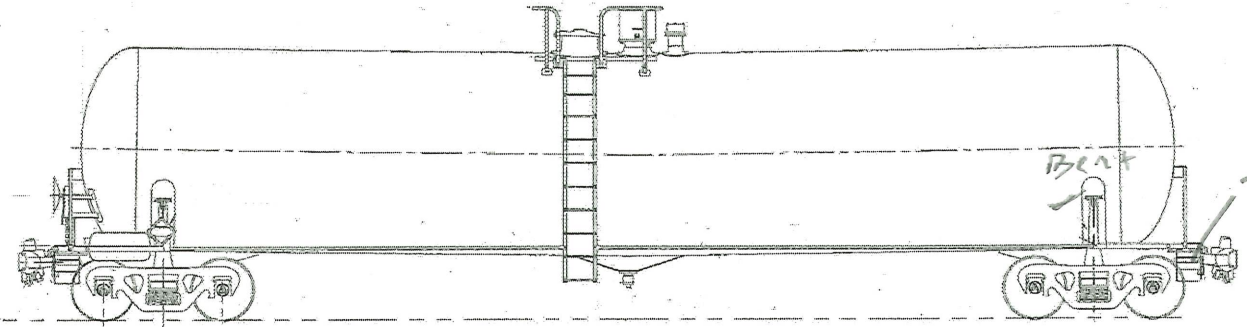
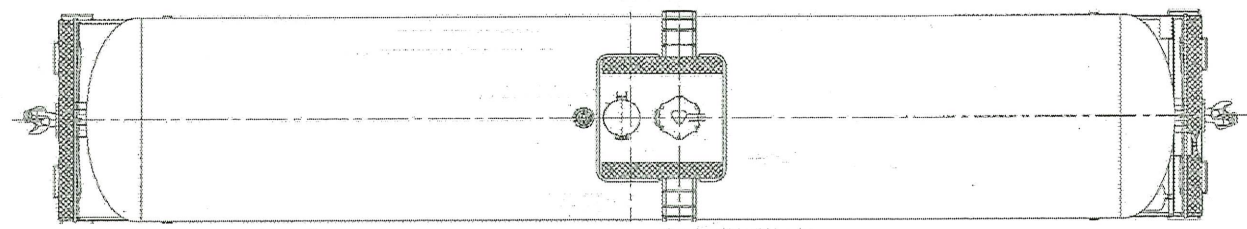
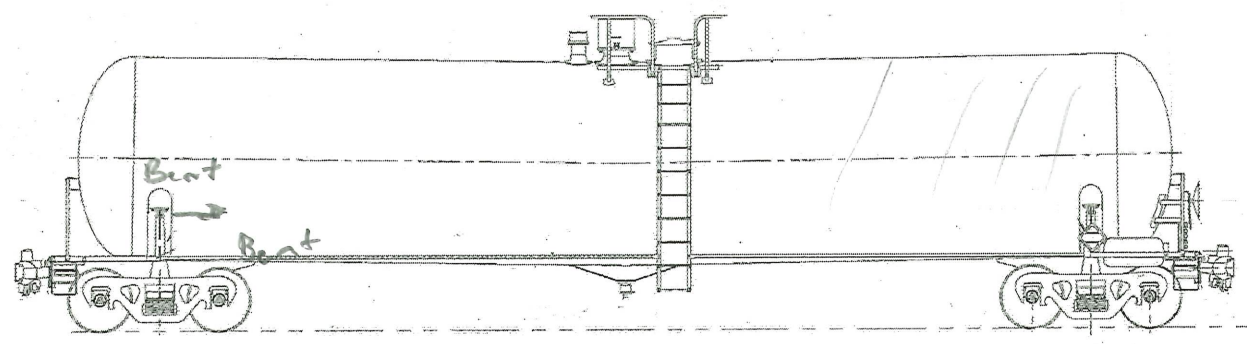
Twisted  
Coupler  
Sheared

Platform  
missing

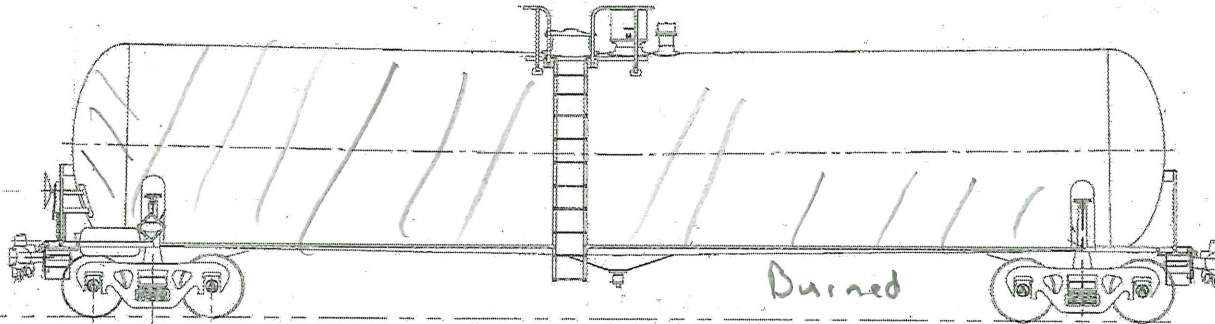
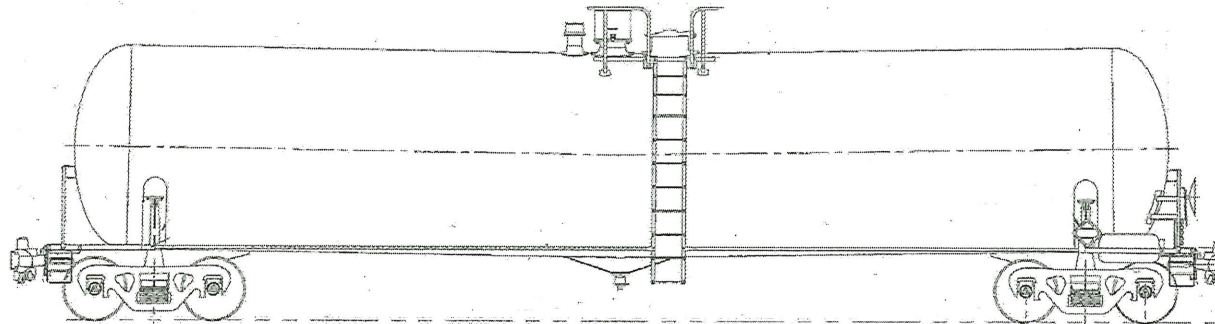
Burned  
Brake hoses  
Valves  
Bench  
Adaptors etc

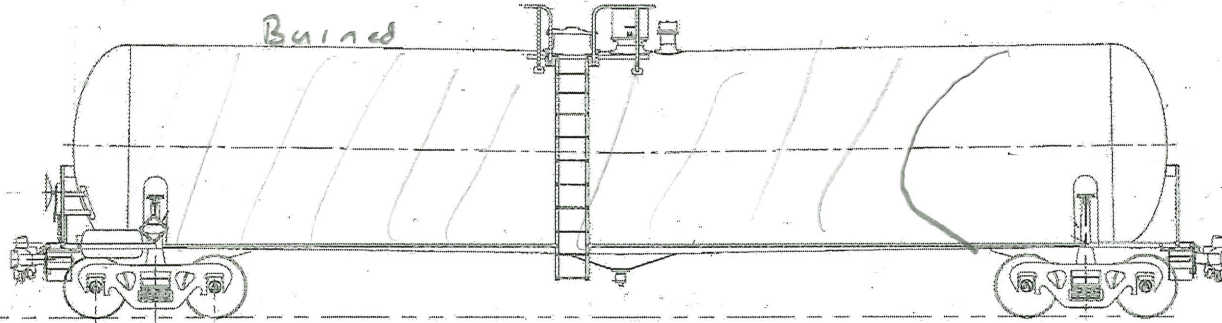
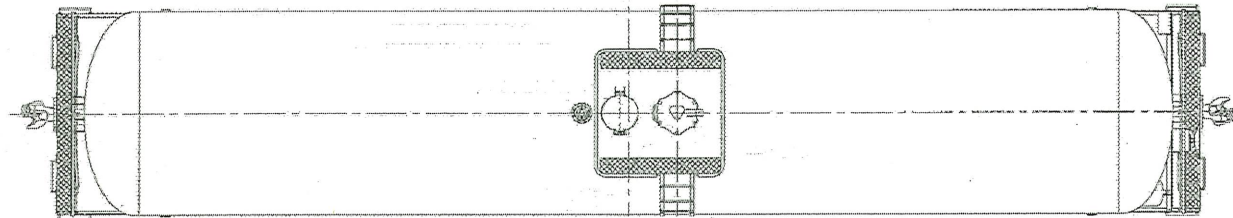
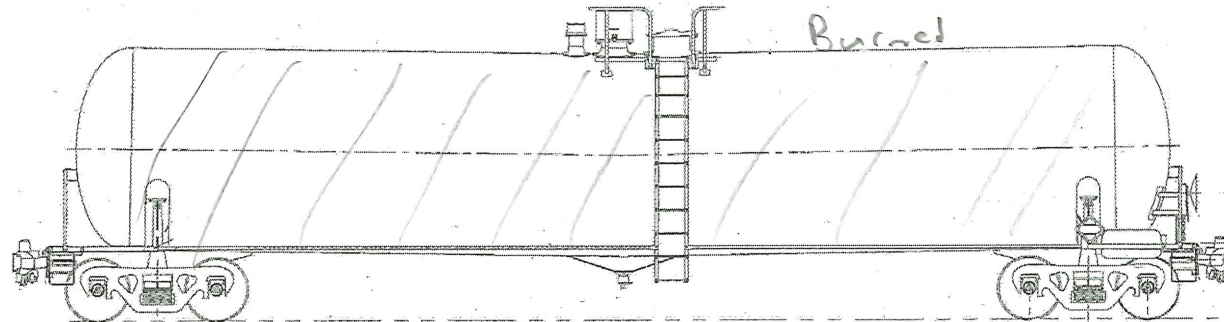
All components  
burned/melted
