NATIONAL TRANSPORTATION SAFETY BOARD  
Office of Aviation Safety  
Washington, DC 20594

**SURVIVAL FACTORS SPECIALISTS' FACTUAL REPORT**

Operator : Peninsula Aviation Services Inc.  
Airplane : Saab 2000 [N686PA]  
Location : Unalaska, AK  
Date : October 17, 2019  
Time : 1740 Alaska daylight time (ADT)<sup>1</sup>  
NTSB # : DCA20MA002

On October 17, 2019, about 1740 Alaska daylight time, Peninsula Aviation Services Inc. d.b.a. PenAir flight 3296, a Saab 2000, N686PA, was landing at Unalaska Airport (DUT), Unalaska, Alaska, when the airplane overran the end of the runway, passed through the airport perimeter fence, crossed a road, and pitched down over shoreline rocks with its nosewheel in Dutch Harbor. Of the 42 airplane occupants, 1 passenger sustained fatal injuries. The airplane was substantially damaged. The airplane was operating as a regularly scheduled passenger flight under the provisions of Title 14 Code of Federal Regulations (CFR) Part 121. Visual meteorological conditions prevailed at the time of the accident. The flight had departed from Ted Stevens Anchorage International Airport (ANC), Anchorage, Alaska, at 1523.

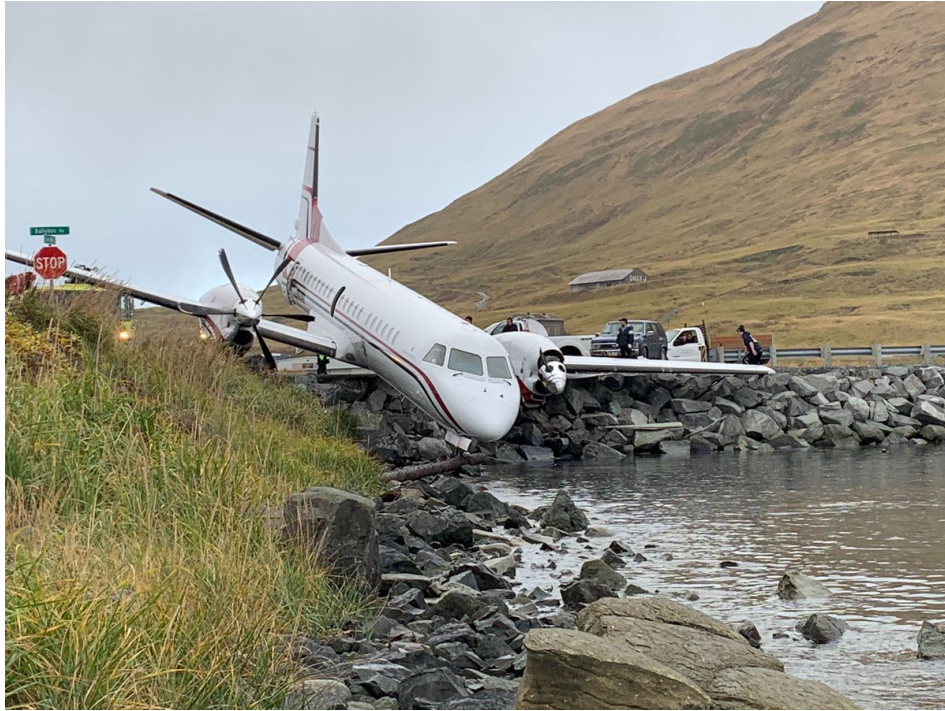
Upon arrival at the scene on October 18, 2019, it was noted that the left propeller had 3 blades separated. Both overwing emergency window exits had been removed and there were blankets on the wings near the exits. The right rear exit door was fully opened. The front left main cabin door was closed. See photos 1, 2, 3, and 4.

**Photo 1. N686PA in its final resting location.**

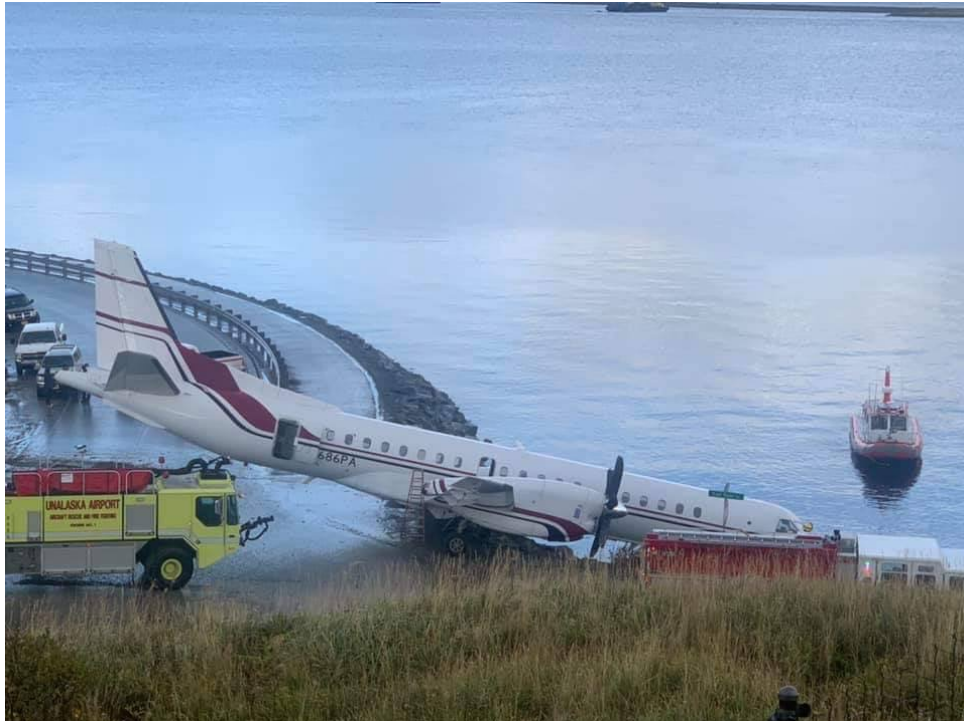
**Photo 2. The right side of N686PA.**

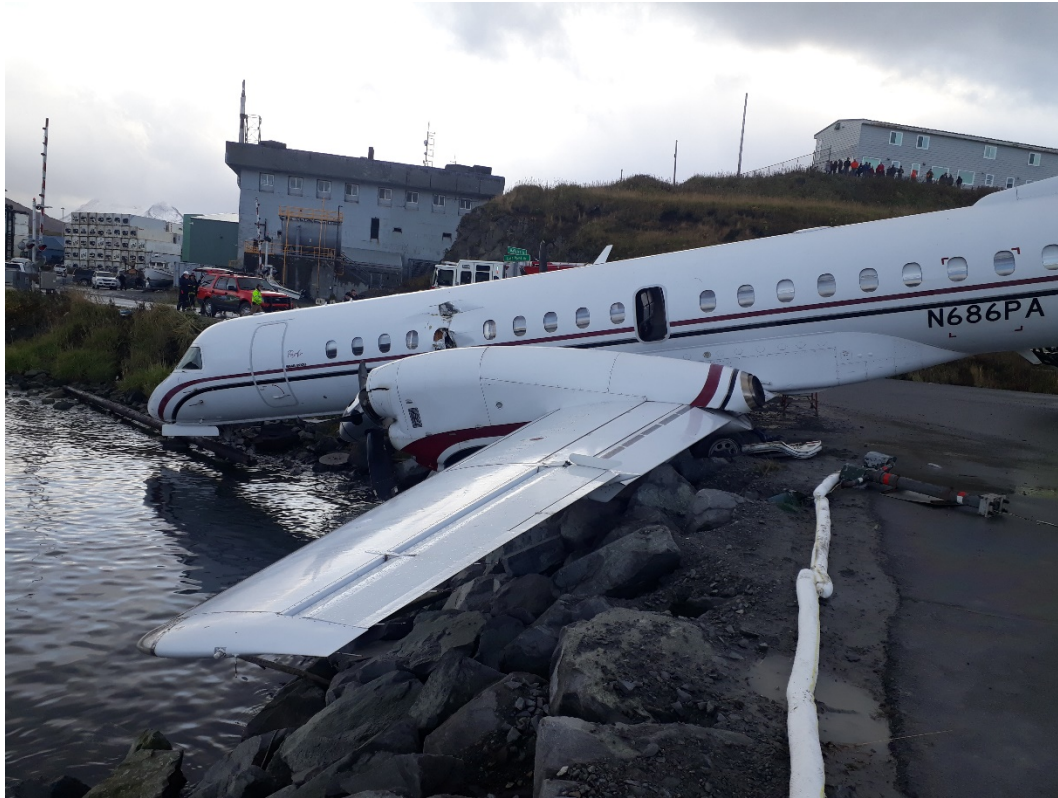
**Photo 3. The left side of N686PA.**

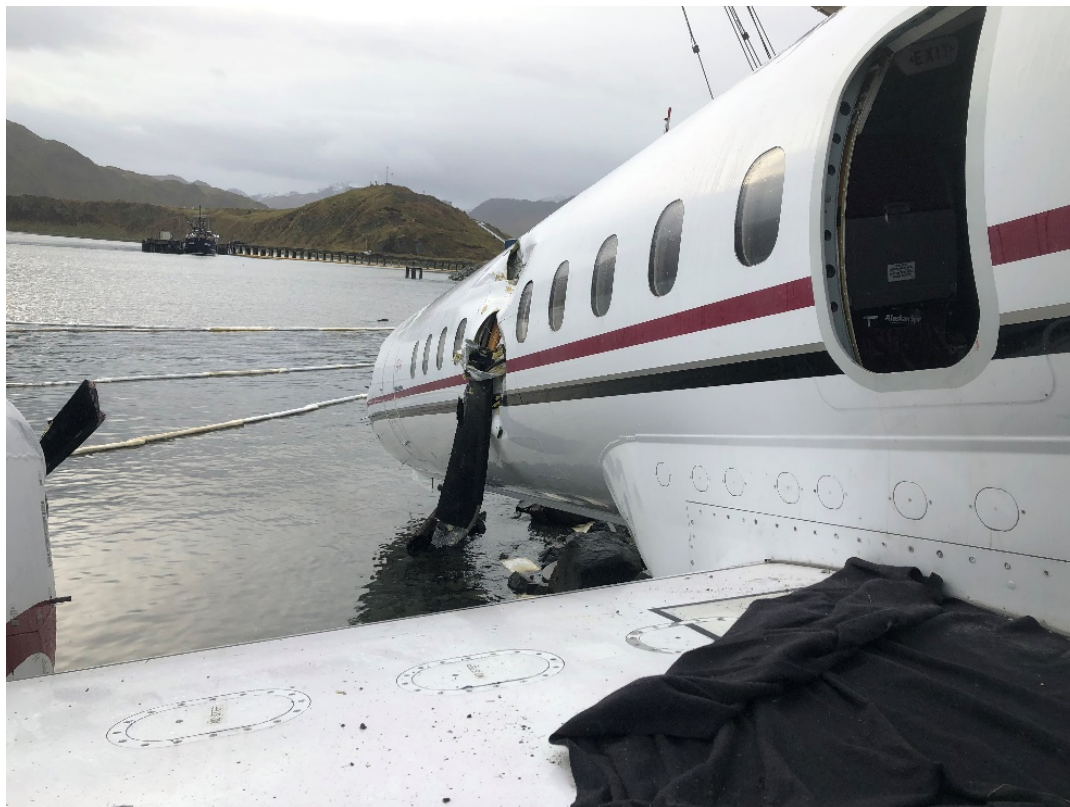
**Photo 4. Left overwing exit and impact area of propeller blade.**

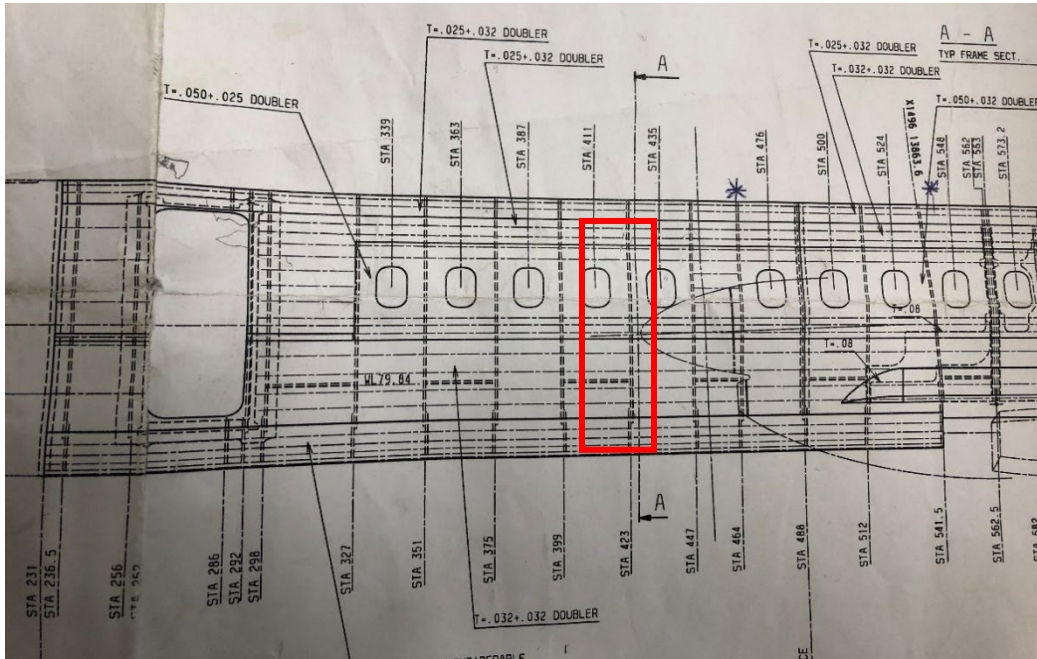
The damaged area of the cabin was contained within an area on the left side between fuselage station (FS) 399 (seat 3A) and 488 (seat 6A), with extensive damage evident at FS 435, which was mid-window and next to seat 4A's seatback. The left side overhead compartment (FS 399 to FS 488) partially separated from its mounts and descended about 6 to 12 inches. Oxygen generators and debris were hanging down into the seats or laying on the floor in this area. The wall panel separated at FS 399 and was displaced rearward and inboard. The wall panel and fuselage skin infringed about 10 inches into the 4A seat area at the lower seatback cushion. The 4A window fuselage frame was located on the cabin floor at row 2.

**Photo 5. Area of extensive damage near FS 435.**

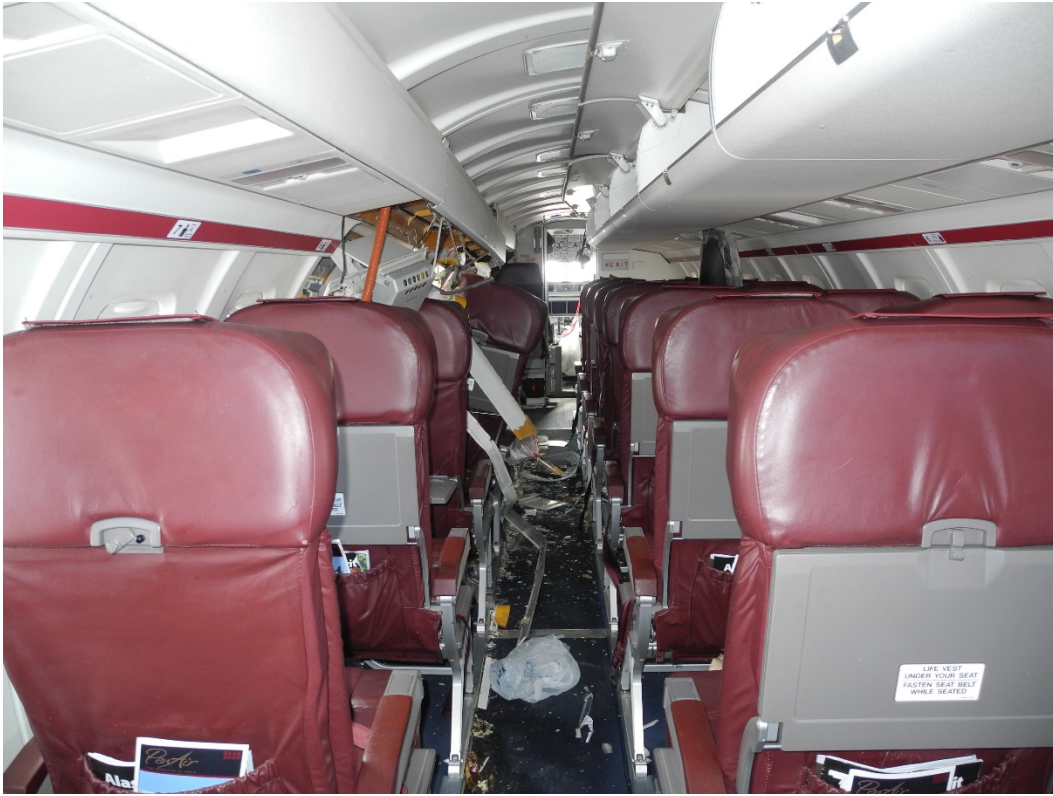
The crew and cabin seats were all intact and secured to the floor. The only seat with substantial damage was seat 4A where the seatback was damaged and displaced inboard toward the center aisle. A propeller blade was firmly in place in a vertical direction in front of the 4F seat. See photos 6-12.

**Photo 6. Forward-facing view of cabin from row 8.**

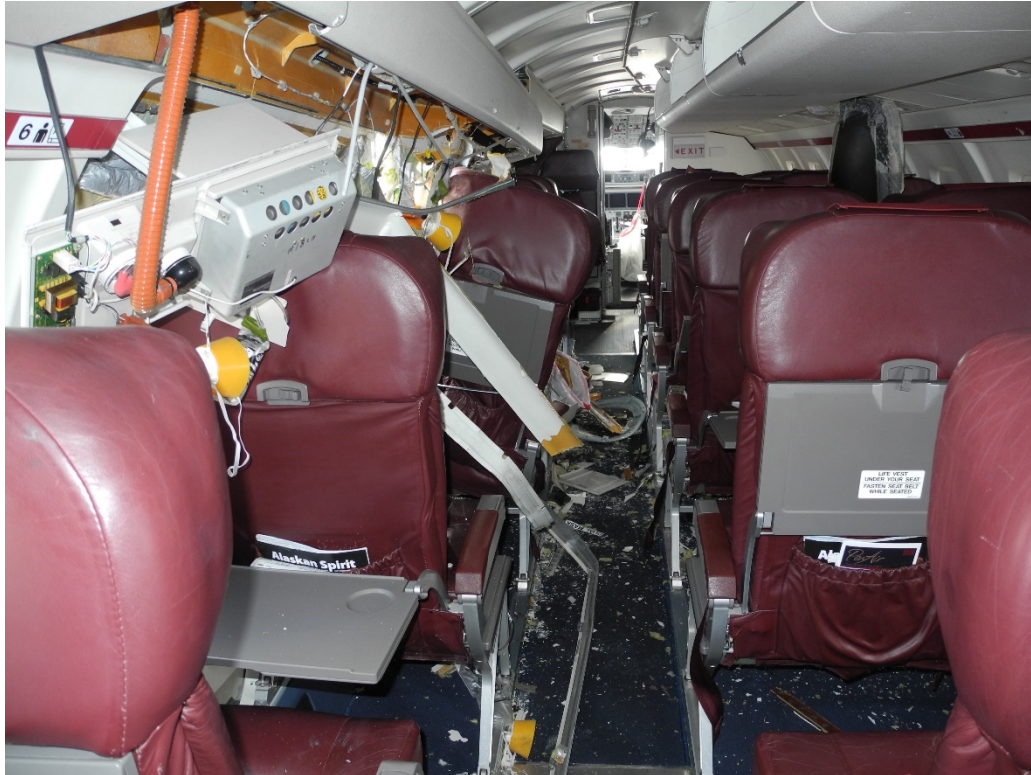
**Photo 7. Forward-facing view of cabin from row 6.**

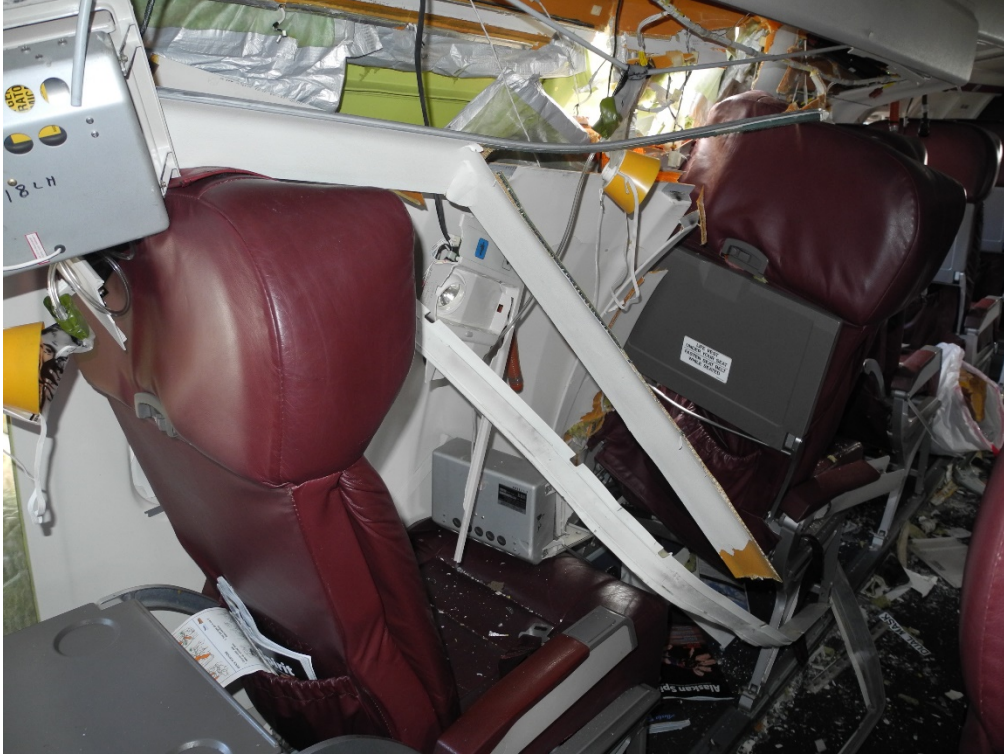
**Photo 8. Interior damage above seat 5A.**

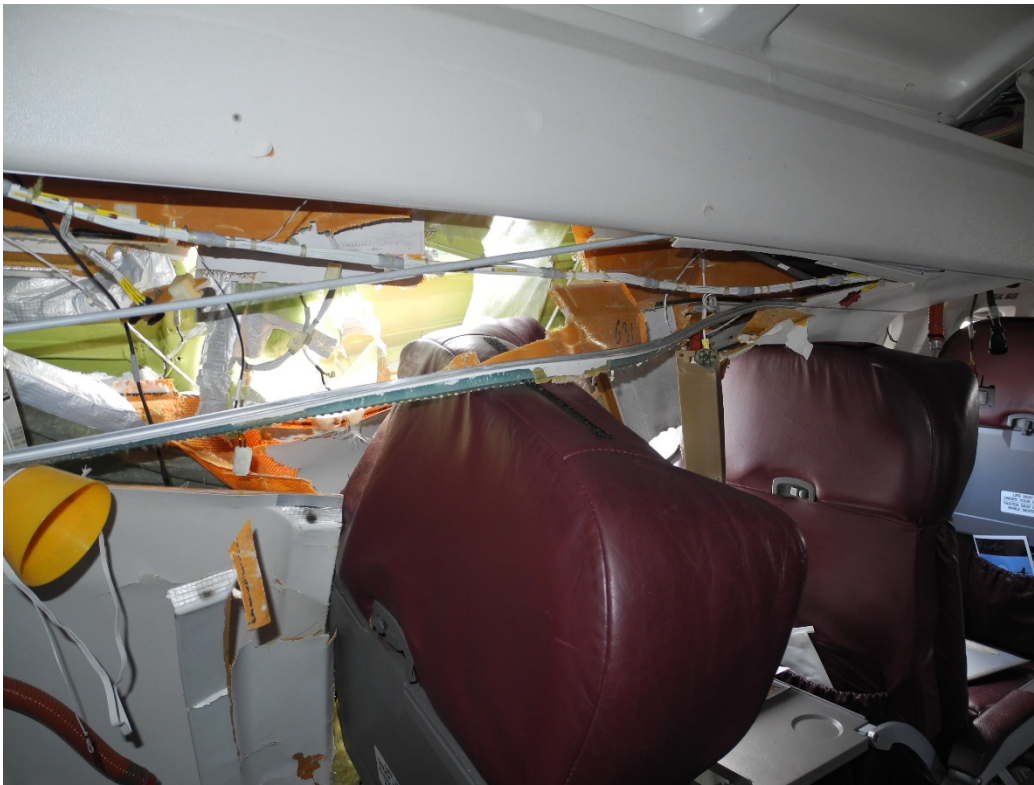
**Photo 9. Interior damage above seat 4A.**

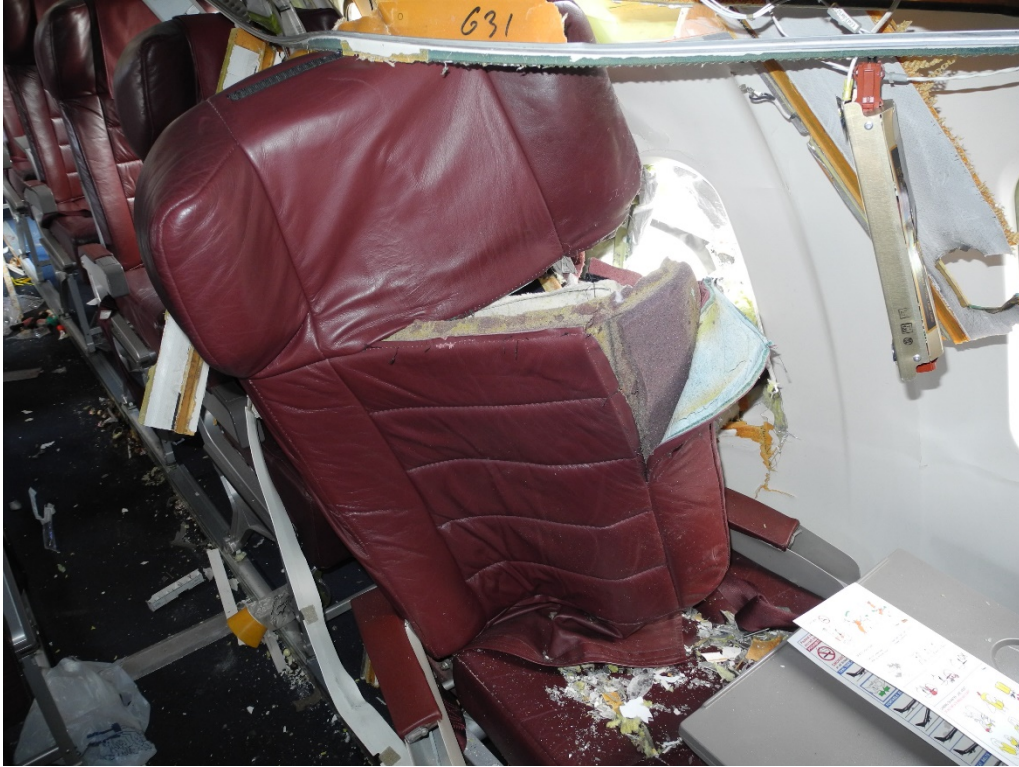
**Photo 10. Damage to seat 4A.**

Seat 4A's seatback was displaced inboard toward the center aisle. The headrest cushion was partially torn away from the seatback, and an 8-inch vertical cut through the foam and cover was evident on the left side, about 4 inches from the top. The bottom seat cushion was ajar. The right armrest was fractured at the forward mount and displaced inboard about 4 inches. The seatbelt (AmSafe P/N 502755-E-2561, M/N 502751-1) was undamaged and functional. The seat cushions were removed and it was noted that the seatback structure was fractured on the left side. The following information was obtained from the seat:

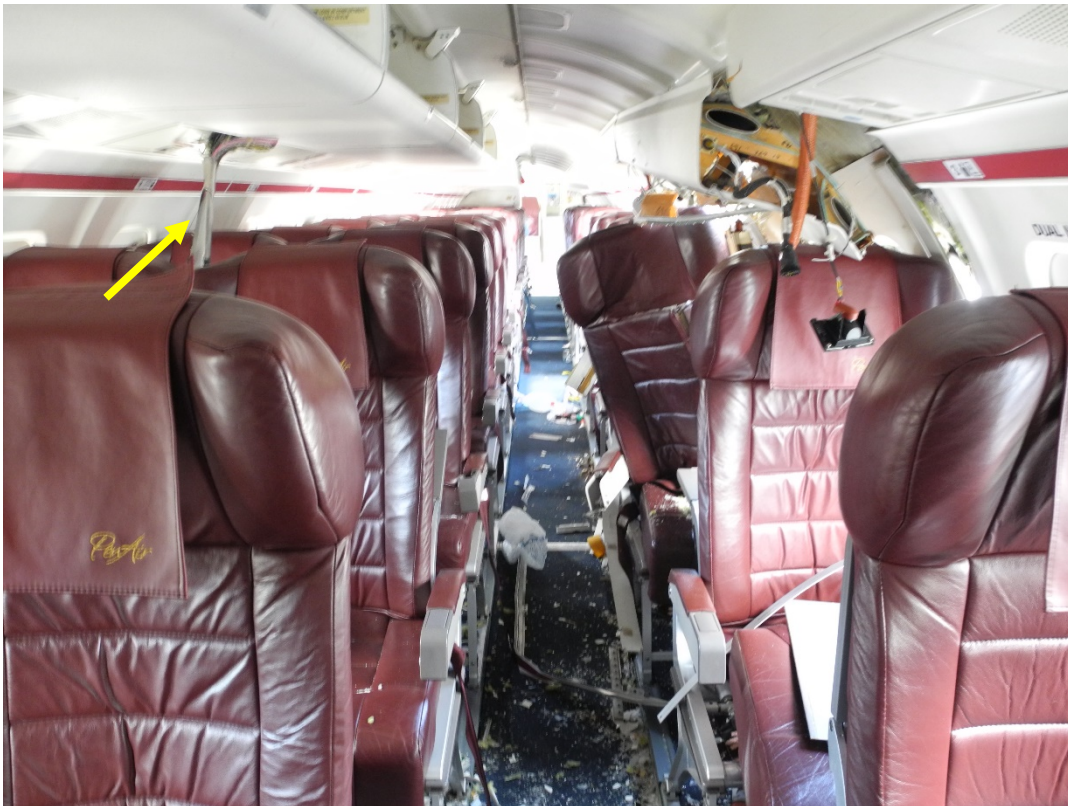
**Photo 11. Aft-facing view showing inboard displacement of seat 4A's seatback and location of propeller blade near seat 4F.**

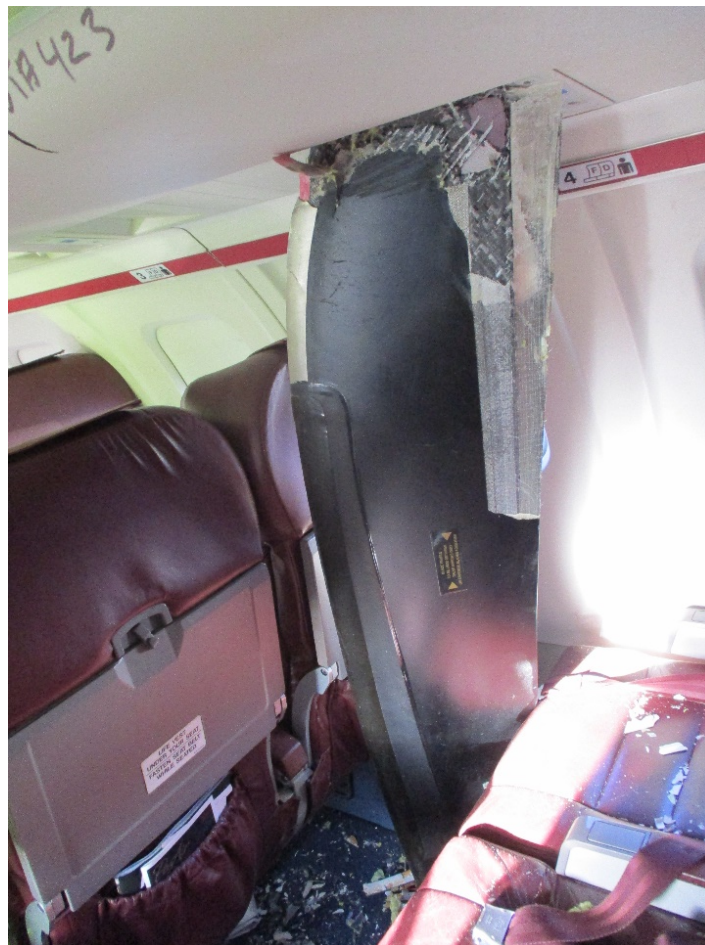
A propeller blade was in front of the seat 4F. It was wedged between the overhead bin and the floor. With the exception of a fracture and slight displacement of the inboard armrest of seat 4D, there was no damage or scrape marks to the overhead bin, floor, or seats 4D/4F.

**Photo 12. Location of propeller blade near seat 4F.**

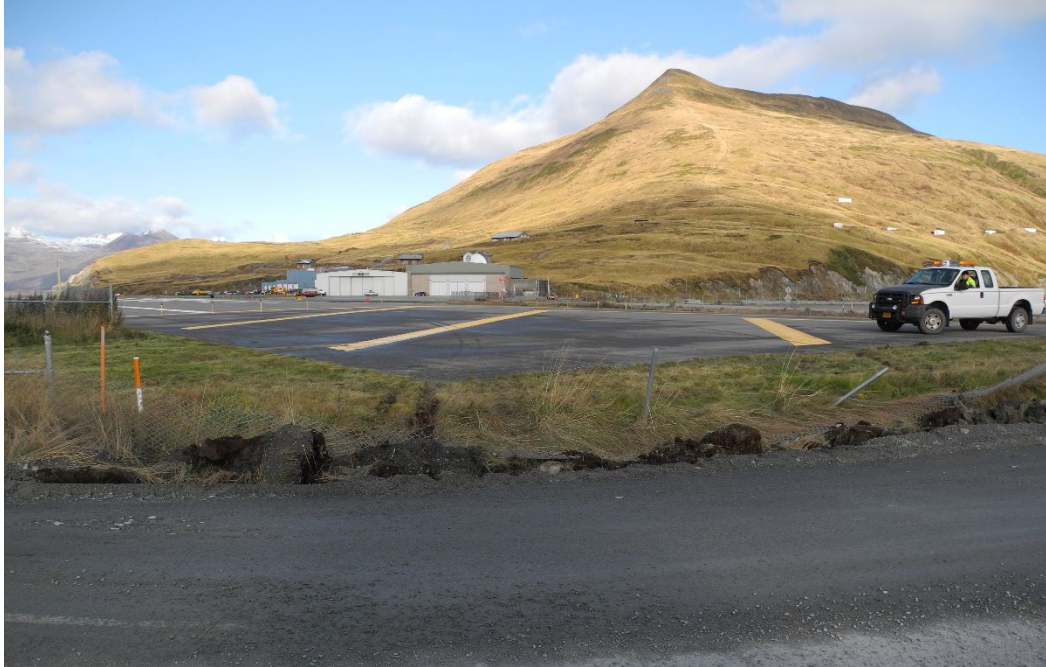
**Photo 13. A postaccident view of the approach end of runway 31 showing the damaged perimeter fence and blast pad.**
