Railroad Investigation Report: RIR-22/04

Union Pacific Railroad Employee Fatality

Vail, Arizona

January 31, 2021

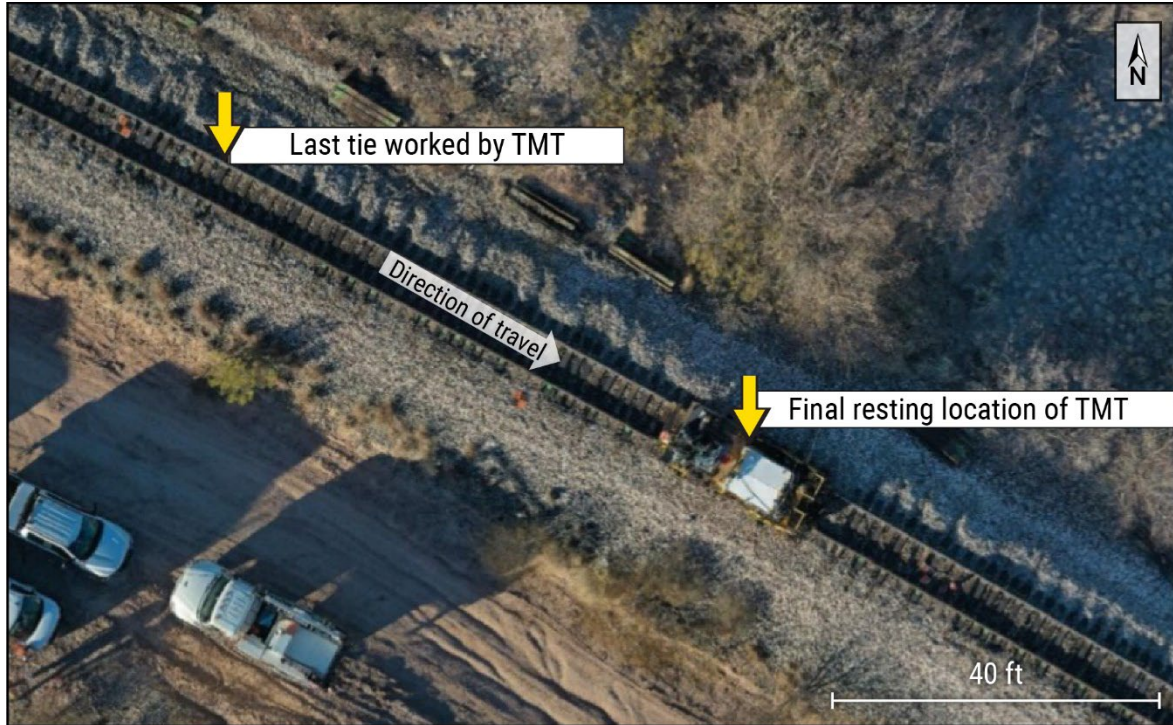
On January 31, 2021, about 12:40 p.m. local time, a Union Pacific Railroad (UP) employee was struck by a railbound track maintenance tamper (TMT) on a main track near Vail, Arizona.¹ The employee was airlifted to a hospital, where he later died from his injuries. The employee was part of a tie gang comprising about 50 people and 23 pieces of equipment, performing crosstie renewal and track surfacing.² Figure 1 shows the track where the fatality occurred and the final resting position of the TMT.

Figure 1. Aerial photograph of TMT in postaccident location. (Photo provided by Pima County Sheriff's Department.)

Postaccident observations revealed that the TMT had continued past about 15 crossties that would have required tamping, which was about 70 feet beyond where the TMT should have stopped.⁵

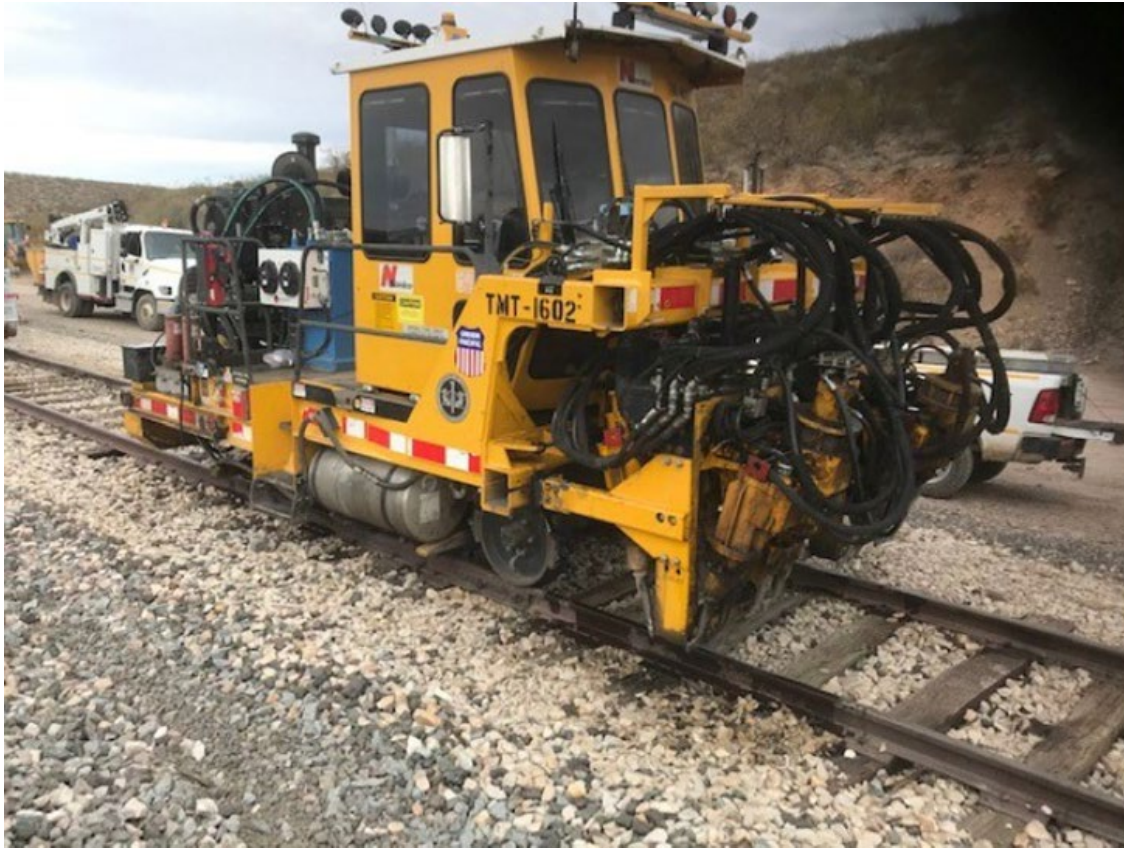
About 9:28 a.m., the tie gang had completed road maintenance machine inspections (including a Nordco, Inc. TMT) and began to move from the siding to the main track. (Figure 2 shows the TMT.) The TMT operator said that when work on the track began, he was tamping new crossties, and the ground worker was marking ties ahead of him by "spray(ing) the down ties" with paint to indicate that those crossties needed to be tamped.³ The operator of the machine ahead of the TMT reported that the ground worker was the appropriate distance from the machines ahead of and behind him. The TMT operator stated that as he was working, he would look down then forward to

Figure 2. Photo of TMT at the accident scene. (Photo provided by UP.)
