## CEN21LA151 (N3394V, Beech 35) – NTSB Examination Report

**SUMMARY OF AIRPLANE EXAMINATION**

-- CEN21LA151 --

Aircraft: Beechcraft 35, N3394V

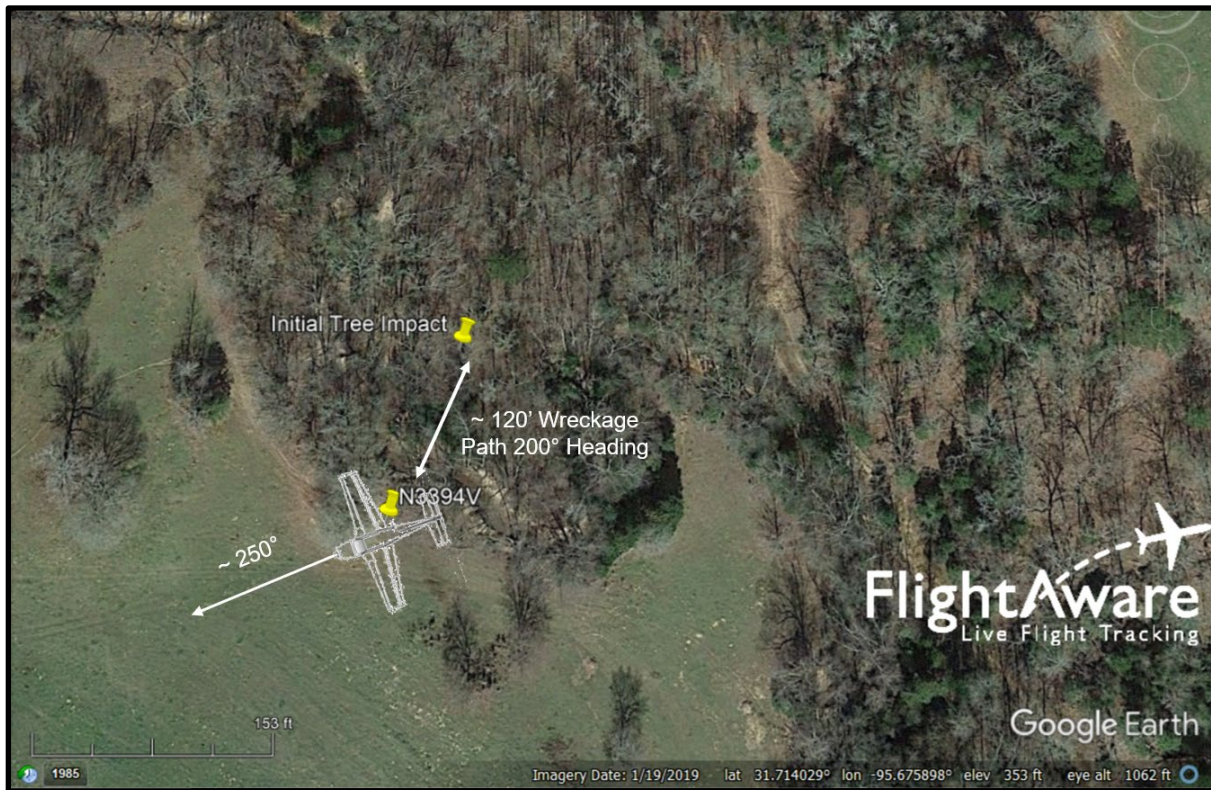
Figure 1 – Image of the accident site (courtesy of Textron Aviation).

- The airplane impacted private property in Palestine, Texas. The area is private property that has trees and pasture.
- The FAA North Texas FSDO (Lou Vargo – aviation safety inspector) and Textron Aviation (Casey Love – air safety investigator) responded to the accident site on March 7, 2021. The wreckage was documented and examined. The wreckage was recovered by Lone Star Retrieval.

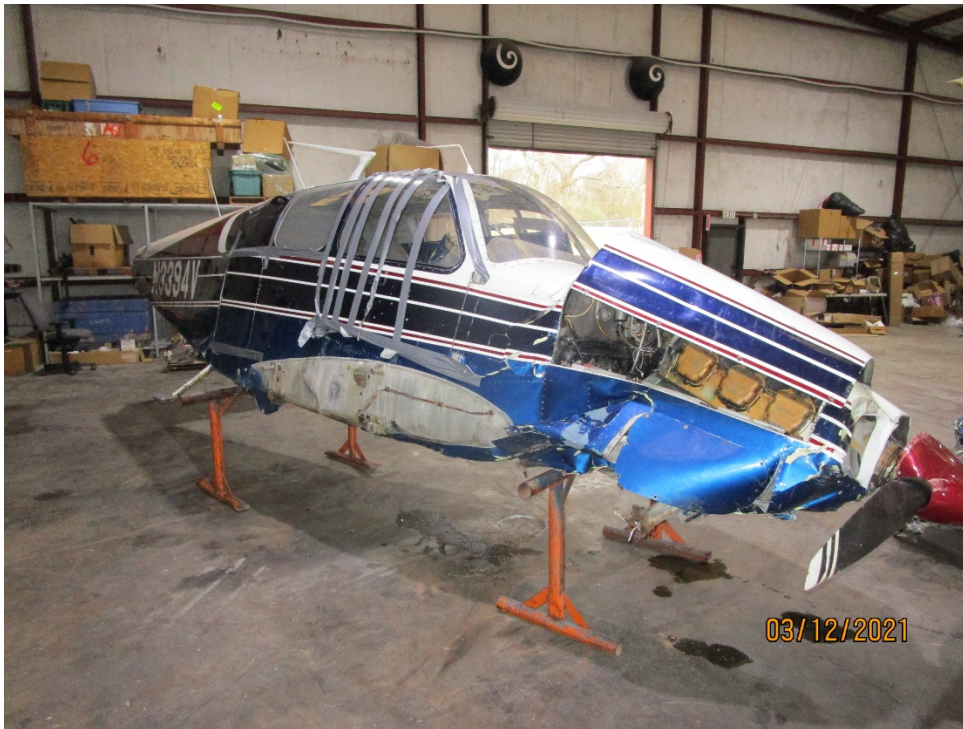
Airplane wreckage on stands, ready for inspection

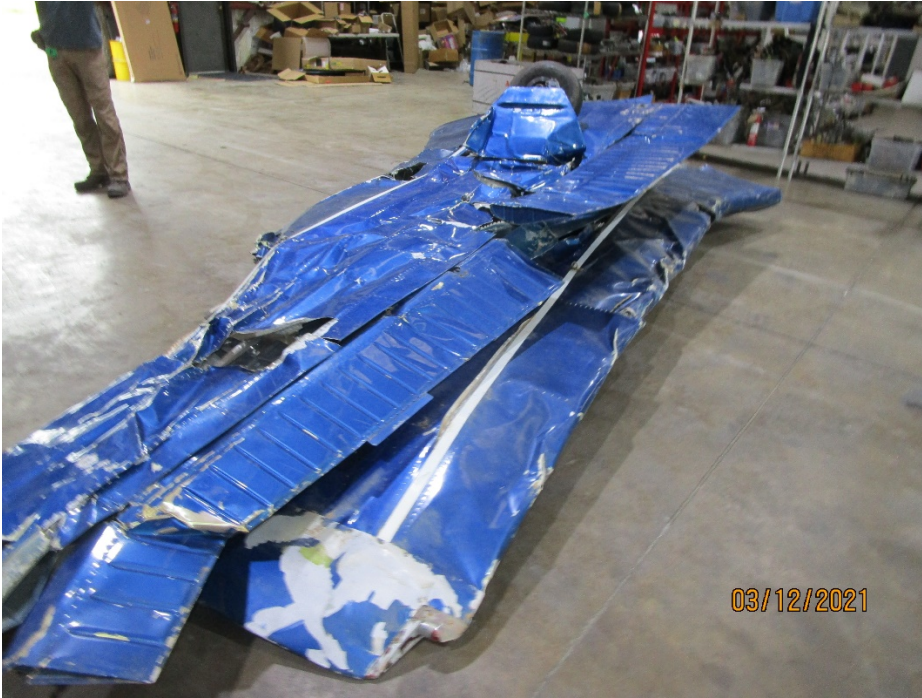
- The right wing of the airplane impacted trees from midspan to the tip. Fragments of the wing skin and wing tip were found along the debris path. All four corners were observed at the accident site. The left side of the fuselage contacted the wing, reducing the cabin volume. The empennage was intact. There was no post impact fire. The forward engine mounts were fracture separated from the engine.

Heavy damage was noted to both wings

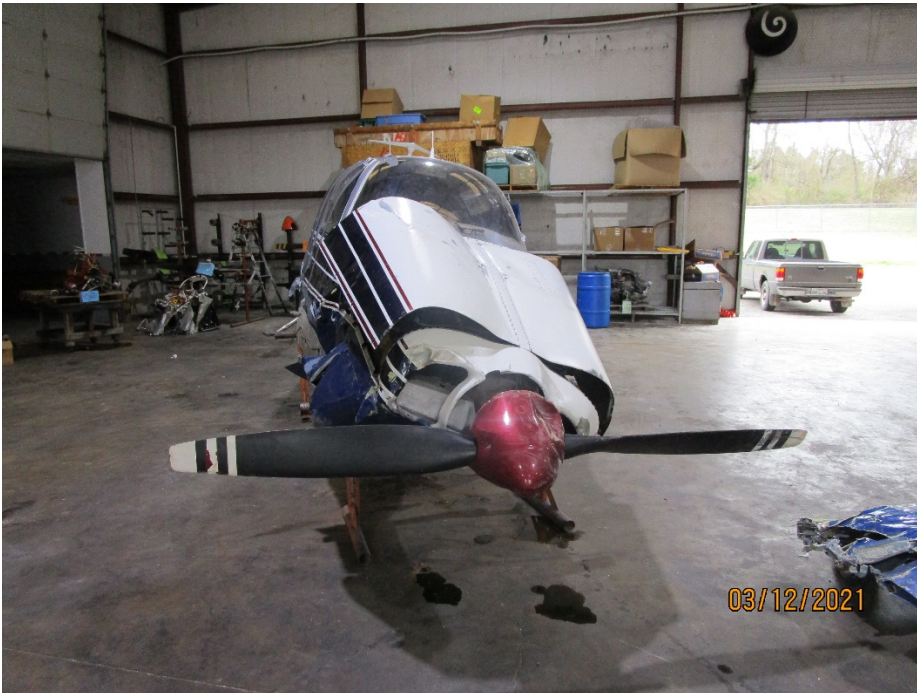
2-bladed propeller appeared to be absent power signatures

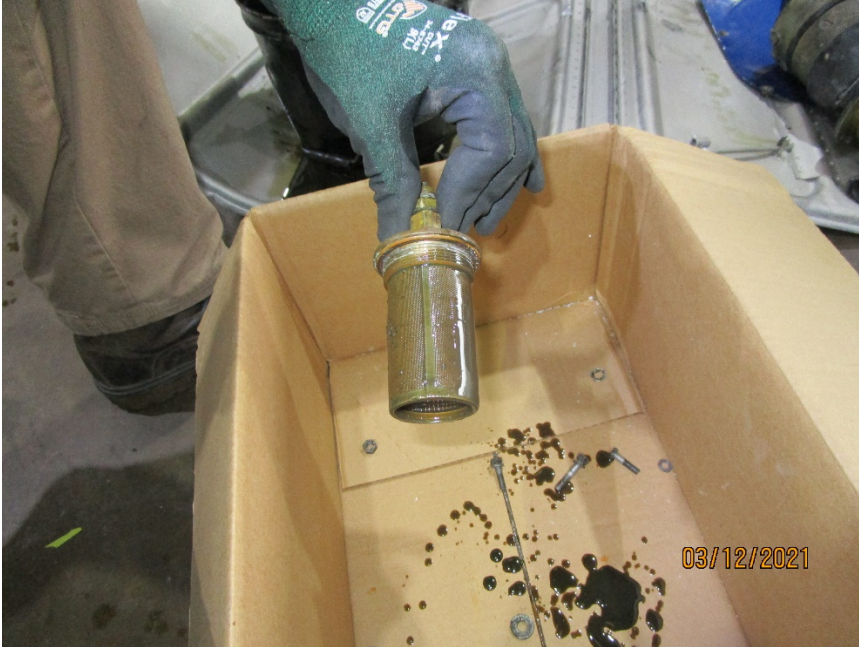
- Each cylinder was examined using a borescope; no abnormalities were noted with either the intake or exhaust valves.
- Oil screen was removed; the screen contained unidentified contaminates.

Oil screen contained unidentified contaminants

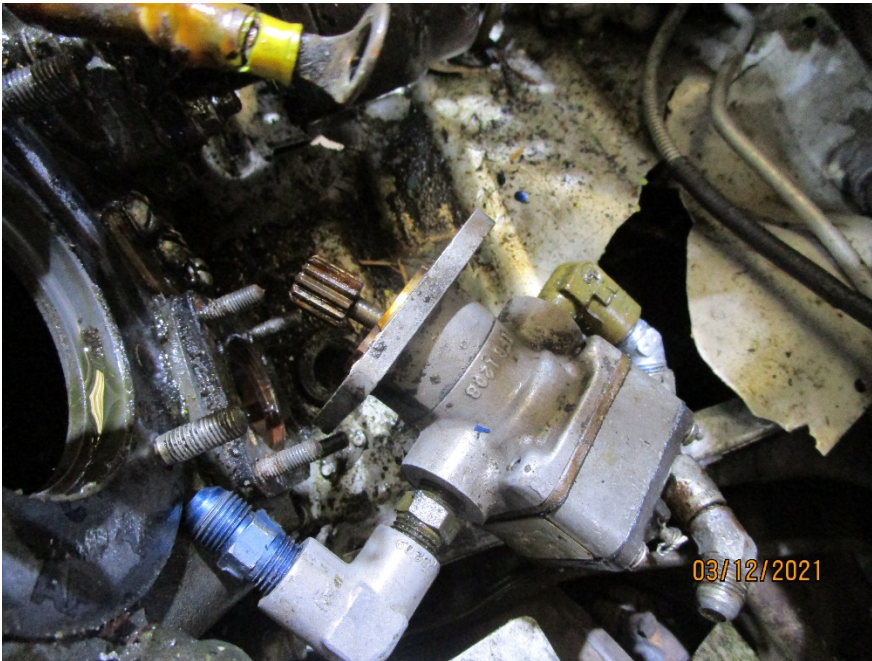
Fuel pump drive coupling, intact, pump rotated freely

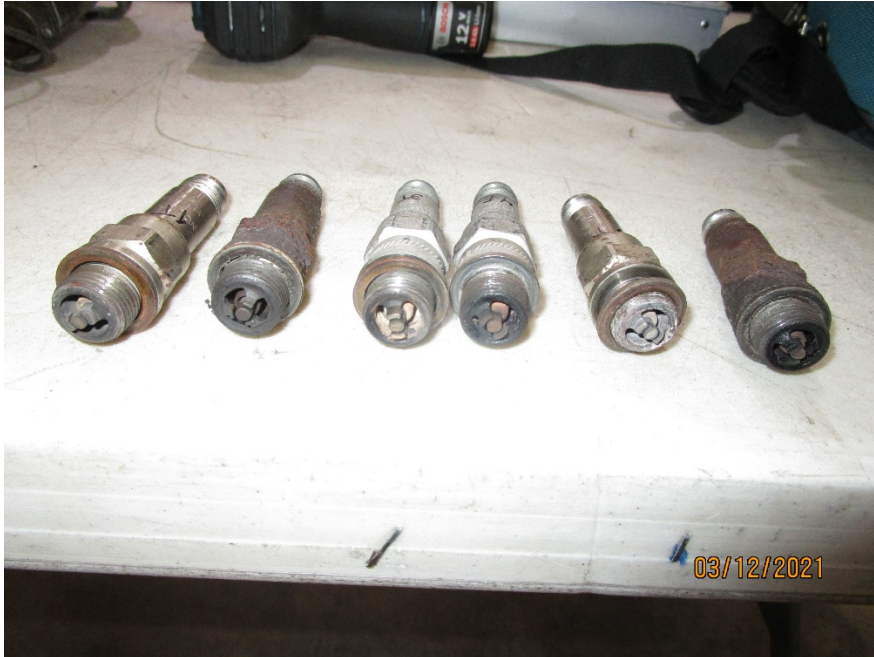
Mixture of old and new sparkplugs

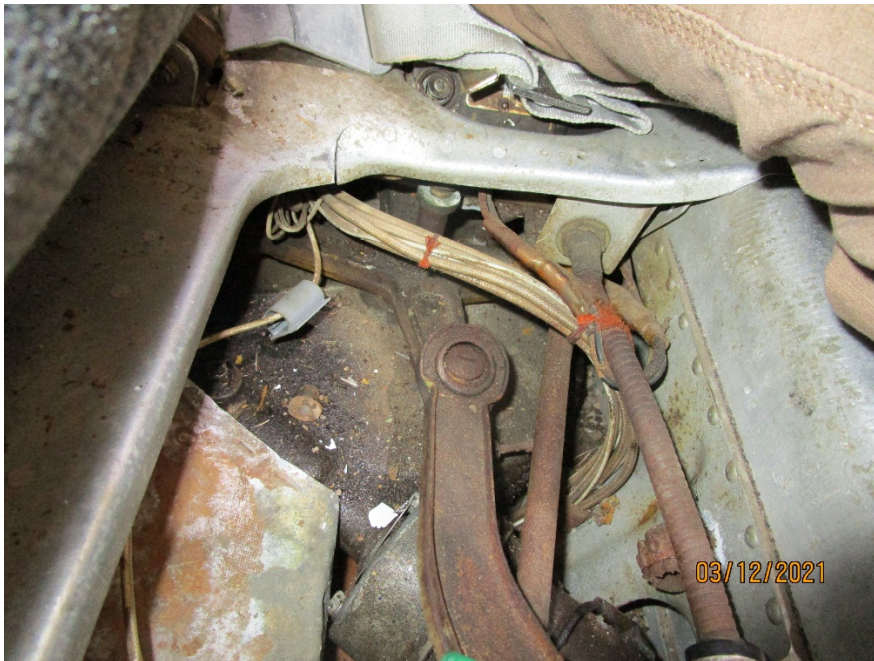
- The landing gear circuit breaker was observed in the tripped position.
- The right landing gear was displaced upward through the wing.
- The nose gear was folded to the right.
- The left landing gear was folded toward the up position and rested on the outside of the closed gear door.

Landing gear circuit breaker was “popped”. Gear indicator in the down position  
And landing gear motor, indicate the landing gear was in the down position.

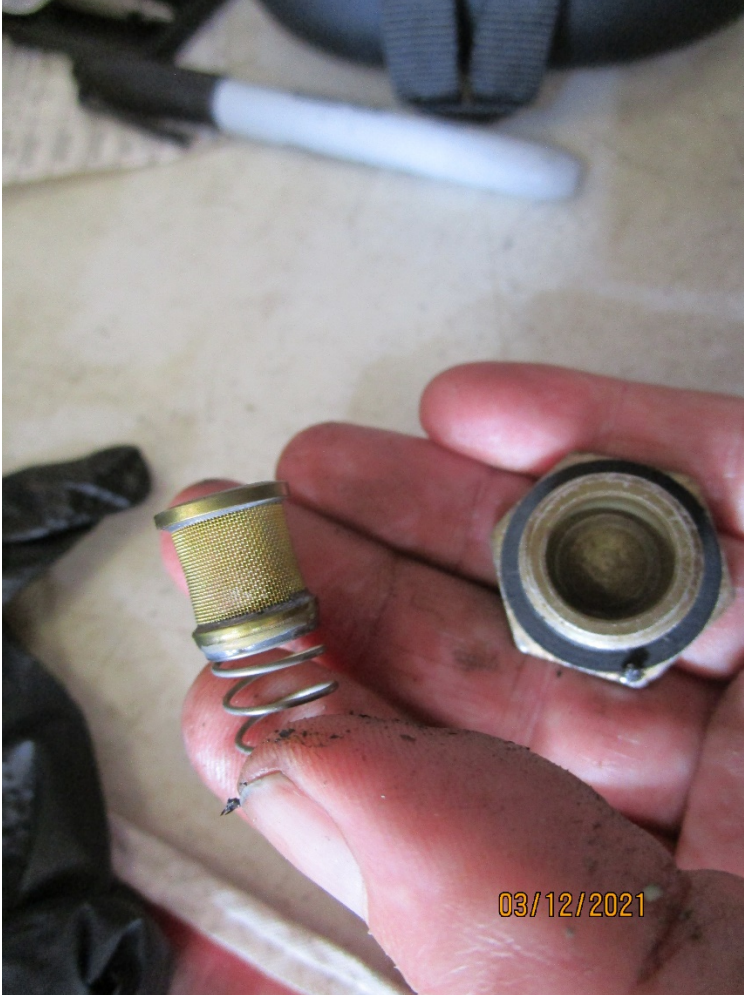
- The carburetor had broken free from the bottom of the engine during the accident sequence.
  - The controls remained attached to the carburetor. The inlet fuel screen for the carburetor was clear of debris.

Fuel screen from the carburetor; clear of contaminants.

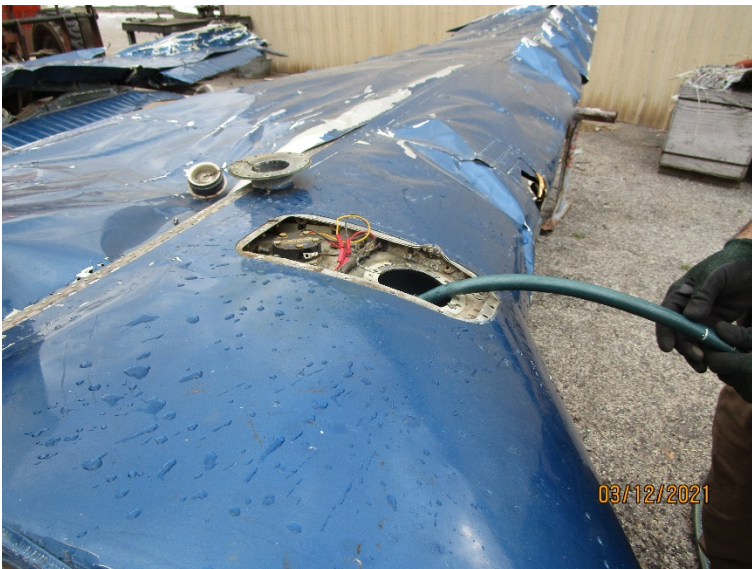
Testing fuel tank for leaks

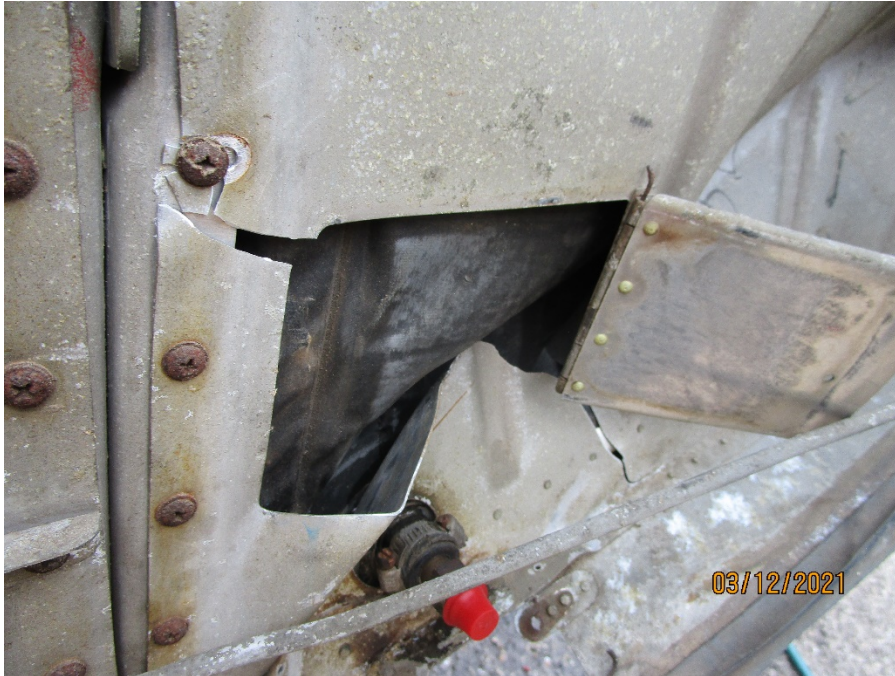
- After the visual examination, both bladders were leak checked using water. The right-wing bladder was not breached. The fuel drain valve leaked at a rate of one drop approximately every 5 seconds. The left-wing bladder was punctured by a fracture in the inboard wing rib. The puncture was roughly in the lower one third between the upper and lower surface of the bladder and 2" to 3" from the aft wall of the bladder. The puncture measured approximately  $\frac{1}{2}$ " in length and produced a steady and noticeable stream of water during the leak test. It was undetermined if other leaks existed in the bladder.

- The airplane had two wing fuel tanks and a 20-gal aux tank, located behind the rear seat.
- The fuel pickup point was capped off on the left wing, and water from a garden hose, was used to fill the wing fuel tank. After a few minutes, water appeared to be leaking from the tank. An aluminum piece of sheet metal, at the wing root appeared to have punctured the fuel bladder. The procedure was repeated on the right wing; this time no water appeared to leak.

Left sided did leak, there appeared be a post-cash puncture at the wing root

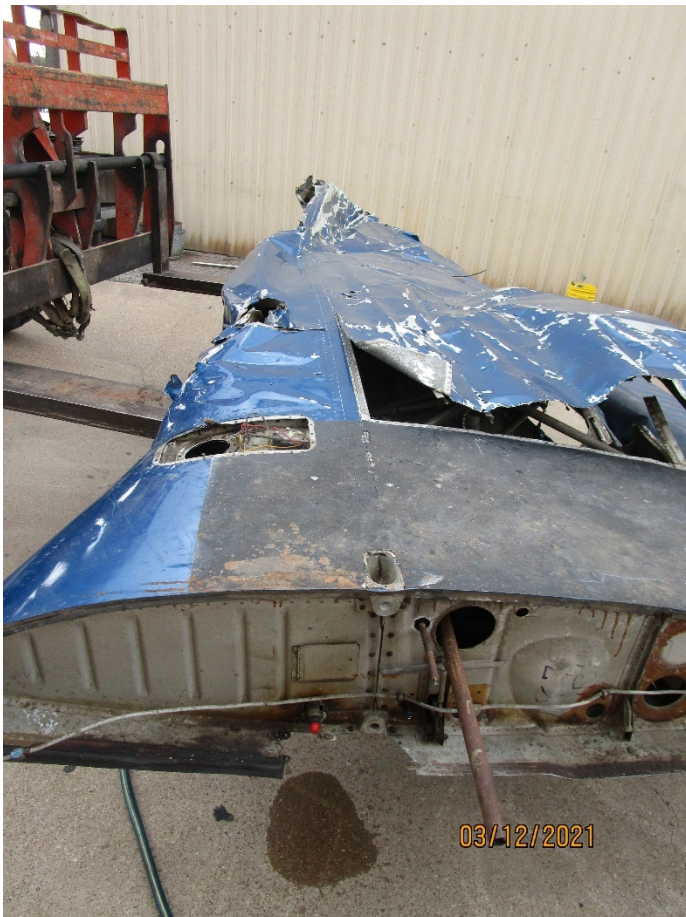
Water test was repeated for the right wing

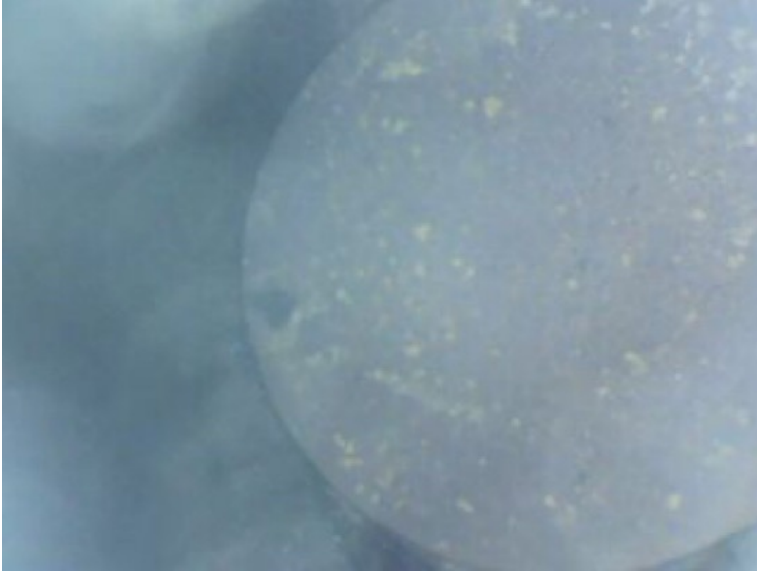
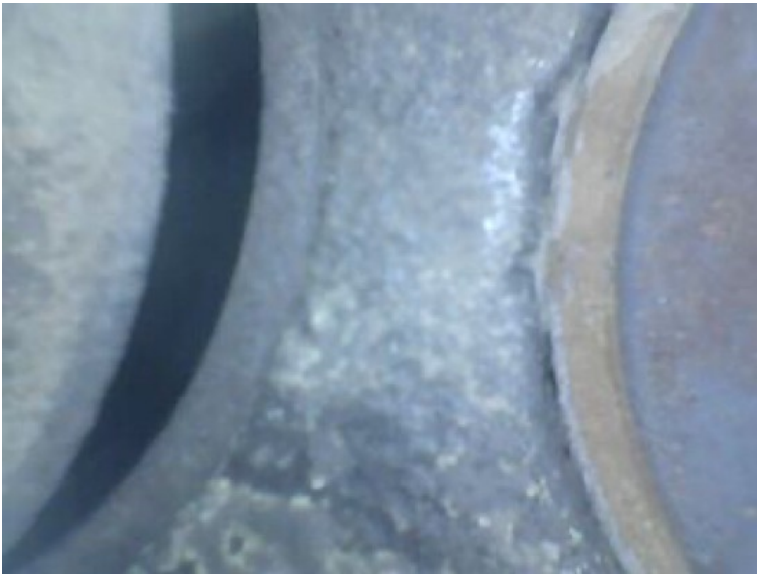
A borescope was used to inspect the engine's intake and exhaust valves
